**SUBJECT: Stream Buffer Reduction and Enhancement for Forest Creek Lot 1
5222 Forest Ave SE, Parcel 141030-0057, Mercer Island, WA
Revised (City File # CAO24-032)**

FIGURE 1: EXISTING CONDITIONS
SEASCOPE HOMES
FOREST AVE - BUFFER MITIGATION PLAN
MERCER ISLAND, WASHINGTON
PARCEL 1410300057

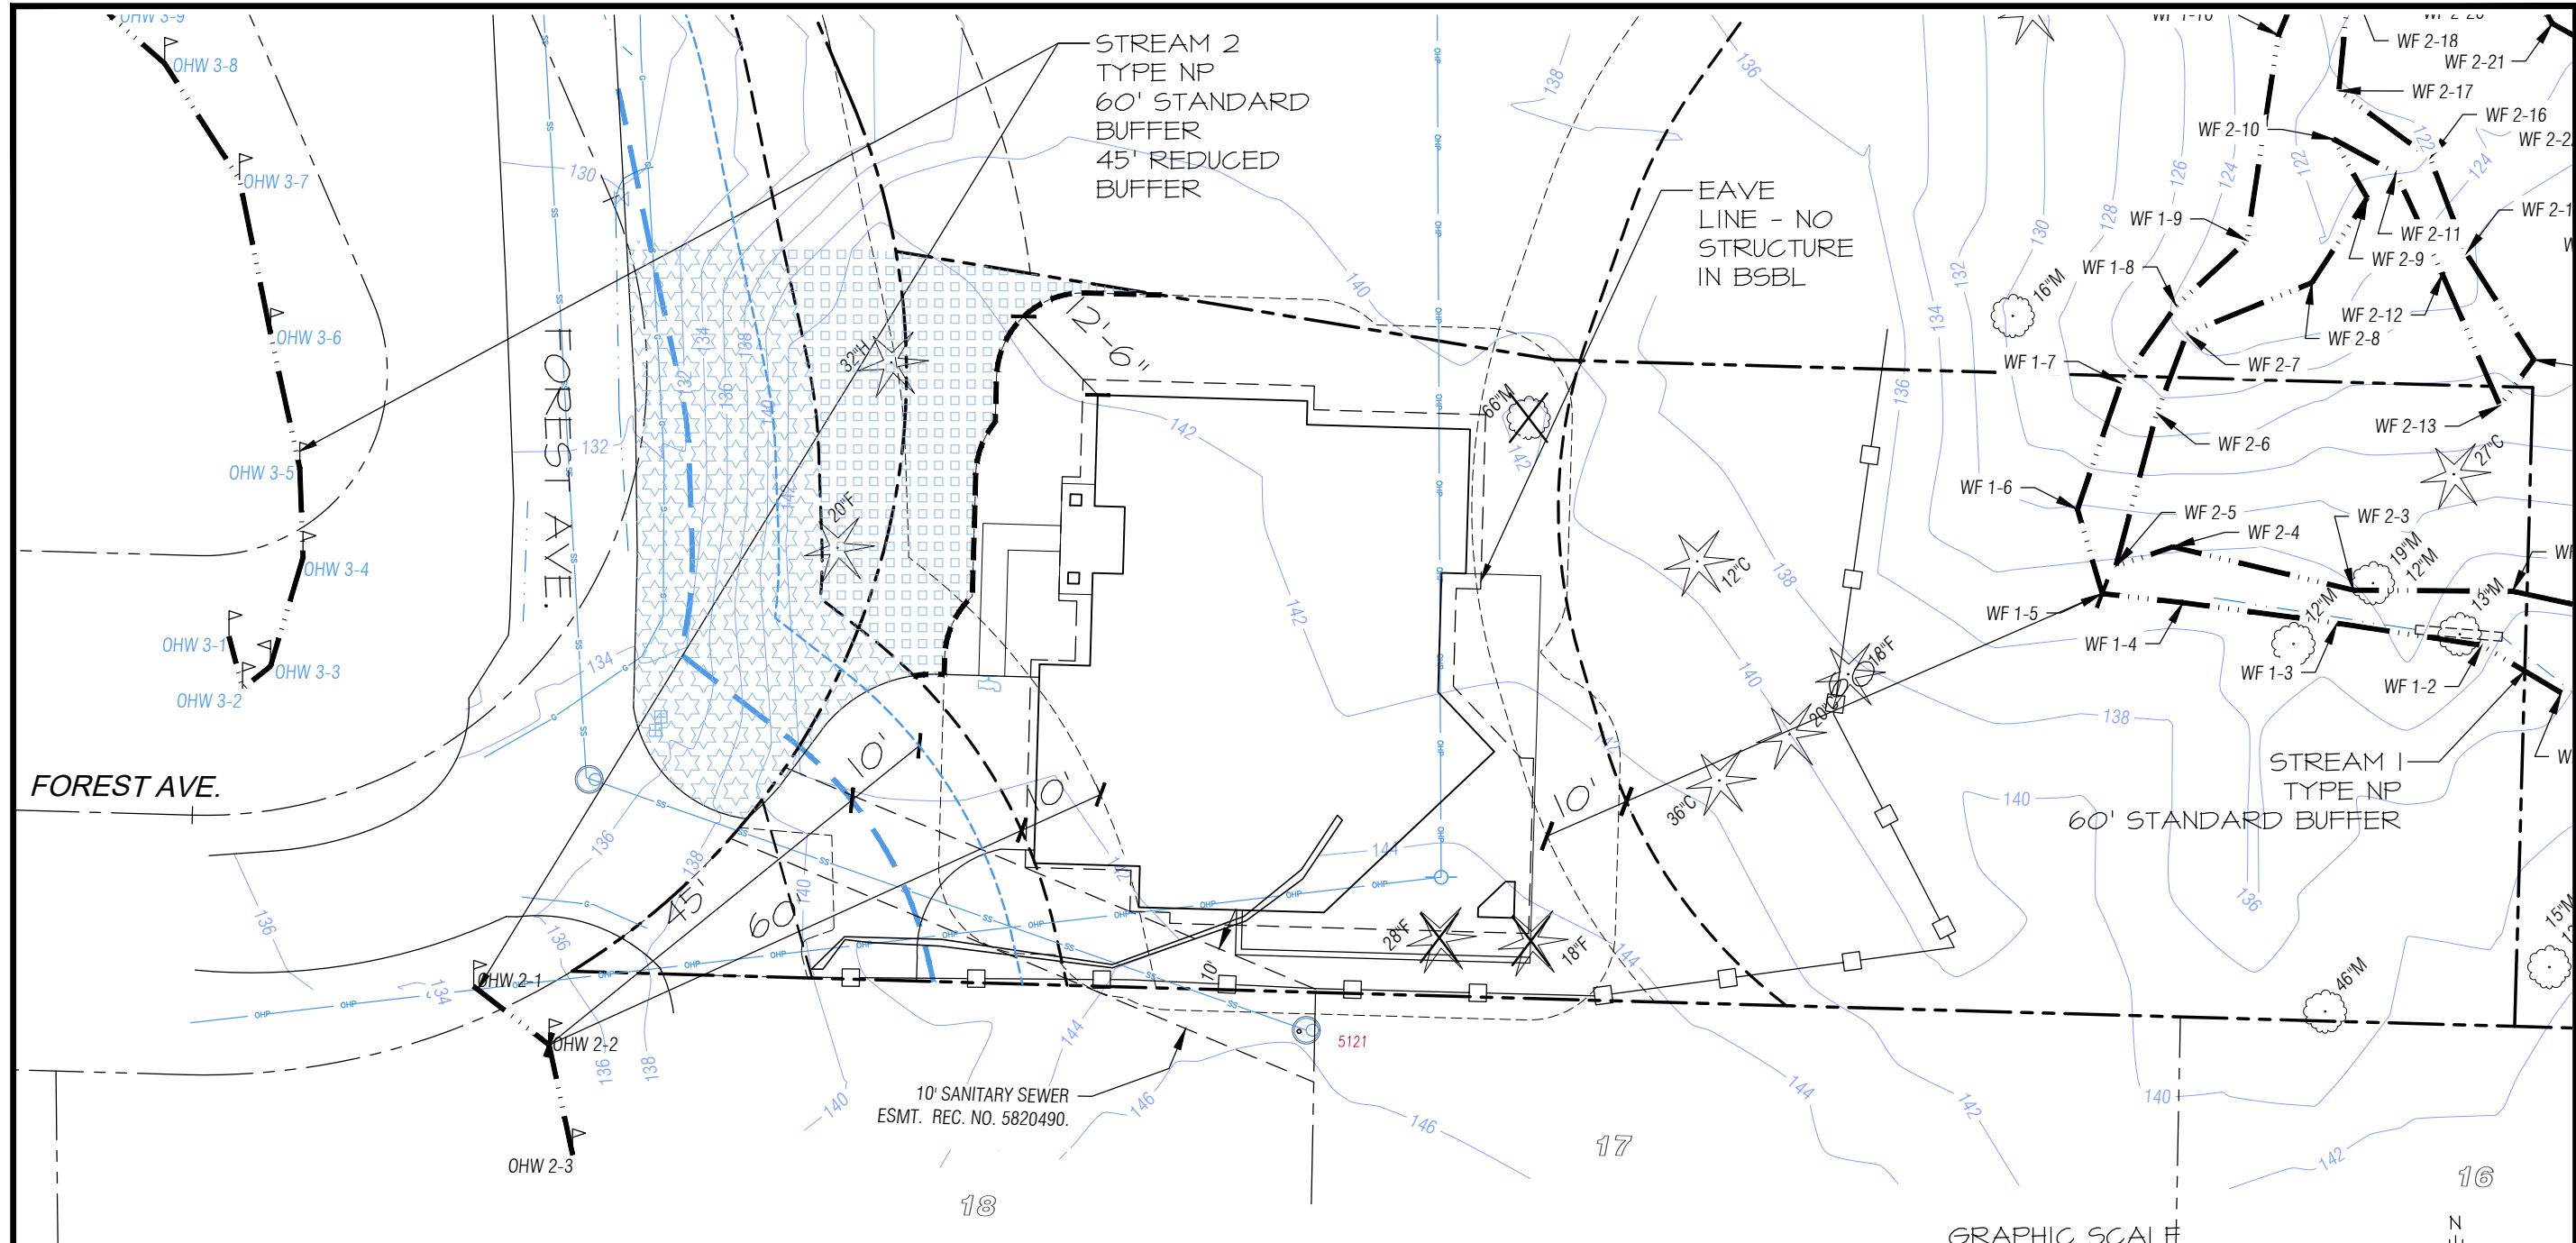
FIGURE 2: SITE PLAN
SEASCAPE HOMES
FOREST AVE - BUFFER MITIGATION PLAN
MERCER ISLAND, WASHINGTON
PARCEL 1410300057

The standard 60-foot watercourse buffer from Stream 2 currently extends into the southwest portion of the site and the required location of the proposed residence. A reduced buffer is proposed for Stream 2. No buffer reduction is proposed for Stream 1

The Stream 2 watercourse buffer will be reduced from 60 feet to 45 feet in places and will not be less than 75% of the standard buffer.

- BUFFER ENHANCEMENT - HAND REMOVE HIMALAYAN BLACKBERRY AND ENGLISH IVY AROUND EXISTING SNOWBERRY, SWORD FERN, TALL OREGON GRAPE, AND DOUGLAS FIR. REPLANT AT 75% PLANTING DENSITY 1,375 SF
- BUFFER REPLACEMENT WITH ENHANCEMENT - PLANT AT 100% PLANTING DENSITY 934 SF

The proposed project would not reduce the buffer adjacent to any significant native vegetated areas and would only reduce the Stream 2 buffer in one small area in the vicinity of the existing access drive.

The existing preserved buffer in the far western portion of the site and the adjacent right-of-way in the vicinity of the preserved trees would be restored with native plantings. Tree protection and construction limit fencing will be installed as required.

Although the area of proposed buffer impact is currently degraded and does not provide a significant functional benefit to the watercourse, we have prepared a compensatory mitigation planting plan (**Figures 1 through 5**) that will increase the habitat functions of the watercourse buffer over current conditions. It is our understanding that the City of Mercer Island does not want trees planted in the right-of-way so the enhancement plan focusses on shrubs in that area.
