**Subject: Geotechnical Report Addendum
Mercer Island 3-Lot
7621 Southwest 22nd Street
Mercer Island, Washington
RGI Project No. 2020-404-1**

Mercer Island 3-Lot
 Site Vicinity Map
 Address: 7621 Southeast 22nd Street, Mercer Island, Washington 98040

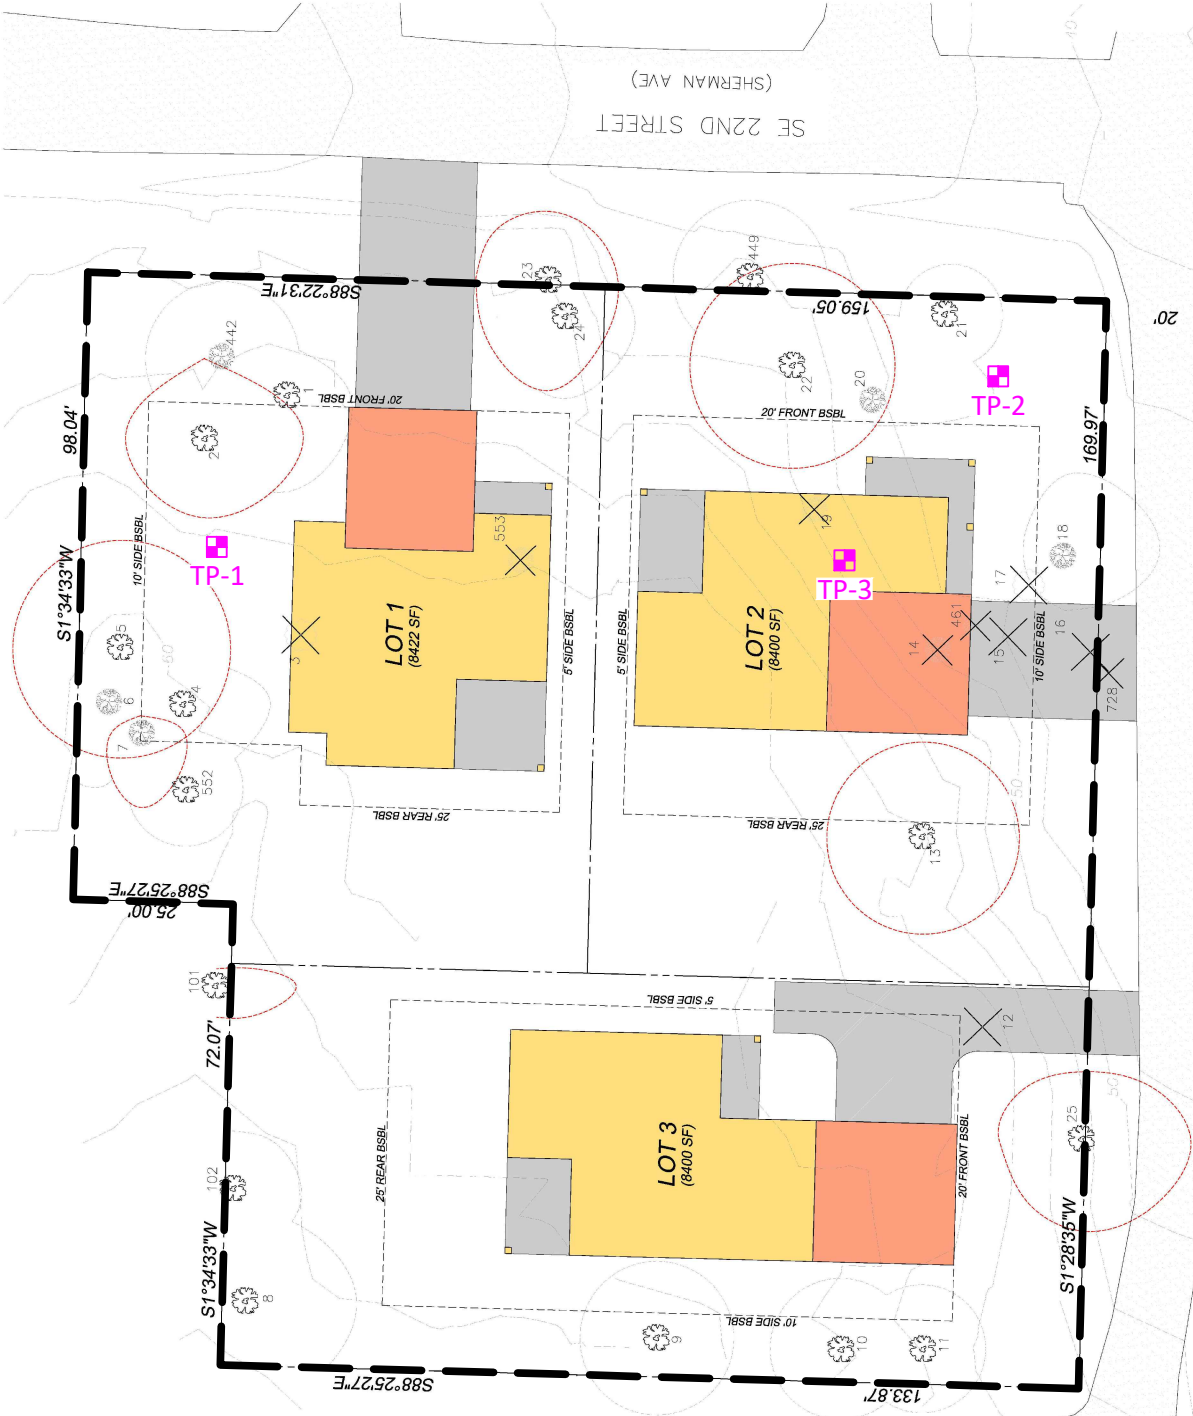
Mercer Island 3-Lot		Figure 2
RGI Project Number: 2020-404-1	Geotechnical Exploration Plan	Date Drawn: 09/2020
Address: 7621 Southeast 22nd Street, Mercer Island, Washington 98040

■ = Test pit by RGI, 08/28/20
 = Site boundary

On August 28, 2020, RGI observed the excavation of three test pits across the site. The approximate exploration locations are shown on Figure 2.
