MMC LLC

Subject: Critical Area Ordinance (CAO) Report
Mehlhaff Mercer Island – Critical Area Ordinance (CAO)
4854 E Mercer Way, Mercer Island, WA 98040

QG Project No.: QG25-100

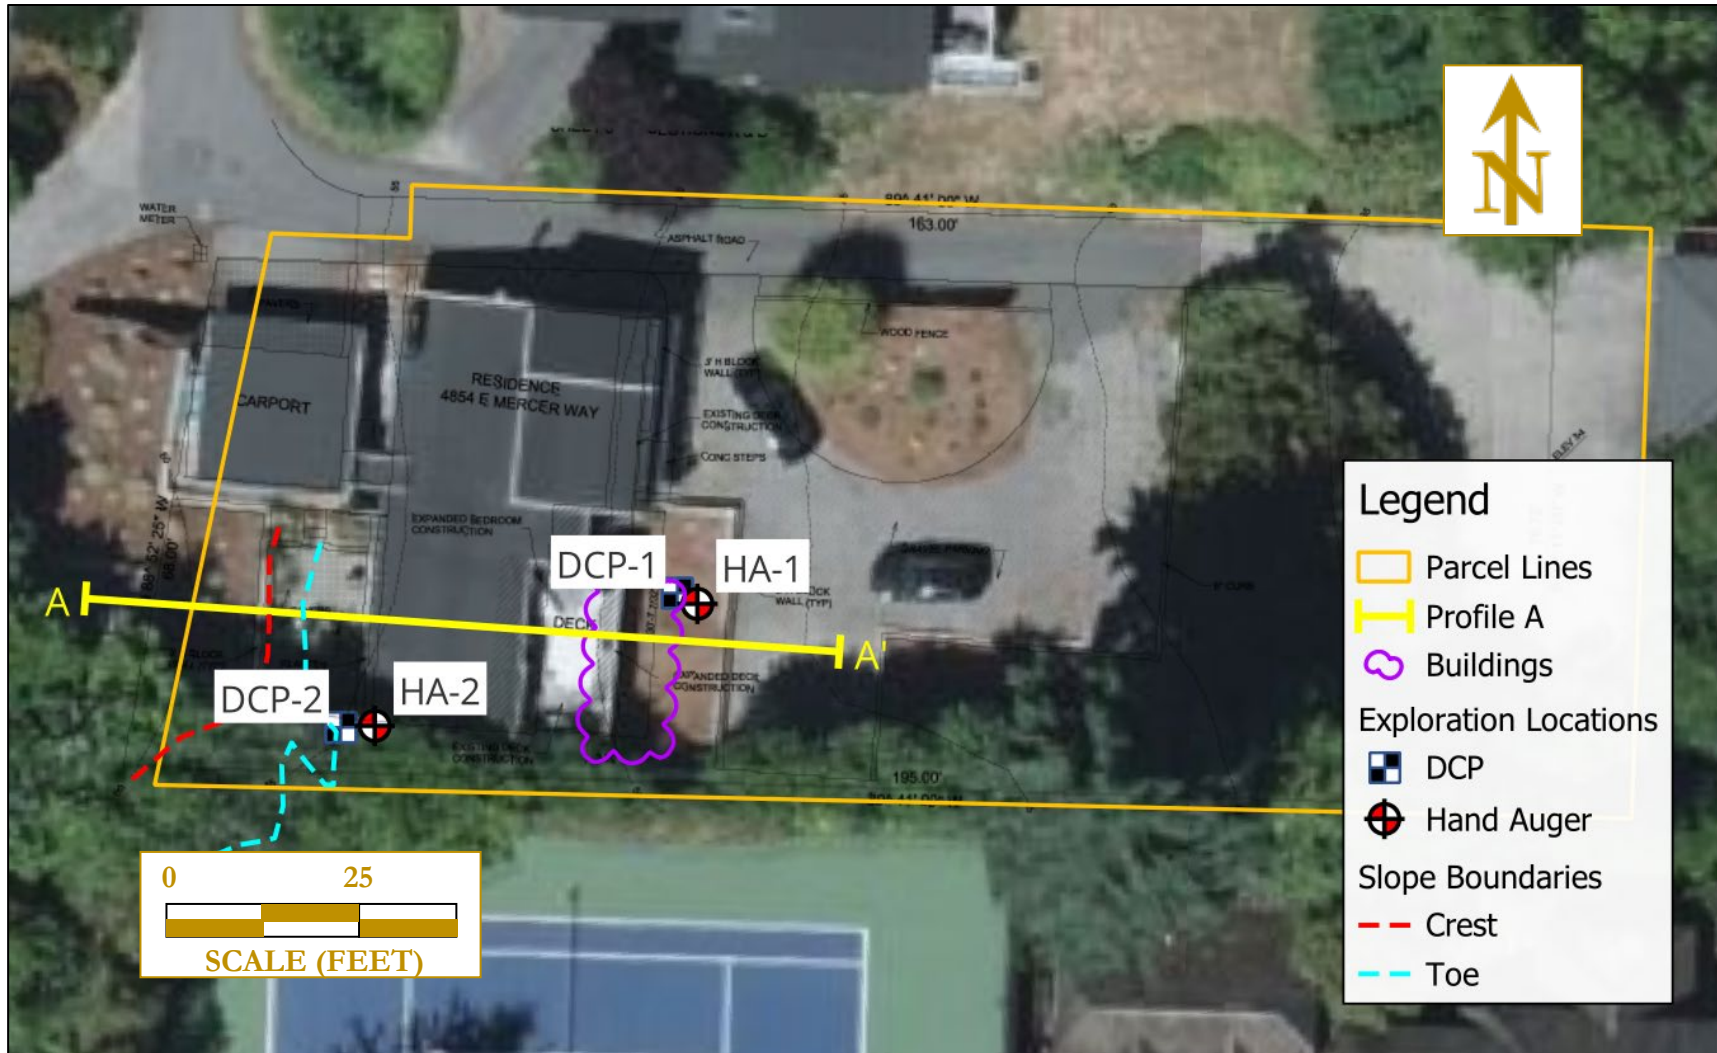
Figure 2

Site Map
4563 33rd Ave S CAO

Source: King Co. GIS, 2025
Scale & Locations are approx.
Not for Construction

The project site is a developed residential parcel containing a local slope and is roughly rectangular in shape, sloping downward to the east. There are three retaining walls on the property, all approximately 3 feet in height. The current slope on site descends to the east at a rate of about 3H:1V before encountering the first wall and continues at 3H:1V before encountering the second wall. The slope is vegetated with a few shrubs. After the second wall is a patio before encountering the existing home. To the east of the home is flat before encountering the third retaining wall. To the north, east, south, and west are residential homes and Lake Washington is to the east.

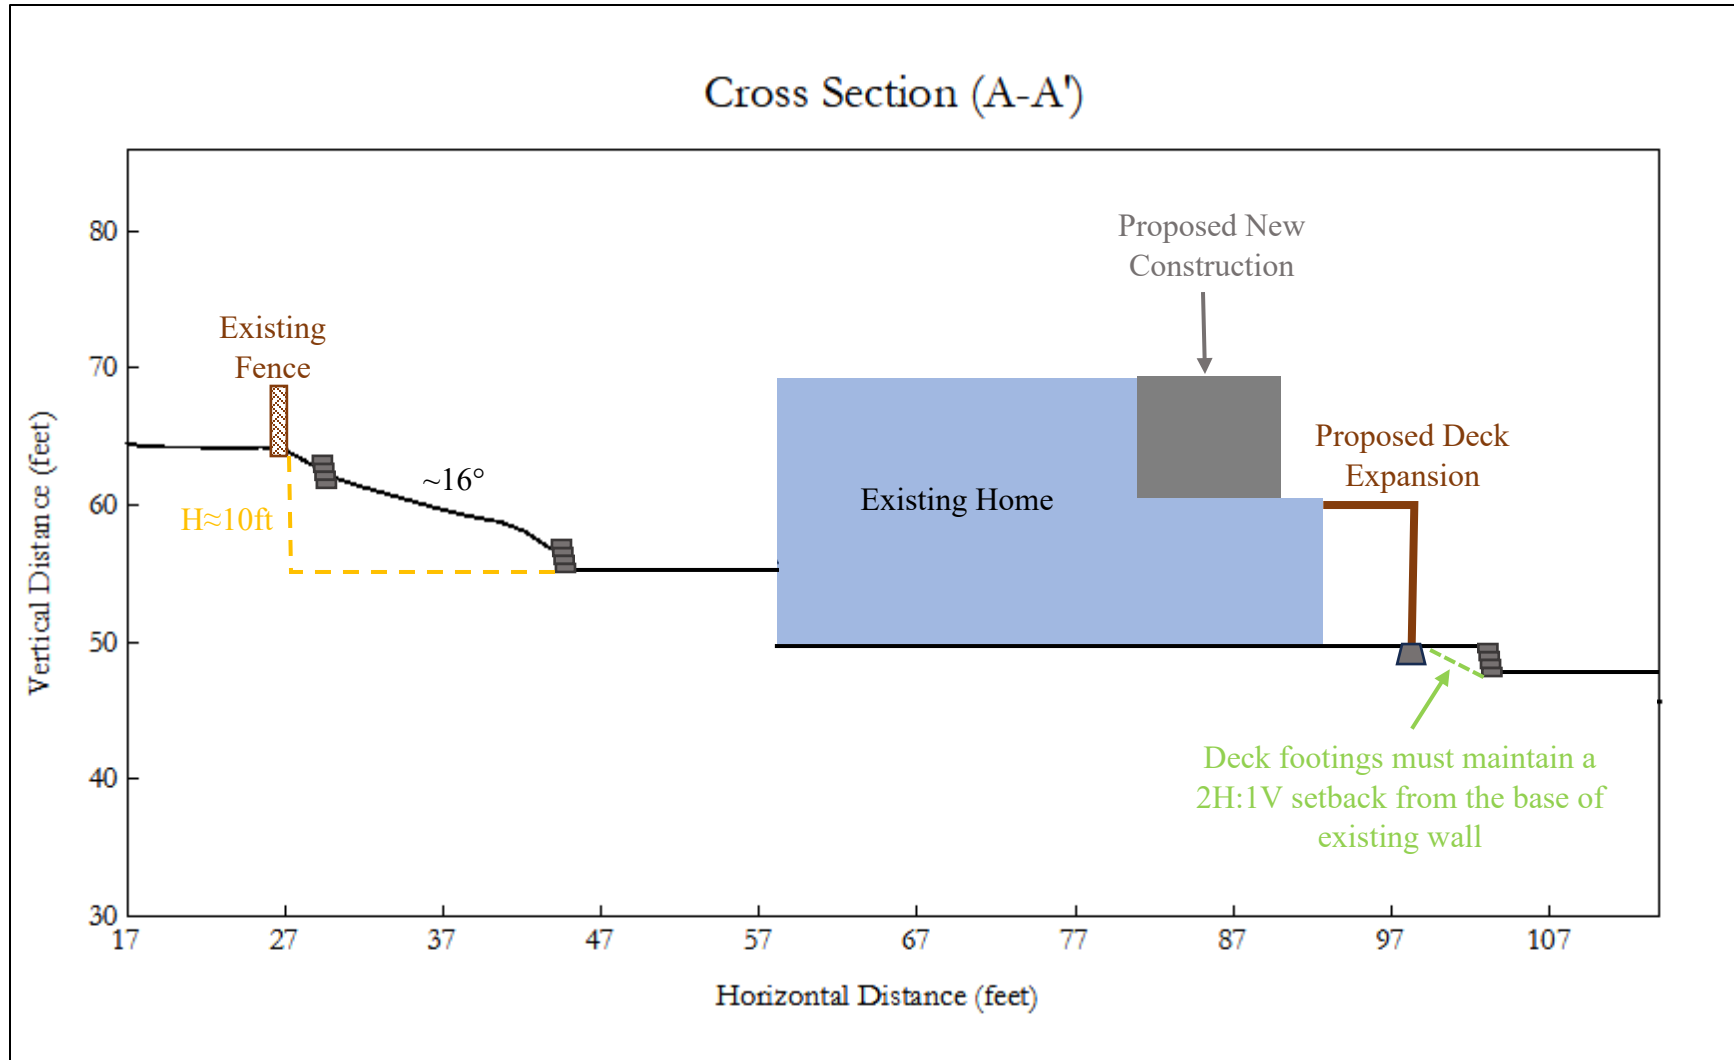
Figure 3

Slope Profile A – A'
Mehlhoff Mercer Island CAO

Source: WA LIDAR & Hand Measurements
Scale & Locations are approx.
Not for Construction

QG reviewed existing topographic data and general site observations made during our visit to infer general slope setbacks based on height and inclination of the typical slopes present on the site in proximity to the proposed structure.

Considering the existing site modifications, including the construction of landscape walls, QG does not prescribe a slope setback for the proposed deck addition. However, deck footings should be embedded below or maintain a 2H:1V setback from existing wall. The proposed new construction location appears suitable. The setback does not prohibit lightweight surface improvements such as septic, uncovered decks, patios, walkways, landscaping, pathways, etc. (if approved by the project engineer).
