DRAINAGE REPORT

LORENZINI SFR LOT 2
4719 86TH AVE SE Mercer Island, WA

DRS Project No. 21071
Mercer Island Permit No. XXXX-XXX

D. R. STRONG Consulting Engineers, LLC
620 7th Ave.
Kirkland WA 98033
(425) 827-3063

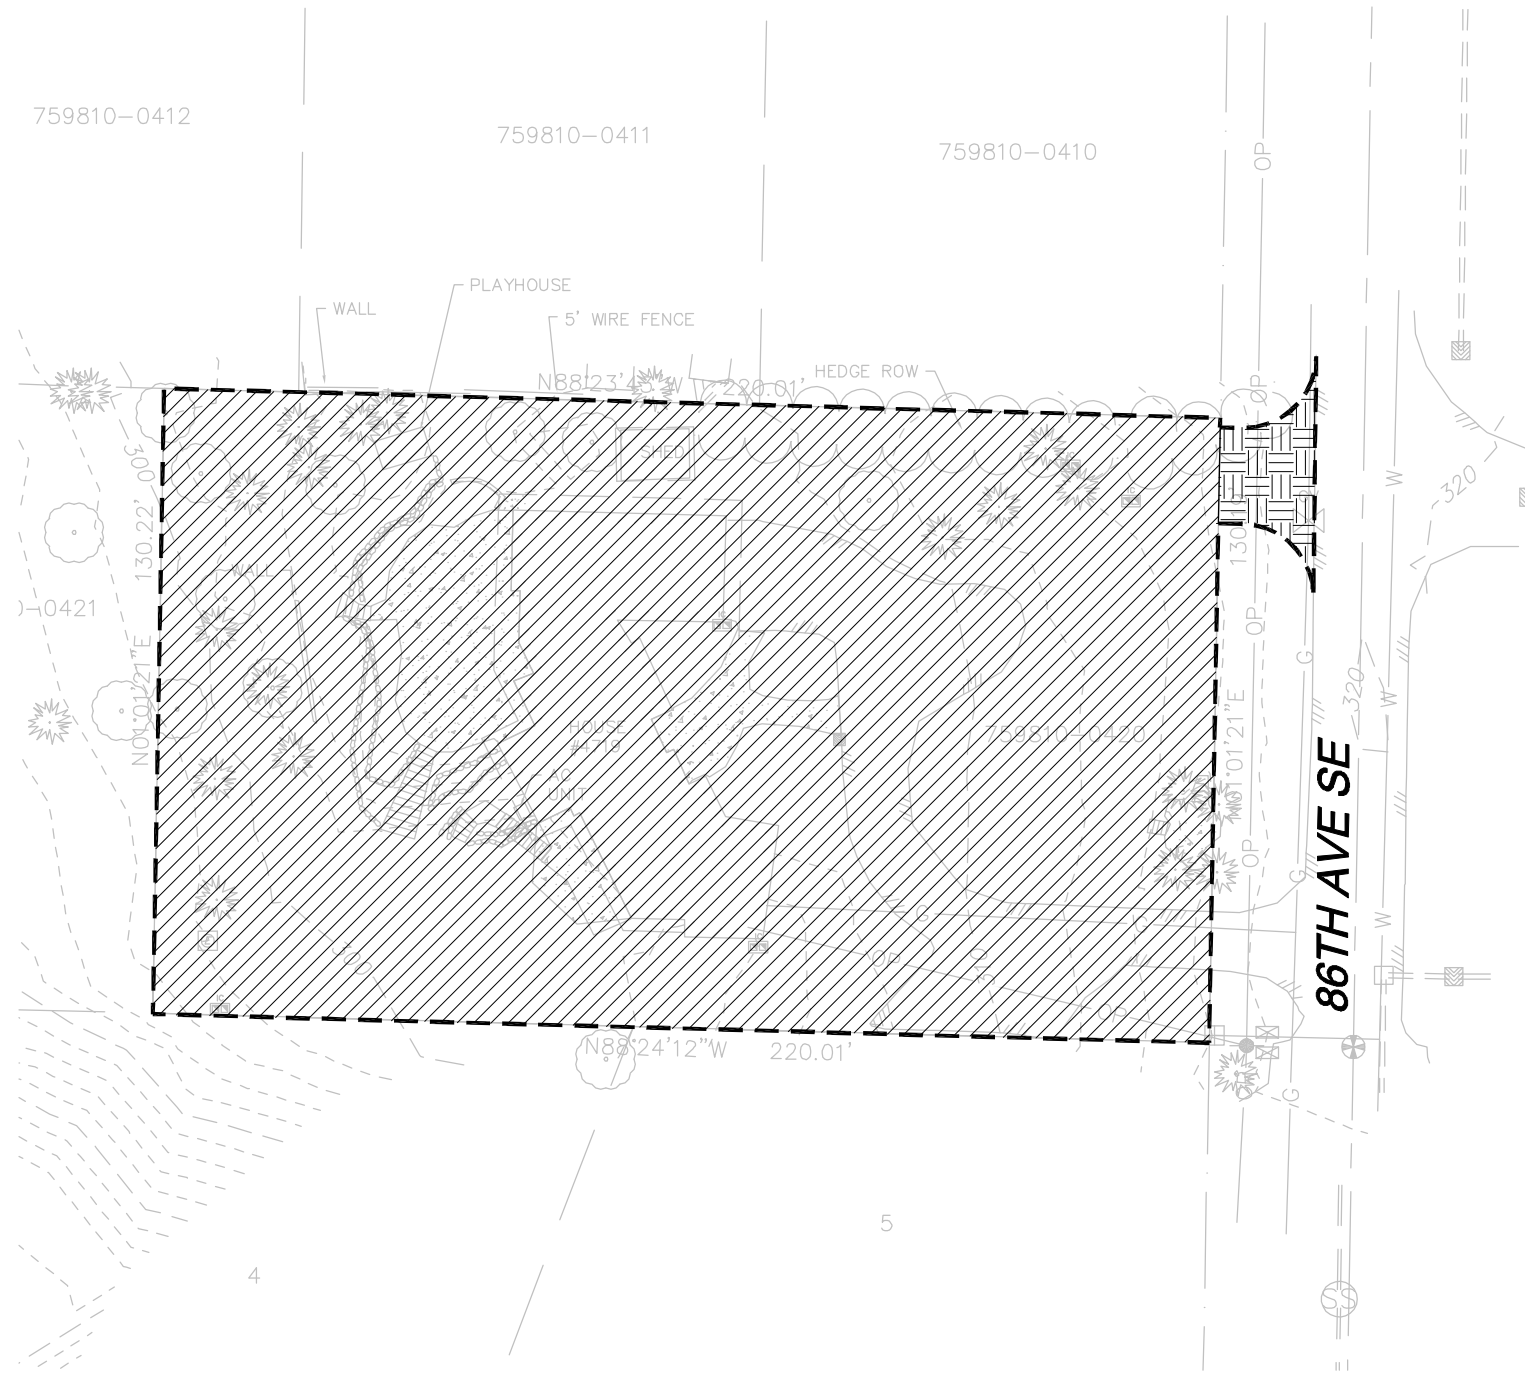
FIGURE 3 DEVELOPED FIGURE

Predeveloped and Developed Figures shown for entire Short Plat due to single system for both proposed lots.

TOTAL SITE/PROJECT AREA: 29,138 S.F. (0.669 ACRES)

ROW:	494 S.F. (0.011 ACRES)
	PERVIOUS:	0 S.F. (0.000 ACRES)
	IMPERVIOUS:	494 S.F. (0.011 ACRES)
