DRAINAGE REPORT

LORENZINI SFR LOT 2
4719 86TH AVE SE Mercer Island, WA

DRS Project No. 21071
Mercer Island Permit No. XXXX-XXX

D. R. STRONG Consulting Engineers, LLC
620 7th Ave.
Kirkland WA 98033
(425) 827-3063

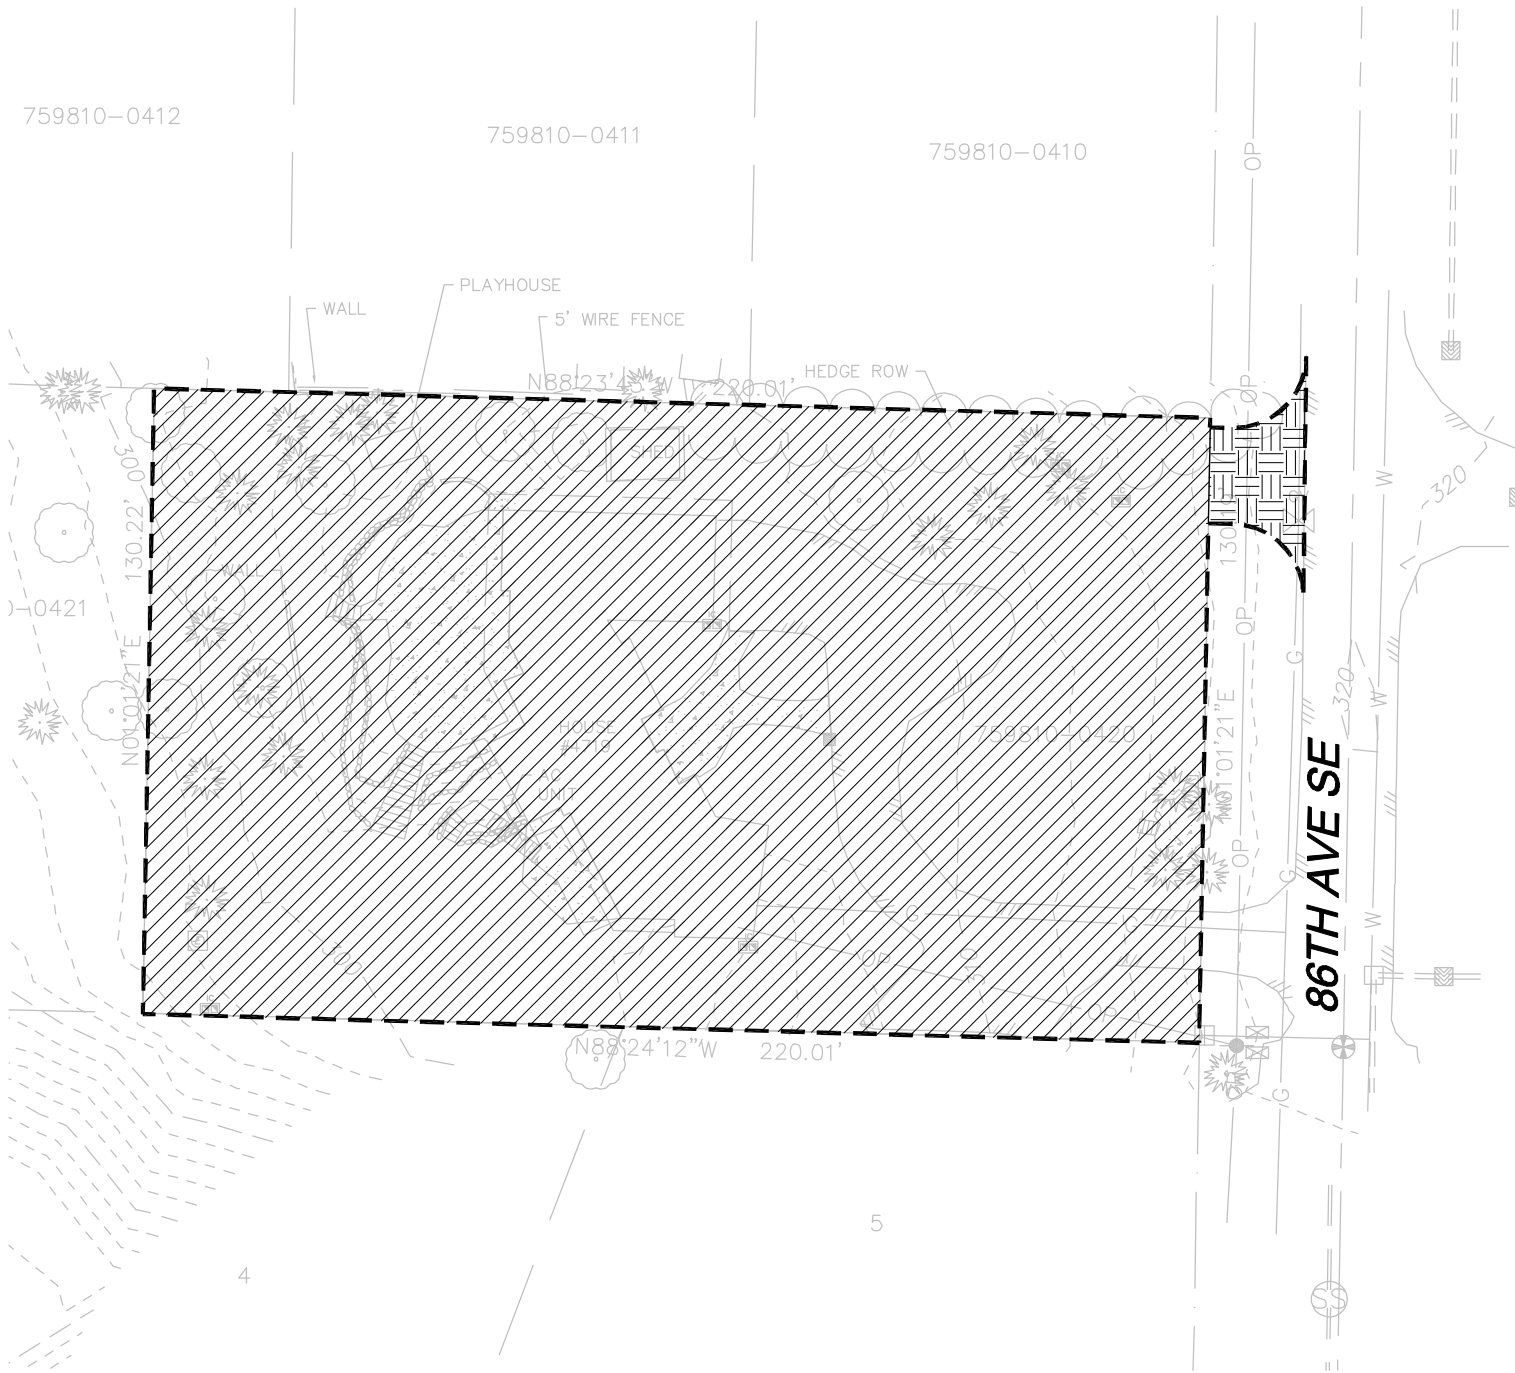
FIGURE 3 DEVELOPED FIGURE

Predeveloped and Developed Figures shown for entire Short Plat due to single system for both proposed lots.

TOTAL SITE/PROJECT AREA: 29,138 S.F. (0.669 ACRES)

ROW:	494 S.F. (0.011 ACRES)
	PERVIOUS:	0 S.F. (0.000 ACRES)
	IMPERVIOUS:	494 S.F. (0.011 ACRES)

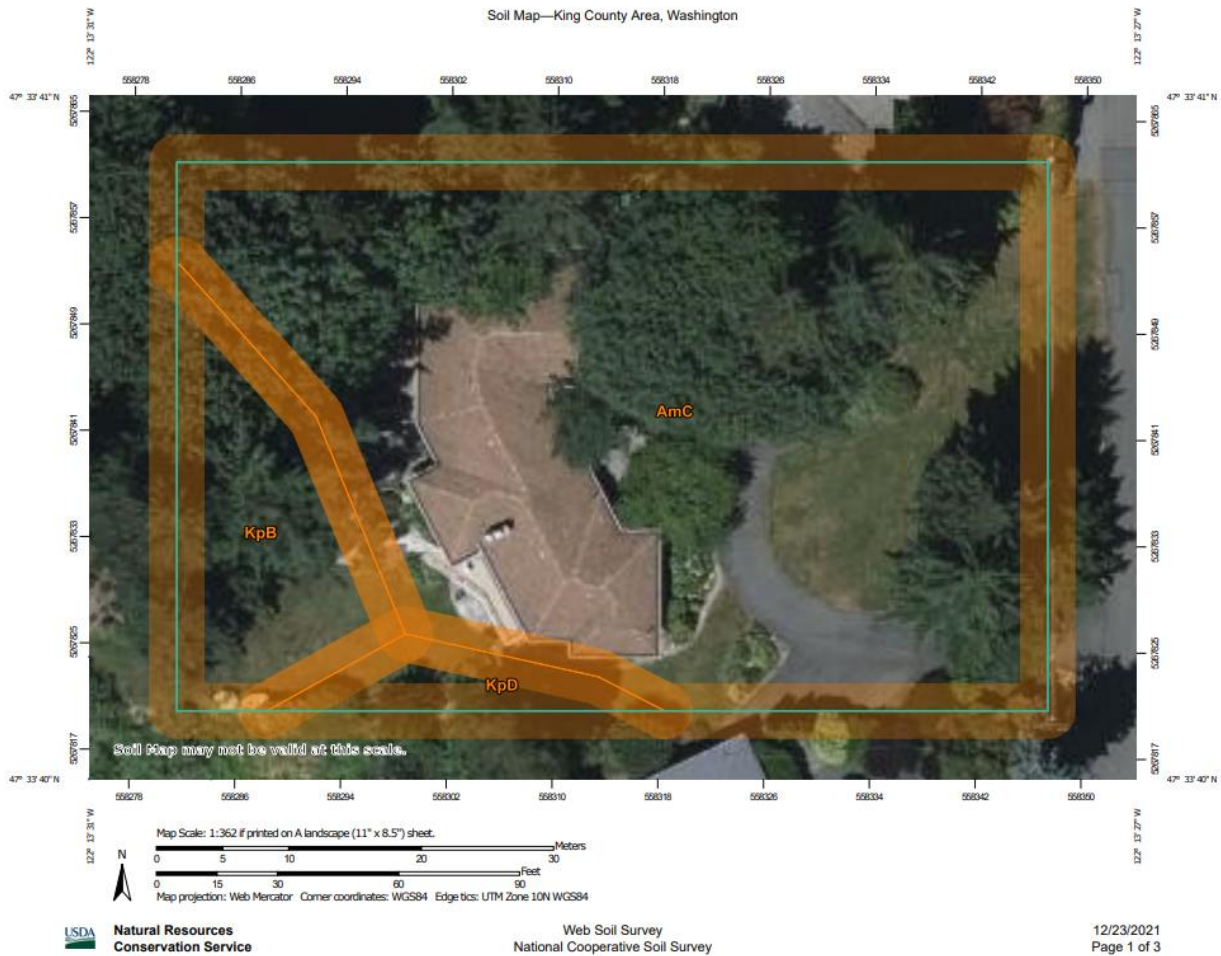
FIGURE 4 SOILS MAP

AmC—Arents, Alderwood material, 6 to 15 percent slopes

National map unit symbol: 1hmsq
Elevation: 50 to 660 feet
Mean annual precipitation: 35 to 60 inches
Mean annual air temperature: 50 degrees F
Frost-free period: 150 to 200 days
Farmland classification: Prime farmland if irrigated

The USDA Web Soil Survey describes the soil on Site as Arents, Alderwood material, 6 to 15 percent slopes (AmC - 6-15% slopes), Kitsap silt loam, 2 to 8 percent slopes and Kitsap silt loam, 15 to 30 percent slopes.

A continuous simulation model, WWHM 2012, was used to analyze the pre- and post-developed runoff rates. The soil type is modeled as hydrologic soil group C for the Alderwood SCS classification as shown in Figure 4. In the pre-developed condition, the entire Site is modeled as %forest+. In post-development conditions, the soil types are unchanged from the pre-developed conditions. Pursuant to the 2019 Department of Ecology Stormwater Management Manual for Western Washington, Volume III-
