**GEOTECHNICAL ENGINEERING STUDY  
78<sup>TH</sup> AVENUE SOUTHEAST SINGLE-FAMILY RESIDENCE  
4115 – 78<sup>TH</sup> AVENUE SOUTHEAST  
MERCER ISLAND, WASHINGTON**

**ES-10099**

**PREPARED FOR**  
**RKK CONSTRUCTION, INC.**

**November 15, 2024**

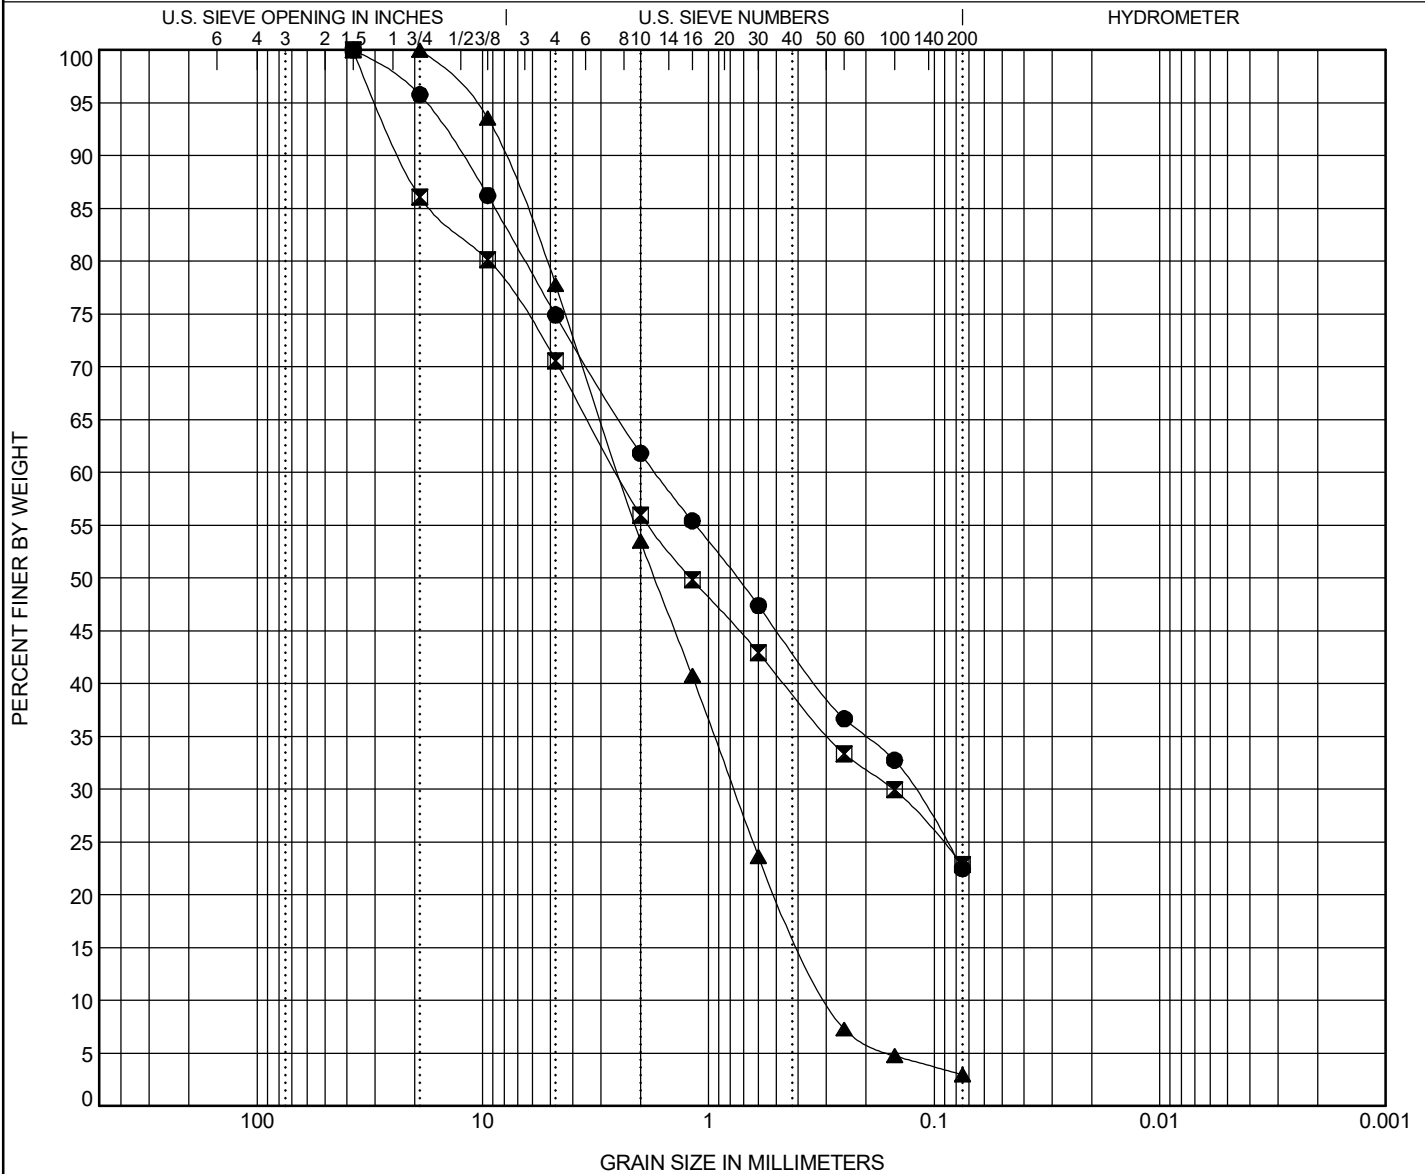
GRAIN SIZE USDA ES-10099 78TH AVENUE S.E. SFR.GPJ GINT US LAB.GDT 10/10/24

COBBLES	GRAVEL		SAND			SILT OR CLAY
	coarse	fine	coarse	medium	fine

Specimen Identification	Classification							Cc	Cu
● TP-01 6.00ft.	USDA: Brown Very Gravelly Sandy Loam. USCS: SM with Gravel.								
☒ TP-02 1.50ft.	USDA: Brown Very Gravelly Sandy Loam. USCS: SM with Gravel.								
▲ TP-03 5.50ft.	USDA: Brown Very Gravelly Coarse Sand. USCS: SP with Gravel.							0.82	8.72

Underlying the topsoil, native soils encountered at the test locations were observed to be medium dense grading to dense silty sand with gravel (Unified Soil Classification, SM) and poorly graded sand with gravel (SP). These soils are consistent with the typical makeup of glacial till with the exception of the poorly graded sand with gravel which could represent the advance outwash layer typically observed below a till cap in glacial depositional environments. ESNW was unable to explore deeper to determine the thickness of the outwash sands due to the limits of the excavation equipment provided by the client. Density was observed to increase with depth. In general, the native soil was generally encountered in a moist condition during the time of exploration.
