FACET

Drainage Report – Rev 1

ADDRESS: 6423 E Mercer Way Mercer Island, WA 98040

**FOR SUBMITTAL TO:
CITY OF MERCER ISLAND**

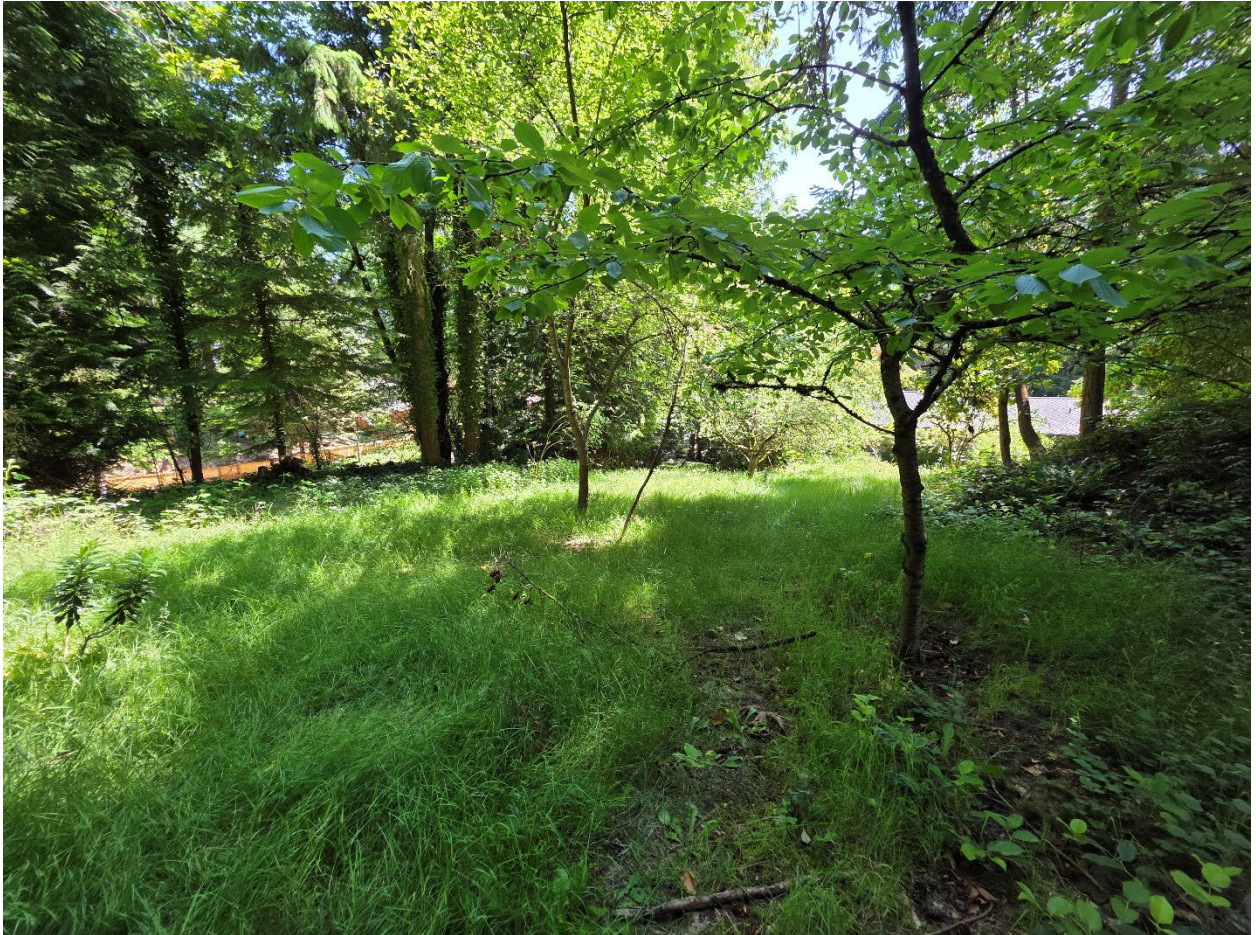
Plate 1 – General conditions of the property, looking downslope to the east from the approximate location of the currently proposed house, where the ridge crest broadens. (6/18/2025)

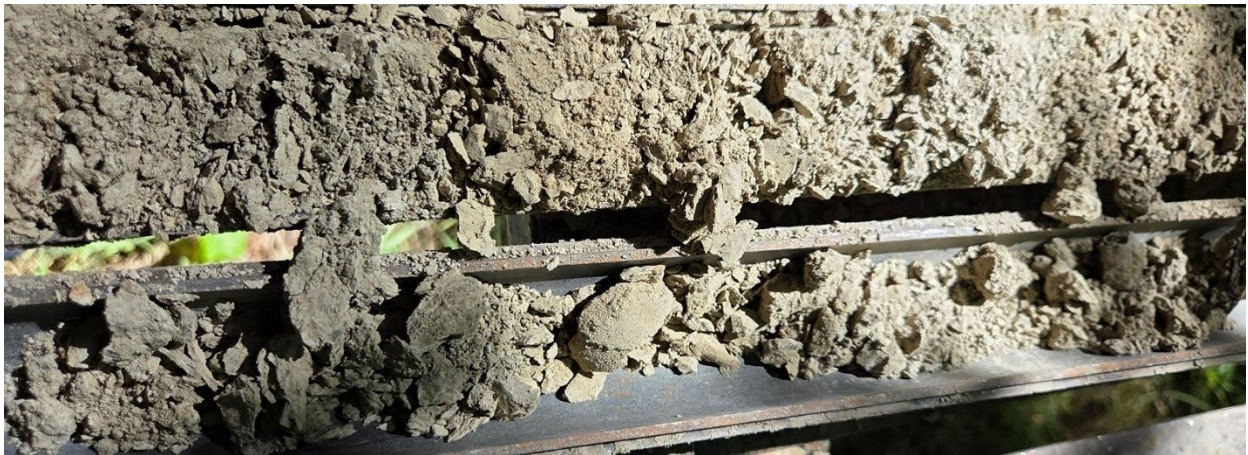
Plate 4 – Pre-Olympia, Non-glacial Fine Grained: Hard, sandy SILT (Qponf) | PG-1-25, S-4 @ 7½ – 9 feet.

Selected Sample Photos: Plates 4 through 6 below depict select soil samples obtained from our recent test borings. For reference purposes, the split-soon samplers pictured below have an outside diameter of 2 inches.

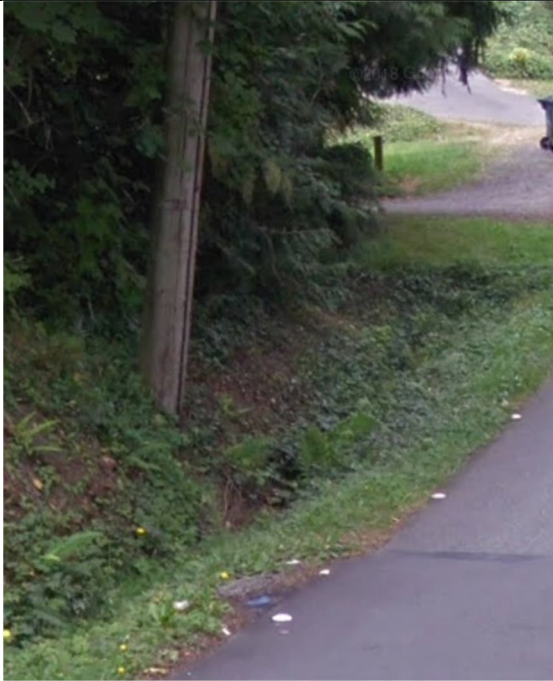
Photo 1 (looking north): culvert flowing north into type 1 catch basin. 8" corrugated polyethylene pipe flowing north.

There was no visual indication of conveyance system capacity problems, localized flooding, erosion impacts, or violations of surface water quality standards. Additionally, there was no evidence of any damage to the drainage system. See Appendix E of this report for the Downstream Drainage Exhibit and Downstream Analysis Photos.

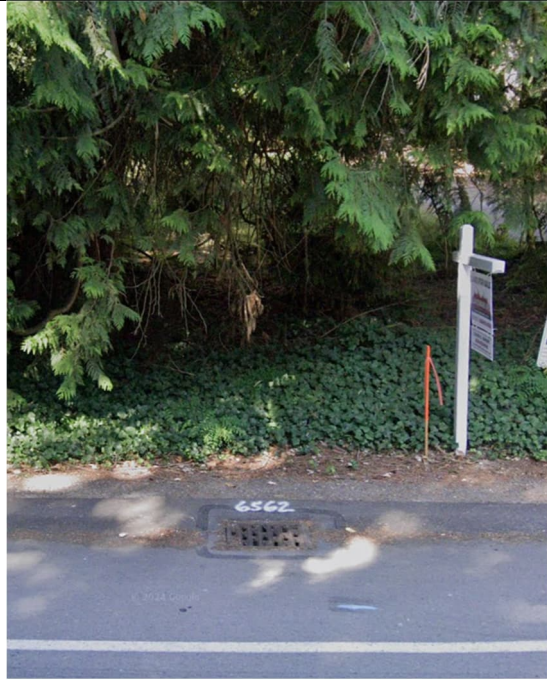
Photo 2 (looking west): type 1 catch basin. 12" concrete pipe flowing north.
