## **CRITICAL AREA STUDY**

**Zhang Property – Tax ID 1438700145**  
**City of Mercer Island, WA**

*Wetland Resources, Inc. Project #21016*

First Submittal: July 19, 2021  
**Revision 1: February 22, 2022**

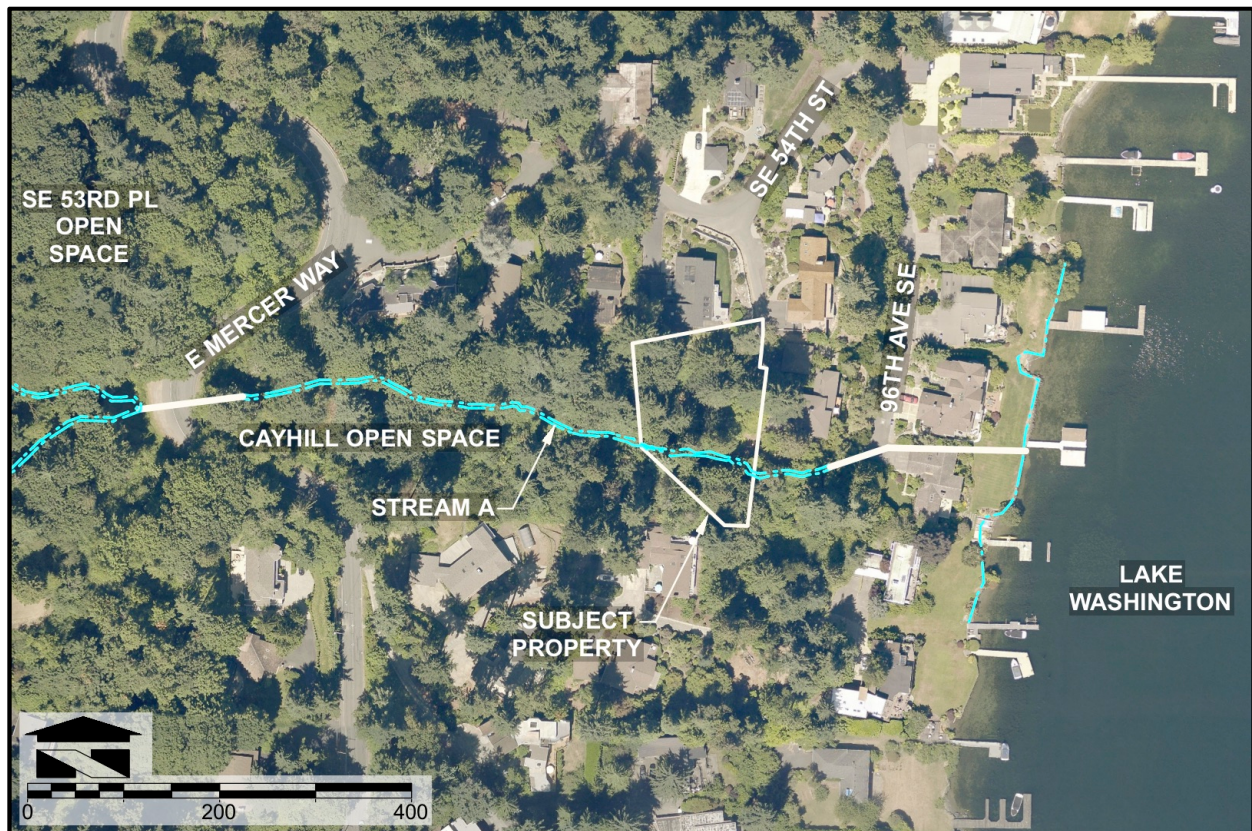
Figure 1: Aerial Overview Map (image source: King County)

The terminus of the unnamed private road extends into the northeast corner of the property and provides access to an existing garage. Stream A flows from west to east through the center of the parcel. No wetlands were observed on or near the property.

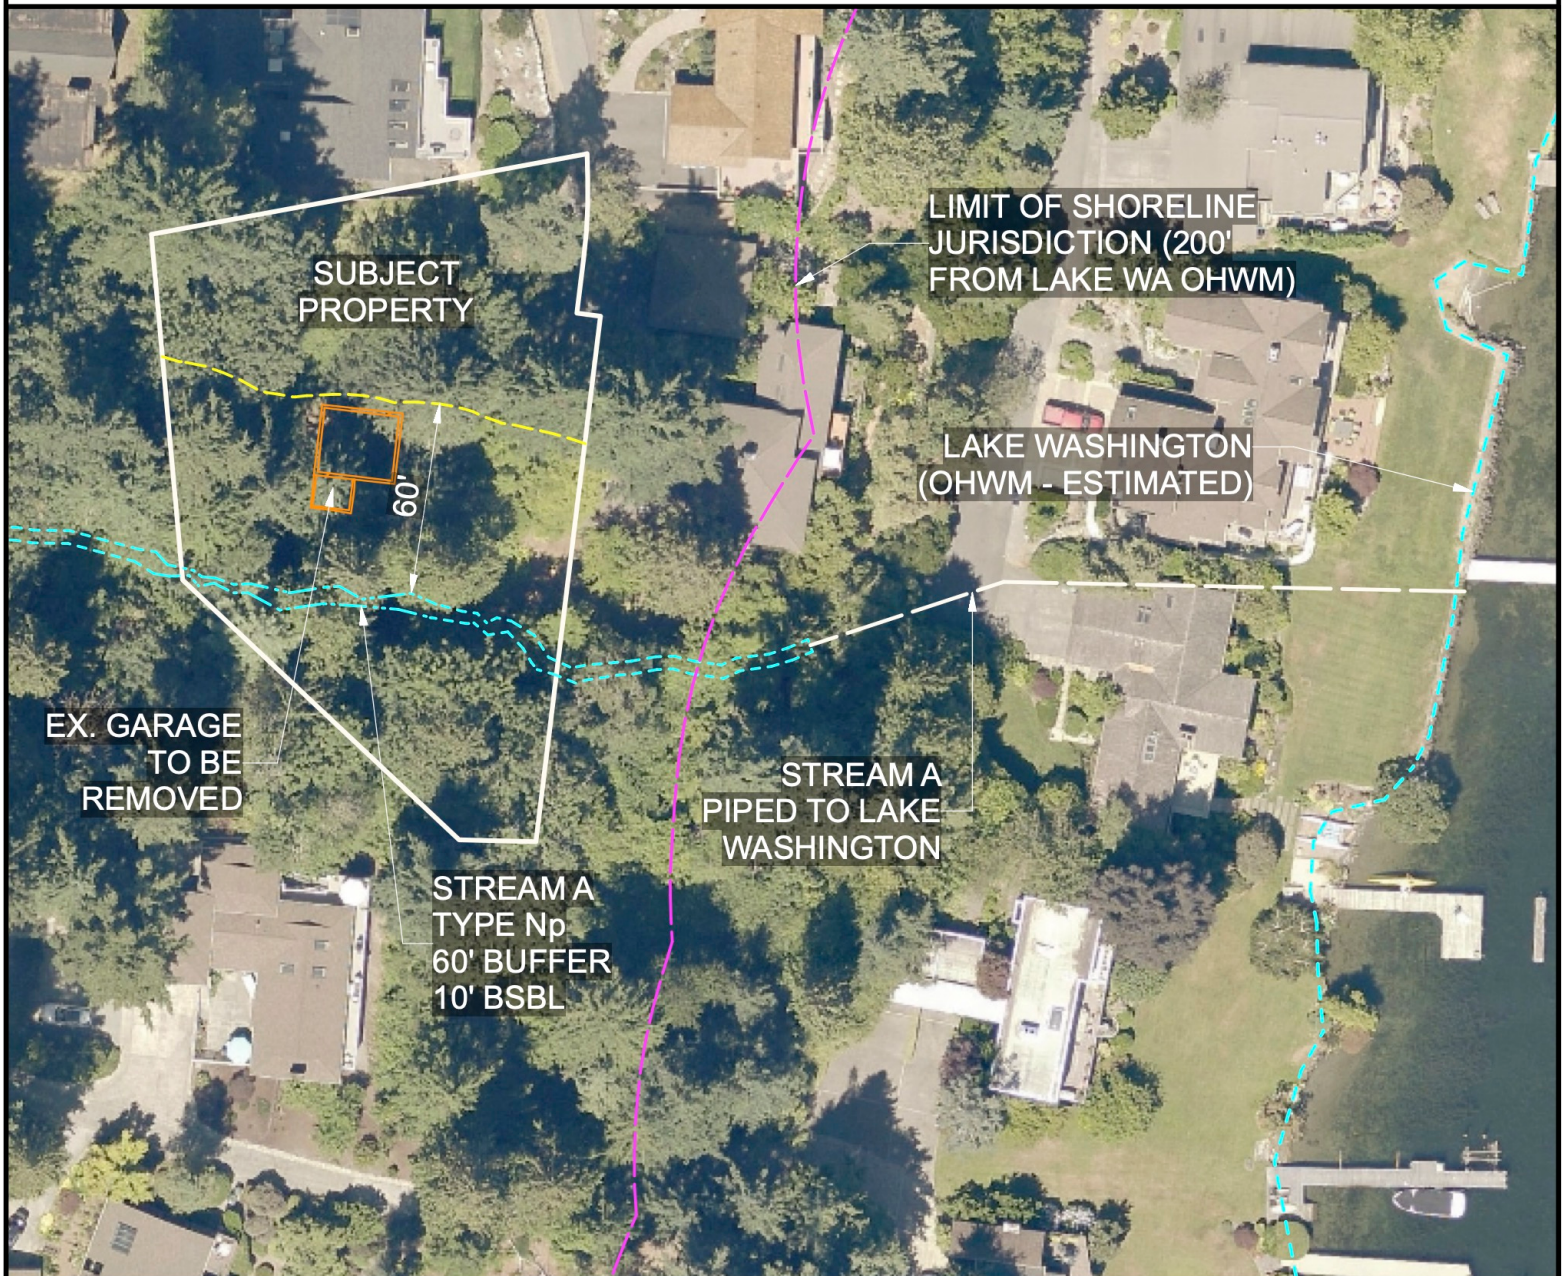
# CRITICAL AREA STUDY MAP - EXISTING CONDITIONS

**ON-SITE PORTION OF STREAM A WAS  
DELINEATED AND SURVEYED. OFF-SITE  
PORTION OF STREAM A WAS ESTIMATED  
USING PUBLICLY AVAILABLE RESOURCES  
AND BASED ON INTERPRETATION OF THE  
DIGITAL ELEVATION MODEL.**

Stream A is a narrow, slightly down-cut stream that flows eastward through the center of the subject site. Two tributaries to Stream A originate west of East Mercer Way in the Southeast 53<sup>rd</sup> Place Open Space. At the confluence of the tributaries, Stream A is culverted beneath East Mercer Way and outflows into the Cayhill Open Space property. The stream flows along the north boundary of Cayhill Open Space until it enters the subject property from the west.

The on-site portion of Stream A forms at the base of a broad ravine that slopes east towards Lake Washington. The stream channel varies between narrow, channelized areas and shallow braided areas where the stream temporarily broadens. Stream A meanders to the east through the subject property channel along the topographic low point of the ravine before discharging onto the adjacent parcel to the east (5425 96<sup>th</sup> Ave SE).

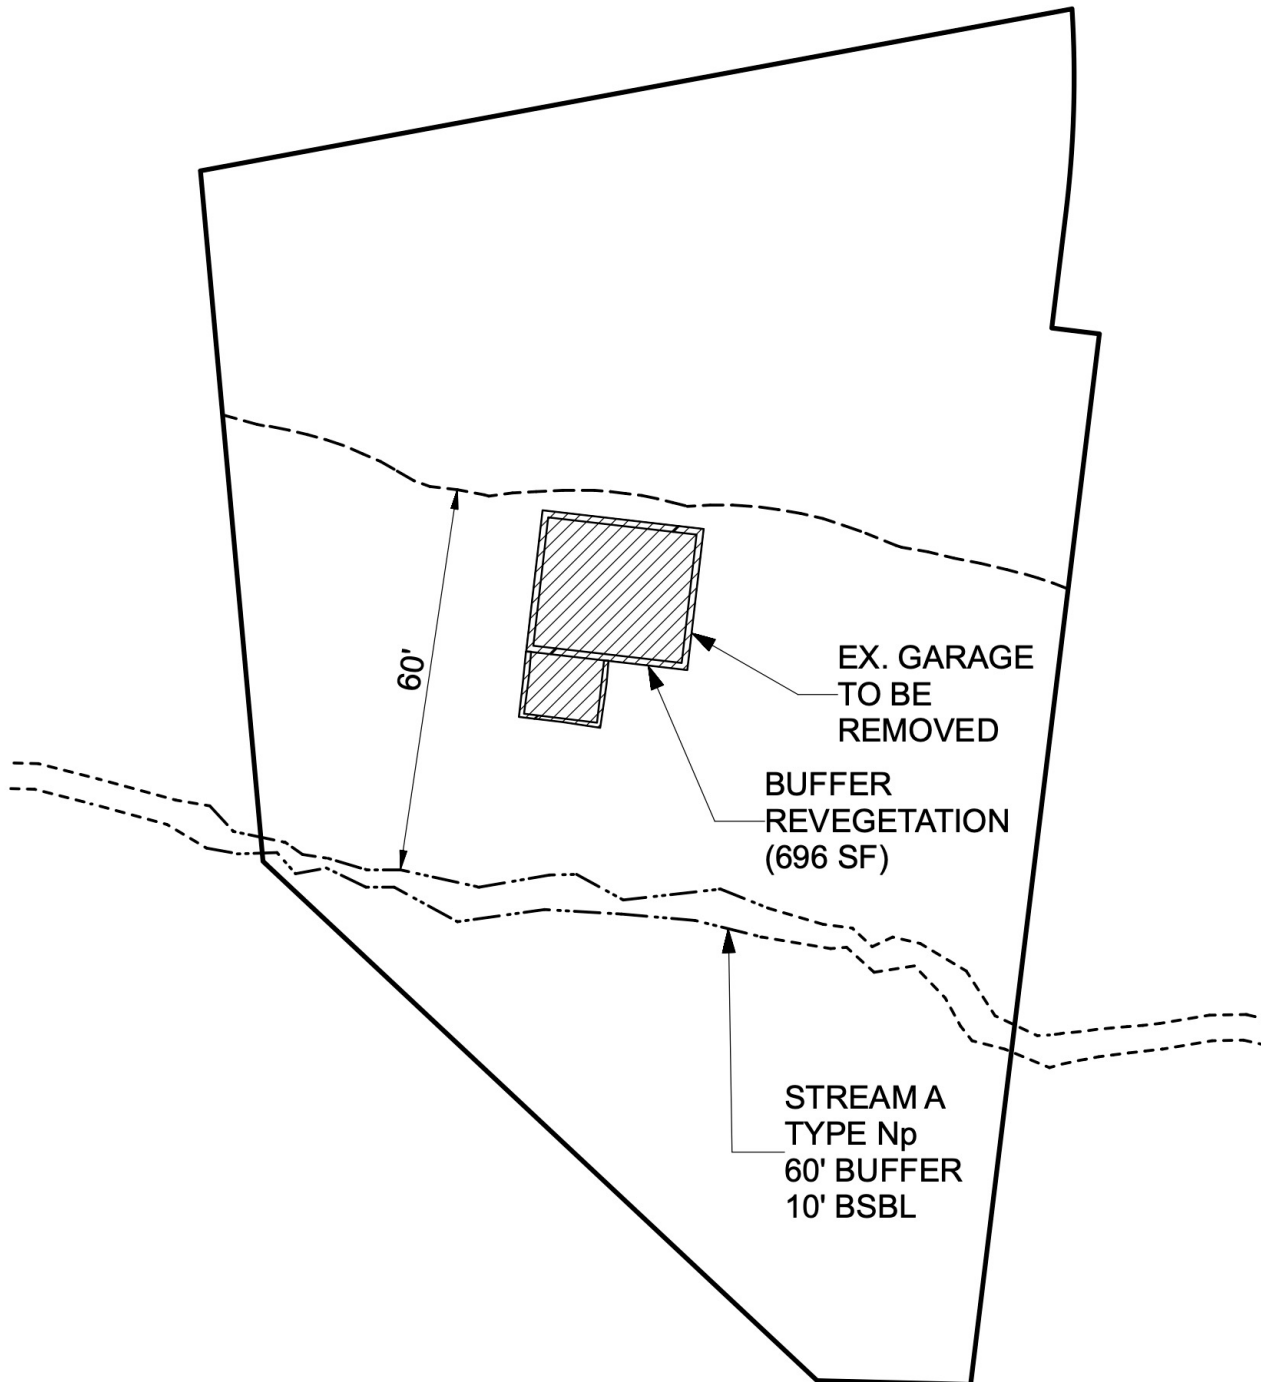
# CRITICAL AREA STUDY MAP - PROPOSED DEVELOPMENT

BUFFER REVEGETATION

MICC 19.07.130.4 requires the revegetation of previously disturbed areas following demolition of structures within stream buffers. A total of 696 square feet of buffer restoration is proposed in the footprint of the existing garage. Restoration plantings have been designed to mimic native on-site vegetation. The restoration planting plan is as follows:
