*Subsurface Exploration, Geologic Hazard,  
and Geotechnical Engineering Report*

## **HERZL-NER TAMID CONSERVATIVE CONGREGATION K-8 EXPANSION**

Mercer Island, Washington

December 12, 2024

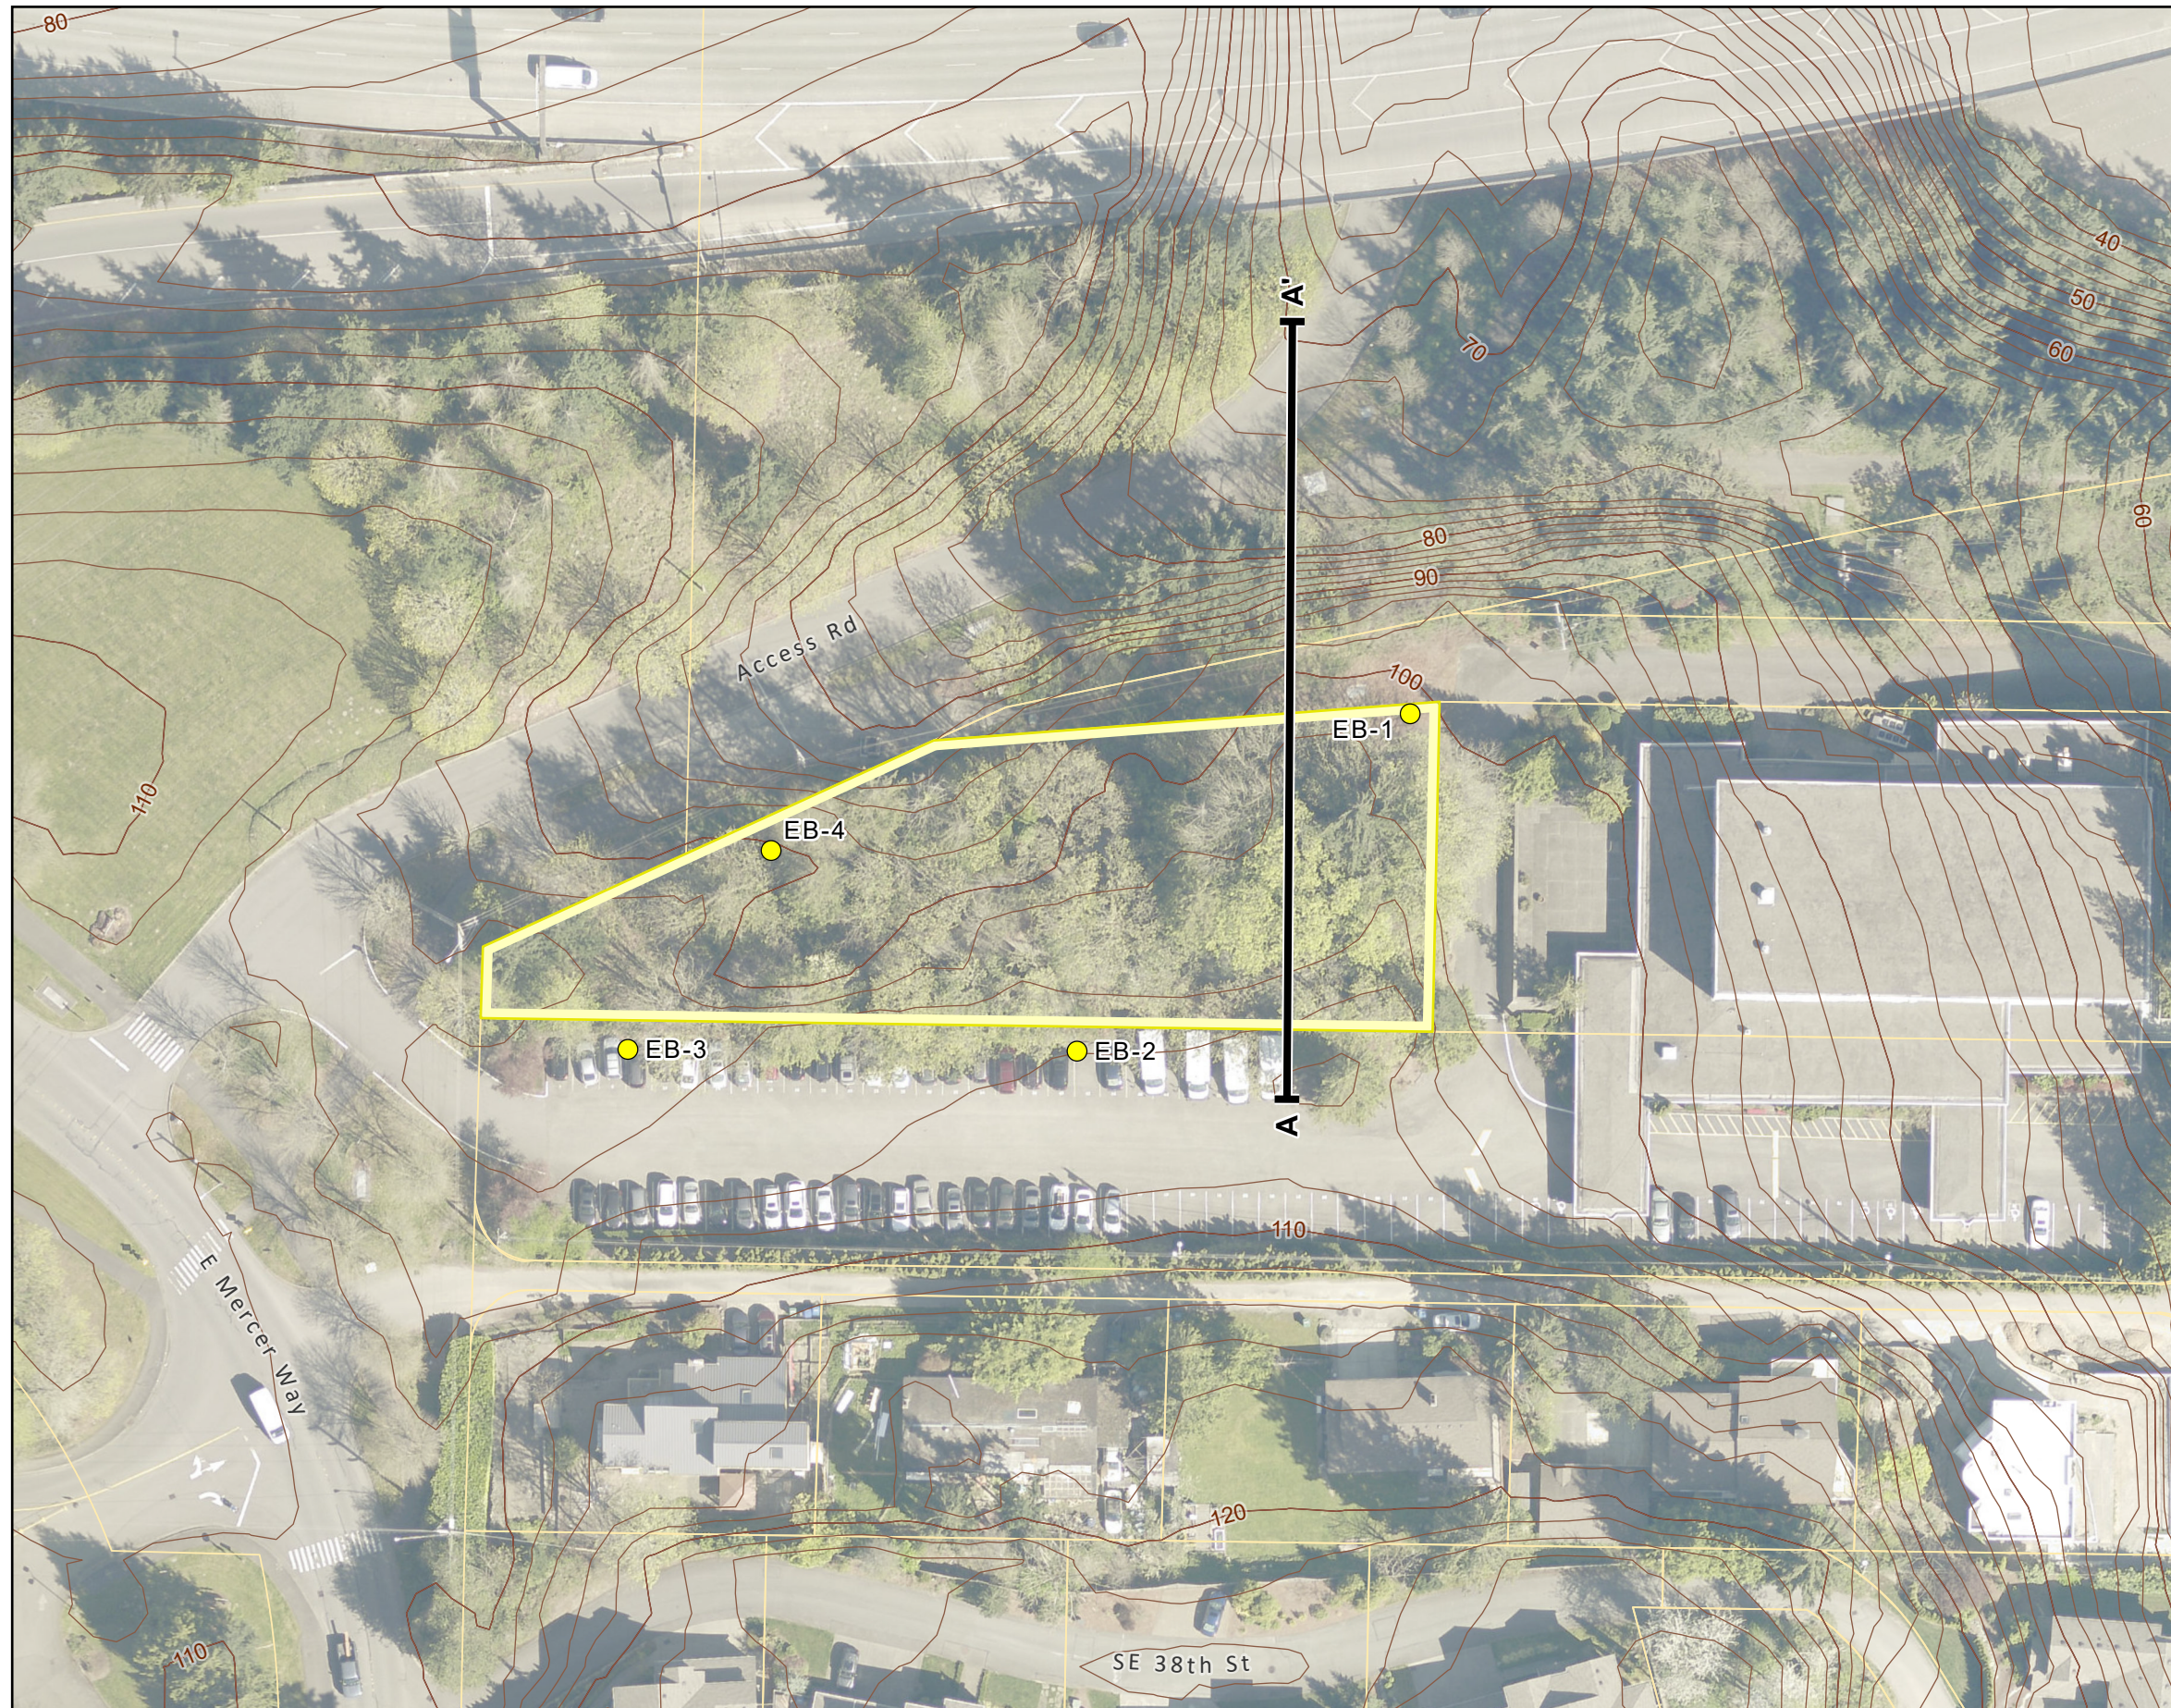
PROJ NO. 20210371E001	DATE: 12/24	FIGURE: 2
--------------------------	----------------	--------------

Our field studies for this phase of work were completed in September and December 2023 and included advancing four exploration borings (EB-1 through EB-4) across the site to define the general soil and shallow groundwater conditions below the proposed K-8 expansion building. The exploration locations are shown on the “Existing Site and Exploration Plan,” Figure 2 and “LIDAR Based Shaded Relief,” Figure 3. The various types of sediments, as well as the depths where characteristics of the sediments changed, are indicated on the exploration logs presented in Appendix A. The depths indicated on the logs where conditions changed may represent gradational variations between sediment types in the field. The locations of our field explorations were determined by approximate measurements from known site features.

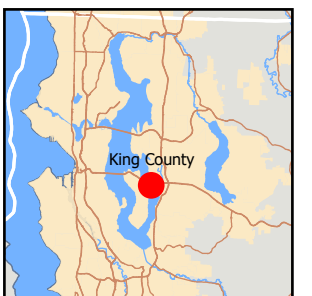
PROJ NO. 20210371E001	DATE: 12/24	FIGURE: 3
--------------------------	----------------	--------------

We also reviewed the 2021 King County Light Detection and Ranging (LIDAR)-based shaded relief map of the site and steep slope area as provided on the Washington State Department of Natural Resources (WADNR), Division of Geology and Earth Resources, LIDAR portal. Shaded relief maps generated from LIDAR data provide a detailed image of the ground surface, even in heavily vegetated areas. Such images can reveal the presence of geomorphic features, such as faults or landslide features, not visible on conventional aerial photos. The LIDAR-based shaded relief map of the project site and vicinity along with topographic contours are shown on Figure 3. The LIDAR imaging does not reveal any indications of recent landsliding activity along the steep slope area.

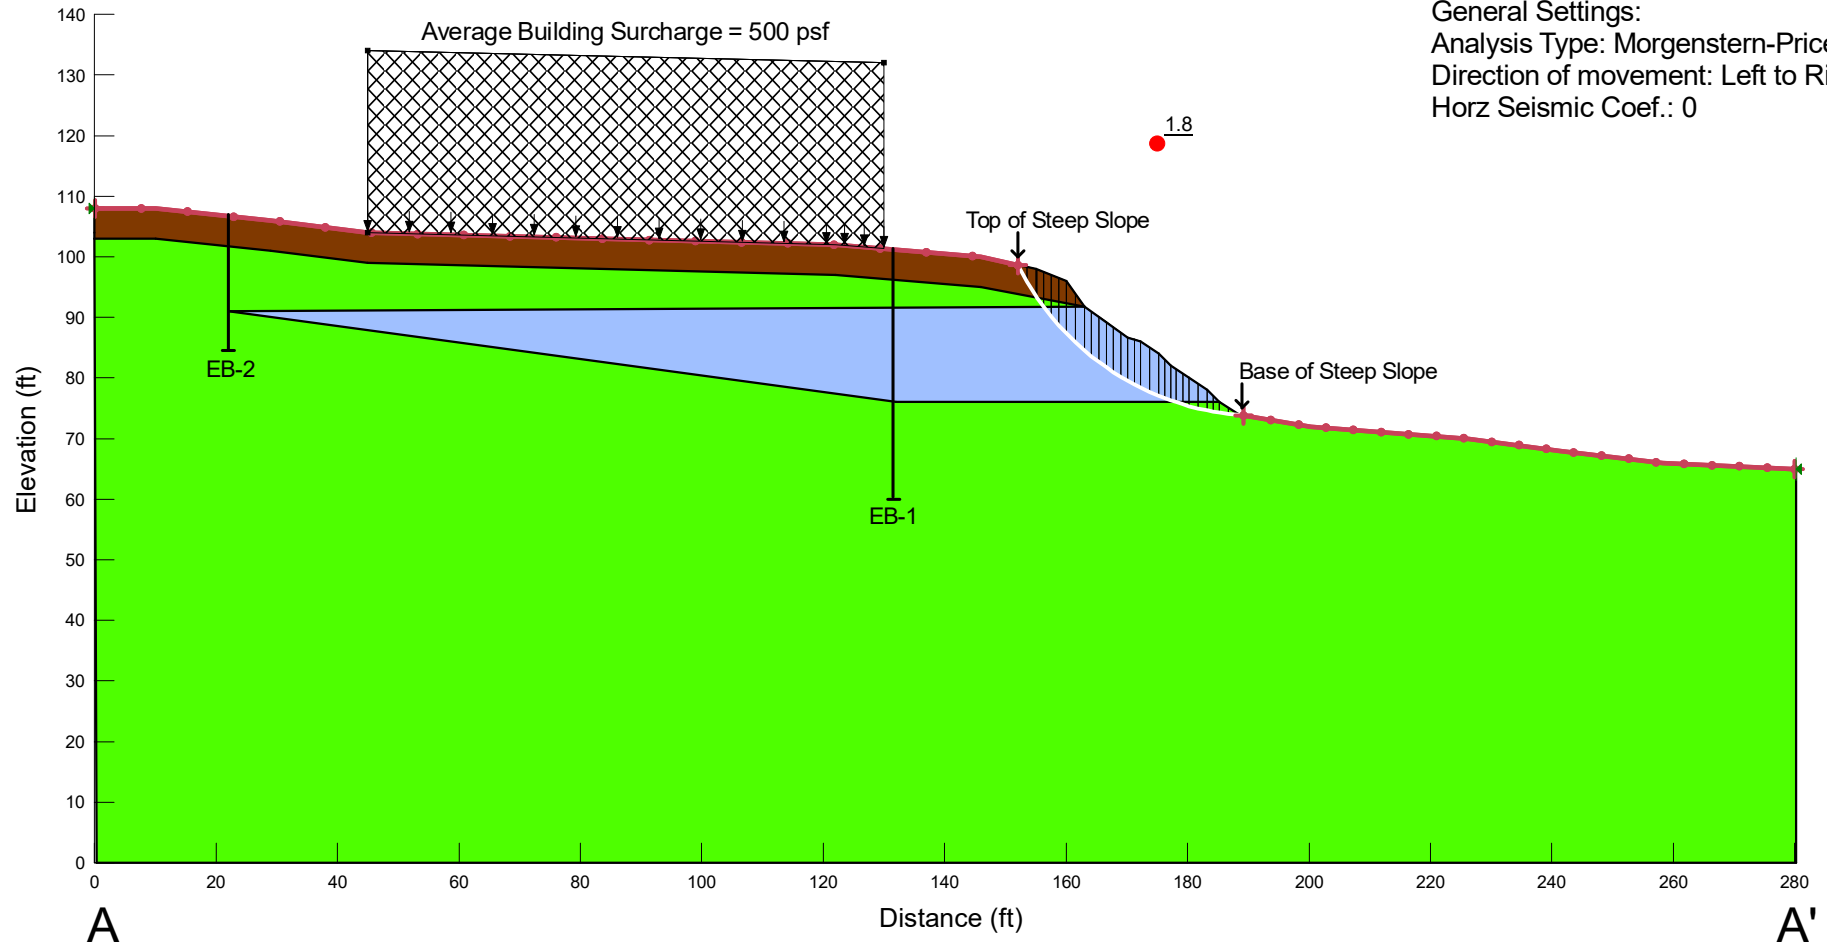
A-A' Static Conditions

To evaluate the potential for deep-seated slope failures occurring along the steep slope and potentially extending into the subject property and/or below the footprint of the proposed school building, we performed a slope stability analysis along Cross-Section A-A' (see Figure 2) using the computer program SLOPE/W, Version 8.16, by Geo-Slope International. The program uses the Morgenstern-Price method for evaluating various potential rotational failures within the core of the slope. Input parameters for the analysis included slope geometry, geology and soil strength parameters, groundwater conditions, and seismic ground motions. The geologic stratigraphy shown on the SLOPE/W model were based on the horizontal extrapolation of the geologic units encountered in EB-1 and EB-2. Soil strength parameters were based on the subsurface conditions encountered within our exploration borings and our experience with similar subsurface conditions encountered in the Puget Sound region, and are shown on the SLOPE/W models in Appendix C.

Color	Name	Unit Weight (pcf)	Effective Cohesion (psf)	Effective Friction Angle (°)
■	Fill	115	0	32
■	Pre-Fraser Nonglacial (Sand)	135	0	40
■	Pre-Fraser Nonglacial (Silt)	130	500	26

General Settings:  
 Analysis Type: Morgenstern-Price  
 Direction of movement: Left to Right  
 Horz Seismic Coef.: 0

The stability of a slope can be expressed in terms of its factor of safety (FOS). The FOS is the ratio between the forces that resist sliding to the forces that drive sliding. For example, a FOS of 1.0 would indicate a condition where the driving forces and the resisting forces are exactly equal. Increasing FOS values greater than 1.0 indicate increased stability. A FOS below 1.0 indicates conditions where the driving forces exceed the resisting forces and slope movement is imminent.

The MICC does not appear to specify a minimum FOS for slope stability; however, local geotechnical engineering practice (as well as the King County jurisdiction) requires a minimum slope stability FOS of 1.5 for static conditions and 1.1 for seismic conditions. The slope stability model for Cross-Section A-A' indicates a minimum FOS of 1.8 for static conditions and 1.1 for seismic conditions, which meets or exceeds minimum requirements and indicates that the potential for deep-seated slope failures to affect the proposed development is low. In accordance with the MICC, we recommend the project maintain a minimum buffer width of 25 feet between the building footprint and the top of the steep slope.
