**GEOTECHNICAL ENGINEERING STUDY
PROPOSED SINGLE-FAMILY RESIDENCE
7615 EAST MERCER WAY
MERCER ISLAND, WASHINGTON**

ES-9607.01

April 22, 2024
Updated November 1, 2024

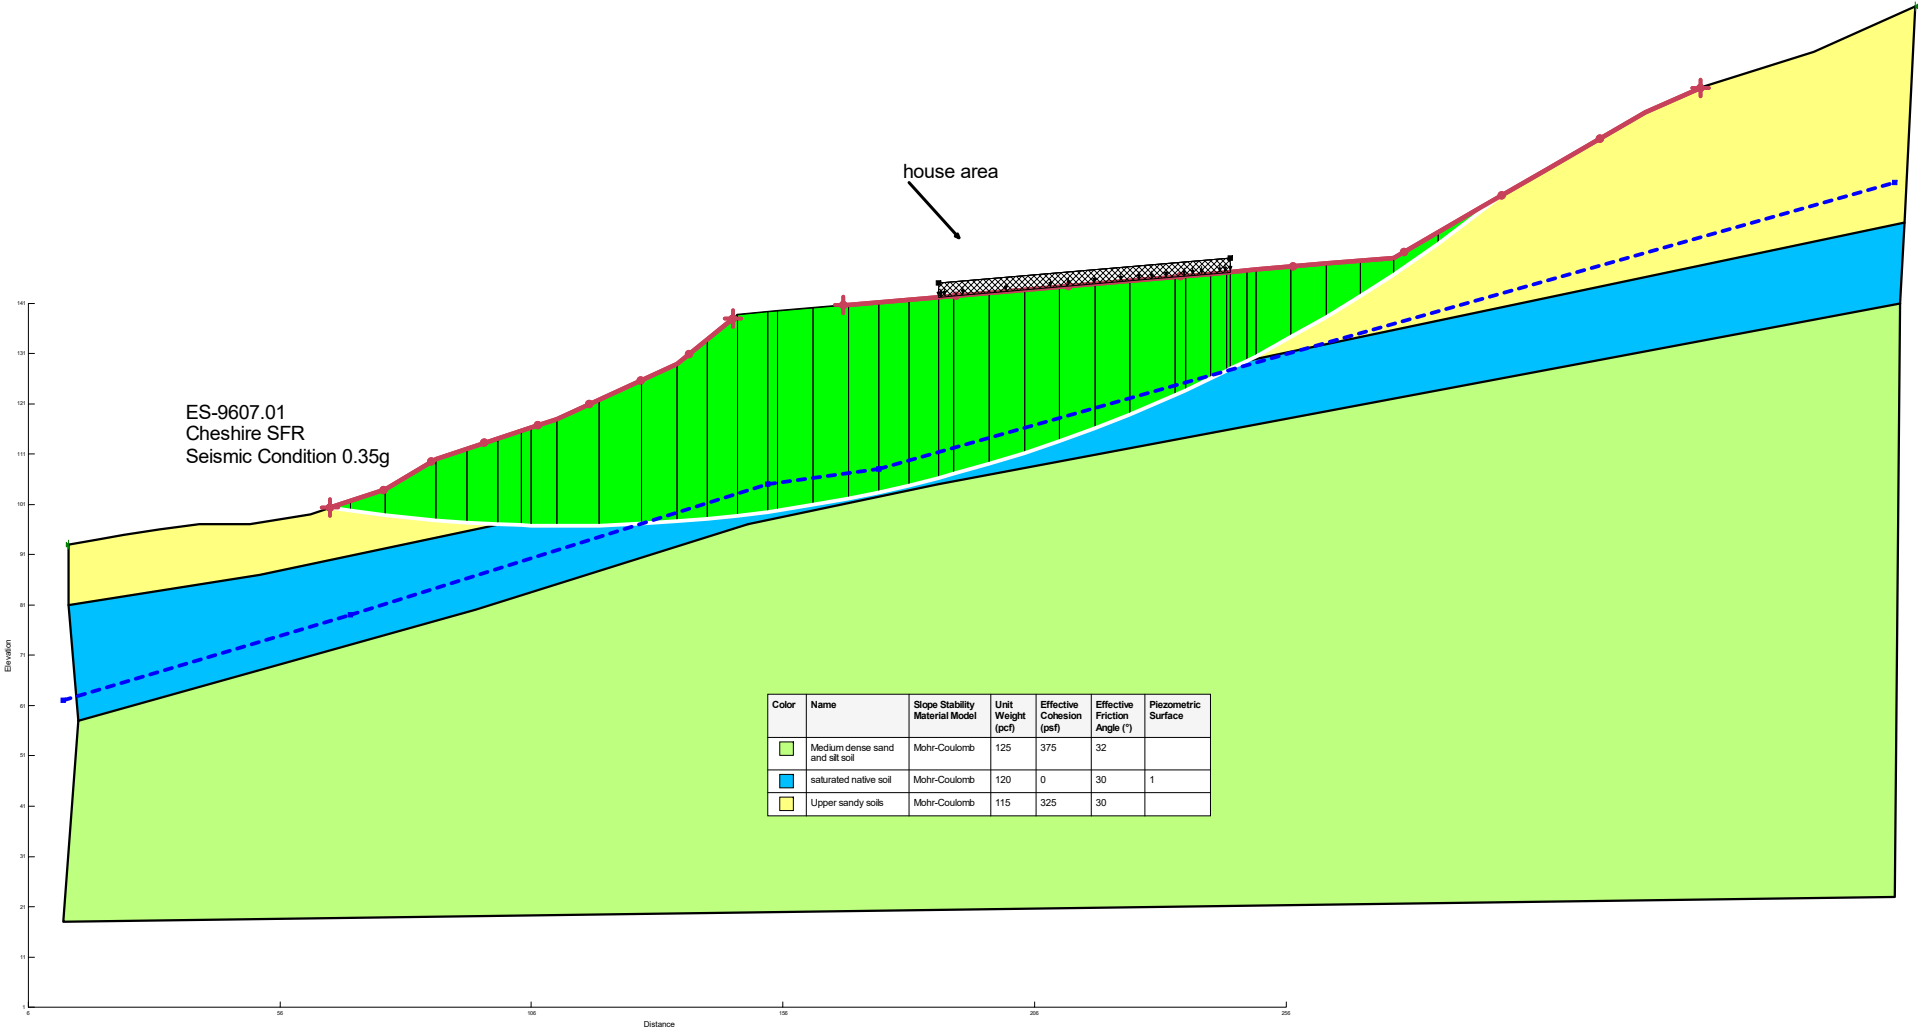
ES-9607.01
Cheshire SFR
Seismic Condition 0.35g

Color	Name	Slope Stability Material Model	Unit Weight (pcf)	Effective Cohesion (psf)	Effective Friction Angle (°)	Piezometric Surface
Light Green	Medium dense sand and silt soil	Mohr-Coulomb	125	375	32	
Blue	saturated native soil	Mohr-Coulomb	120	0	30	1
Yellow	Upper sandy soils	Mohr-Coulomb	115	325	30

Our analyses indicate the site soils are stable when subjected to the maximum credible earthquake loading of 0.35g (minimum FOS of 1.07) and increases when subjected to a horizontal force of 0.3g (FOS of at least 1.15). The modeled cohesion value within the silt and silty sand units were reduced for the static condition to represent a nearly drained condition, although it is reasonable to assume this soil type remains in a partially undrained condition which reflects a reasonable modeling approach. It is important to note that the subsurface conditions on this site consist of a mixture of silt, silty sand and sand deposits that do not exhibit a clear failure plane; therefore, in our opinion the analysis is relatively conservative and overall slope stability may be more resistant than modeling suggests.
