9734 SE 40TH ST

KING COUNTY PARCEL No. 2655500176

CRITICAL AREA STUDY

PETERMAN CONSULTING, LLC
12450 80TH AVE S
SEATTLE, WA 98178
(206) 666-8736

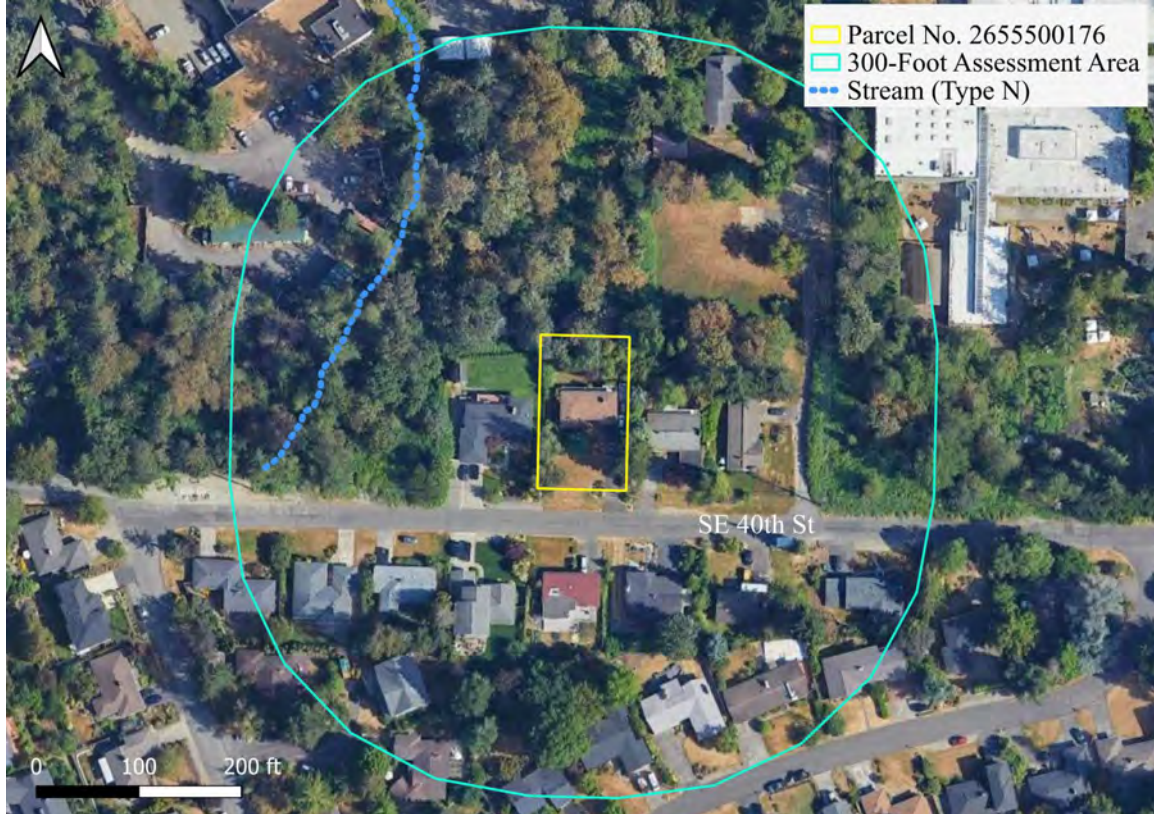
Figure 2. Map showing the location of the observed stream.

In addition to the wetland investigation, a stream evaluation was completed to identify all areas that would meet the definition of a natural water feature according to Washington Administrative Code (WAC) 222-16-030. Peterman Consulting identified one stream feature (S1) located entirely offsite but within 300 feet of the subject property (Figure 2).

During the December site visit there was flowing water observed. Observations were made of stream field indicators as defined in the Washington State Department of Ecology's (DOE) *Determining the Ordinary High Water Mark for Shoreline Management Act Compliance in Washington State* (2016). The ordinary high water mark (OHWM) determination was made using visual observations during the site visit and with data from the Washington Department of Natural Resources' (WDNR) LiDAR Portal website (WDNR 2024a). Flagging of the OHWM was not completed as the stream is located entirely off site and to the north of the subject property. A summary of the stream is provided in Table 1.

A stream channel (S1) was observed offsite that had flowing water during the December site assessment. The stream's ordinary high water mark was not delineated as it is located entirely offsite of the subject property. There are no streams located on the subject property.

According to Mercer Island City Code (MICC) Chapter 19.07.180, stream S1 is a Type N stream as it does not have any record of fish utilization and does not appear to have the potential to support fish habitat due to an average observed channel width less than 2 feet wide. According to the city's maps, the source of the water flow that emerges from a culvert from under SE 40th St. is from piped stormwater main lines from the neighborhood to the south. Stream S1 exists mostly as a piped watercourse and does not have many open sections as it flows north under I-90 and eventually into Lake Washington. The stream's buffer was defined according to MICC 19.07.180. The stream's location was mapped using onsite observations and the WDNR's public LiDAR data.

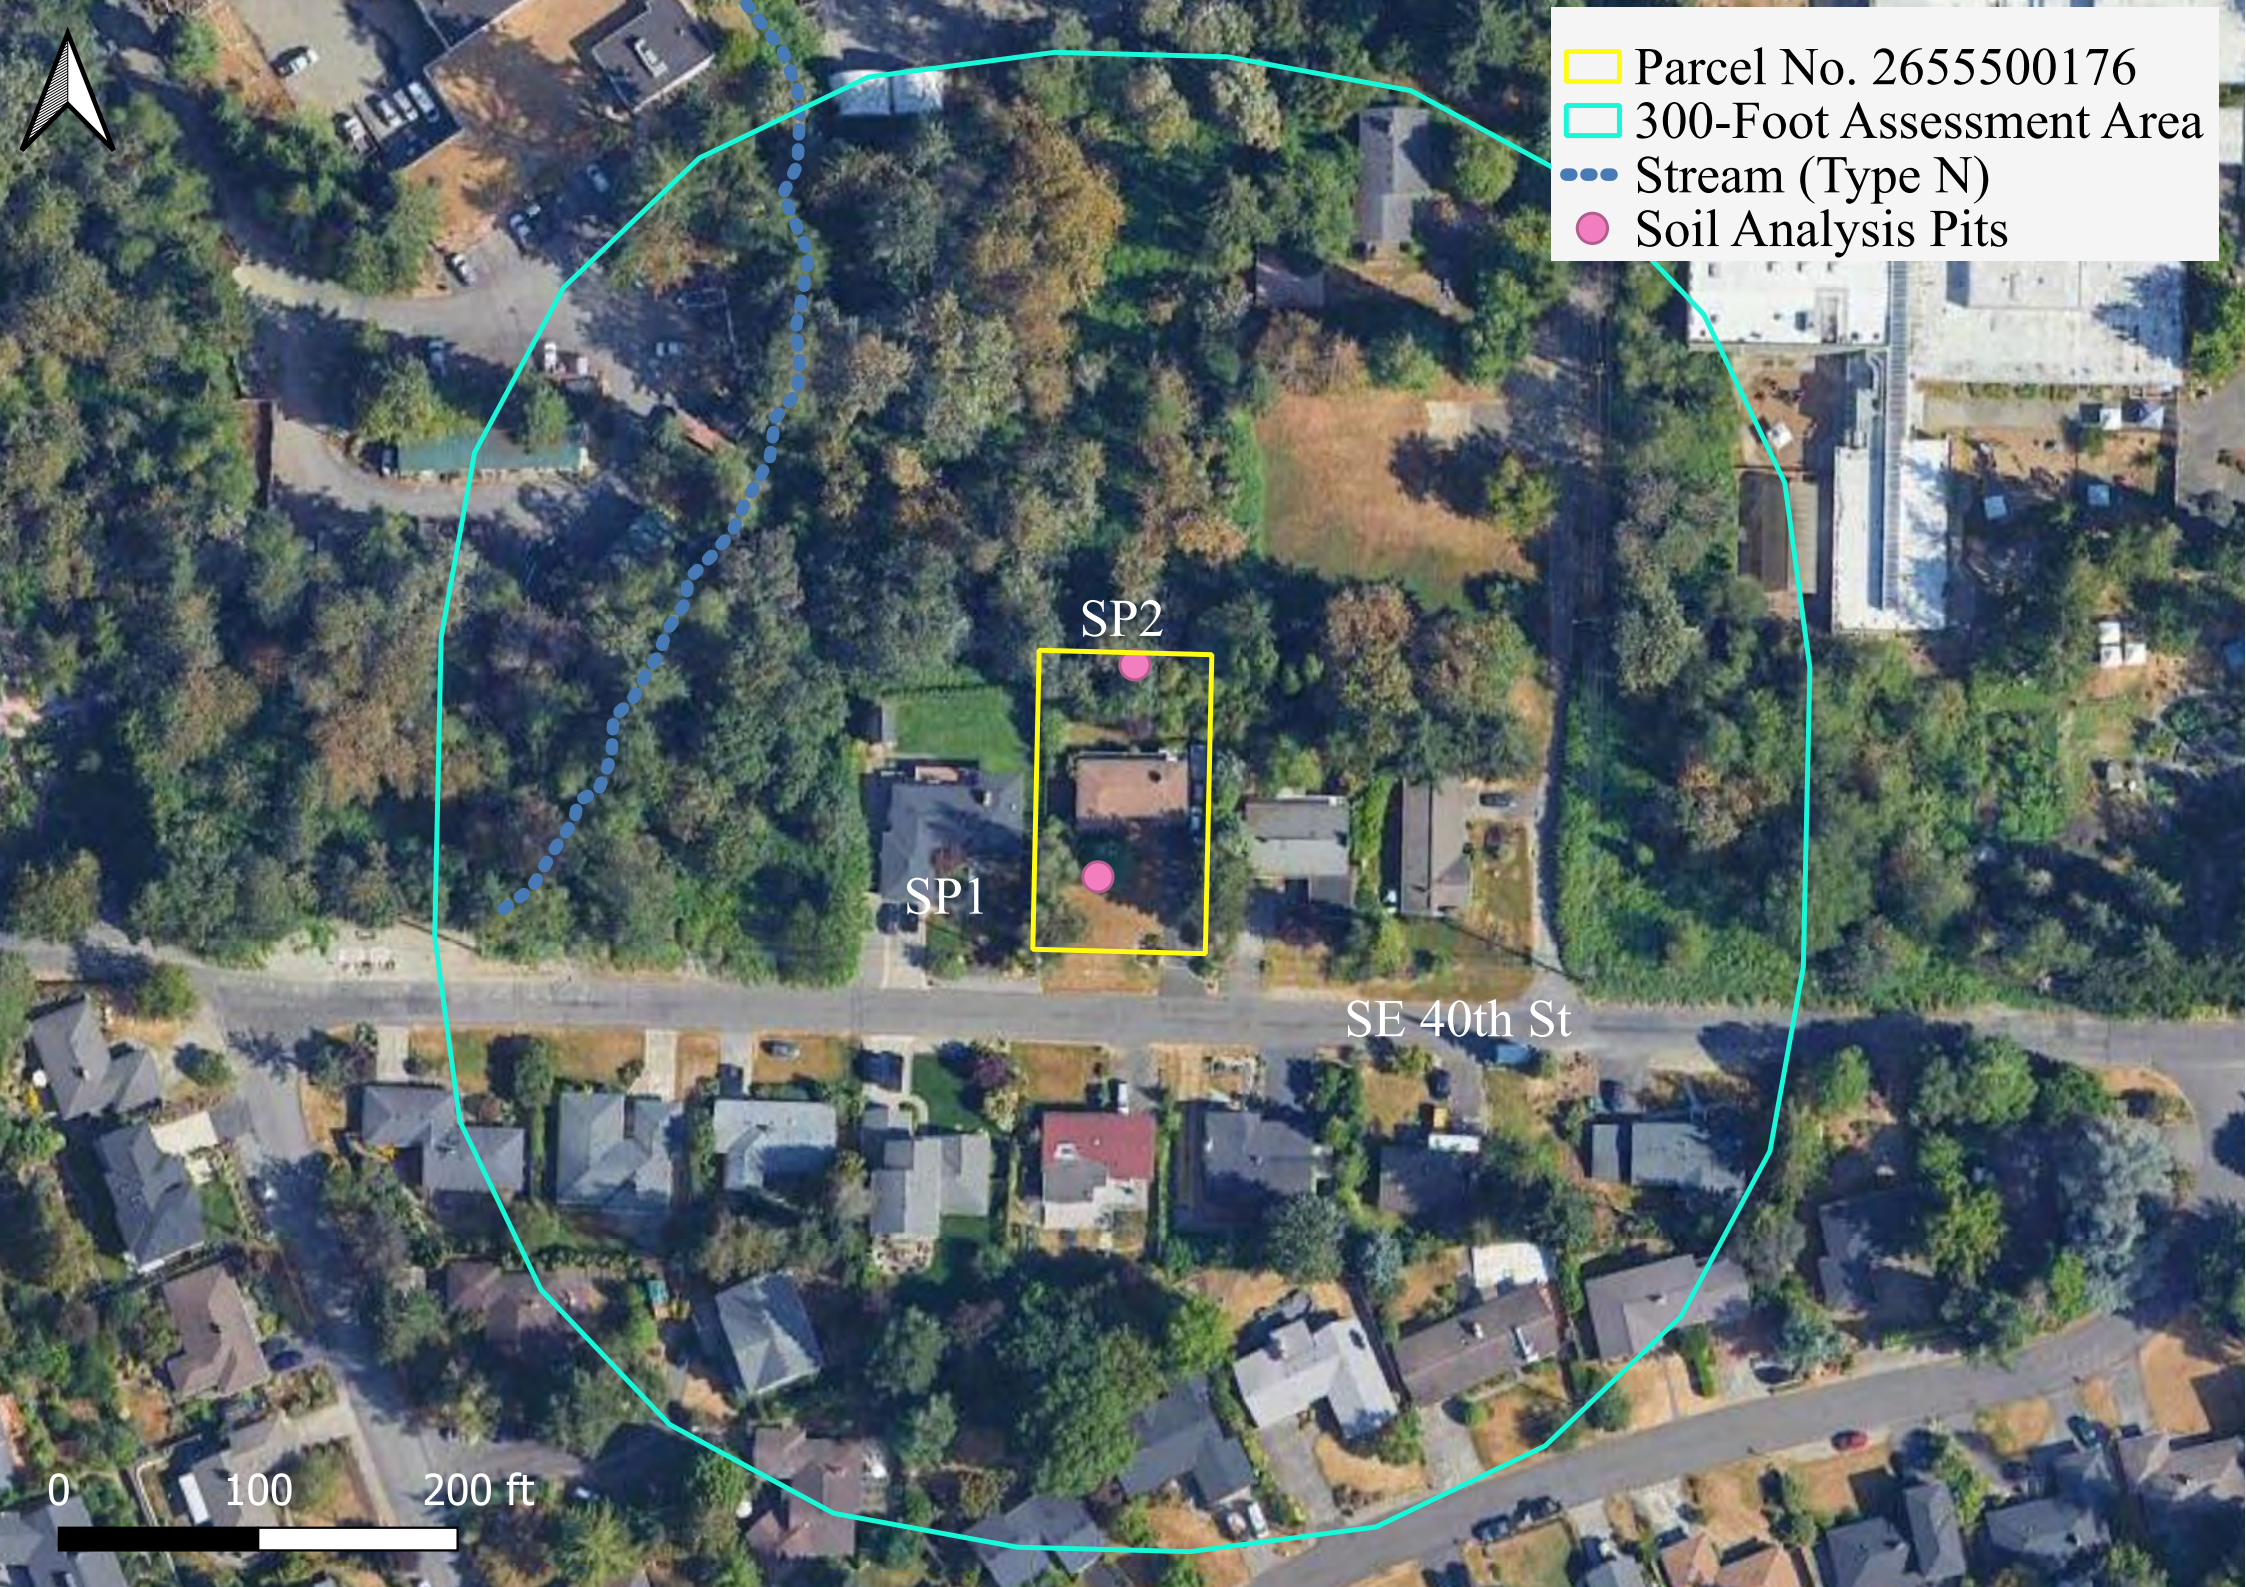
APPENDIX A: CRITICAL AREAS MAP

- Parcel No. 2655500176
- 300-Foot Assessment Area
- Stream (Type N)
- Soil Analysis Pits

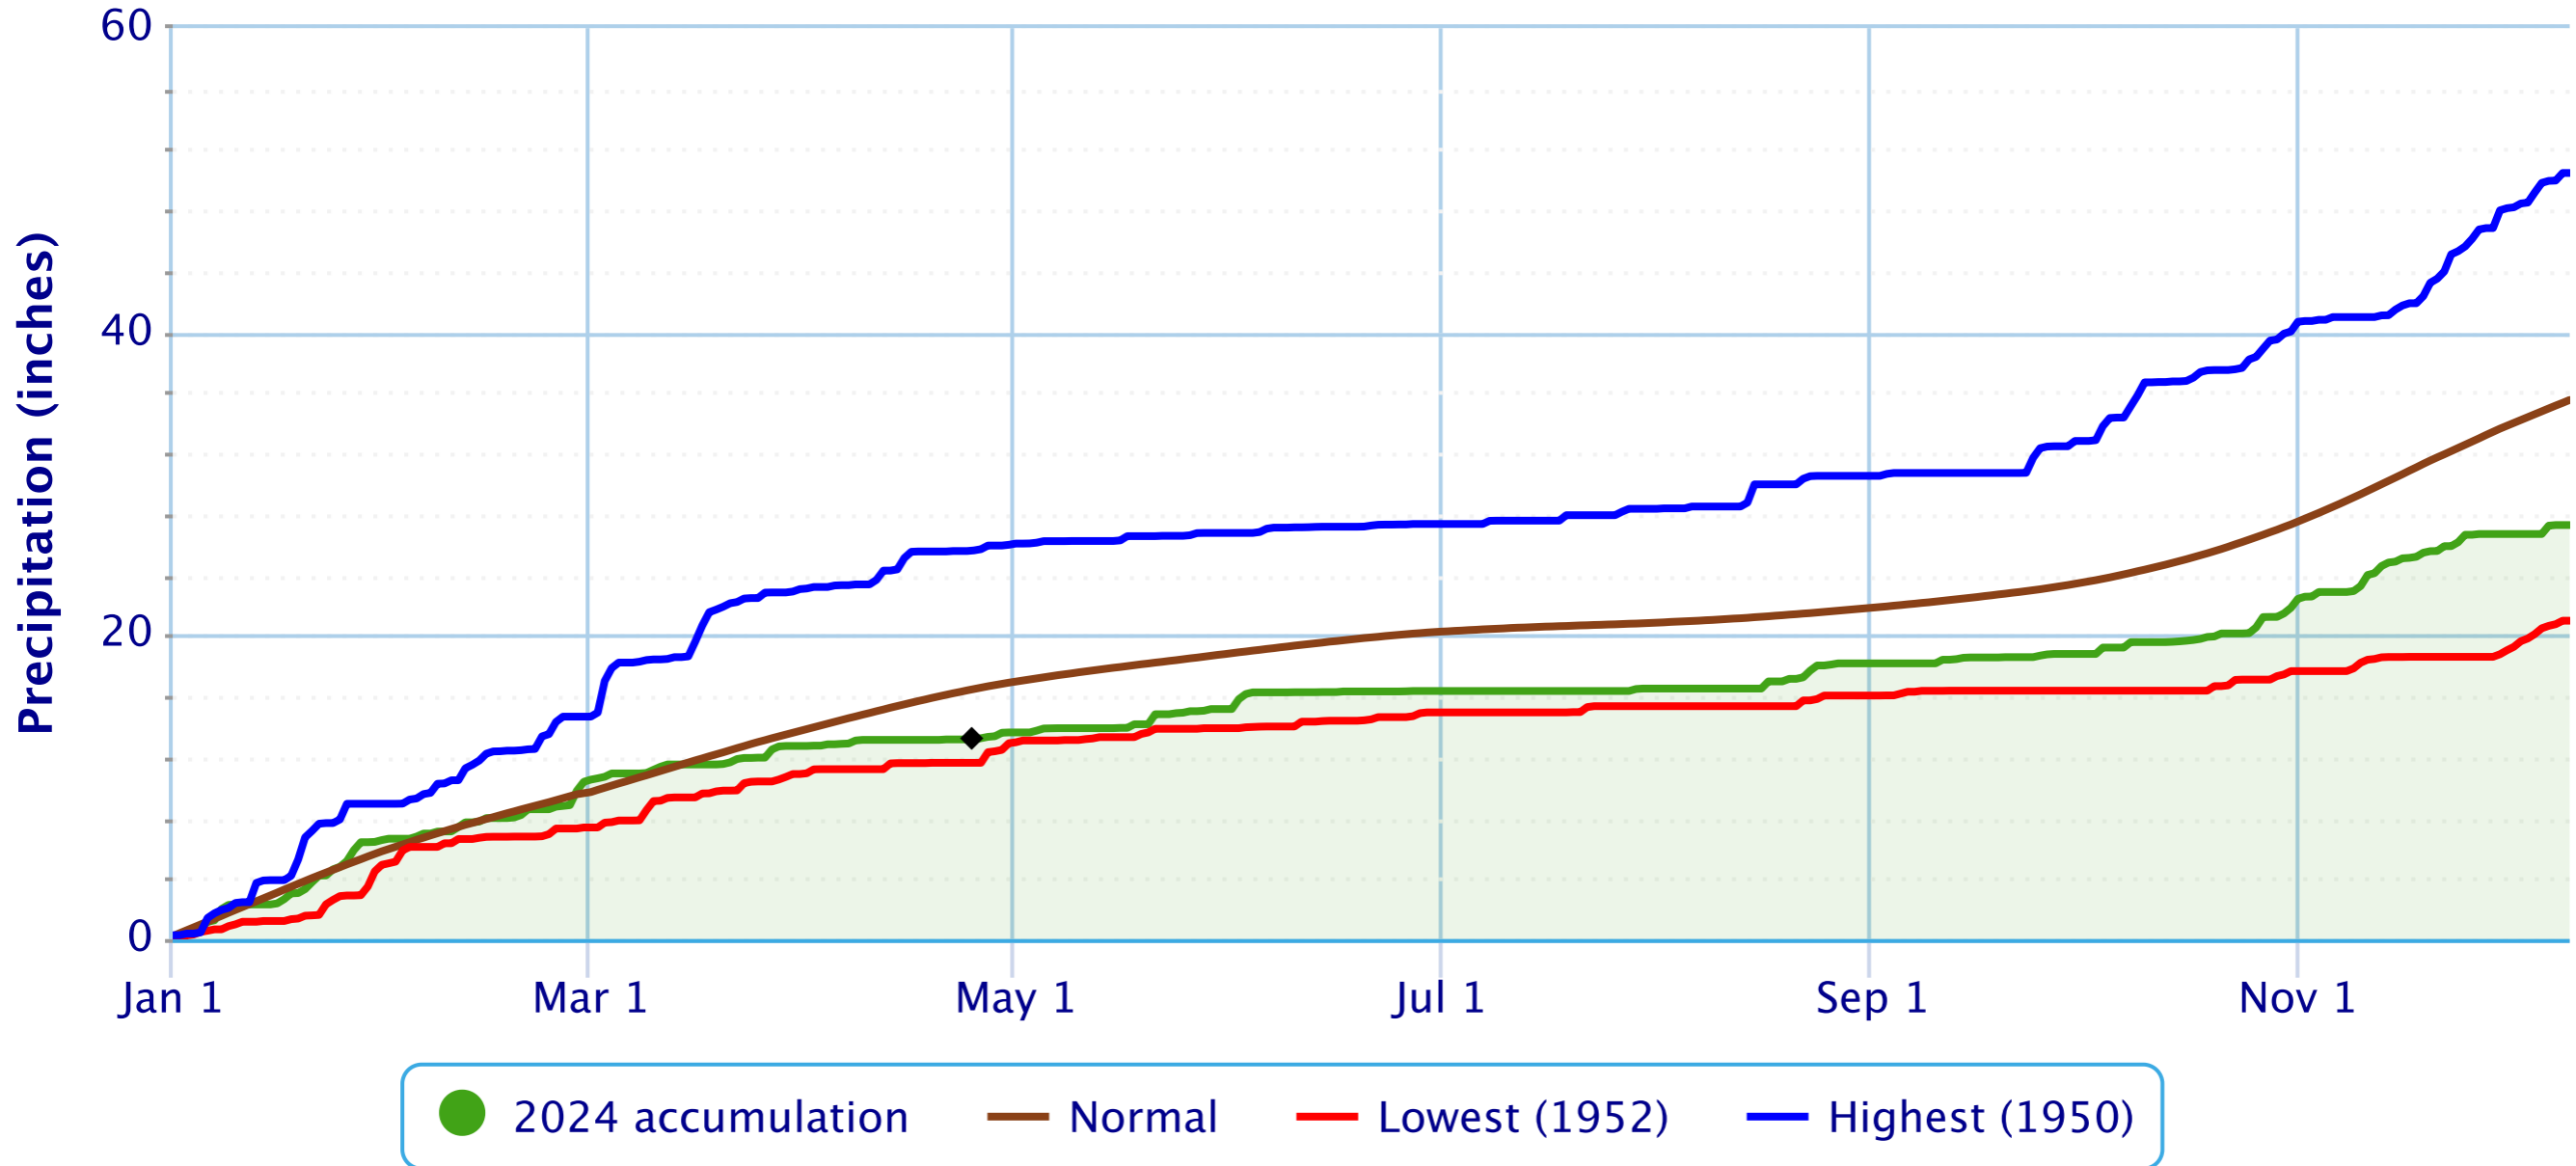
Accumulated Precipitation – SEATTLE TACOMA AIRPORT, WA

The total precipitation recorded at the station from December 1st, 2023 through November 30th, 2024 (35.16 inches) was approximately 89 percent of the normal rainfall (39.34 inches) that occurs during a typical water year (NOAA 2024b). Table 2 below presents an analysis of the appropriate NRCS WETS table for the three months preceding the field investigation.

Bins were established to evaluate the overall rainfall period during the field investigation; drier (sum in 6-9), normal (sum is 10-14), wet (sum is 15-18). A sum of 11 indicates that hydrologic conditions are normal. Data from the start of the year for the accumulated precipitation for that weather station shows that it has remained below the normal average since the end of March (Appendix C).

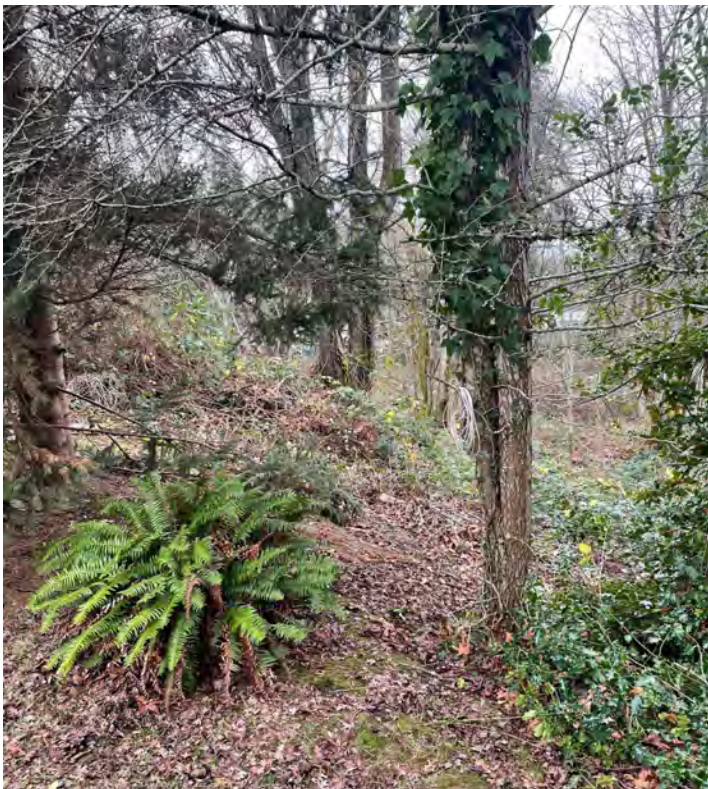
Photo 4. Looking northwest towards soil analysis pit 2. No hydric soils were observed on the subject property.

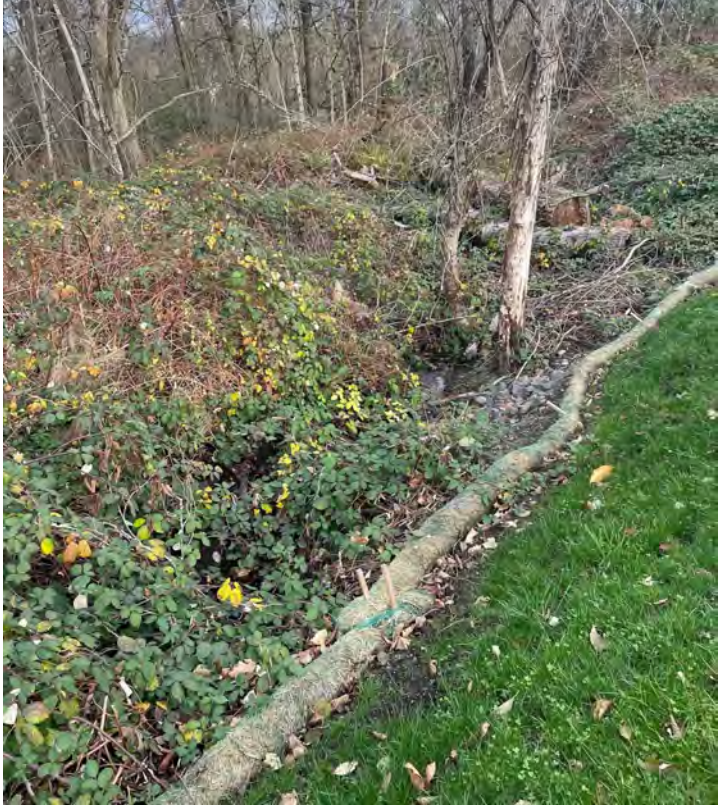
Photo 5. Looking northeast towards the observed offsite stream near SE 40th St.

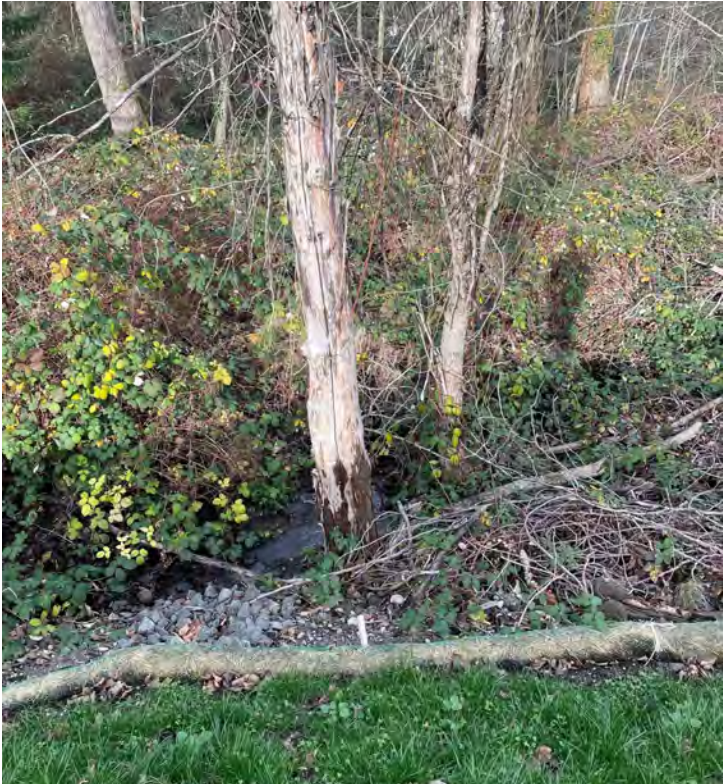
Photo 6. Looking north towards stream S1.
