**2262 78TH AVE SE**

KING COUNTY PARCEL No. 5315101697  
CRITICAL AREA STUDY

JUNE 17TH, 2024

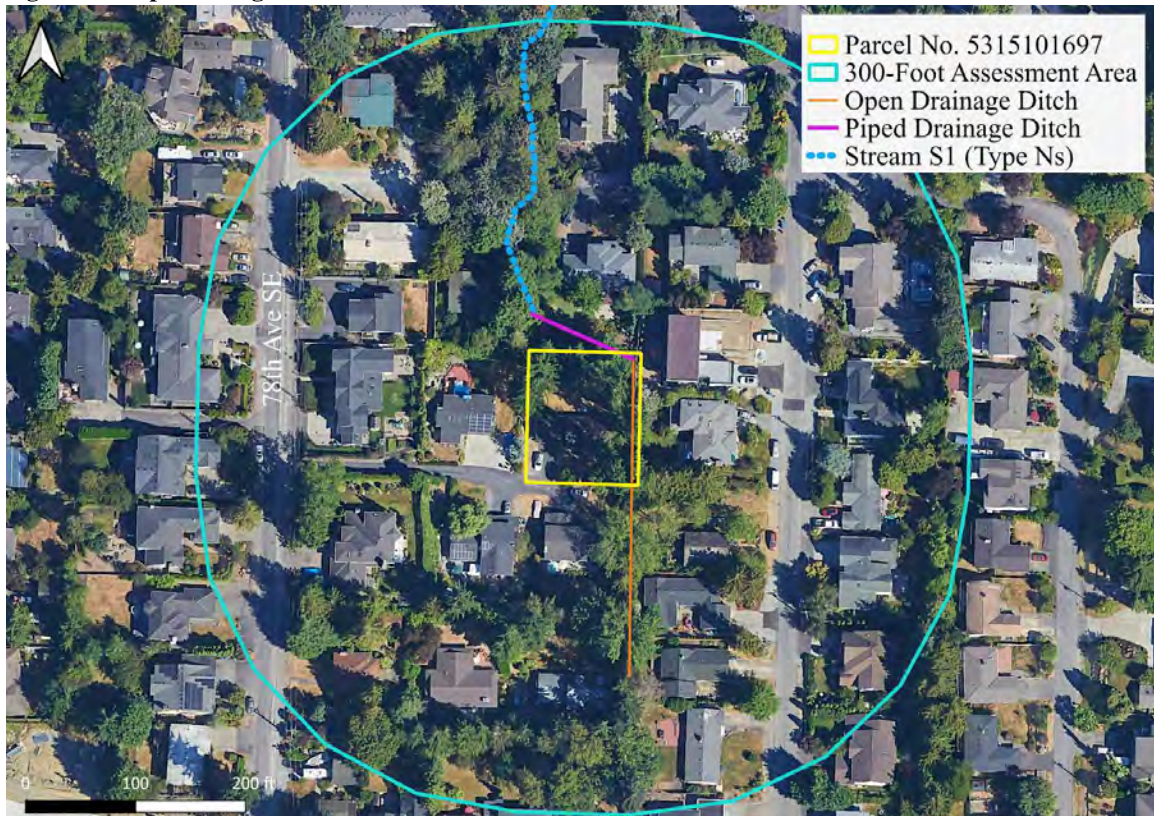
**Figure 2. Map showing the location of Stream S1.**

feature (S1) located entirely offsite but within 300 feet of the subject property (Figure 2). During the May site visit there was flowing water observed. Observations were made of stream field indicators as defined in the Washington State Department of Ecology's (DOE) *Determining the Ordinary High Water Mark for Shoreline Management Act Compliance in Washington State* (2016). The ordinary high water mark (OHWM) determination was made using visual observations during the site visit and with data from the Washington Department of Natural Resources' (WDNR) LiDAR Portal website (WDNR 2024a). Flagging of the OHWM was not completed as the stream is located entirely off site and to the north of the subject property.

According to Mercer Island City Code (MICC) Chapter 19.07 Stream S1 is a Type Ns stream as it does have any record of fish utilization and does not appear to have the potential to support fish habitat due to an observed channel width smaller than 2 feet. The stream's buffer was defined according to MICC 19.07.180. A summary of the stream is provided in Table 1.

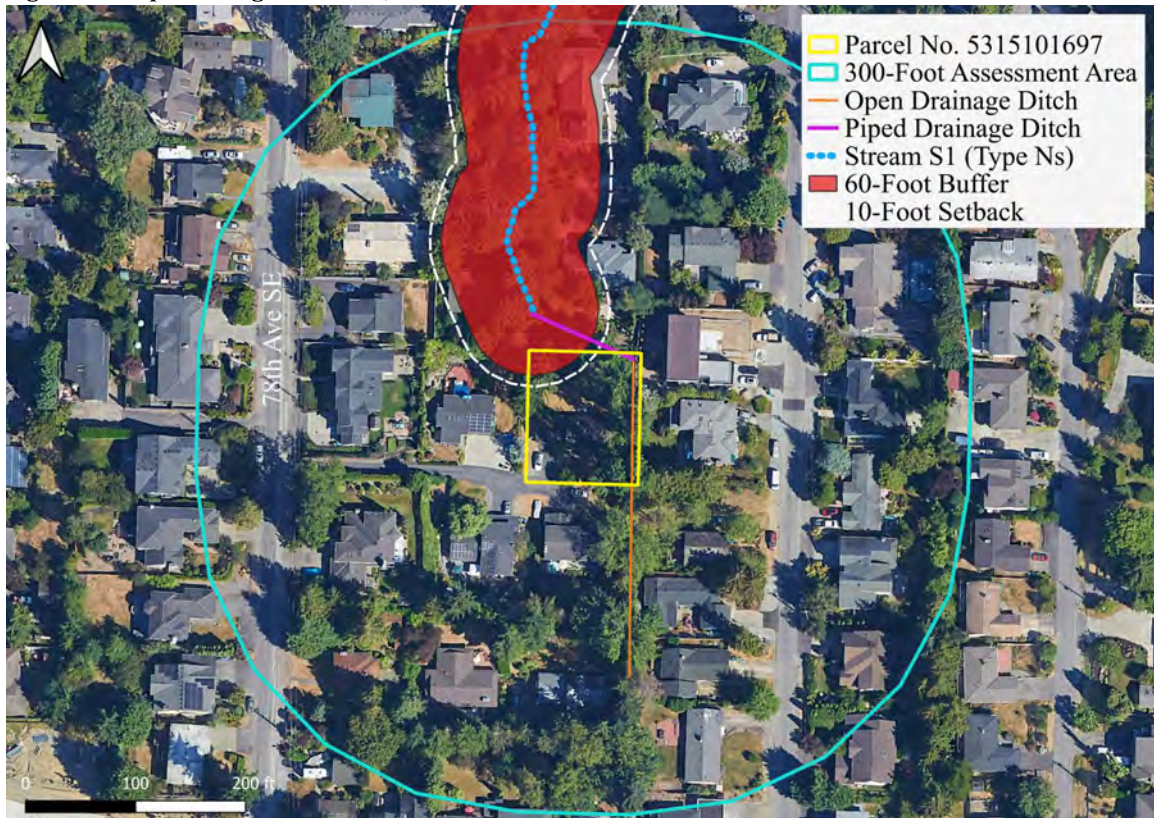
**Figure 3. Map showing stream S1, buffer and setback.**

In summary, the site assessment performed on May 30th, 2024 resulted in the identification of one stream (Appendix A). Stream S1 was not delineated because it is located entirely off site of the subject property. The soil analysis pits that were dug on the subject property did not indicate the presence of hydric soils or wetland hydrology. According to MICC 19.07.180, the buffer for S1 and all Type N streams is 60-feet from the observed ordinary high water mark (Figure 3). Buildings and other structures are to be set back 10 feet from the watercourse buffer.

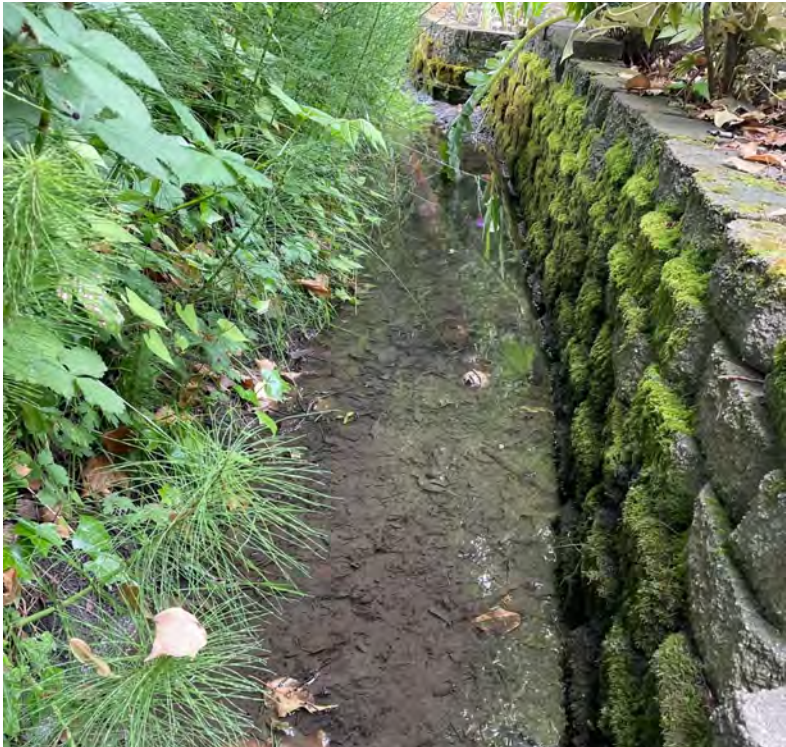
The onsite ditch is not a regulated watercourse because it is a human built excavation that conveys stormwater and is not identified by the state of Washington as a classified or unclassified stream. The Type N stream begins at the end of the culvert located approximately 35 feet offsite to the north on King County tax parcel No. 5315101680. The stream's location was mapped using onsite observations and the WDNR's public LiDAR data. Photos of the subject property are included in Appendix D.

**Photo 1.** Looking south at the stormwater ditch.

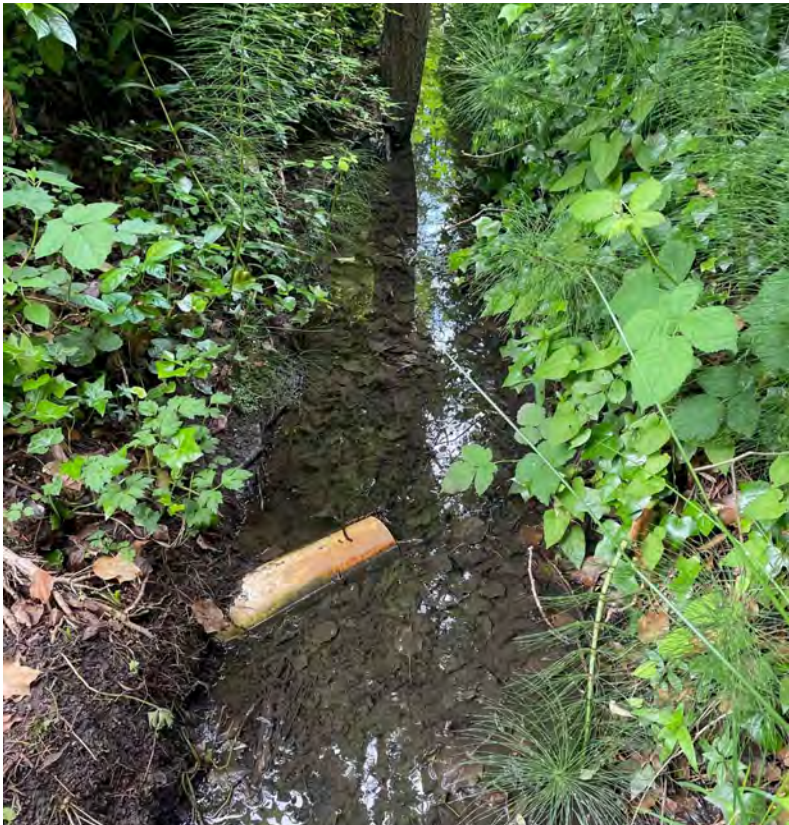
**Photo 2.** Looking north towards the onsite stormwater ditch.

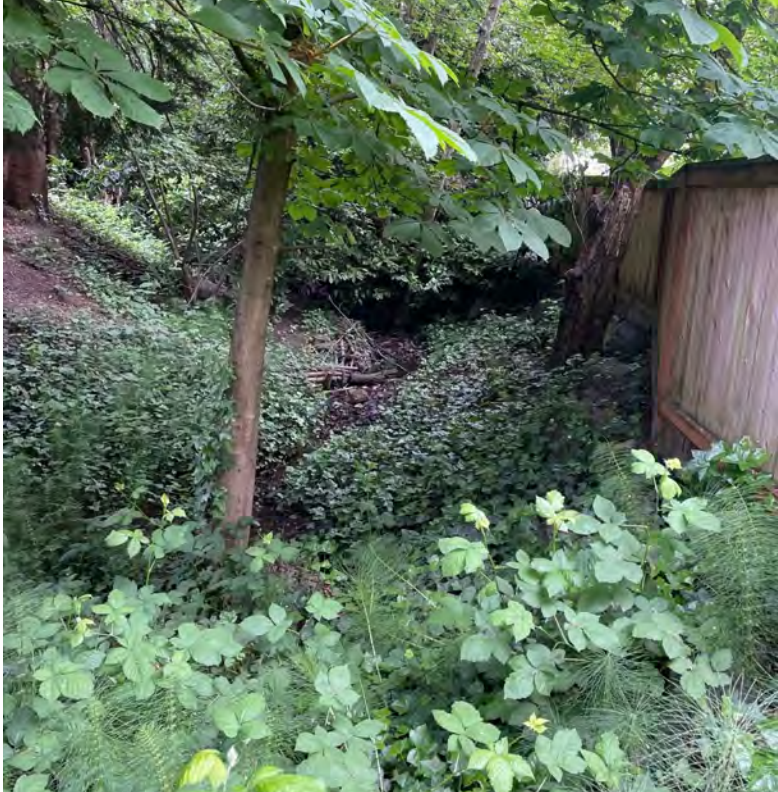
A stream (S1) was observed entirely offsite that had flowing water during the May site assessment. The stream's ordinary high water mark was not delineated as it is located entirely off site of the subject property. The stream flows from south to north and is fed by a stormwater drainage ditch that itself connects with a series of stormwater pipes leading from SE 24th St (Appendix C). According to MICC 19.16.010, the definition of a watercourse does not include drainage ditches. The drainage ditch is piped along the north border of the subject property and is an open drainage ditch along the east border.

**Photo 3.** Looking north towards stream S1.

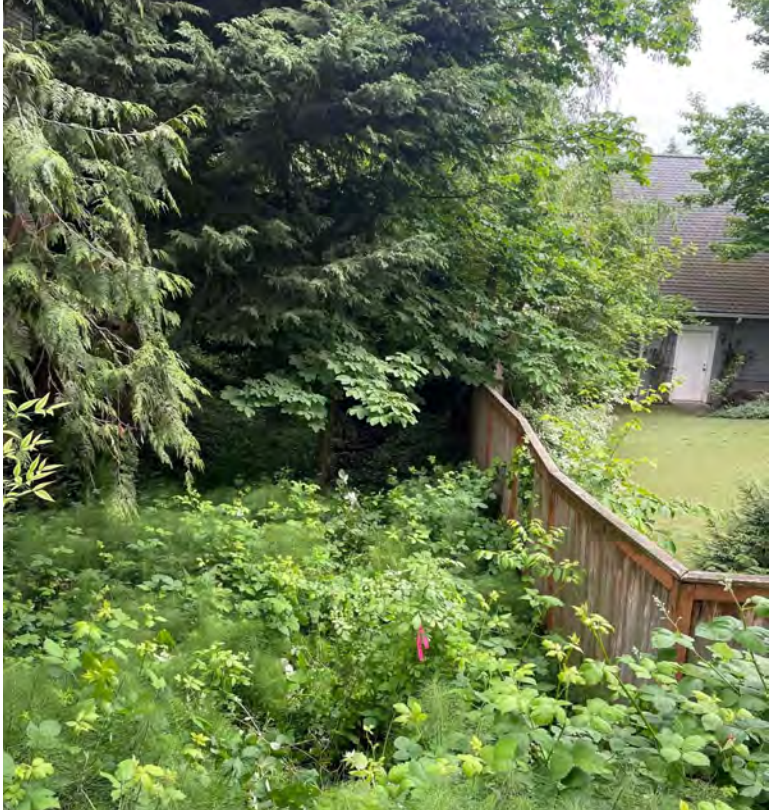
**Photo 4.** Looking north towards stream S1.

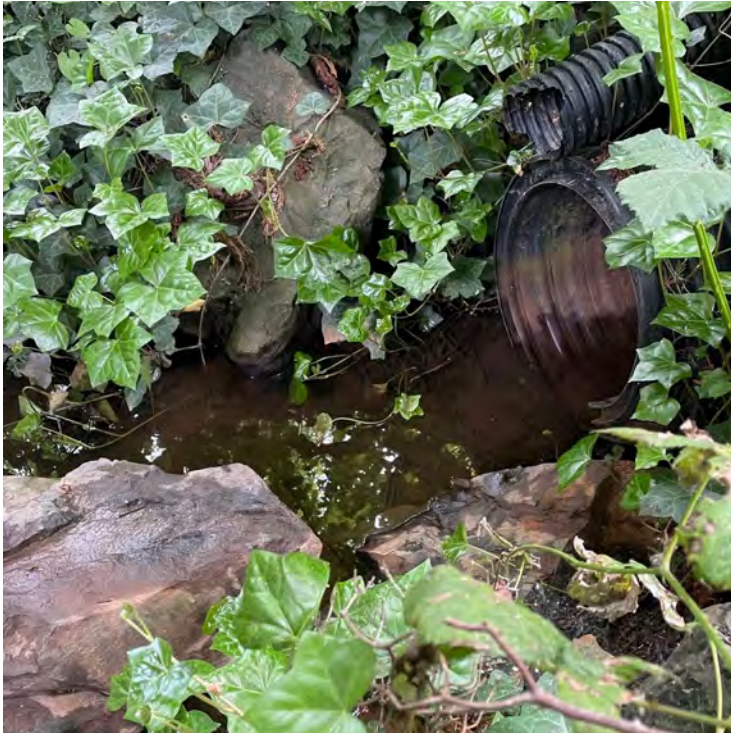
**Photo 5.** Looking at western end of piped drainage.

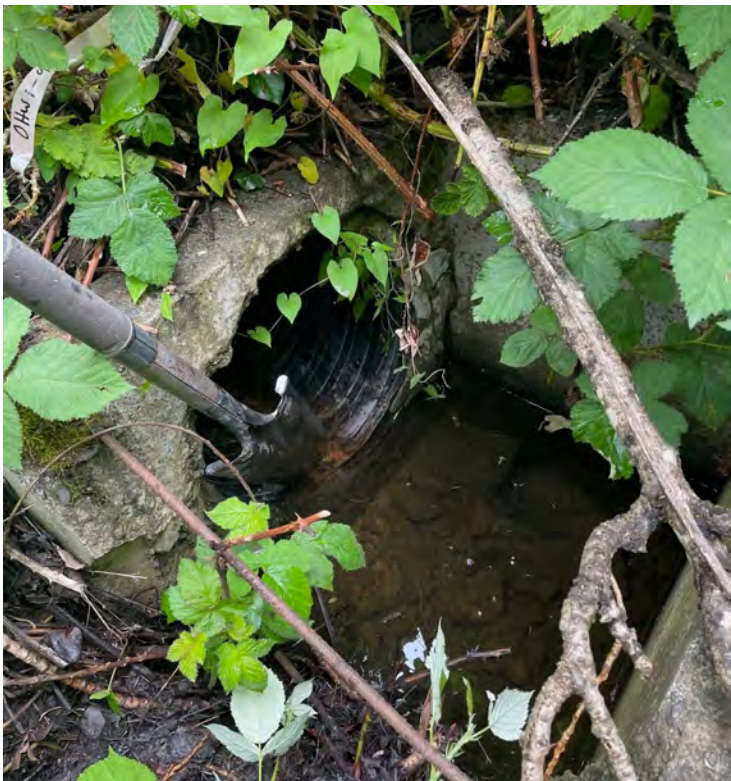
**Photo 6.** Looking at eastern end of piped drainage.
