## Eastside Environmental Pros

Project: EE-577

REFERENCE: King County Tax Parcel #426000-0020  
SUBJECT: Critical Areas Study

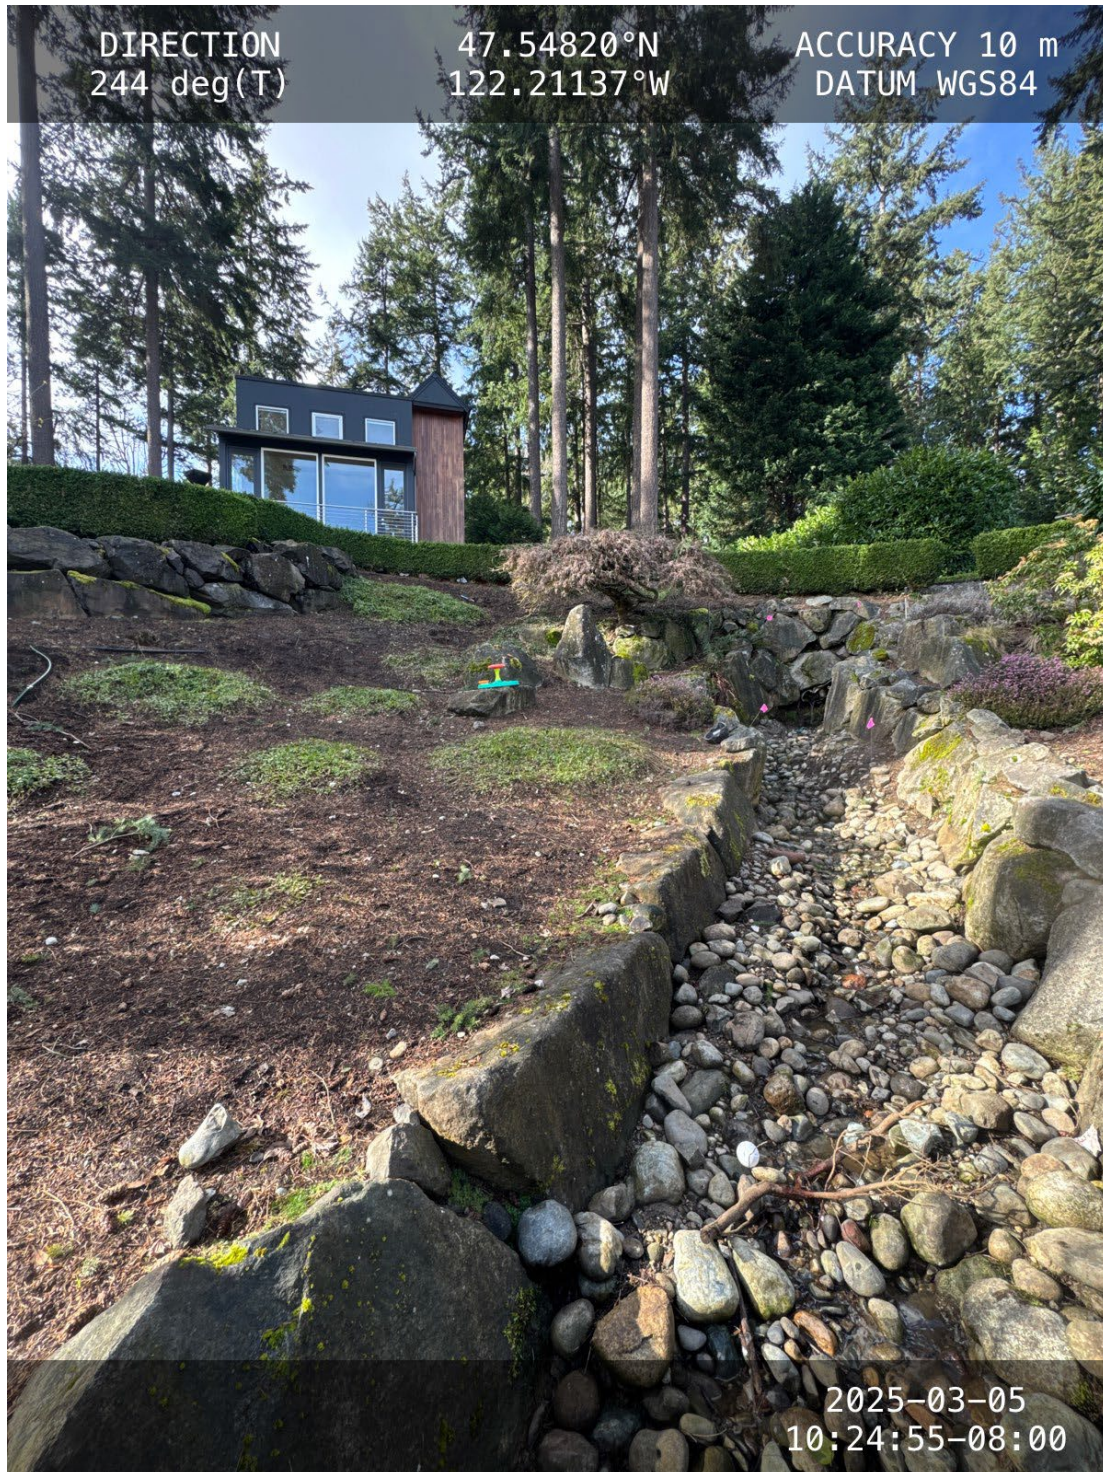
**Photo 1.** Photo of onsite watercourse (Stream 1) located within created rock channel that continues offsite through a pipe to the east, photo taken facing upslope to the west toward house.

Stream 1 is located within an engineered rock-lined stream channel and extends offsite to the west and east (**Photo 1**). Stream 1 is primarily fed by groundwater and runoff from upslope areas and flows eastward before it outlets into Lake Washington. Stream 1 has an average bankfull width of 4-6 feet onsite. Its streambed is comprised of large, medium and small sized cobbles. Stream 1 is recorded as a Type Ns watercourse according to the Mercer Island GIS Portal. Type Ns streams require 60-foot buffers and 10-foot building setbacks per MICC §19.07.180 and MICC §19.07.180.7 respectively. Additionally, portions of Stream 1 are piped offsite to the east and west (**Figure 1**). These portions of piped watercourse qualify 10-foot buffers per MICC §19.07.180.C.6.d. which states, *“when daylighting is determined by qualified professional(s) to result in one or more of the following outcomes: ...iii. The inability of a legally established existing lot to meet the vehicular access requirements of this title.”*

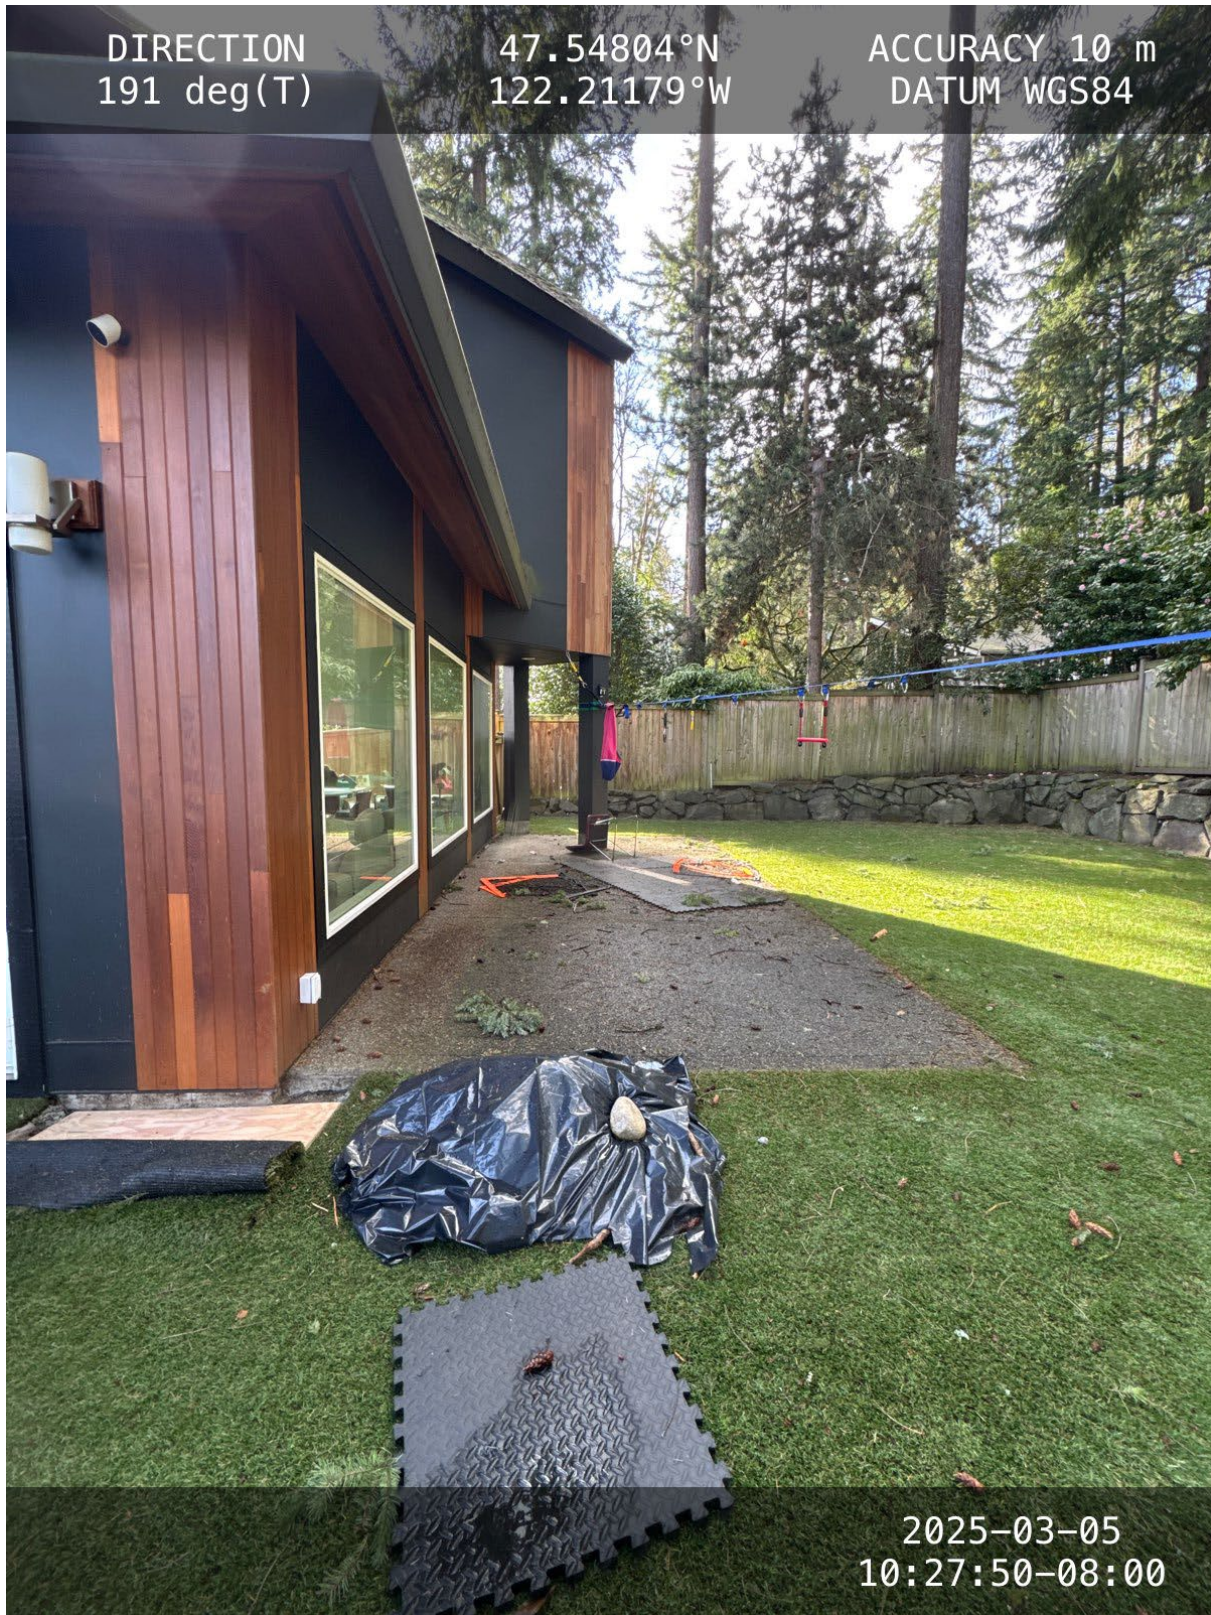
Photo 2. Photo of the proposed SFR expansion area, photo taken facing house to the south.

The expanded portion of the structure is located almost entirely within the original footprint of the existing patio and adjacent artificial turf grass. This patio and its adjacent “lawn” areas, composed of synthetic turf, are considered hardscape due to their impervious nature. Though this development is located entirely outside stream areas, a small portion of this addition is located within Stream 1’s buffer. Therefore, a small amount of buffer averaging is proposed as part of this modification for this project. And is described further in the following **“Buffer Averaging”** section.

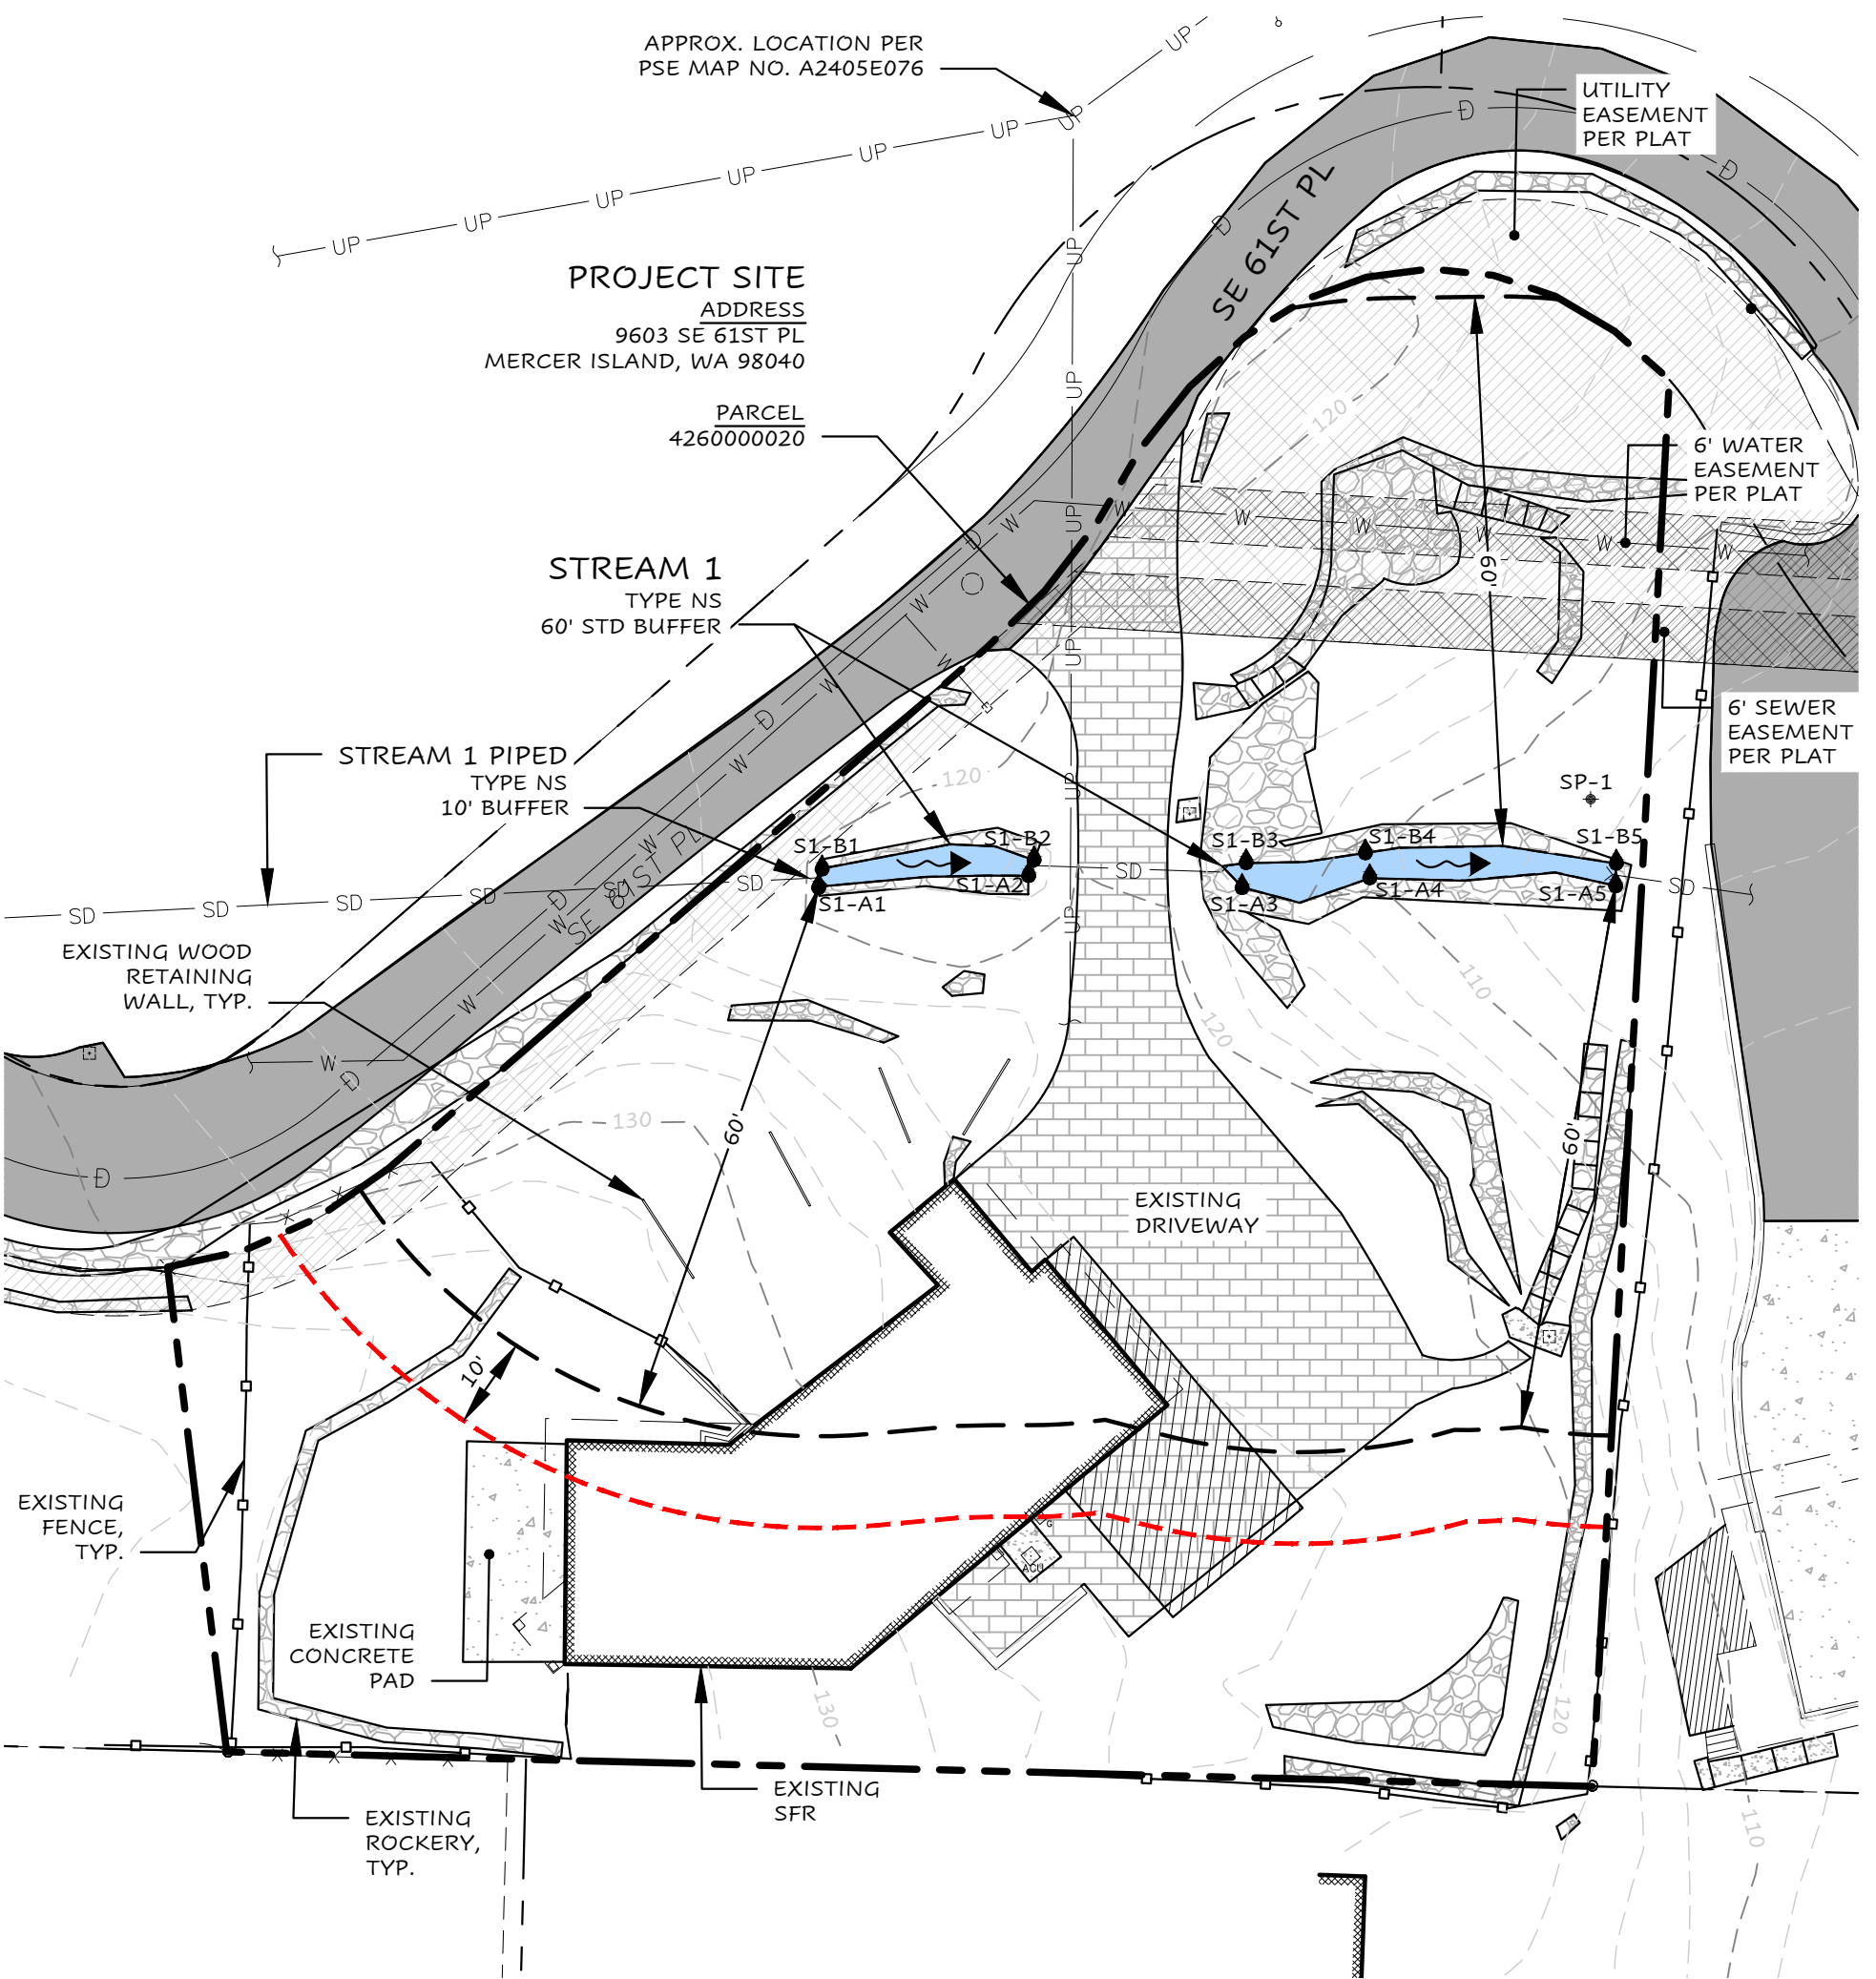
FIGURE #1  
EXISTING CONDITIONS MAP  
ACKLEY CRITICAL AREAS REPORT  
CITY OF MERCER ISLAND, WASHINGTON

One (1) watercourse was identified onsite and continues offsite to the east but within the Study Area during the 5<sup>th</sup> March 2025 Site visit (**Figure 1**). In addition, a potential landslide hazard area is depicted on the City of Mercer Island's Geospatial Hub. Therefore, **per section 19.07.160.B(1)-Geologically hazardous areas** "*When an alteration within a landslide hazard area, seismic hazard area or buffer associated with those hazards is proposed, the applicant must submit a critical area study concluding that the proposal can effectively mitigate risks of the hazard. The study shall recommend appropriate design and development measures to mitigate such hazards. The code official may waive the requirement for a critical area study and the requirements of subsections (B)(2) and (B)(3) of this section when he or she determines that the proposed development is minor in nature and will not increase the risk of landslide, erosion, or harm from seismic activity, or that the development site does not meet the definition of a geologically hazardous area.*".

These piped portions of Stream 1 are located adjacent to and directly under Southeast 61<sup>st</sup> Street which provides access to several residential lots. Daylighting this watercourse would require the removal of the road and relinquishing access to these legally established existing lots, which would be inconsistent with vehicular access requirements. Therefore, daylighting the watercourse is not a feasible option, and this portion of watercourse requires a 10-foot setback as depicted in **Figures 1** and **2**.

## EXISTING CONDITIONS MAP

One (1) watercourse (Stream 1) was identified during the onsite the 5 March 2025 Site visit (**Figure 1**). Stream 1 is located within the central portion of the Site and continues offsite to the east and west via underground piping. In addition, a potential landslide hazard area is depicted on the City of Mercer Island’s Geospatial Hub. Therefore, additional investigation

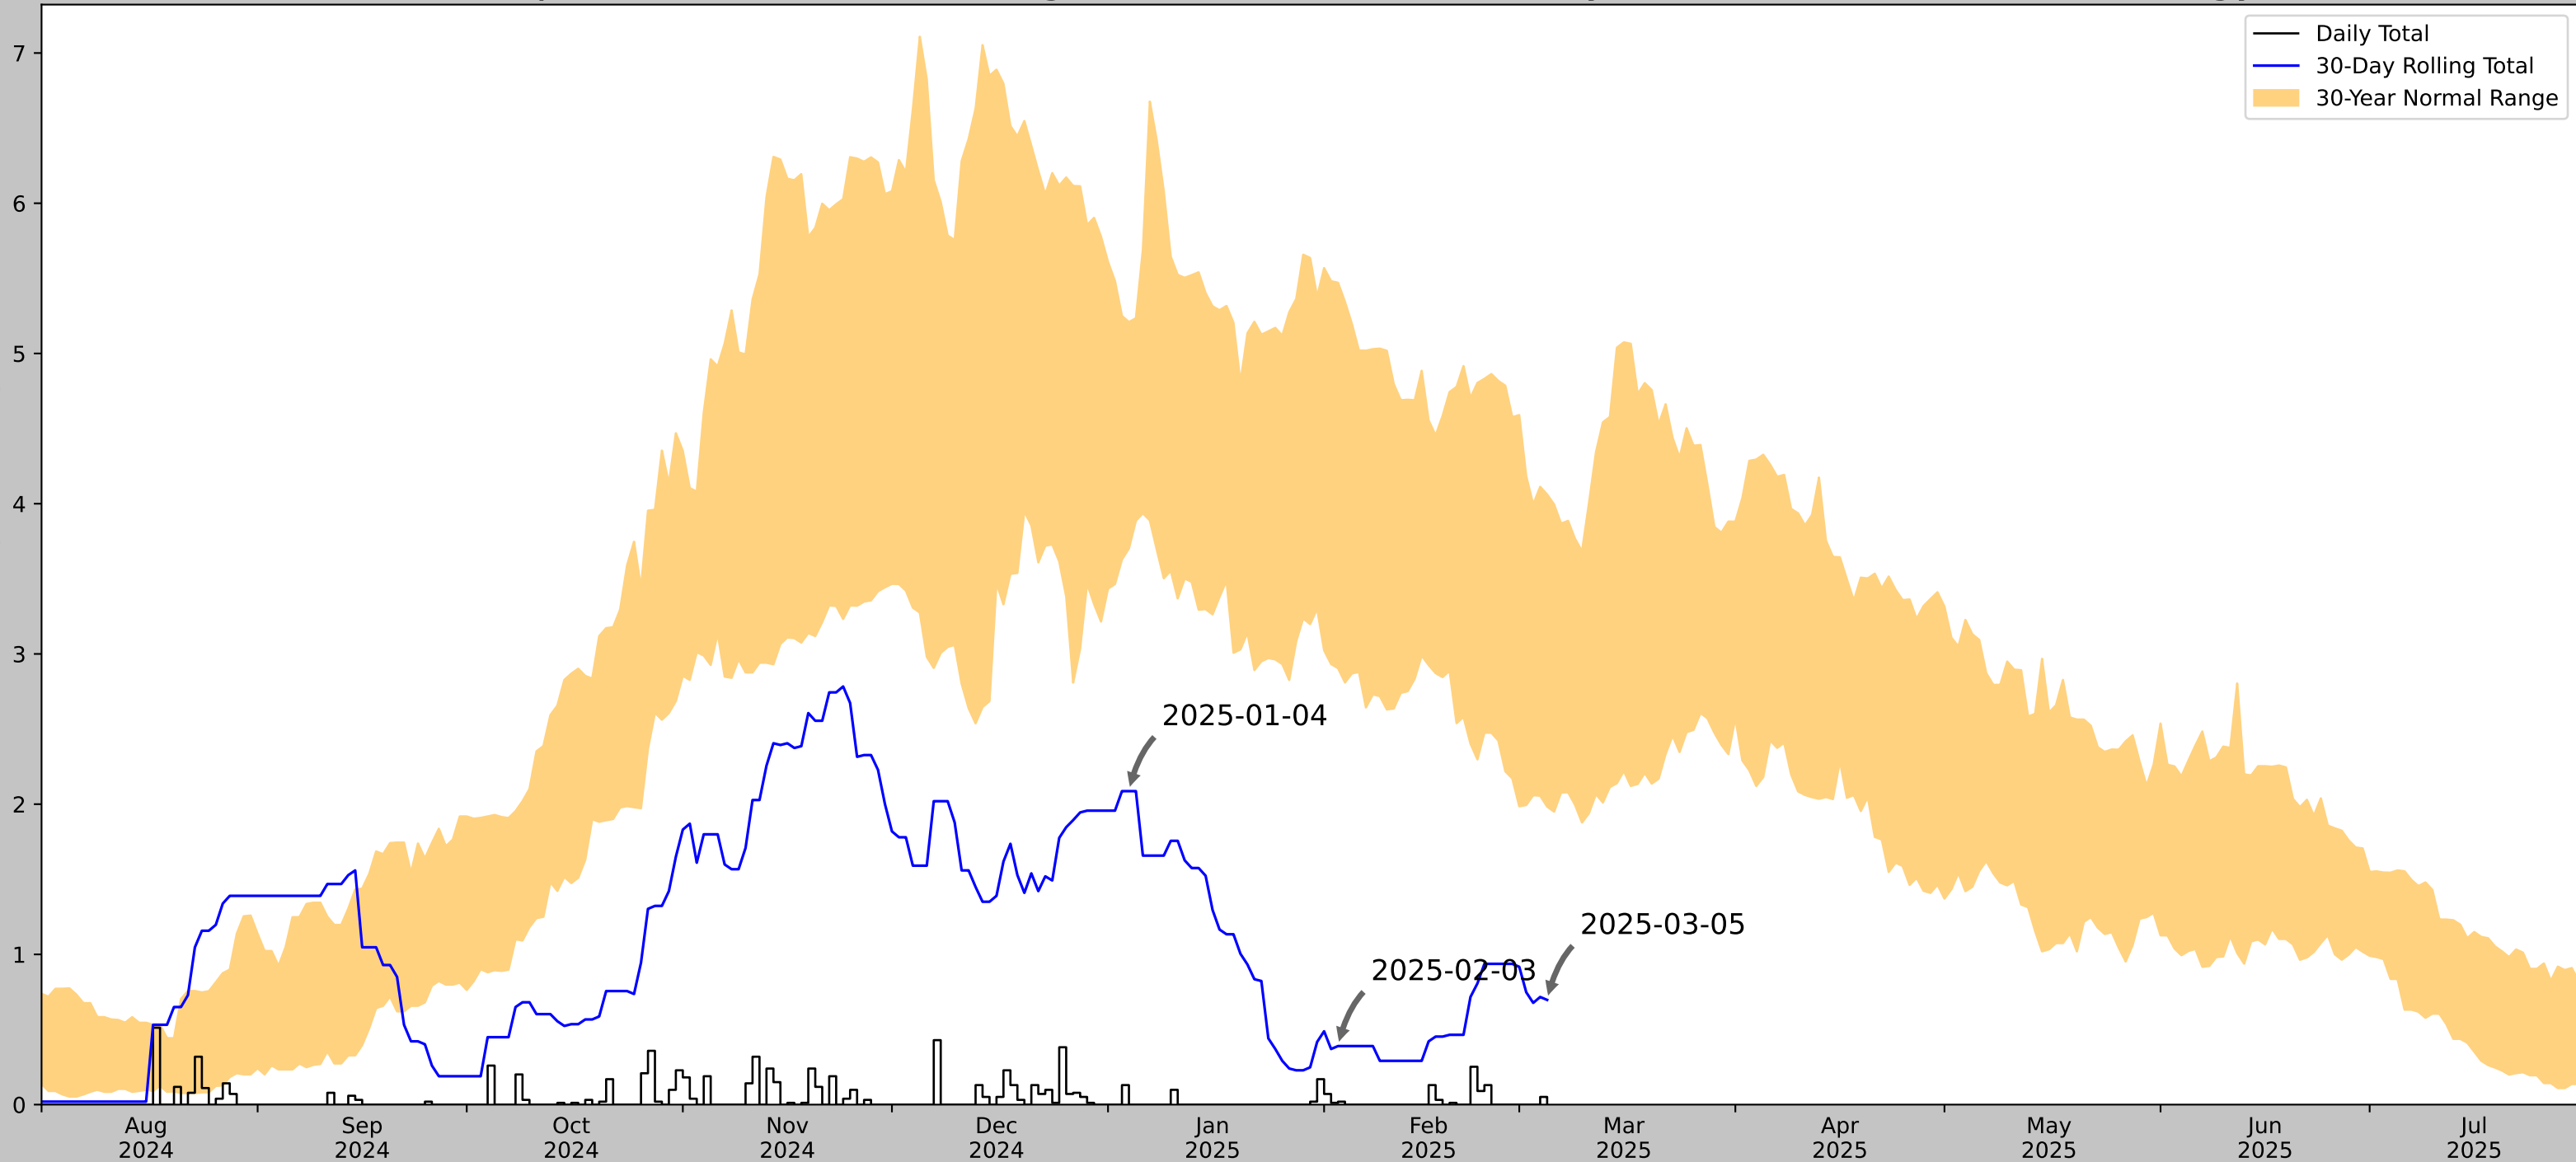
This normal precipitation analysis follows the methodology described by Sprecher and Warne (2000). The Corps Antecedent Precipitation application tool was used to determine that drier than normal climatic conditions were present during the 5 March 2025 Site Evaluation.

# Antecedent Precipitation vs Normal Range based on NOAA's Daily Global Historical Climatology Network

A Wetland Determination Datasheet was recorded within a representative location on-site (**Attachment 1**). Climatic conditions were evaluated through the Army Corps of Engineers Antecedent Precipitation Tool application (**Attachment 2**). Climatic conditions during the Site visit were **drier than normal**.
