## Earth Solutions NW LLC

**Subject: Critical Area Report  
78<sup>th</sup> Avenue Southeast Single-Family Residence  
4115 – 78<sup>th</sup> Avenue Southeast  
Mercer Island, Washington**

**Vicinity Map**  
**78th Avenue S.E. SFR**  
**Mercer Island, Washington**

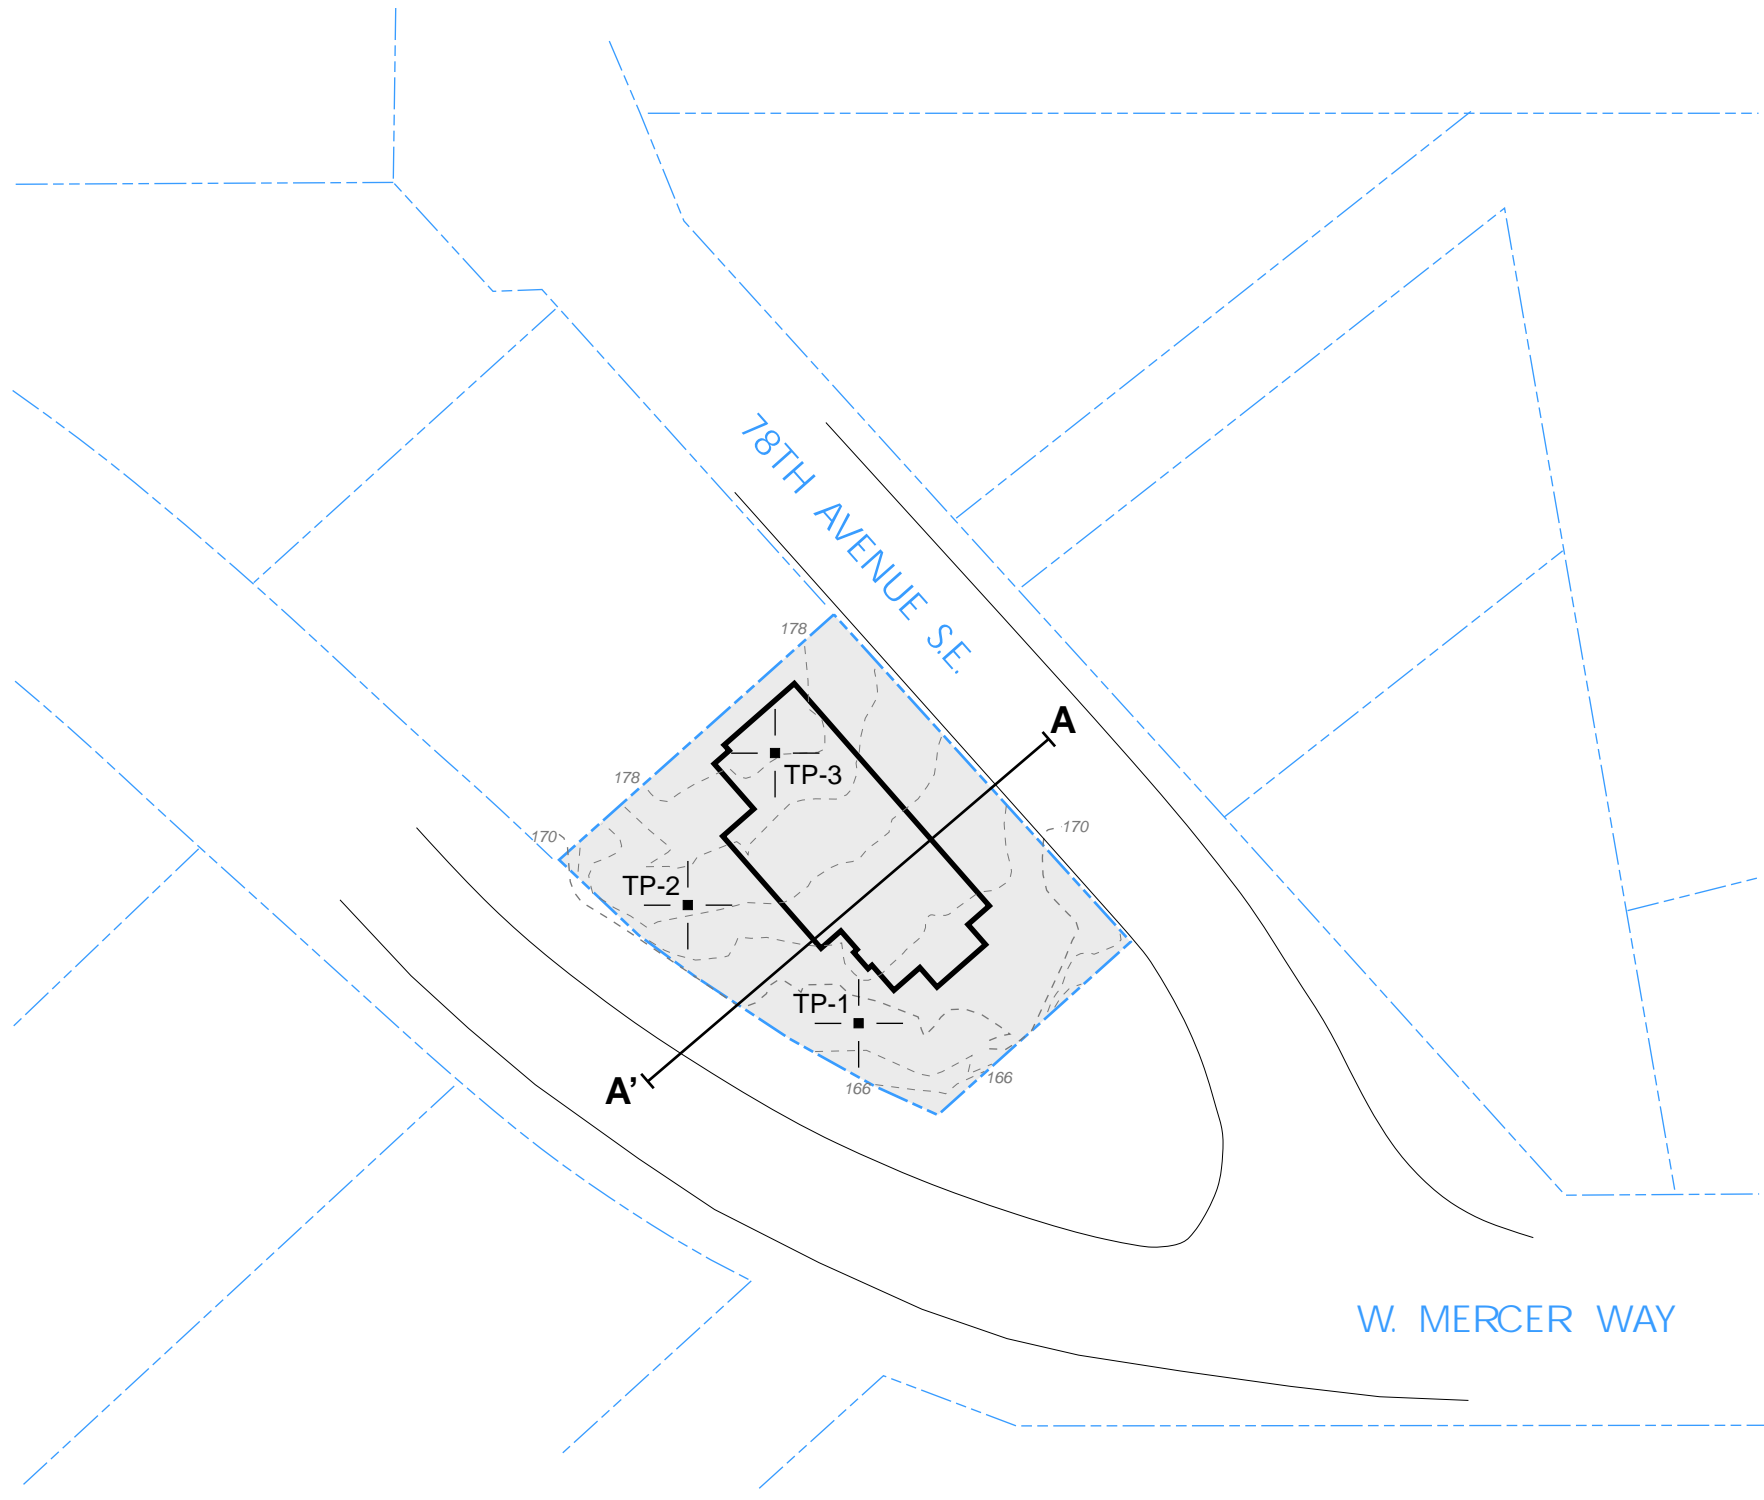
Drawn MRS
Checked SHA
Date 01/31/2025
Proj. No. 10099.01
Plate 2

- TP-1 | ■ | Approximate Location of ESNW Test Pit, Proj. No. ES-10099, Sept. 2024
- ▭ | Subject Site
- ▭ | Proposed Building
- | Cross-Section

ESNW has included a site plan (Plate 2) which includes the previous test locations and property boundaries (including topography) as an attachment to this document. The topography illustrated on Plate 2 was developed by utilizing the site survey provided ESNW.

Please see the Subsurface Exploration Plan which is attached to this study.
