Eastside Environmental Pros

Project: EE-720

REFERENCE: King County Tax Parcel #545260-0020

SUBJECT: Critical Areas Study

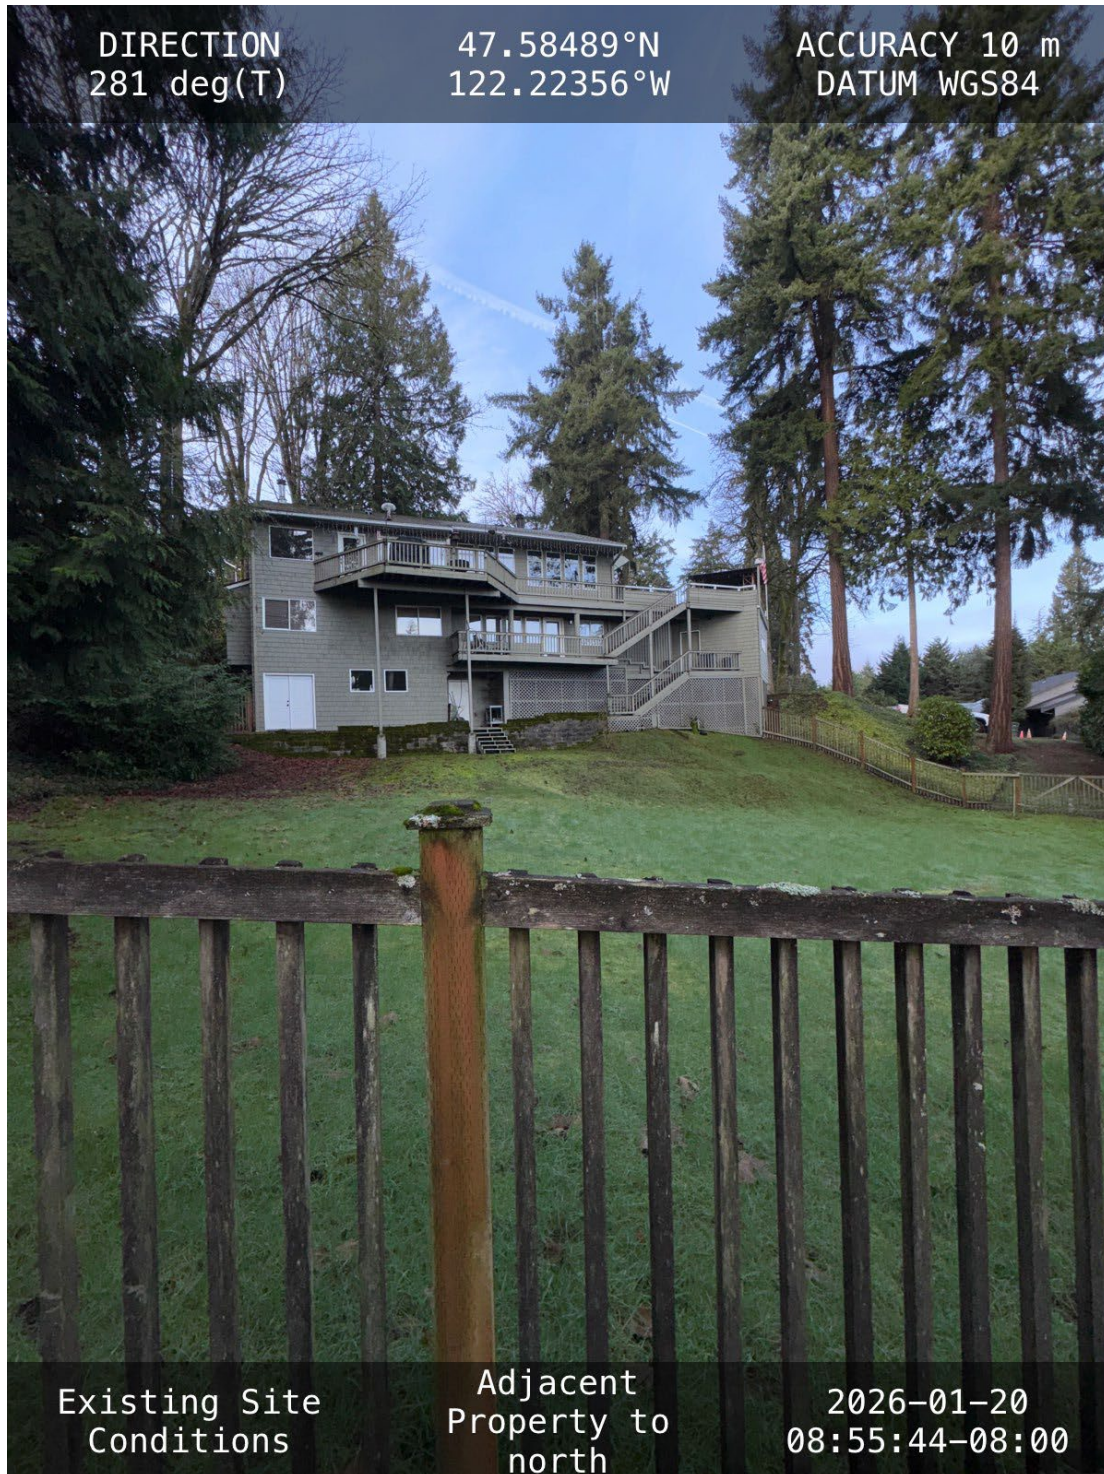
Photo 1. Photo of GIS mapped location of off-Site watercourse (Stream 1) located underground (piped) that continues off-Site through a pipe to the northwest, photo taken facing upslope to the west toward off-Site house.

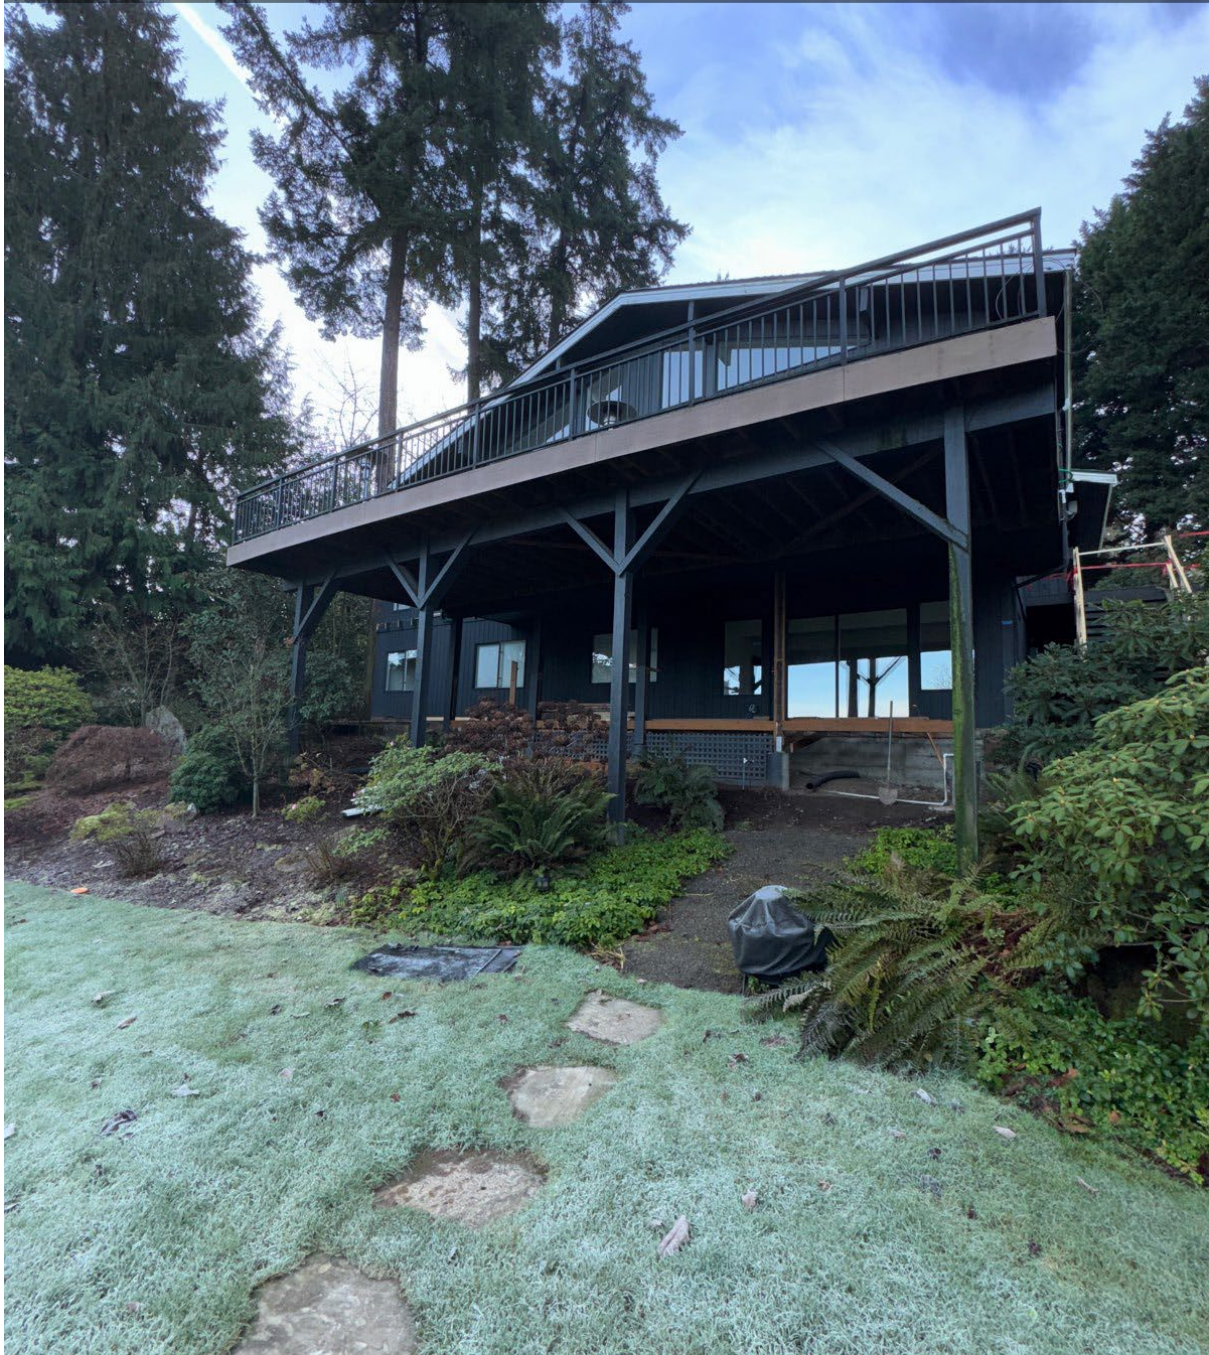
Deck on
northernmost
side of house

Photo 2. Photo of the proposed in-kind deck replacement area, photo taken facing house to the south.

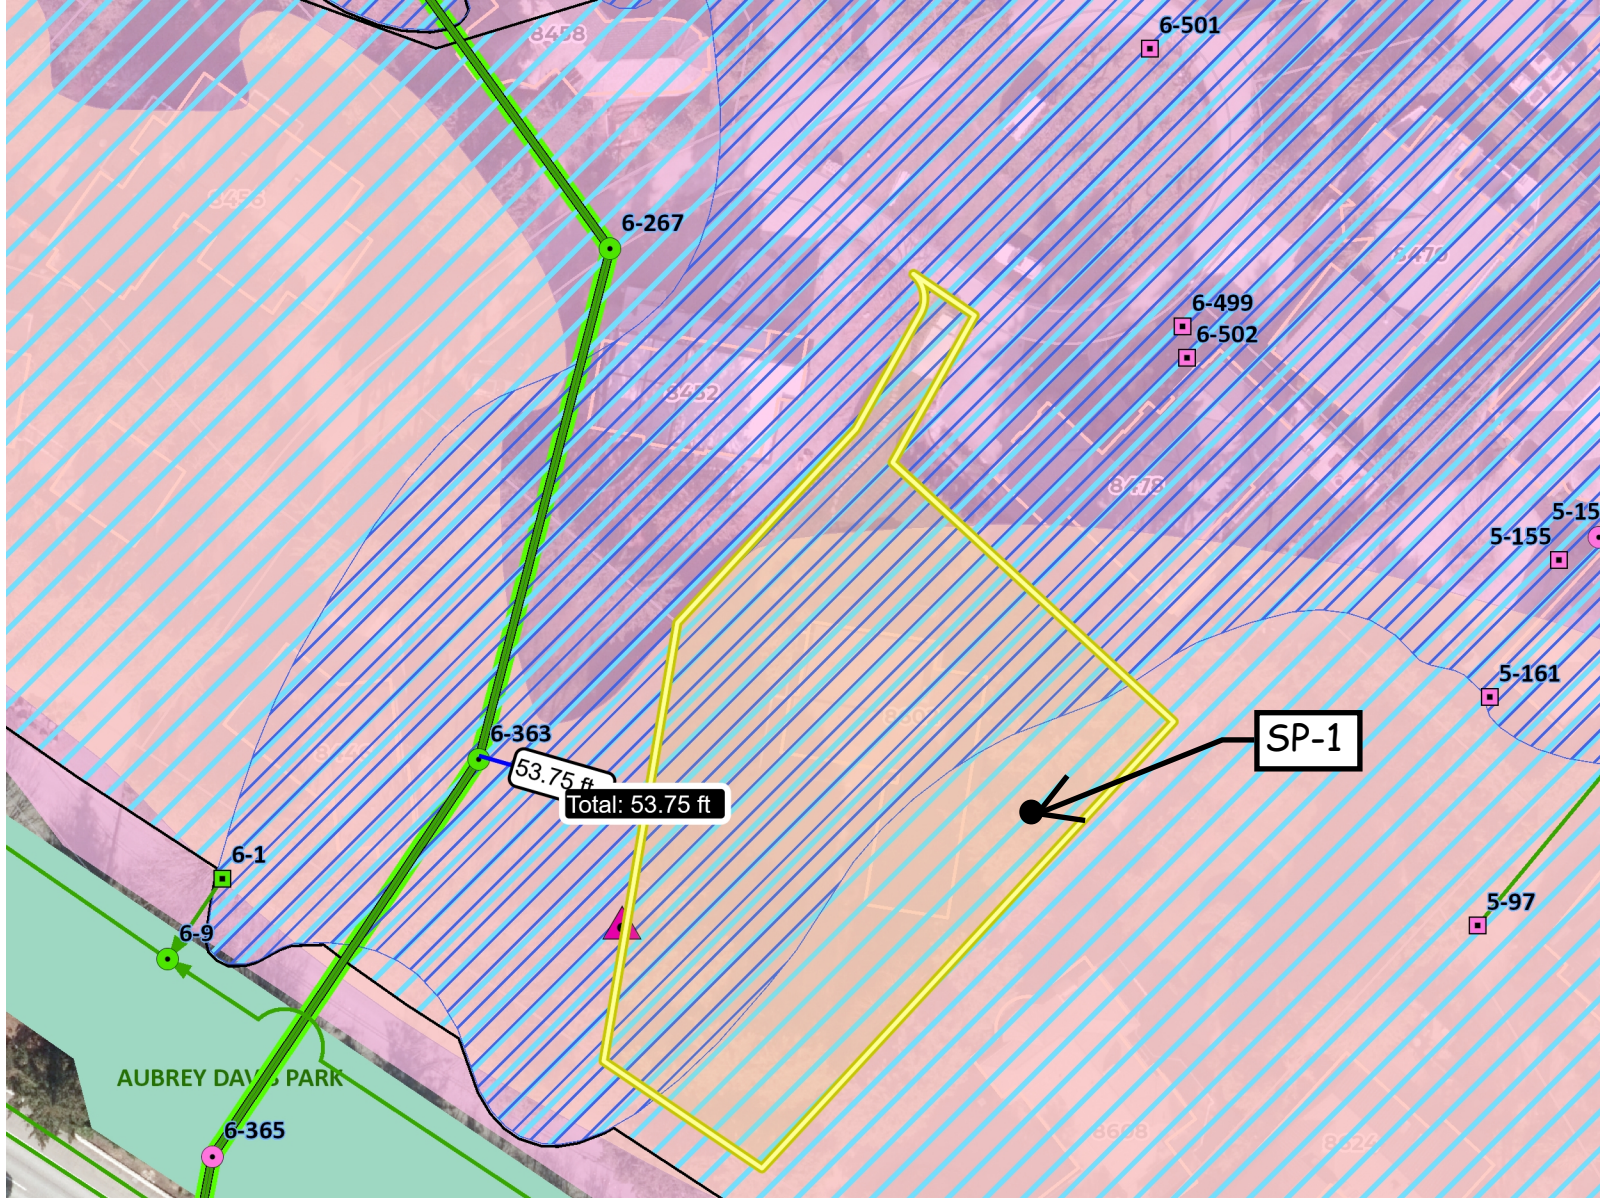
Figure 1. Existing Conditions Map

One (1) Type Np, **pip**ed watercourse was identified off-Site west of the Site and continues off-Site to the east but within the Study Area during the 20th January 2025 Site visit (**Figure 1**). In addition, a potential landslide hazard area, seismic hazard area, as well as erosion hazard area is depicted on the City of Mercer Island's Geospatial Hub. In accordance with **MCC 19.07.160.B(1)-Geologically hazardous areas** "When an alteration within a landslide hazard area, seismic hazard area or buffer associated with those hazards is proposed, the applicant must submit a critical area study concluding that the proposal can effectively mitigate risks of the hazard. The study shall recommend appropriate design and development measures to mitigate such hazards. The code official may waive the requirement for a critical area study and the requirements of subsections (B)(2) and (B)(3) of this section when he or she determines that the proposed development is minor in nature and will not increase the risk of landslide, erosion, or harm from seismic activity, or that the development site does not meet the definition of a geologically hazardous area." No other critical areas were identified within the Study Area. Critical areas are summarized below:

Stream 1 flows to the west of the Site, within a 36" underground concrete piped system located within a City drainage easement (**Figure 1**) per information in a LiDAR Watercourse and Stormwater Conveyance Analysis (Herrera 2019). Stream 1 flows northeastward before discharging into Lake Washington. Stream 1 is recorded as a piped watercourse according to the Mercer Island GIS Portal. Type N piped streams do not require buffers but do require a 10-foot building setbacks per MICC §19.07.180 and MICC §19.07.180.7 respectively. These portions of piped watercourse qualify 10-foot building setback buffers per MICC §19.07.180.C.6.d.

One (1) Type Np, **pip**ed watercourse (Stream 1) was identified during the onsite investigation and desktop review on January 20th, 2026 Site visit (**Figure 1**). Stream 1 is located offsite to the west of the Site and continues offsite to the northwest through an underground pipe as depicted. In addition, a potential landslide hazard area is depicted on the City of Mercer Island's Geospatial Hub. Therefore, additional investigation may be necessary before development by a licensed geotechnical engineer or consultant. No other critical areas were identified on-Site or within the Study Area.

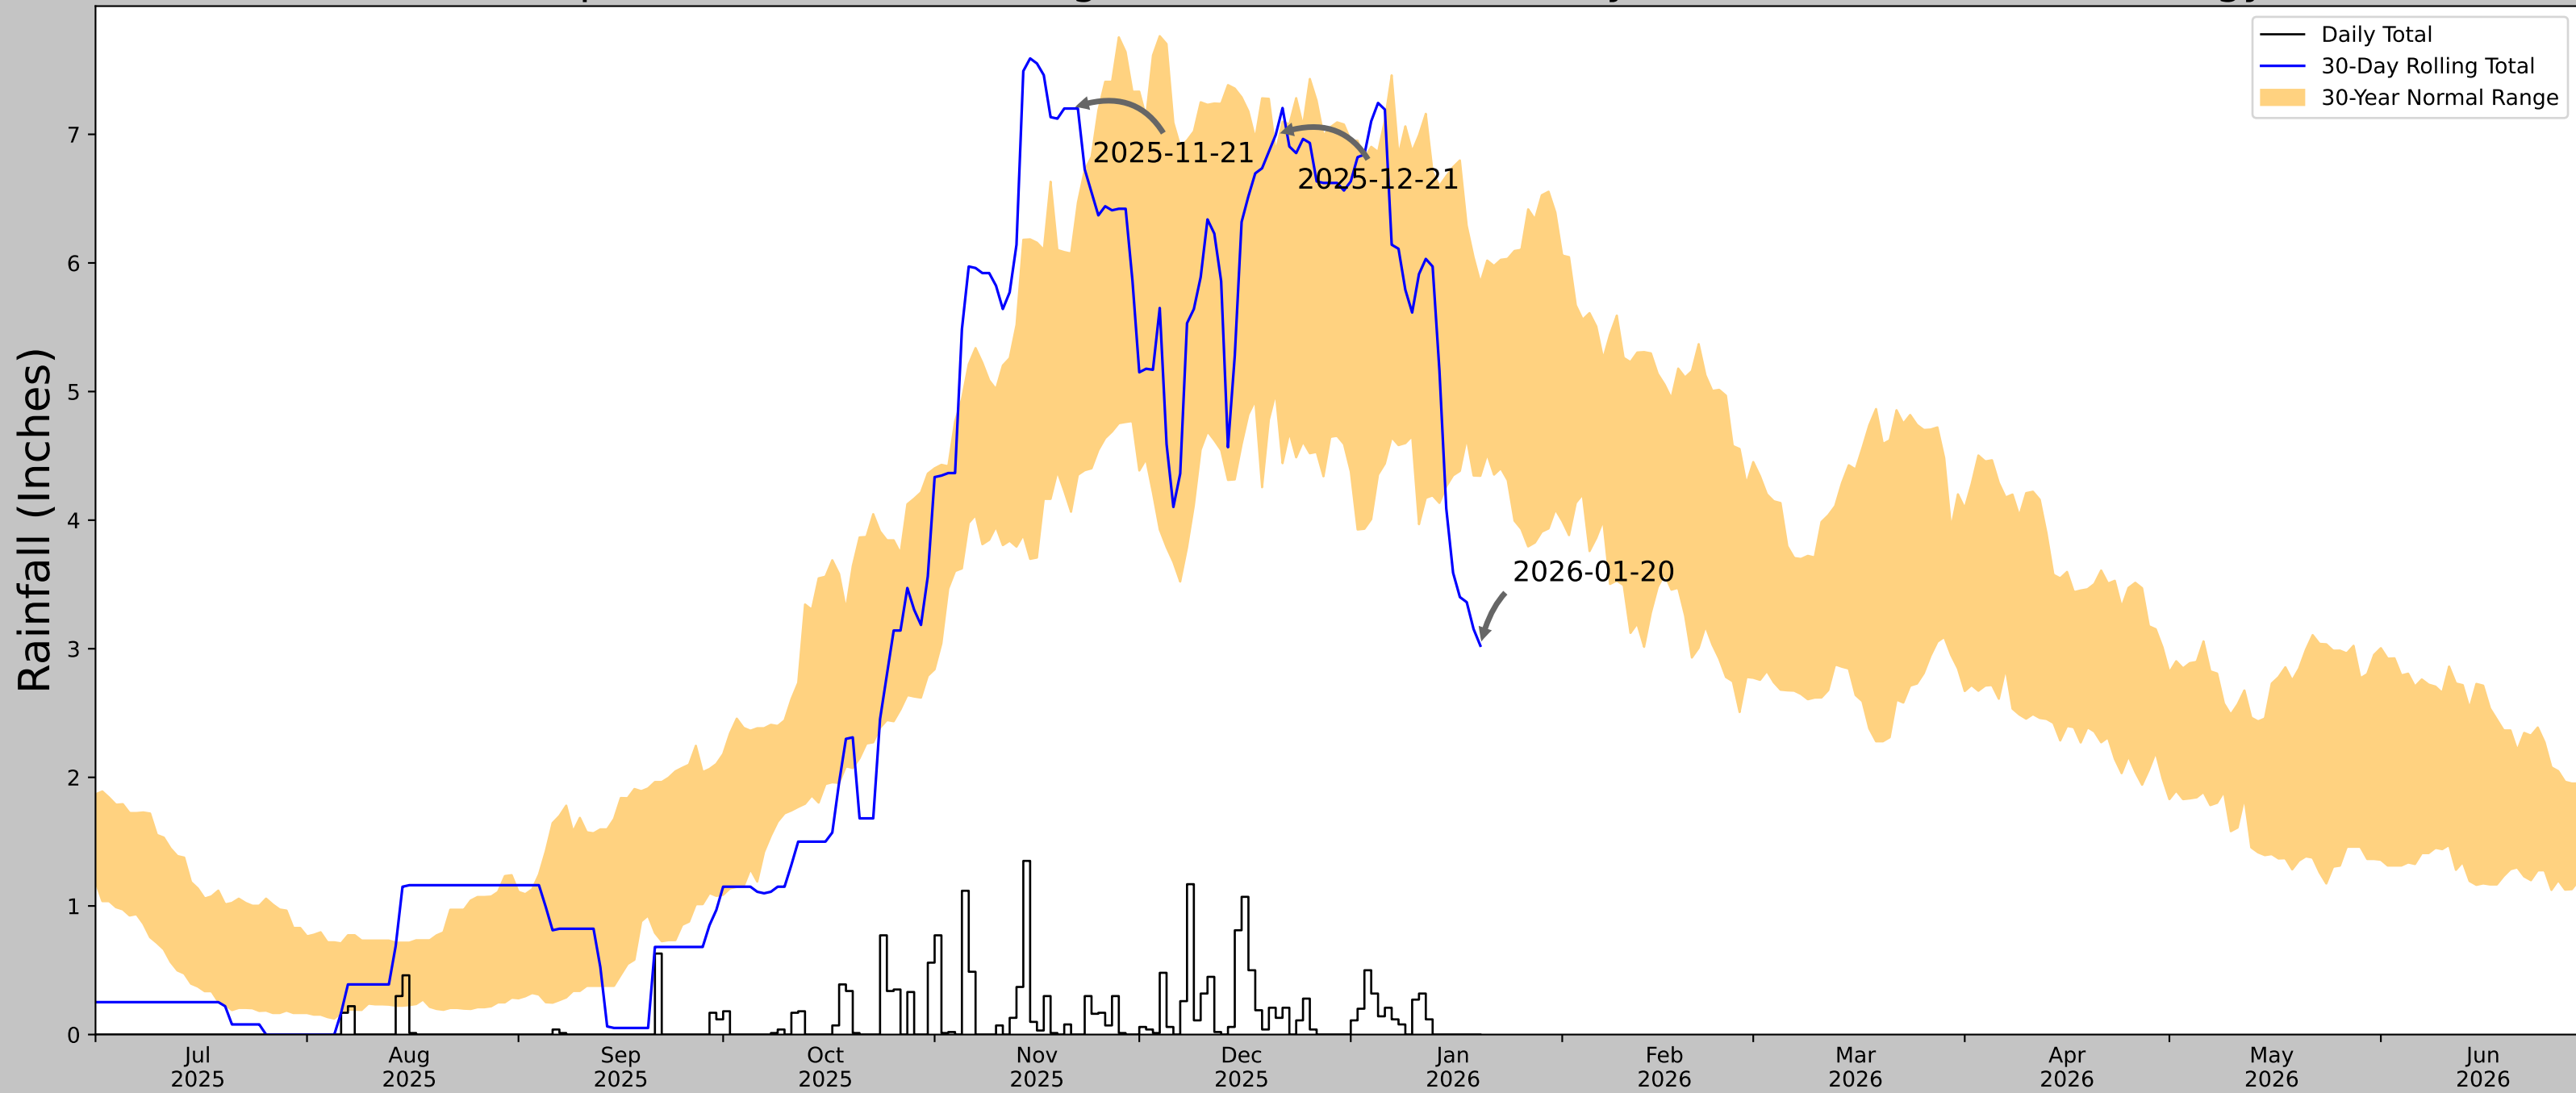
Antecedent Precipitation vs Normal Range based on NOAA's Daily Global Historical Climatology Network

This normal precipitation analysis follows the methodology described by Sprecher and Warne (2000). The Corps Antecedent Precipitation application tool was used to determine that normal climatic conditions were present during the 20 January 2026 Site Evaluation.

30 Days Ending	30 th %ile (in)	70 th %ile (in)	Observed (in)	Wetness Condition	Condition Value	Month Weight	Product
2026-01-20	4.344095	5.846063	3.023622	Dry	1	3	3
2025-12-21	4.990945	6.862992	6.996063	Wet	3	2	6
2025-11-21	4.064567	6.073229	7.200788	Wet	3	1	3
Result							Normal Conditions - 12
