**A** :: Site Plan - Current Coniditions  
 001 scale: 1:40

**Conceptual Development Option A:**  
3 Residential Single Family Parcels

**A** :: Development Option A  
002 scale: 1:40

7600 Block West Mercer Way

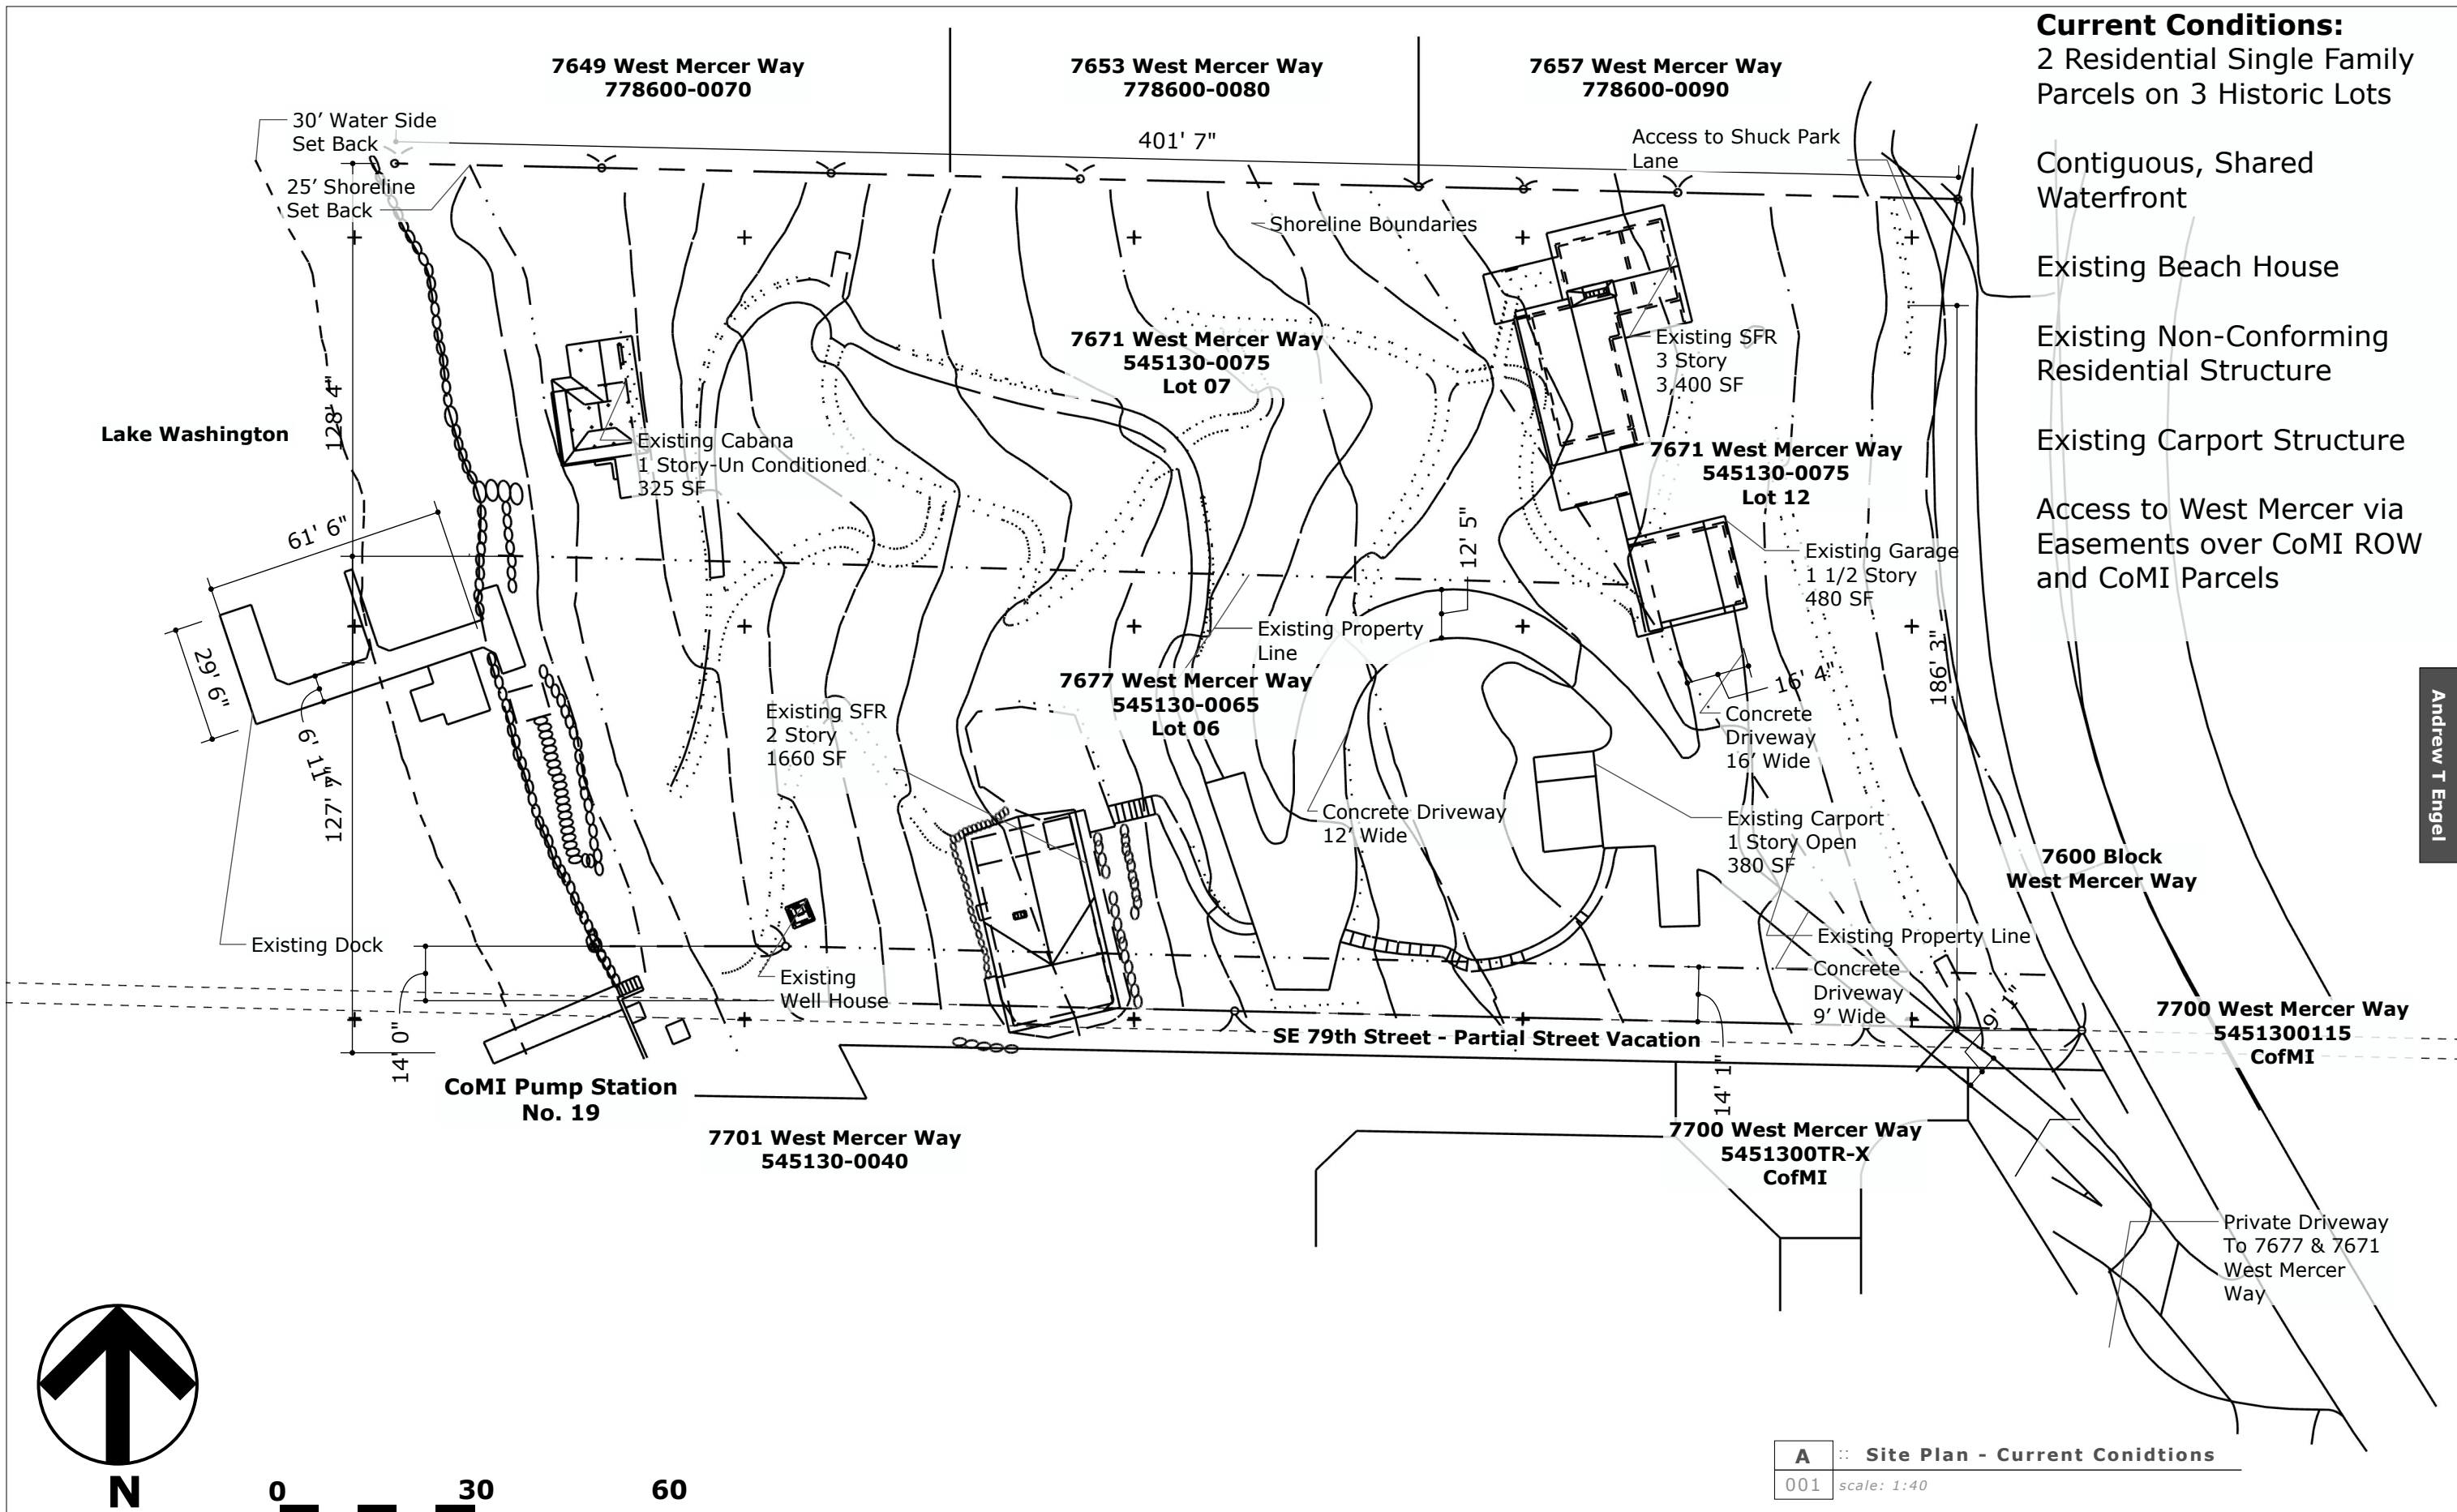
- Shared Use Waterfront Parcel
- New and Improved Private Drive
- Existing Non-Conforming Structure Removed
- Shared Dock Structure to Remain with Modifications
