# SUB-BASIN 46A.3 WATERCOURSE STABILIZATION CRITICAL AREAS STUDY – REVISED

*Prepared for the City of Mercer Island*

October 2025

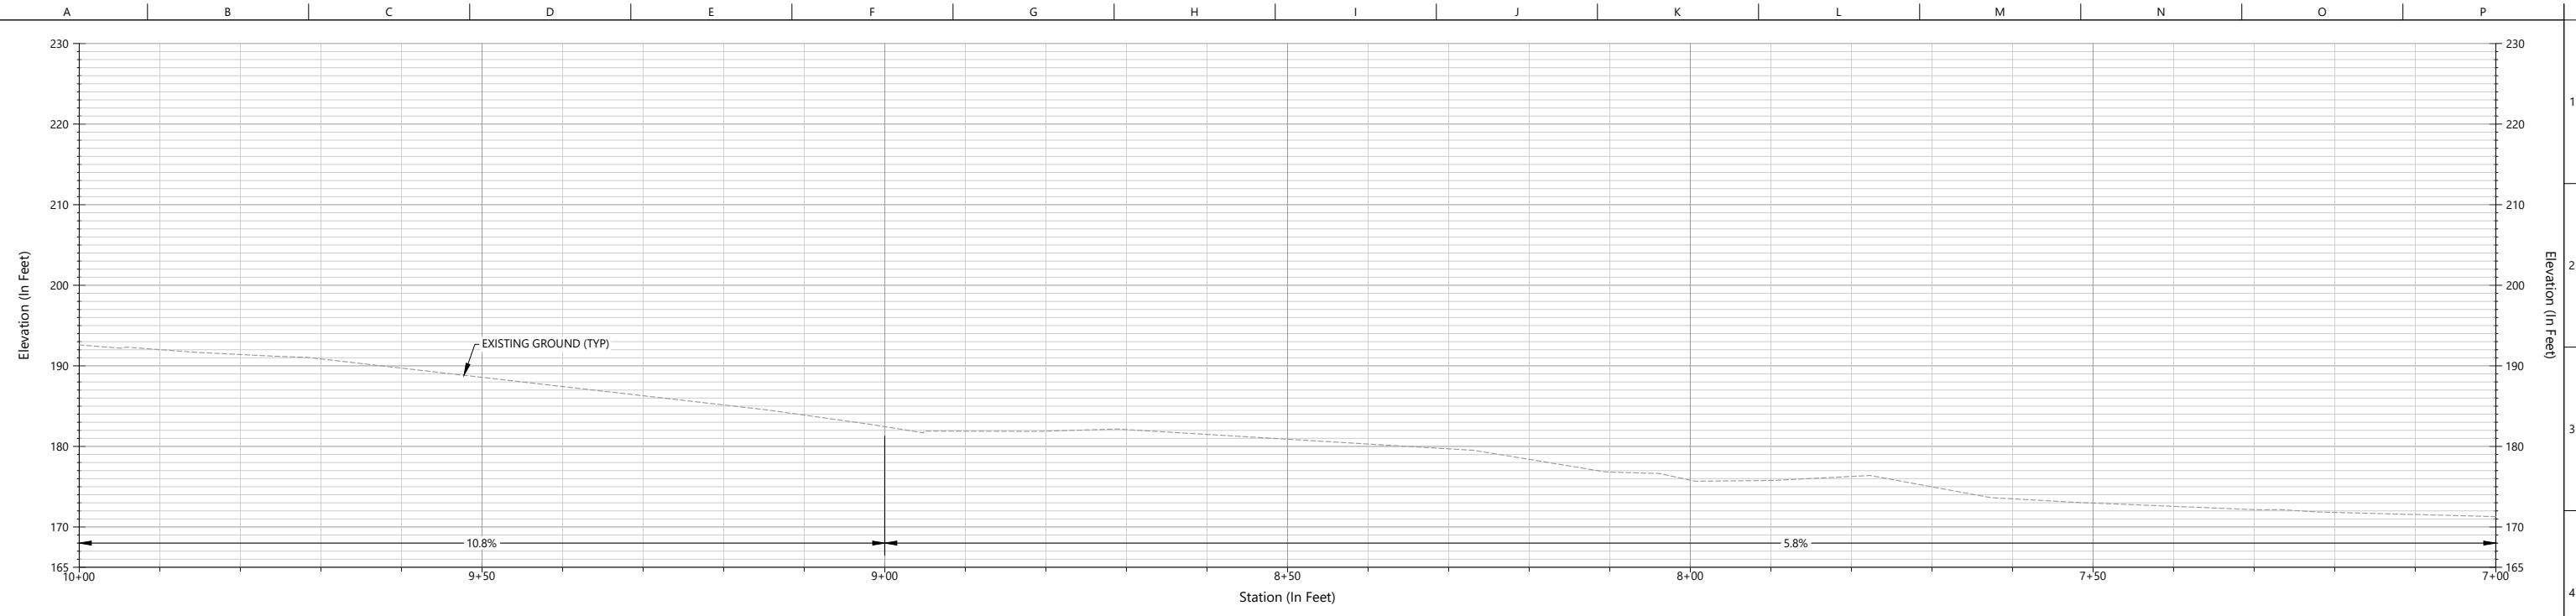
**CHANNEL PROFILE**  
SCALE: 1"=10'

**NOTES:**  
1. REACH-AVERAGED EXISTING GRADE SLOPES SHOWN.

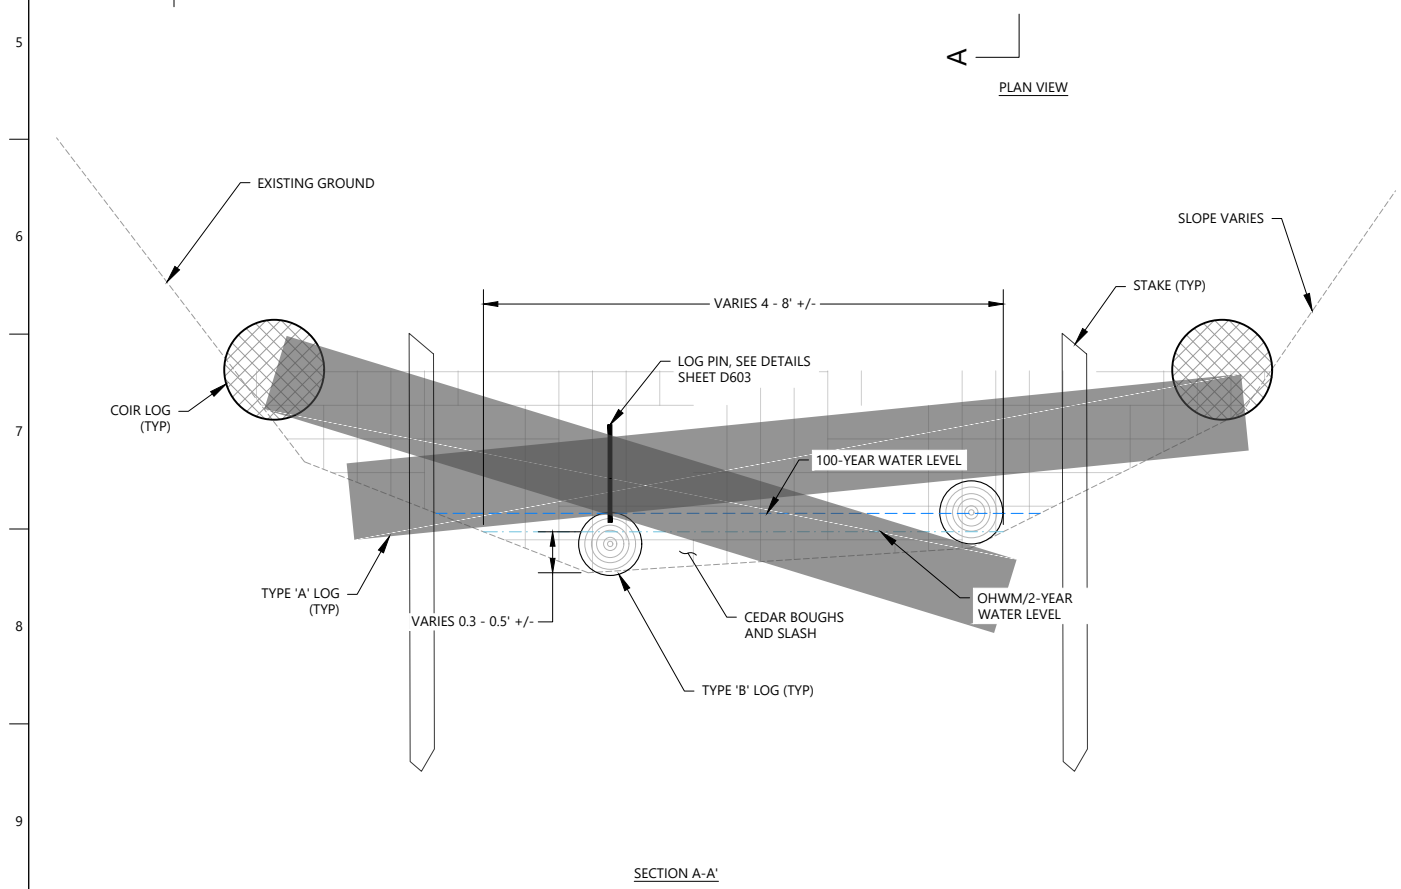
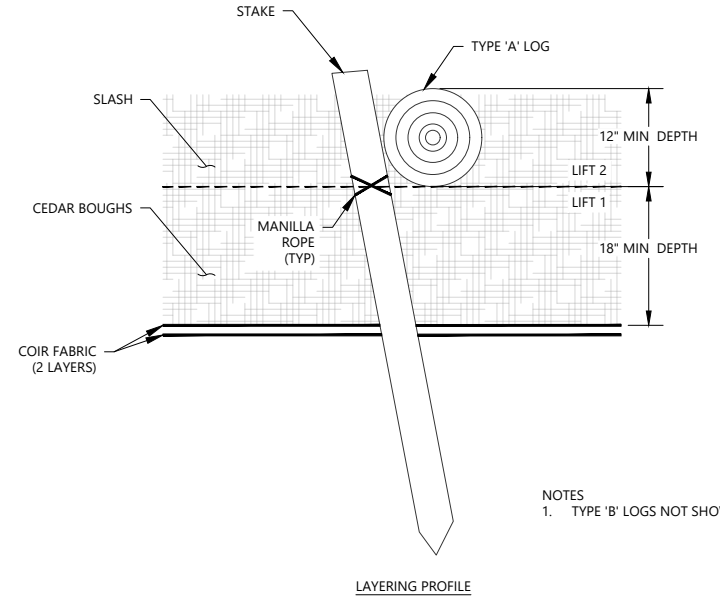
**A** ELJ - TYPE 1  
D601 SCALE: 1"=5'

TYPE 1 ELJ MATERIALS SCHEDULE (PER EACH)			
LOG ID	MATERIAL	UNITS	QTY
A	15' LONG, 12"Ø LOGS	EA	3
B	10' LONG, 10"Ø LOGS	EA	3
	CEDAR BOUGHS	CY	7
	SLASH	CY	5
	COIR 900 (INC 1" WOOD STAKES & U-STAPLES)	SY	34
	LOG PINS	EA	7
	2"x2"x48" DOUGLAS FIR STAKES	EA	14
	MANILA ROPE - 5/8"	LF	260
	COIR LOG	LF	30

- CONSTRUCTION NOTES**
- CEDAR BOUGHS TO BE MINIMUM 10' LONG AND 3/4" TO 2 1/2" Ø MEASURED AT CUT END.
  - CONSTRUCTION SEQUENCE:
    - STAKE STRUCTURE DOWNSTREAM EXTENT, PER CONTROL POINT TABLE SHEET C101. PLACEMENT AND LOCATIONS OF ALL ELEMENTS ARE APPROXIMATE AND MAY VARY AS DIRECTED BY CITY'S REPRESENTATIVE TO ACCOMMODATE CONDITIONS AT THE TIME OF CONSTRUCTION.

- COIR LOG SHALL BE INSTALLED OVERLAPPING SLASH AND EXISTING BANK SLOPE SOIL SO THAT AT LEAST 50% OF LOG IS IN CONTACT WITH EXISTING SOIL. INSTALL LIVE DOGWOOD AND WILLOW STAKES INTO COIR LOG. SEE DETAILS SHEET L102.

NOTES  
1. TYPE 'B' LOGS NOT SHOWN FOR CLARITY.

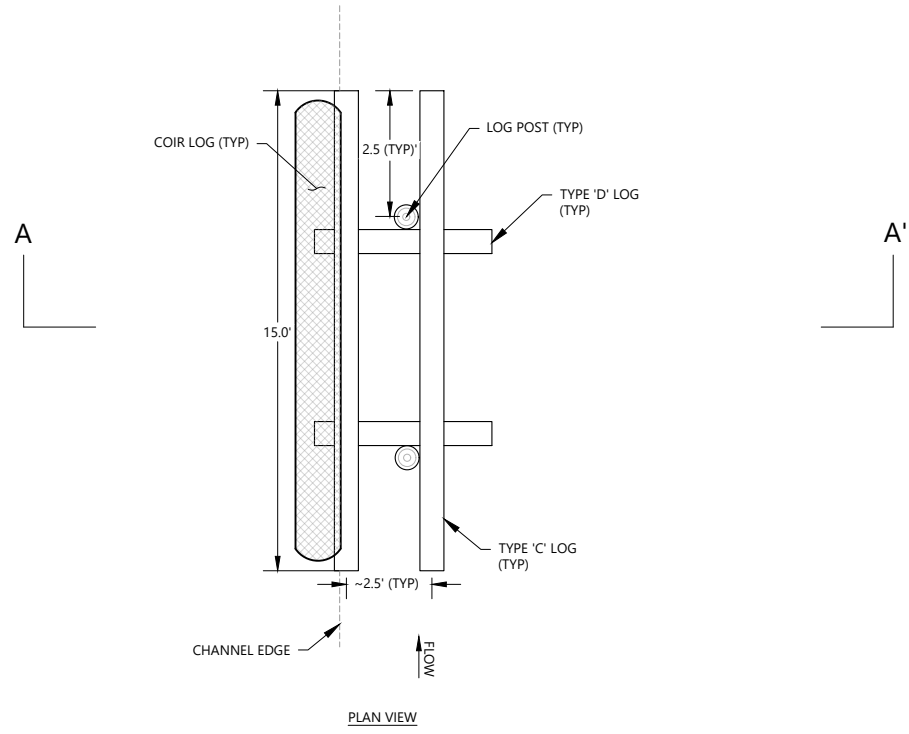
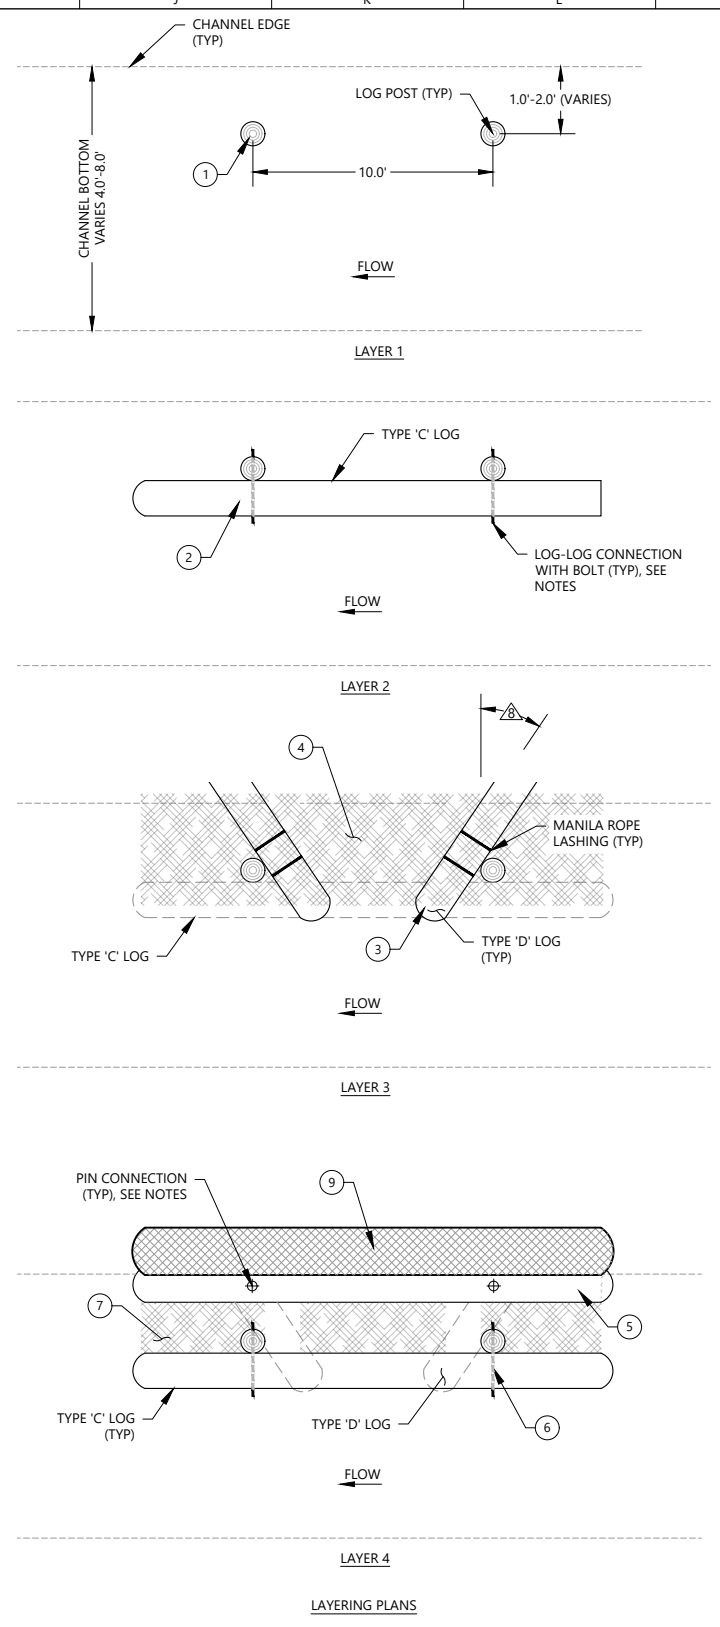
TYPE 2 ELJ MATERIALS SCHEDULE (PER EACH)			
LOG ID	MATERIAL	QUANTITY	UNITS
C	12"x10' LOG POST	2	EA
C	12"x15' LOG	3	EA
D	12"x5' LOG	2	EA
	SLASH	7	CY
	LOG PIN (#5 REBAR 3.5')	2	EA
	LOG PIN (#5 REBAR 2.5')	4	EA
	MANILA ROPE - 5/8"	4	EA
	COIR LOG	15	LF

- NOTES
- POSTS MAY BE EMBEDDED BY AUGERING OR OTHER METHOD APPROVED BY CITY'S REPRESENTATIVE THAT MAINTAINS STABLE SUBSOILS. EXCAVATION AND BACKFILL SHALL NOT BE ALLOWED. ALL POSTS LOCATIONS TO BE STAKED BY CONTRACTOR PRIOR TO INSTALLATION FOR REVIEW AND APPROVAL. BY CITY'S REPRESENTATIVE, LOCATIONS MAY BE ADJUSTED BY CITY'S REPRESENTATIVE TO ACCOMMODATE CONDITIONS AT TIME OF CONSTRUCTION.

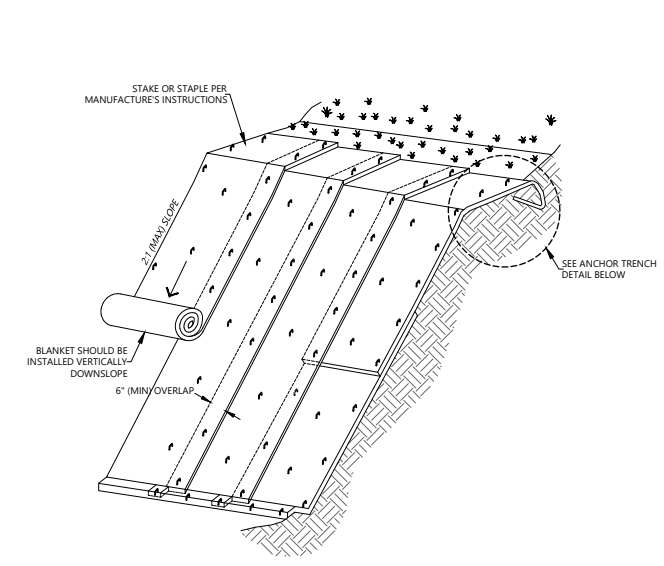
**A EROSION CONTROL BLANKET**  
D604 SCALE: NOT TO SCALE

- NOTES:**
- SLOPE SURFACE SHALL BE FREE OF ROCKS, VEGETATION, STICKS, AND DEBRIS. MATS/BLANKETS SHALL HAVE GOOD SOIL CONTACT. SCARIFY AND/OR TILL SLOPE SURFACE 12" DEEP BEFORE LAYING BLANKET.
  - LAY BLANKETS LOOSELY AND STAKE OR STAPLE AS NEEDED TO MAINTAIN DIRECT CONTACT WITH THE SOIL. DO NOT STRETCH OR TWIST.
  - EROSION CONTROL BLANKETS SHOULD BE USED IN CONJUNCTION WITH REVEGETATION (SEEDING OR PLUG PLANTING) TO SPECIFICATIONS OF REVEGETATION PLAN FOR PROJECT.
  - HAND WALK BLANKET DOWN SLOPE AS BLANKET IS STAKED OR STAPLED TO PREVENT STRETCHING.
  - DO NOT WALK ON BLANKET ONCE IN PLACE.
  - ALL ANCHORS SHALL BE INSTALLED PERPENDICULAR TO SLOPE.
  - DRAWING ADAPTED FROM: CALIFORNIA STORMWATER QUALITY ASSOCIATION, 2003, STORMWATER BEST MANAGEMENT PRACTICE HANDBOOK EC-7 GEOTEXTILES AND MATS.

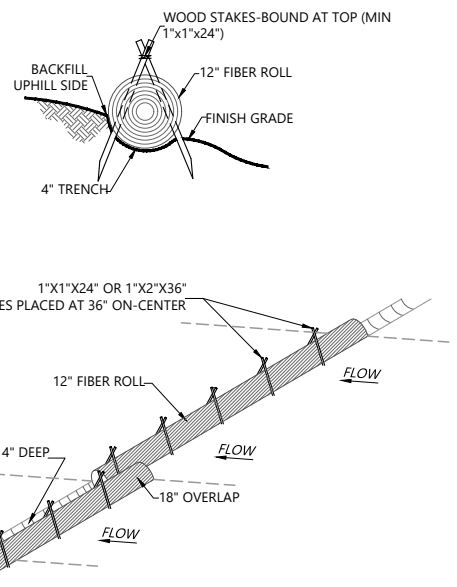
**B COIR FABRIC LOGS**  
D604 SCALE: NOT TO SCALE

- NOTES:**
- FIBER ROLL SHALL BE MADE FROM 100% MATTRESS GRADE COCONUT FIBER AND BOUND BY HIGH STRENGTH COIR NETTING, AND HAVE A MINIMUM WEIGHT OF 5 LBS PER LINEAL FOOT.
  - FIBER ROLLS ON SLOPES SHALL BE INSTALLED ON CONTOUR. SPACING BETWEEN FIBER ROLLS SHALL BE A MAXIMUM OF 10' FOR SLOPES GREATER THAN 2:1 AND 20' FOR SLOPES LESS THAN 2:1.
  - ABUTTING ENDS OF INDIVIDUAL FIBER ROLLS SHALL BE OVERLAPPED A MINIMUM OF 18".

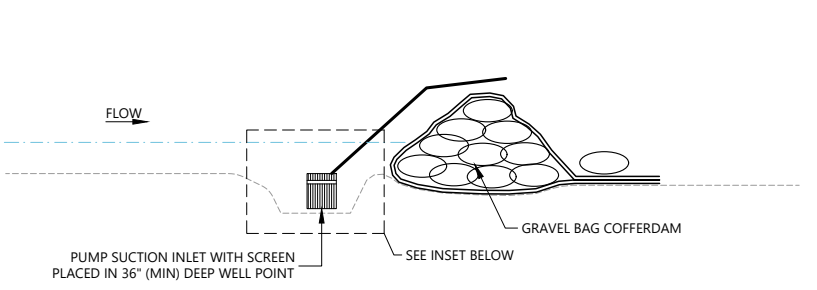
**C DEWATERING SUMP**  
D604 SCALE: NOT TO SCALE

- NOTES:**
- CORRUGATED PLASTIC OR METAL PIPE 36" (MIN), ONE PER EACH PUMP.
  - 1/2" SLOTS, 24" LONG AT 4" SPACING ALL THE WAY AROUND PIPE.
  - STREAMBED SEDIMENT.
  - WIRE SCREEN 1/2" MESH COVERING PIPE BOTTOM, ANCHORED TO PIPE LIMIT OF EXCAVATION. INSTALL PIPE AND BACKFILL WITH STREAMBED MATERIAL.
  - PUMP SECTION INLET OR ELECTRIC SUBMERSIBLE PUMP WITH 1" SCREEN INSTALLED AT INLET OR PUMP SUCTION FACE, OR OTHER SIZE RECOMMENDED BY PUMP SUPPLIER.

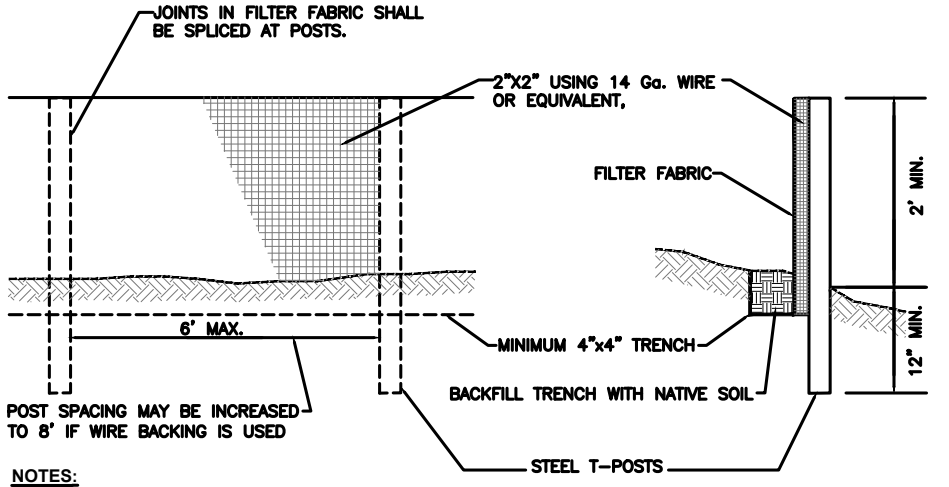
**E SILT FENCE**  
D604 SCALE: NOT TO SCALE

- NOTES:**
- INSTALL SILT FENCE ALONG CONTOUR.

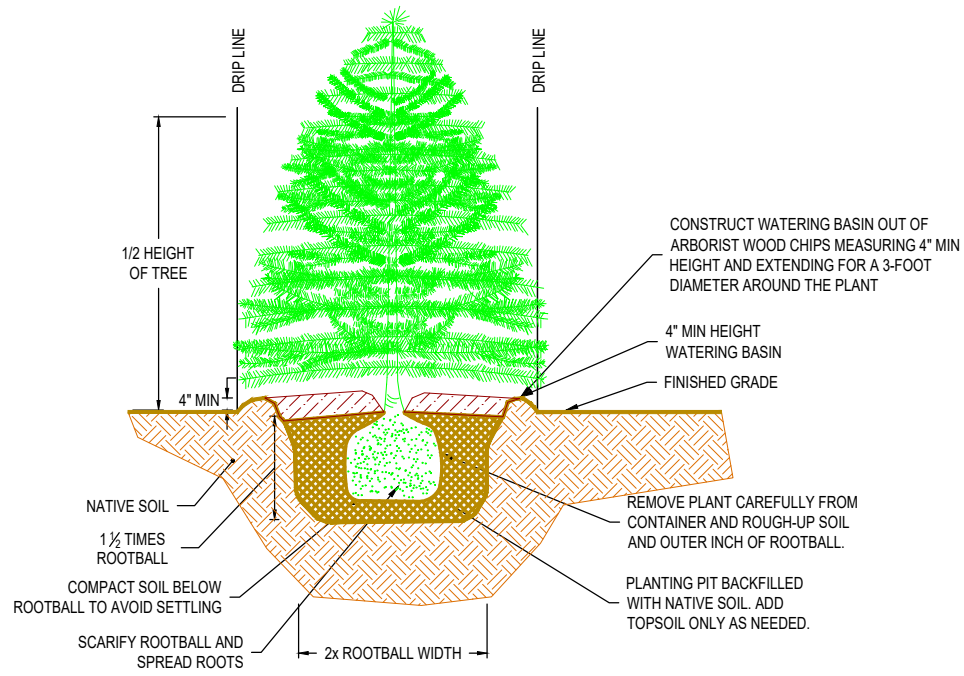
**EVERGREEN TREE PLANTING DETAIL**  
NOT TO SCALE

- NOTES:**
1. ALL PLANT MATERIAL MUST BE KEPT MOIST.
  2. PLACE ALL PLANTS SO THE ROOT COLLAR IS LEVEL WITH FINISHED GRADE.
  3. ENSURE NATIVE SOILS USED IN PLANTING PITS ARE FREE OF RHIZOMES AND ROOTS. ADD TOPSOIL AS NEEDED TO BACKFILL PIT.
  4. FORM A WATERING BASIN 4 INCHES ABOVE FINISHED GRADE.
  5. INSTALL 4-INCH DEPTH OF MULCH WITHIN WATERING BASIN. DO NOT ALLOW MULCH TO TOUCH TRUNK.

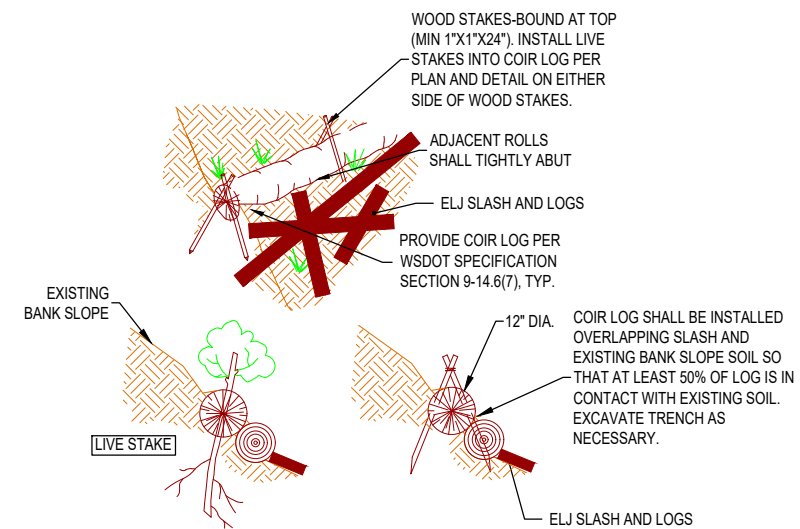
**COIR LOG DETAIL**  
NOT TO SCALE

- LIVE STAKE NOTES:**
1. SOURCE LIVE STAKES FROM SITES NATIVE TO THE PACIFIC NORTHWEST.
  2. KEEP LIVE STAKES MOIST AT ALL TIMES. LIVE STAKES ARE HIGHLY PERISHABLE AND MUST BE STORED PROPERLY BEFORE PLANTING. SEE SPECIFICATIONS FOR ADDITIONAL INFORMATION.

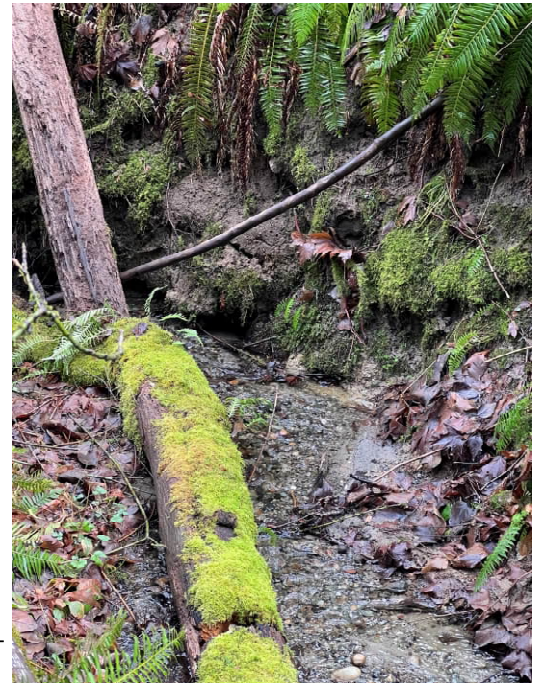
Right: Loose soil near Watercourse 46a.3 stream channel.

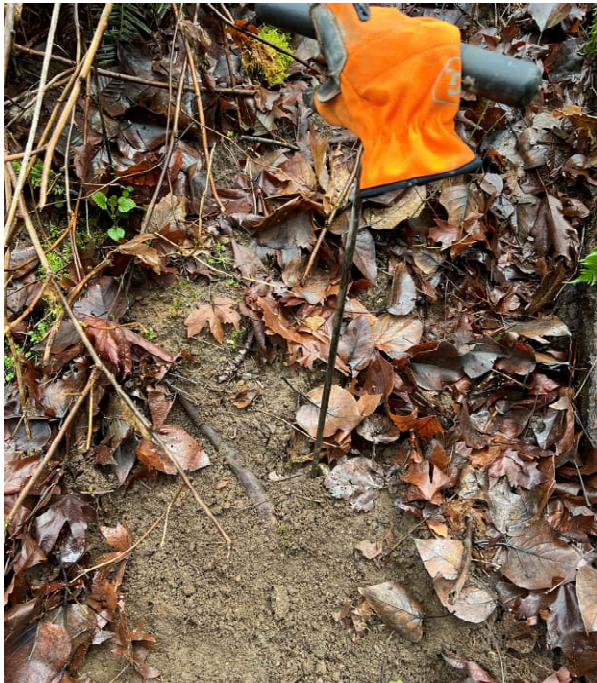
Left: Sandy silt soil exposed on scarp-like feature.

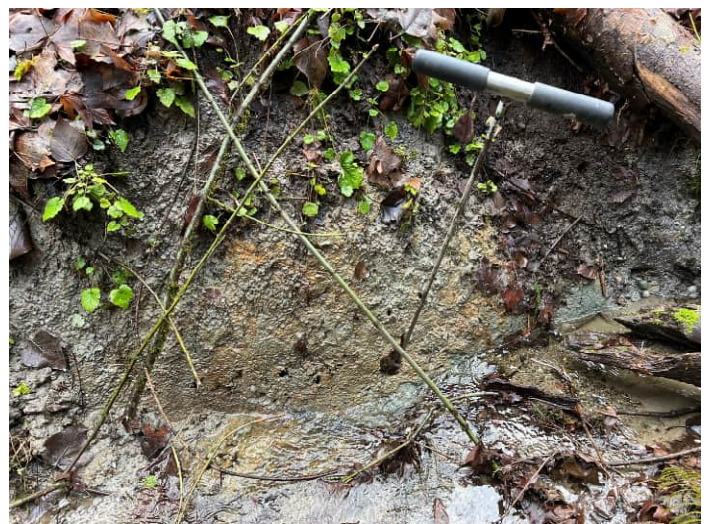
Stiff silty soil in Watercourse 46a.3 stream channel.

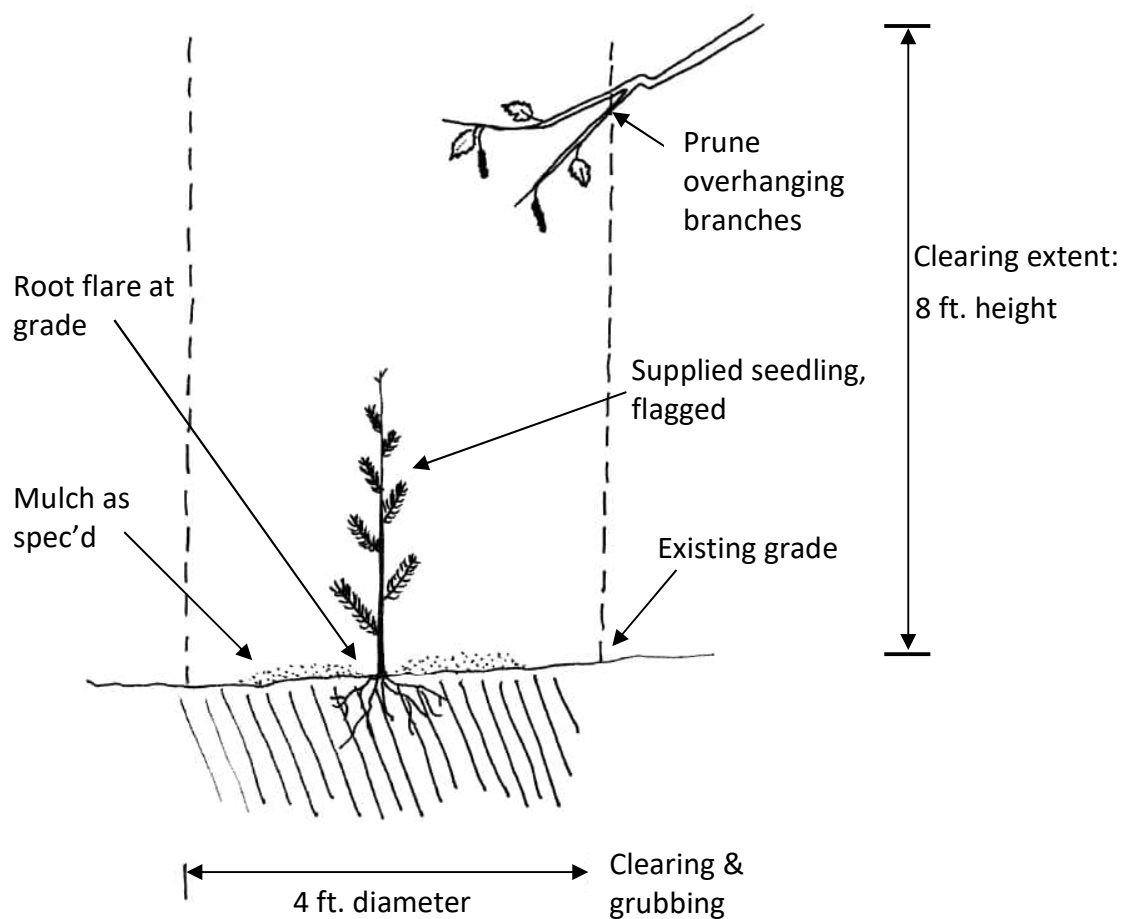
- Clearing and grubbing limits are minimum 4 ft. on slopes less than 30%. Soil to be grubbed free of competing vegetation and loosened throughout entire circle.
- Prune back *any* overhanging vegetation within 8' of ground level within said 4' circle to create a vegetation free "column". Follow generally accepted pruning practices.
- Form a mound of soil and spread roots in the planting hole radially and in a downward direction (it may be necessary to break up root mass and cut circling roots). No "J" roots or pancaked (flattened to a fan) roots.
- Root flare to be set at grade. Do not plant the tree any deeper!

- Backfill soil is native soil.
- Mulch is 3" depth arborist mulch or available leaf litter, as specified in project scope. Do not cover root flare. If leaf litter is scarce or unavailable, City staff may be able to deliver arborist chips to site, depending on availability.
- Flag the tree with 6" or 1" wide fluorescent flagging tape attached to a lateral branch. **Do not tie flagging tape on the main stem.** Flagging will be provided by the City.

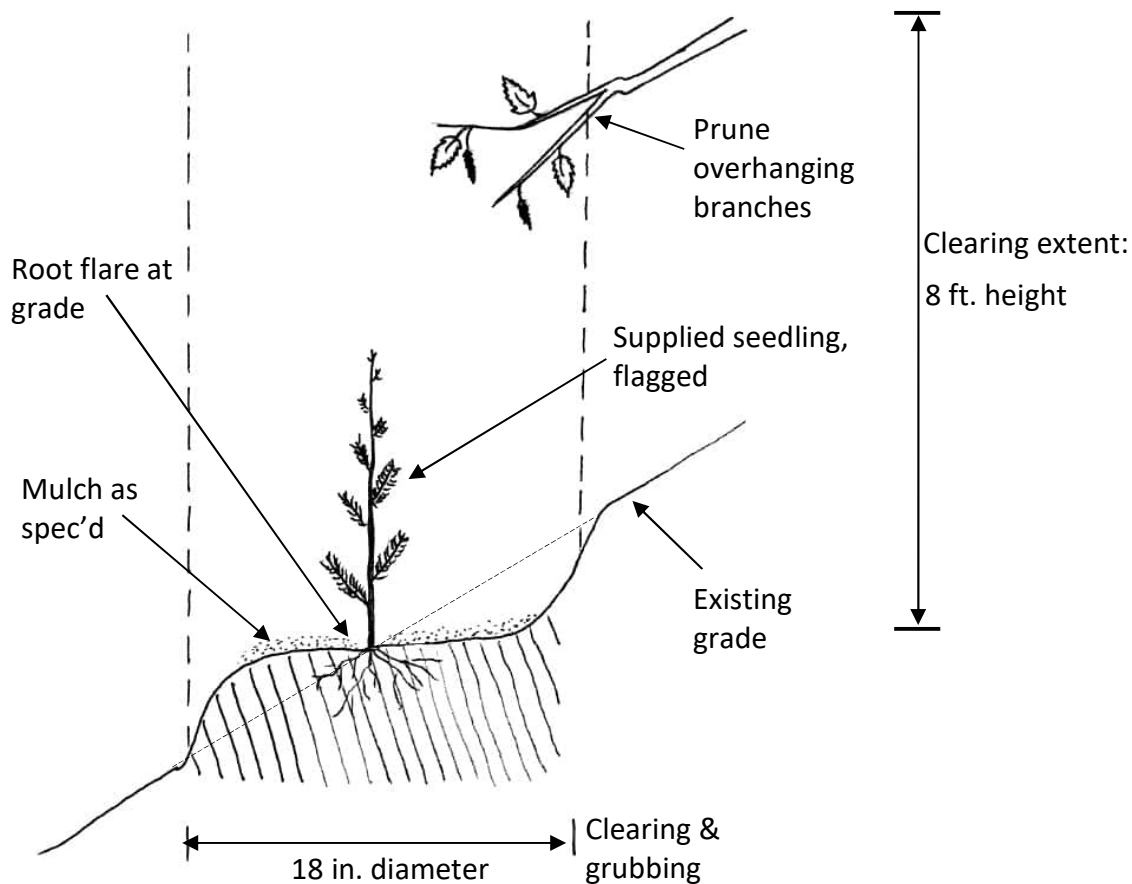
- Clearing and grubbing limits are minimum 18" in diameter on slopes greater than 30%. Soil to be grubbed free of competing vegetation. Form a level shelf with available soil.
- Prune back *any* overhanging vegetation within 8' of ground level within said 18" circle to create a vegetation free "column". Follow generally accepted pruning practices.
- Form a mound of soil and spread roots in the planting hole radially and in a downward direction (it may be necessary to break up root mass and cut circling roots). No "J" roots or pancaked (flattened to a fan) roots.
- Root flare to be set at grade. Do not plant the tree any deeper!

- Backfill soil is native soil.
- Mulch is 3" depth arborist mulch or available leaf litter, as specified in project scope. Do not cover root flare. If leaf litter is scarce or unavailable, City staff may be able to deliver arborist chips to site, depending on availability.
- Flag the tree with 6" of 1" wide fluorescent flagging tape attached to a lateral branch. **Do not tie flagging tape on the main stem.** Flagging will be provided by the City.
