Ecological No Net Loss Assessment Report

**Kavalok Residence
5908 East Mercer Way
Mercer Island, WA 98040**

Northwest Environmental Consulting, LLC
600 North 36th Street, Suite 423
Seattle, WA 98103
206-234-2520

September 2024

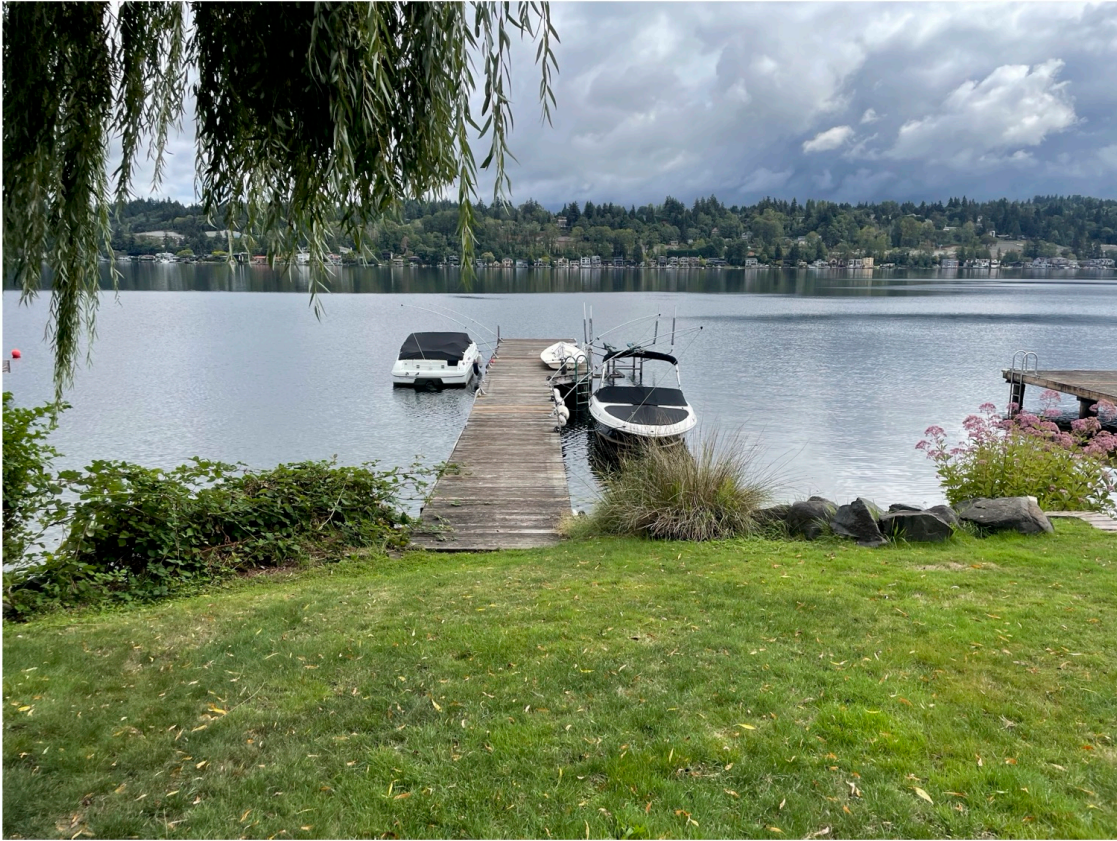
Photo 1 - Existing dock looking waterward.

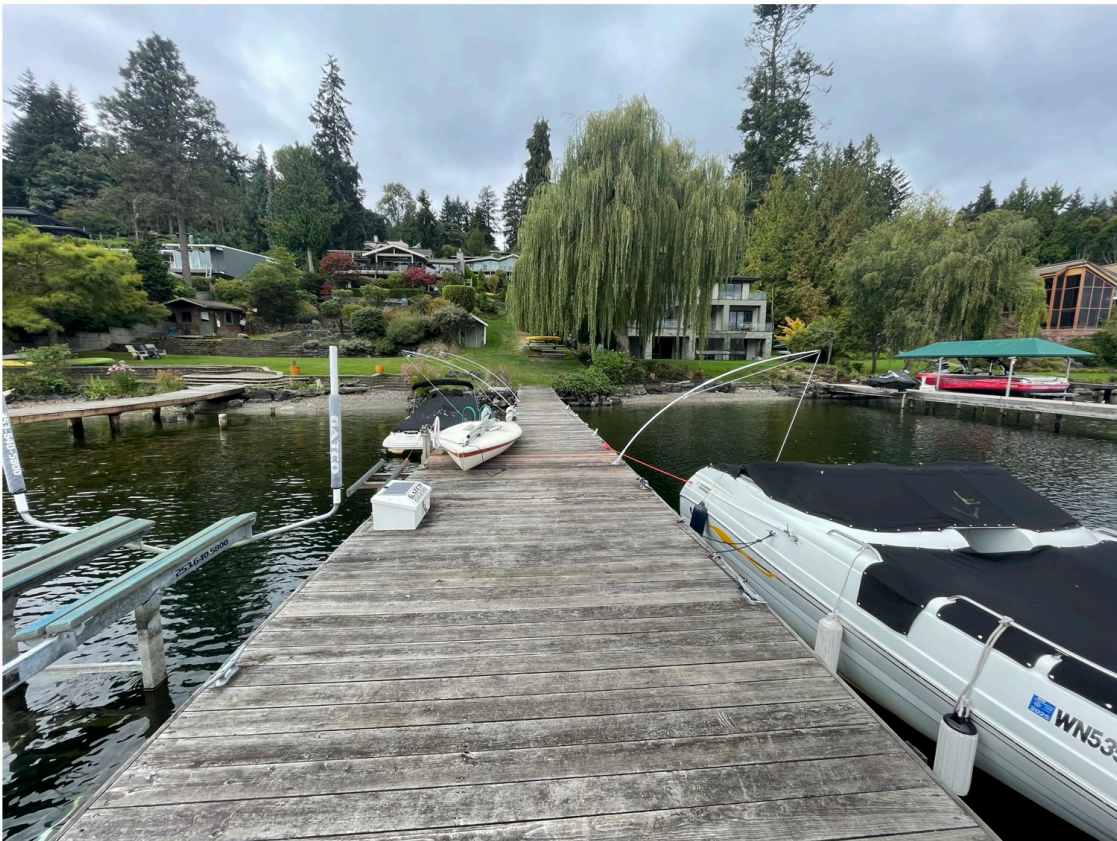
Photo 2 - Existing dock looking landward.

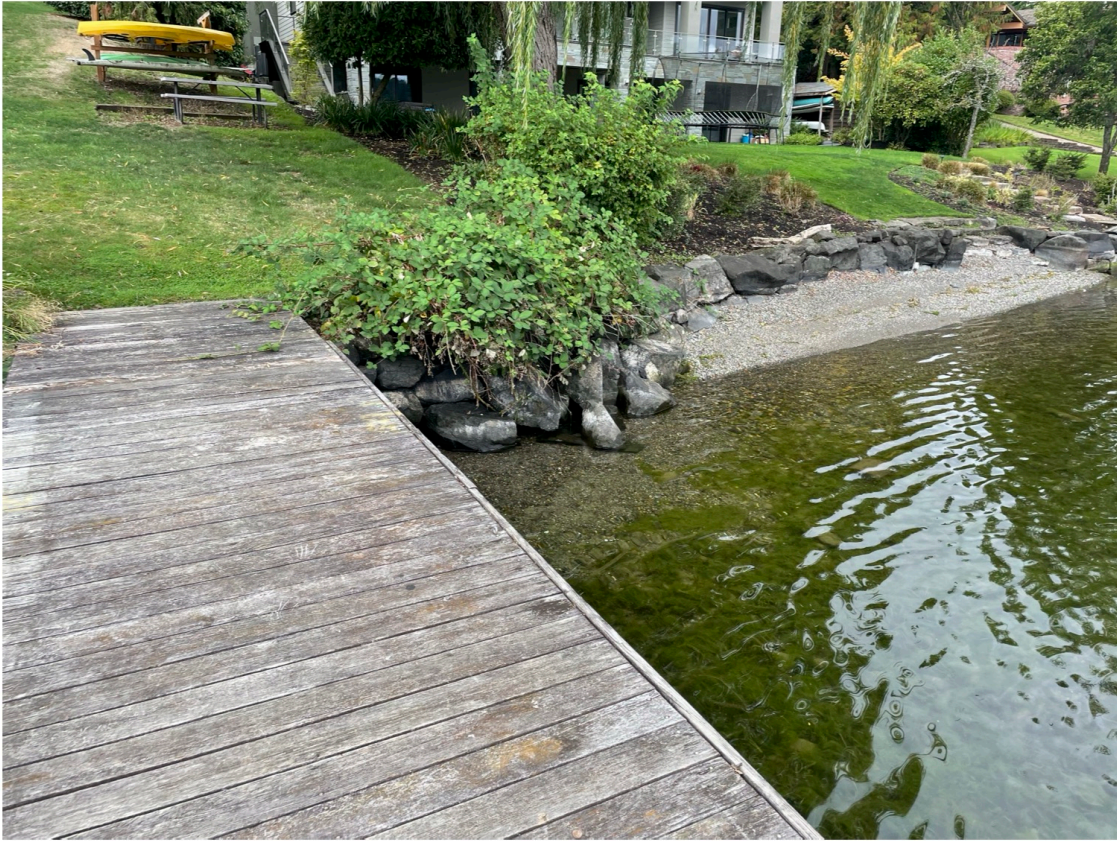
Photo 3 - Existing shoreline north of the dock.

The parcel is maintained as lawn. The shoreline is armored with a basalt bulkhead with some herbaceous vegetation and Himalayan blackberry canes growing immediately landward of the bulkhead. The substrates along the shore are sand and gravel with interspersed cobble starting about 10 feet from shore. Patchy Eurasian milfoil was present starting about 15 feet from shore.

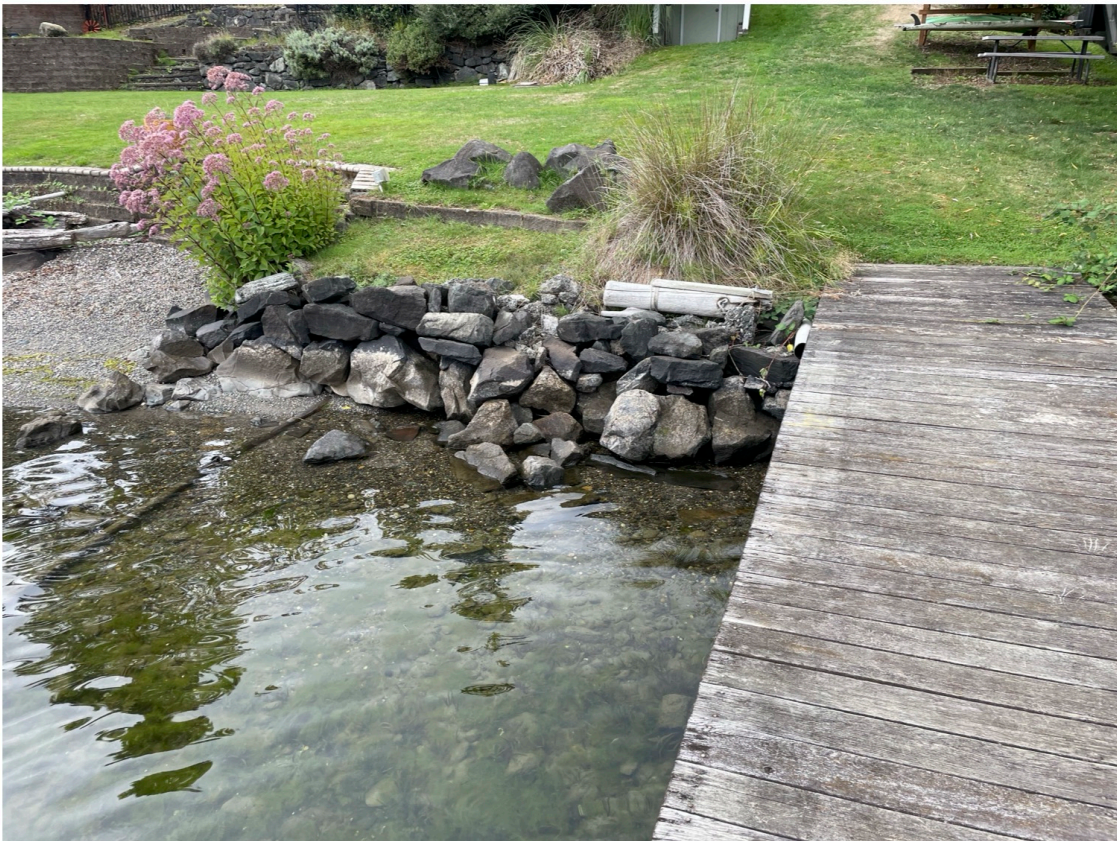
Photo 4 - Existing shoreline south of the dock.

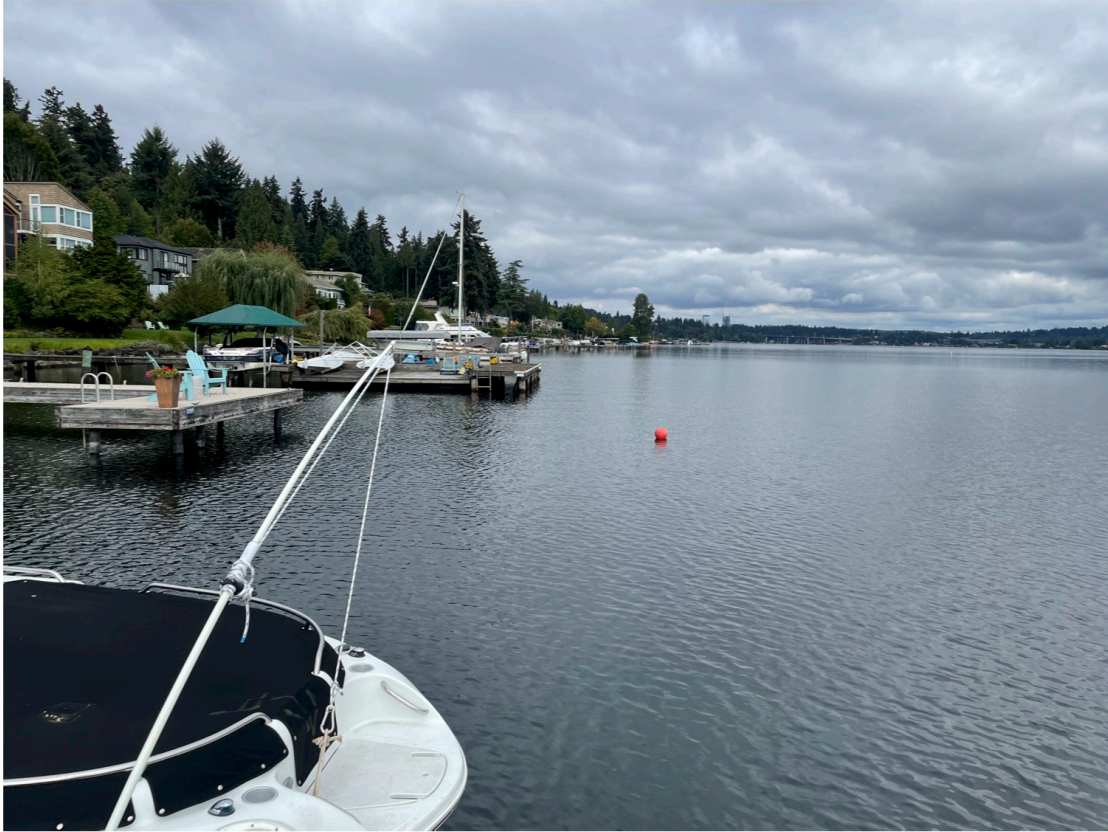
Photo 5 - Existing conditions north of the site.

The neighboring shorelines are landscaped with bulkheads and docks with various landscaping. Both properties have beach coves adjacent to the subject property. A weeping willow is present on the corner of the lot to the north that overhangs the shoreline. See attached photos in Appendix B- Photos.

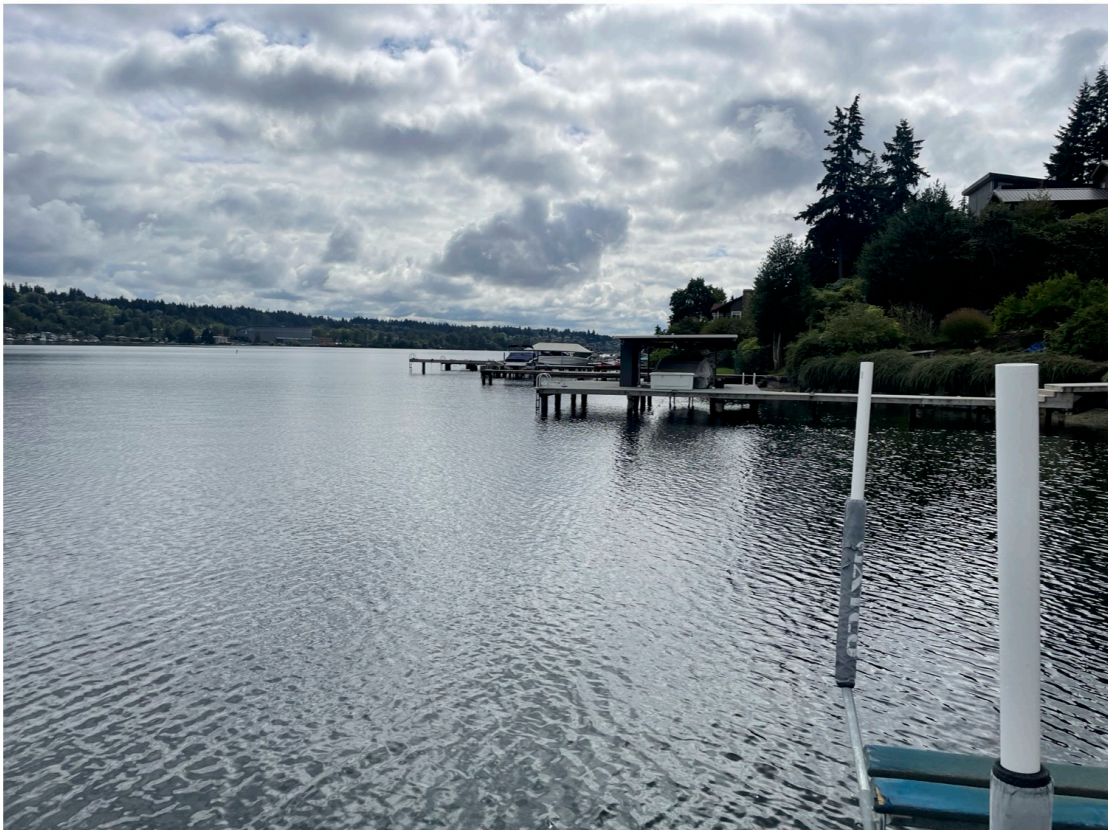
Photo 6 - Existing conditions south of the site.
