WETLAND DELINEATION REPORT

**Herzl-Ner Tamid Property
Mercer Island, Washington**

March 26, 2024

RAEDEKE ASSOCIATES, INC.

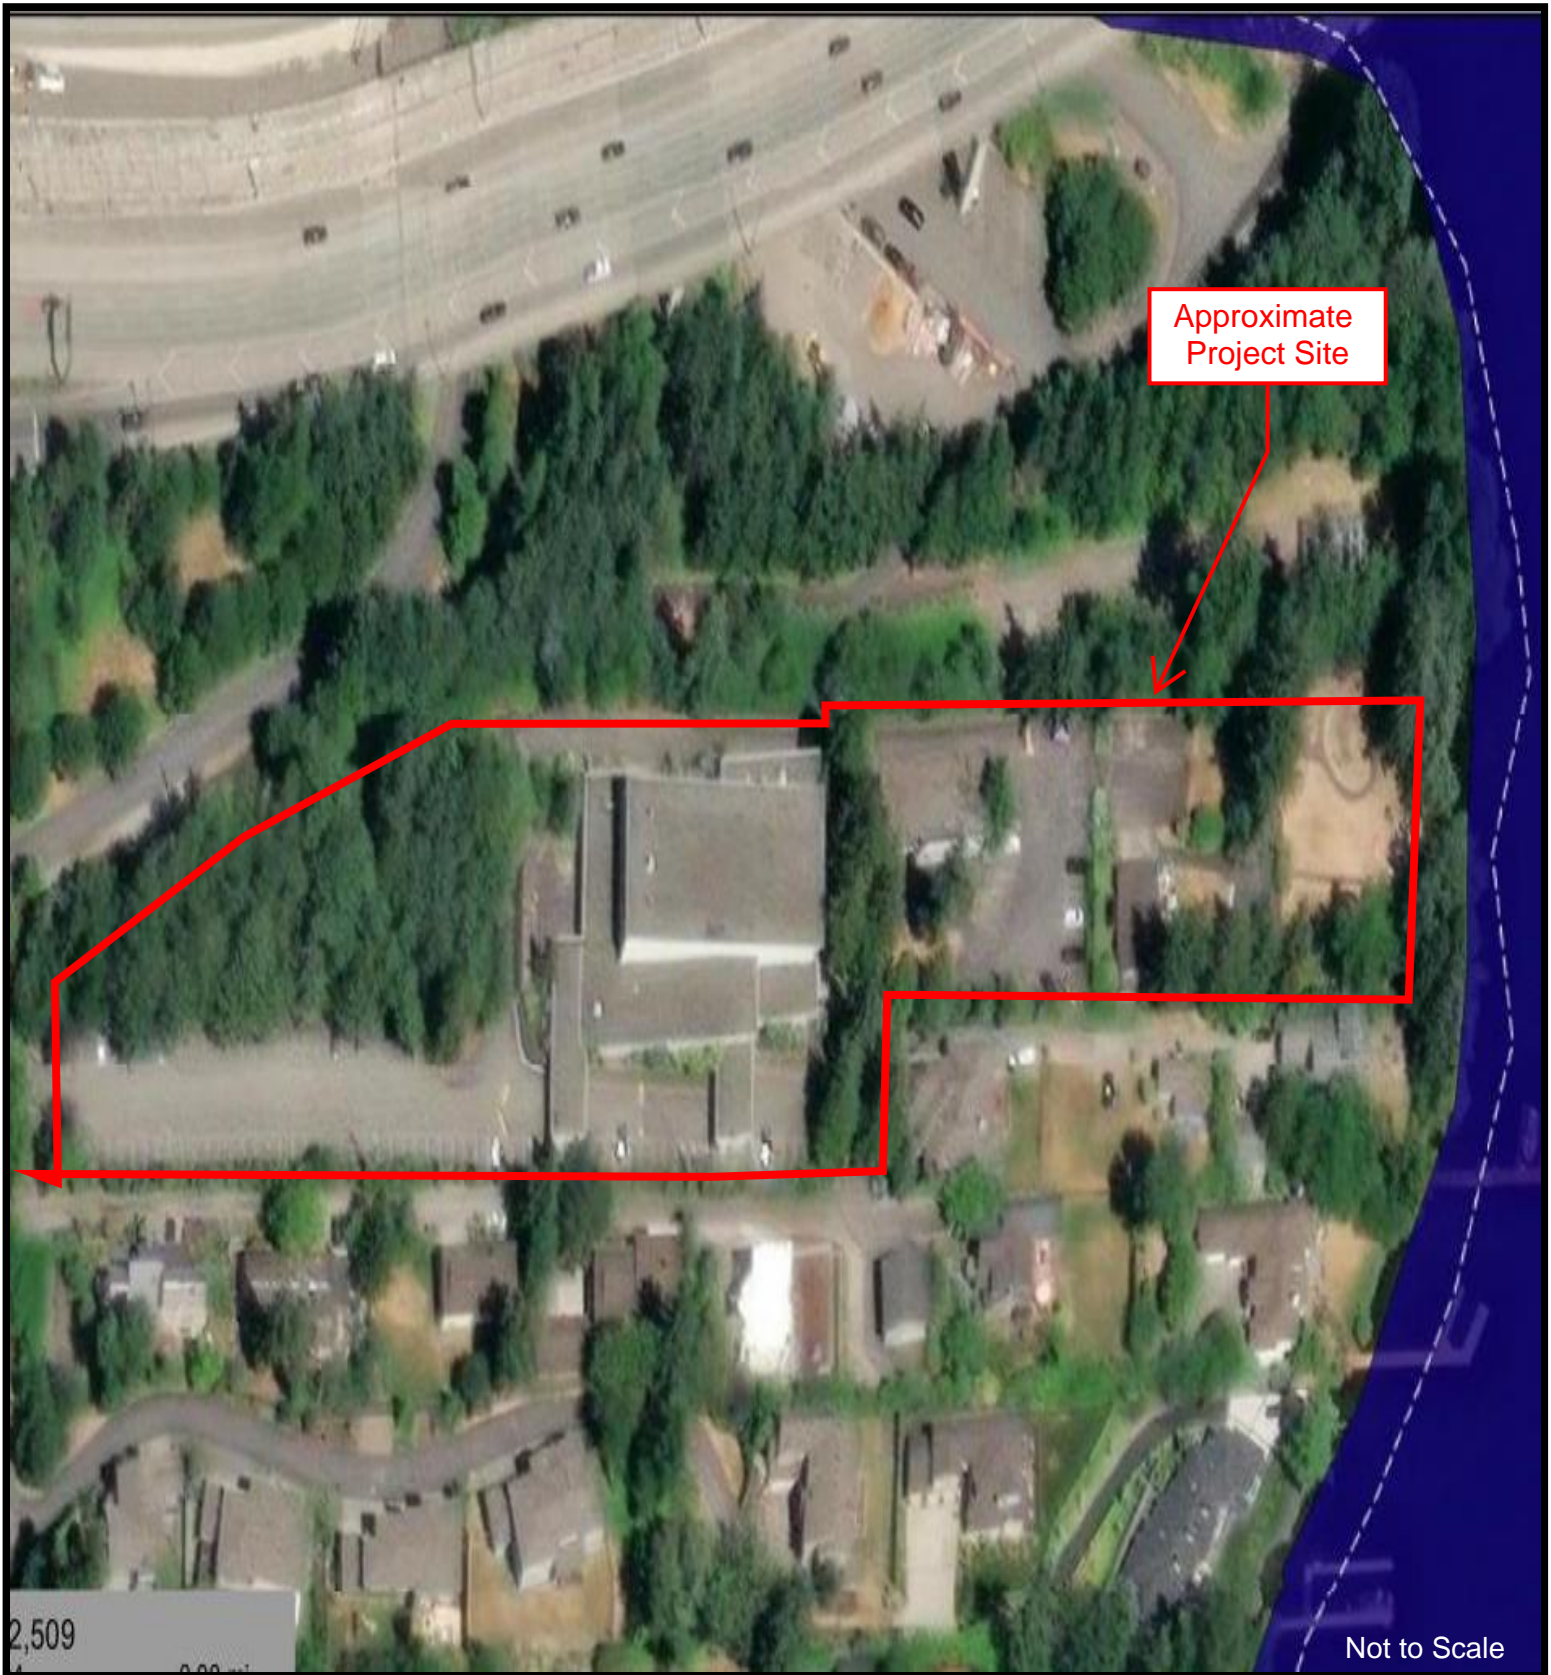
FIGURE 3 - National Wetland Inventory

The USFWS (2023) NWI (Figure 3) does not identify any wetlands or streams on the project site, however, it depicts Lake Washington along the eastern property boundary as a lacustrine, limnetic system with an unconsolidated bottom and a permanently flooded water regime that is diked or impounded (L1UBHh). Wetlands, streams, and lakes shown on the NWI are general in terms of location and extent, as they are determined primarily from aerial photograph interpretation. Thus, the number and extent of existing wetlands located within the project area may differ from those marked on the NWI map.

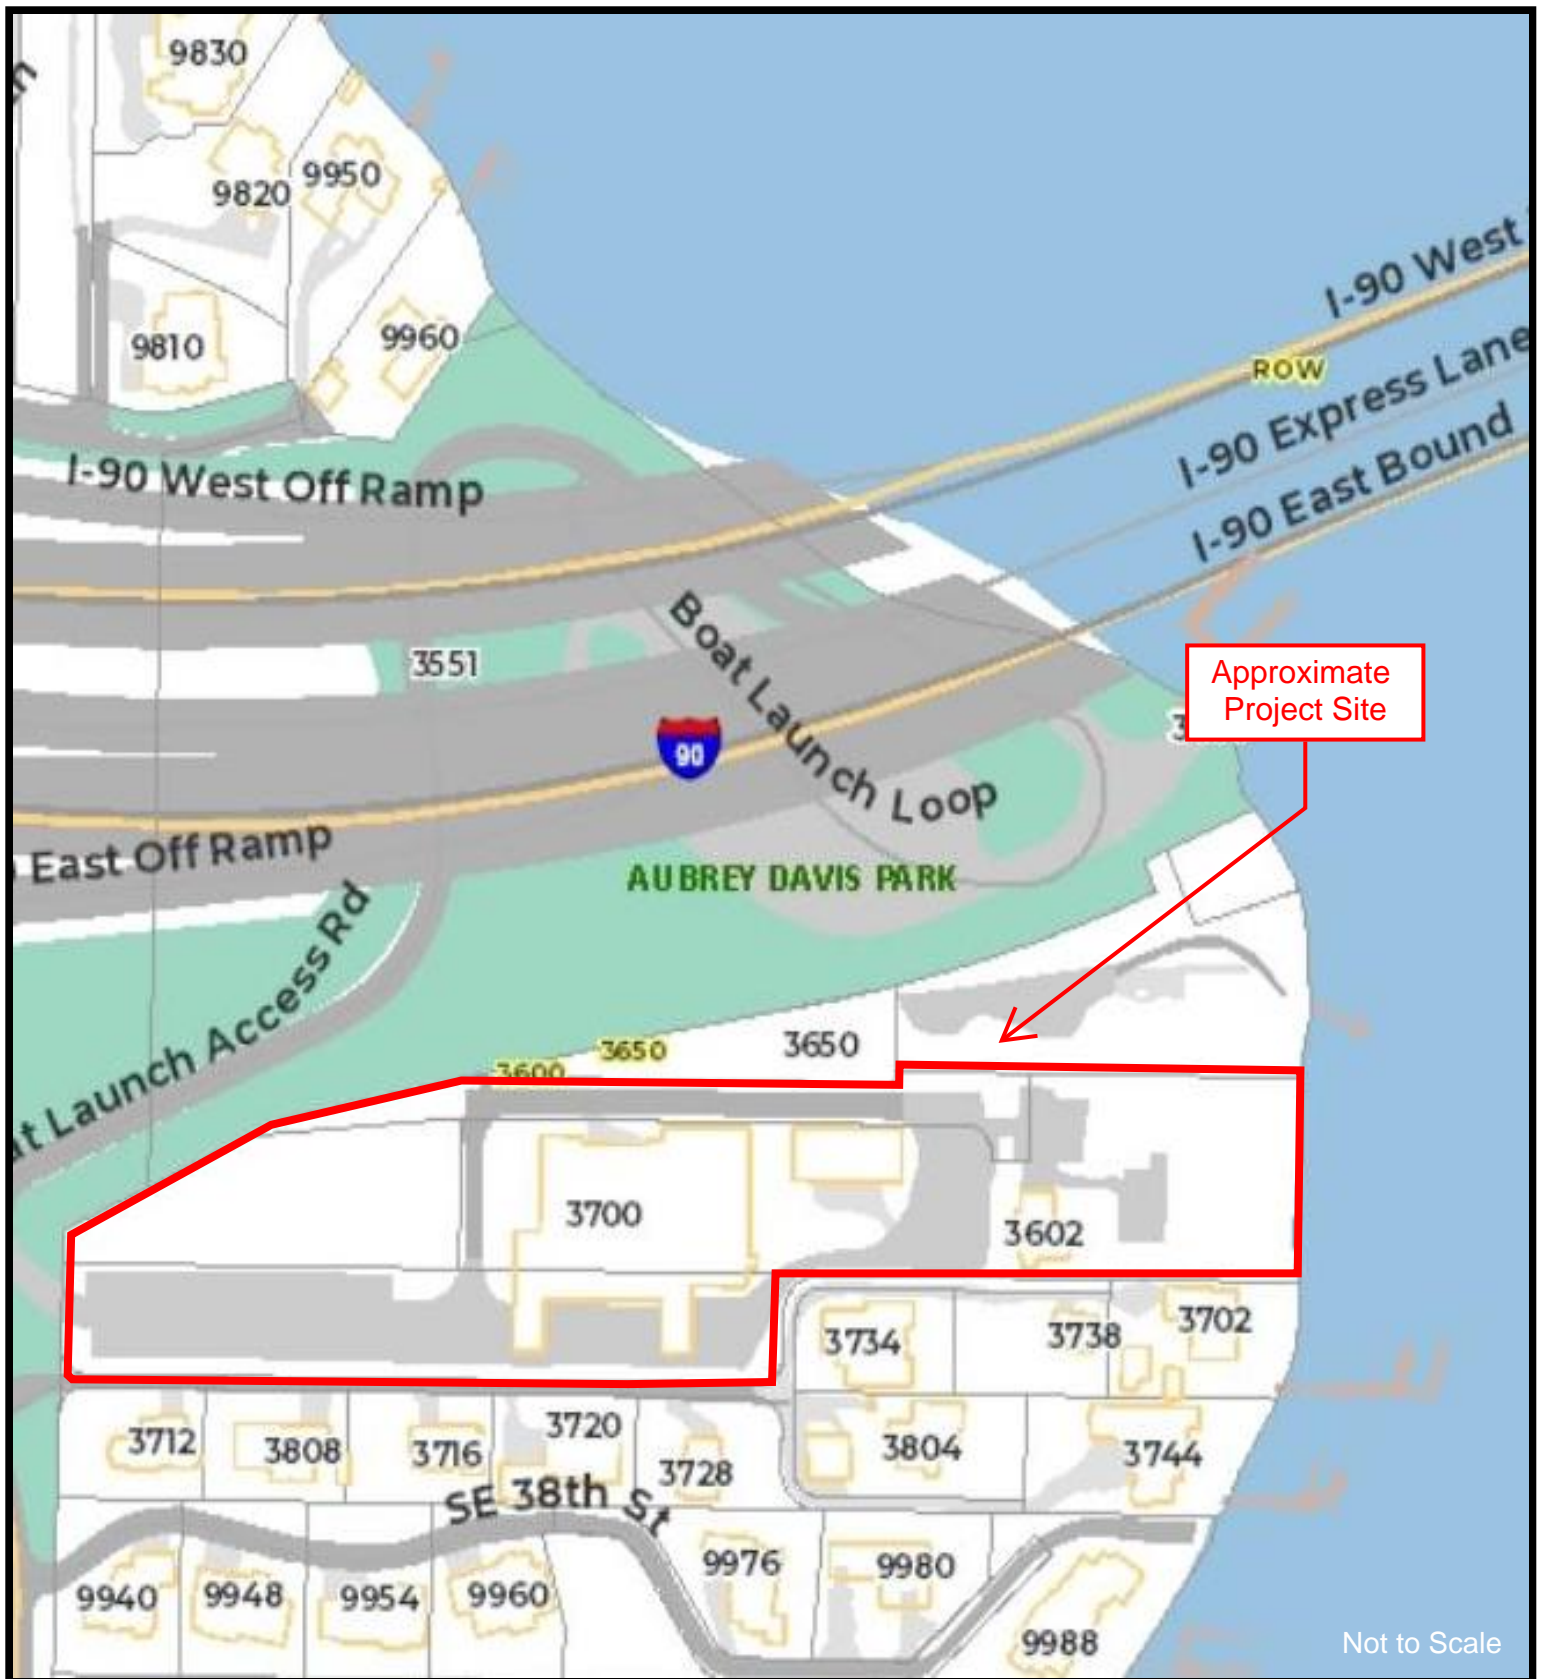
FIGURE 4 - Mercer Island GIS Portal

The City of Mercer Island (2024b) GIS Portal (Figure 4) does not depict any watercourses within or adjacent to the project site.
