## ***Critical Area Study***

*7649 W. Mercer Way  
Mercer Island, Washington 98040*

*PRE24-058*

*Dated:  
February 12, 2025*

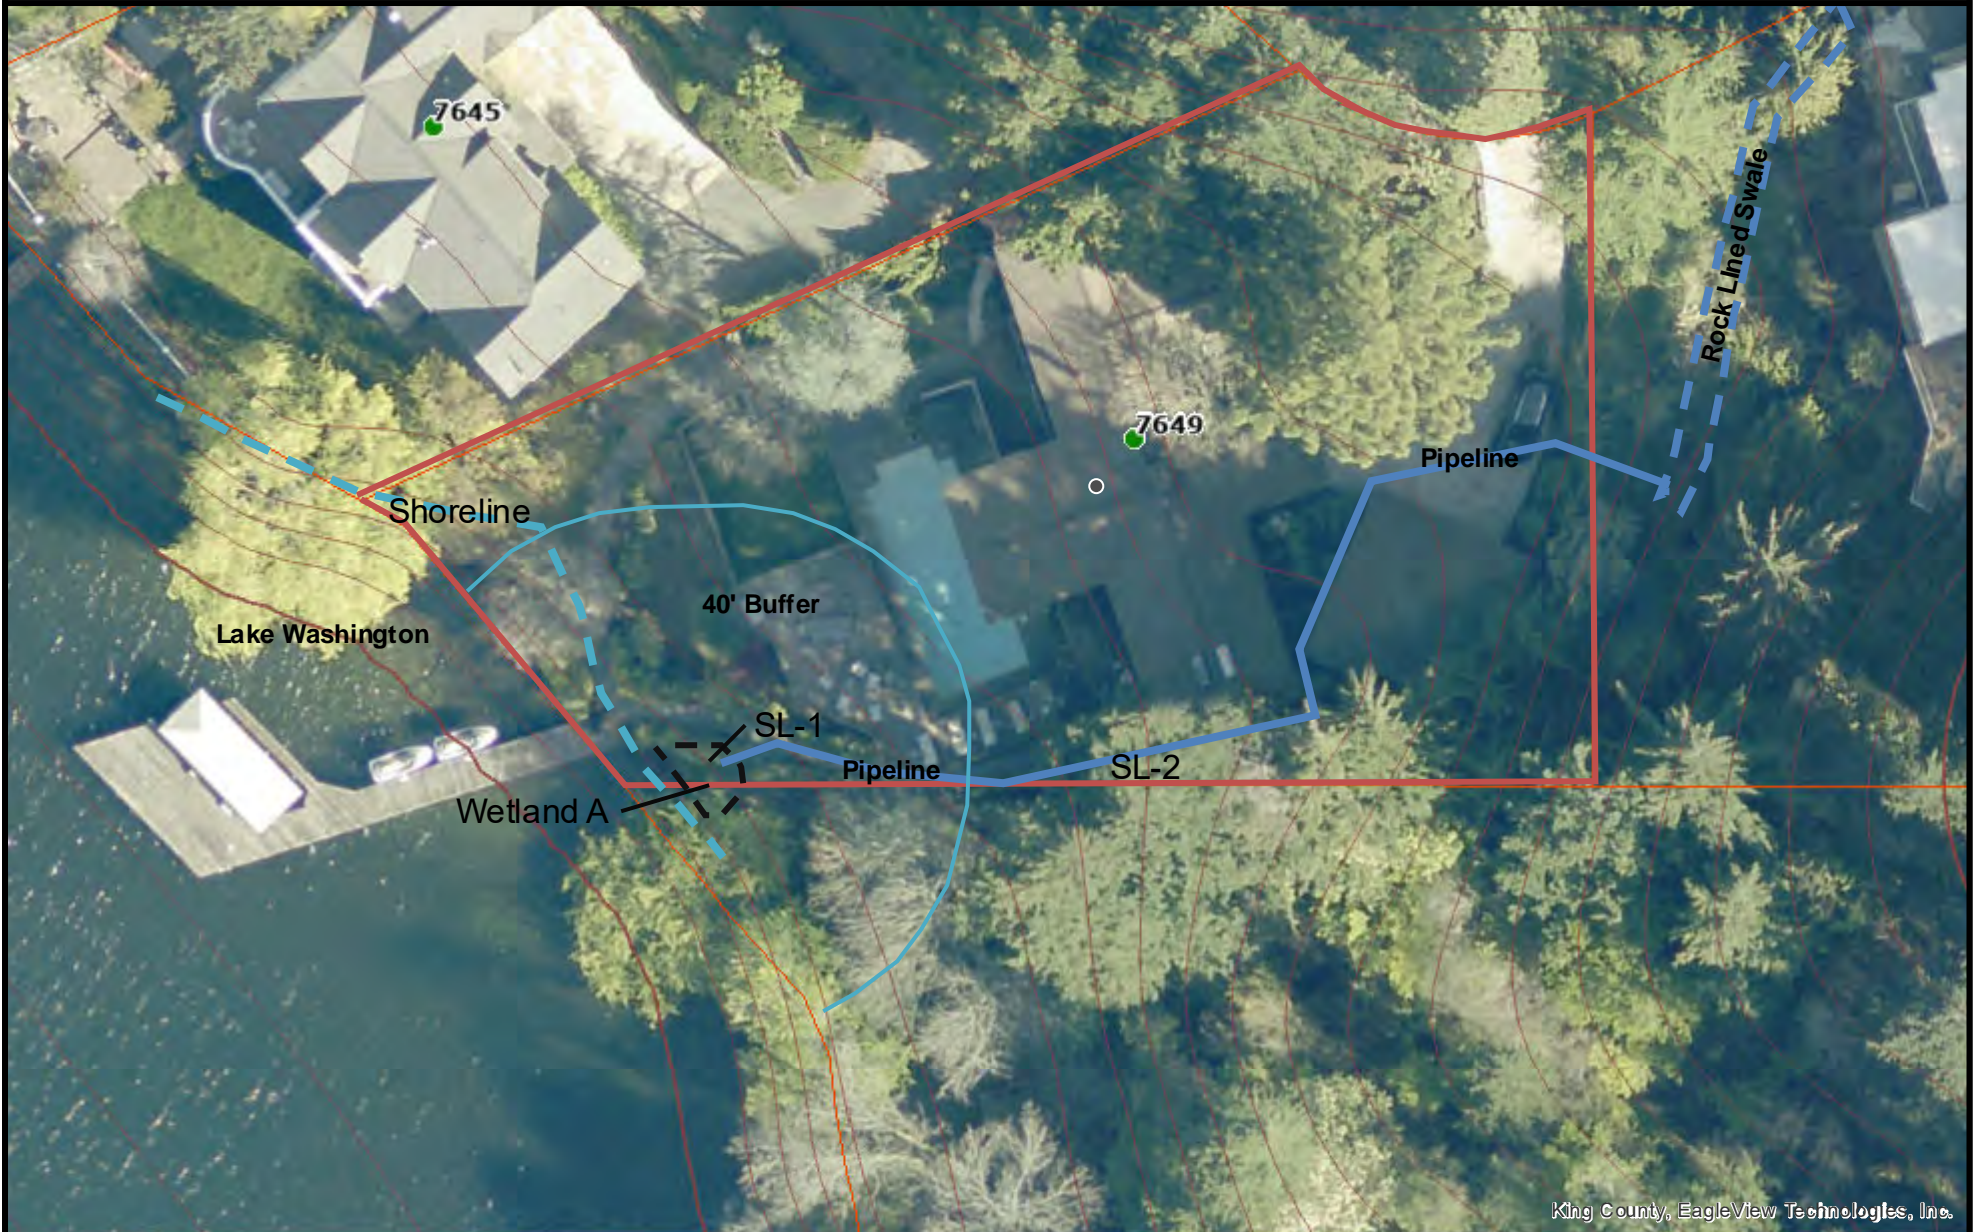
# Critical Area Sketch

There is one wetland onsite identified as Wetland A. The wetland boundary extends between the rock bulkhead and the walkway, see on the attached Critical Area Sketch. The source of hydrology is 6-inch pipeline that originates at the end of a rock lined swale above the driveway, crosses the driveway, extends along the south side of the garage, under the walkway between garage and house, then under the gravel walkway. There is a white PVC pipe cleanout in the gravel walkway below the pool deck, then the pipe turns and discharges at a small plastic junction box in the wetland.

There is one small wetland located between the lower gravel walkway and the rock bulkhead. The wetland is identified as Wetland A. Wetland A is a Category IV wetland with a 35-foot buffer required and a 15-foot structure setback from the outside of the buffer. Unavoidable temporary impacts to the wetland buffer will require restoration.

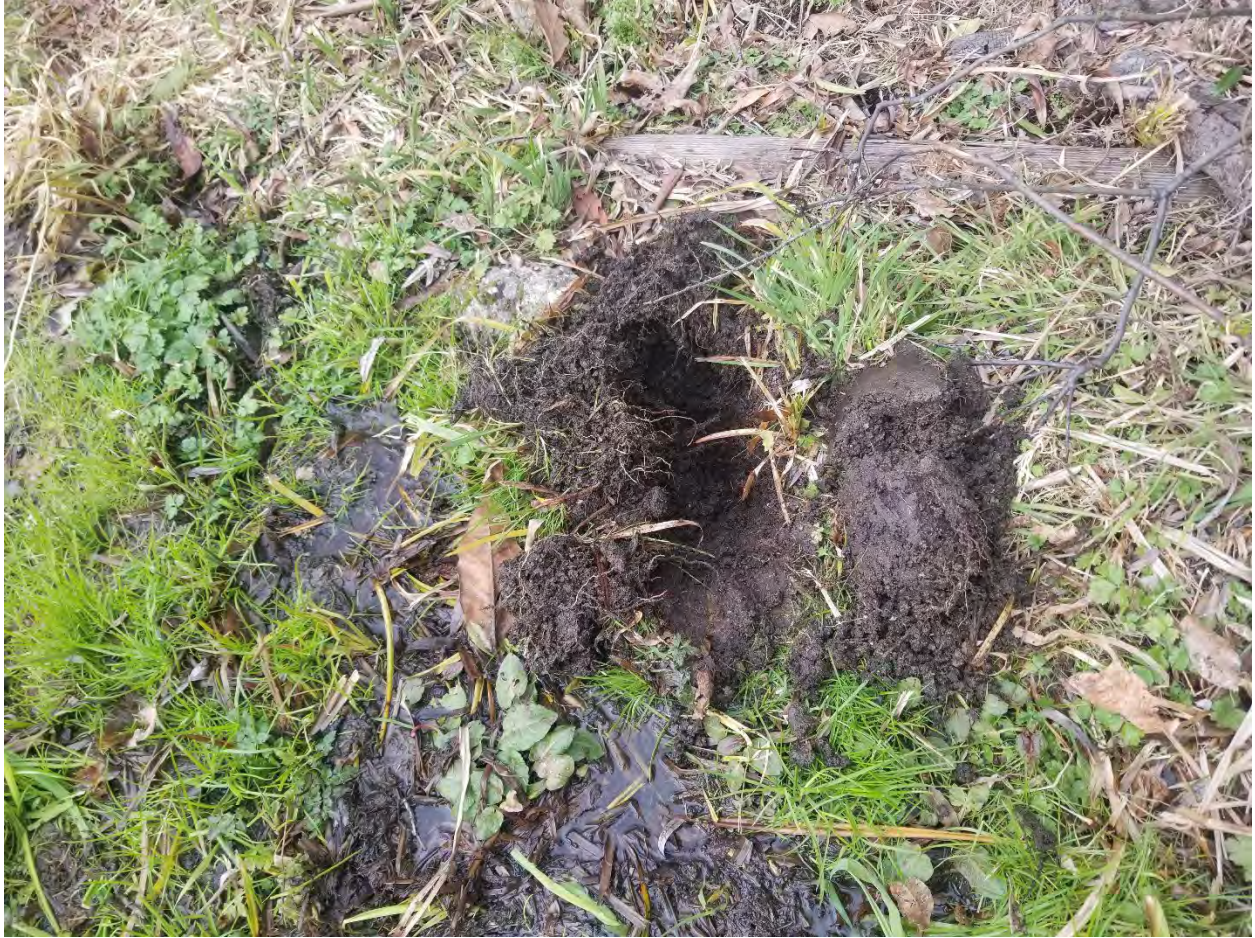
The field investigation was performed on February 10, 2025. The weather was cold and overcast. There are three sample locations identified as SL-1 and SL-2.

The wetland has a black one chroma “A” horizon, more than 12 inches thick, and sand. The soil is saturated through the profile to the soil surface. The plant community includes small-fruited bulrush (*Scirpus microcarpus*), which is an obligate wetland indicator species. The wetland boundary is defined by the extent of saturated soils, topography, gravel walkway, and rock bulkhead. It extends offsite a few feet onto the adjacent parcel to the south.

Wetland A – Sample Location 1 (SL-1)

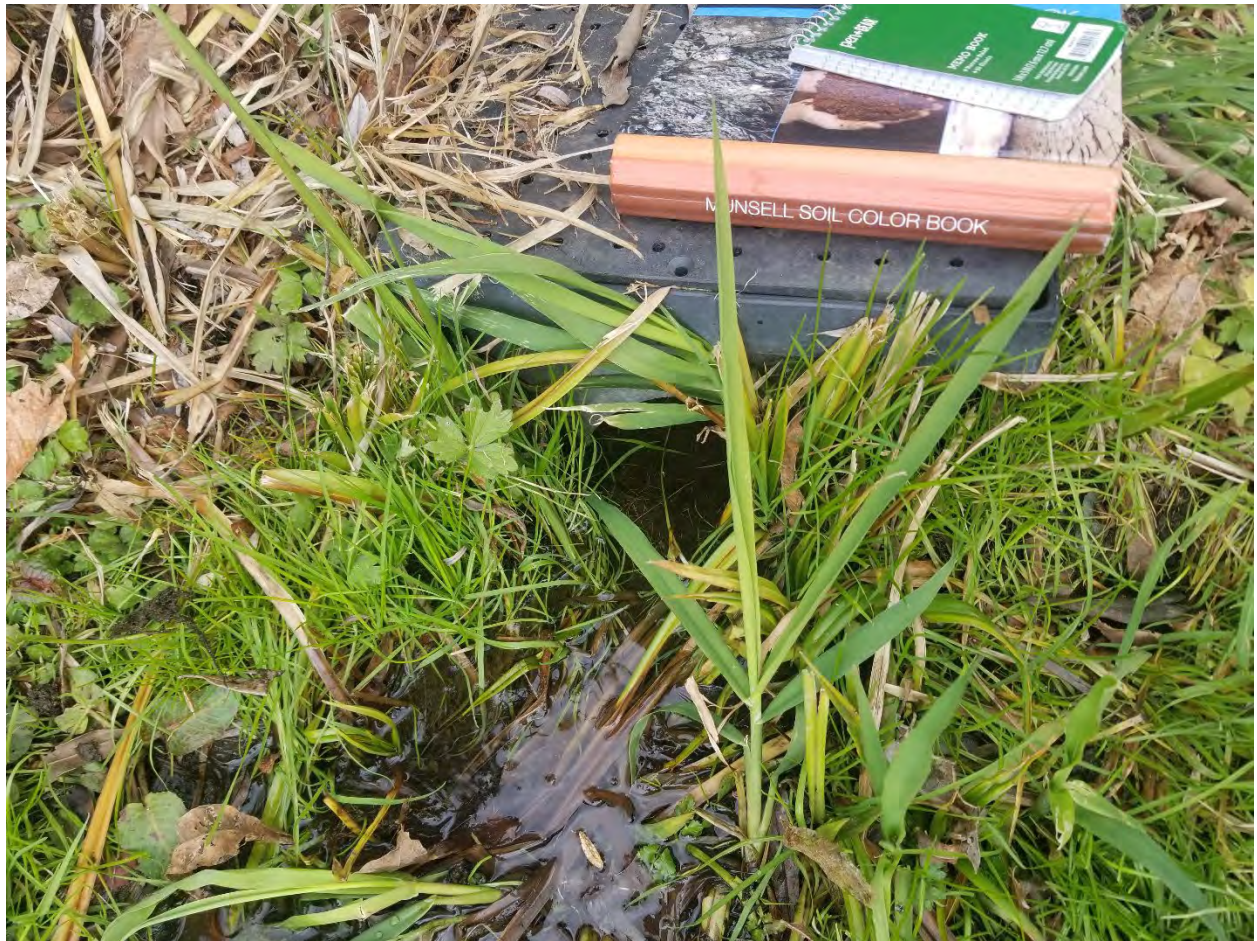
Wetland Pipe Box Outlet

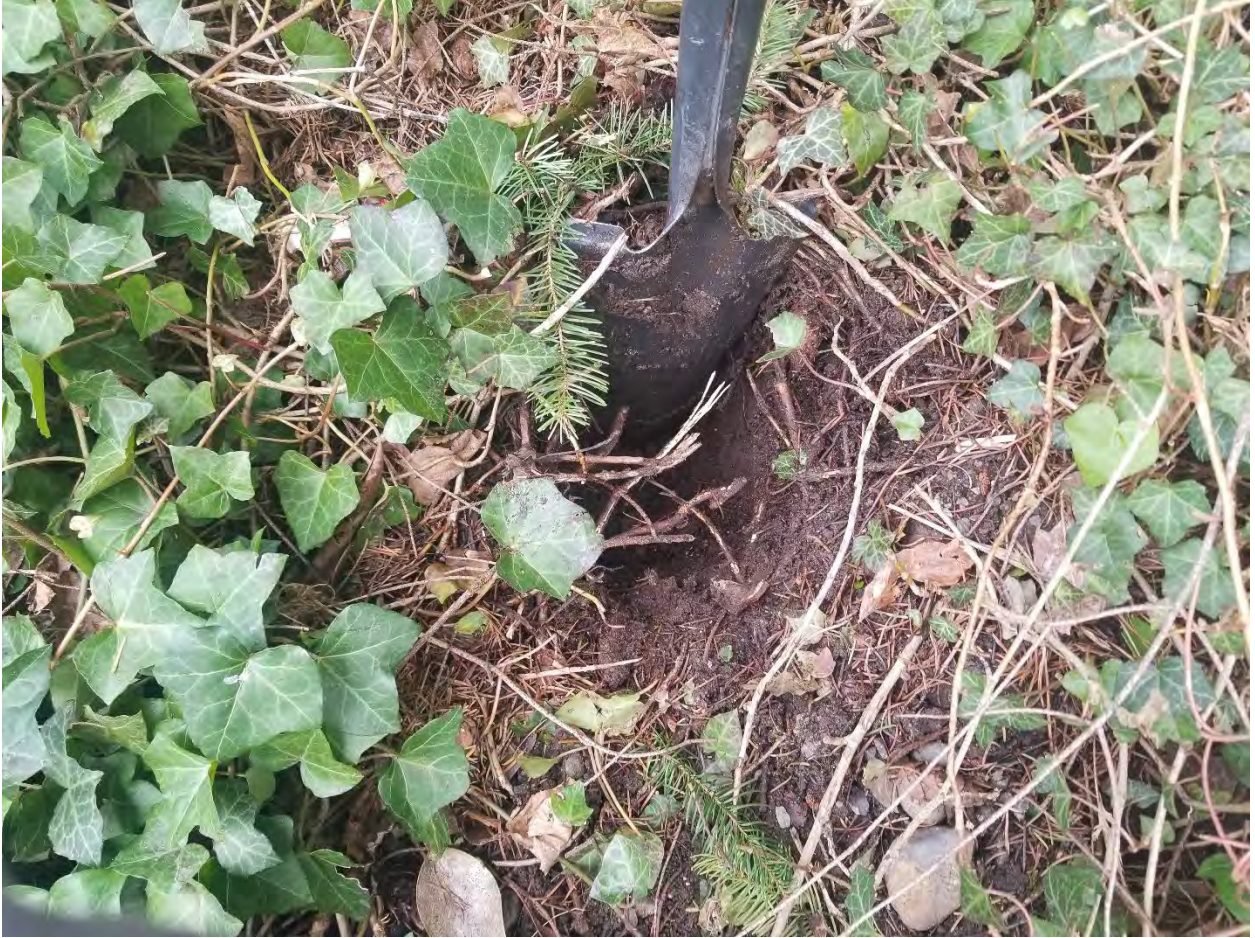
Sample Location 2 (SL-2)

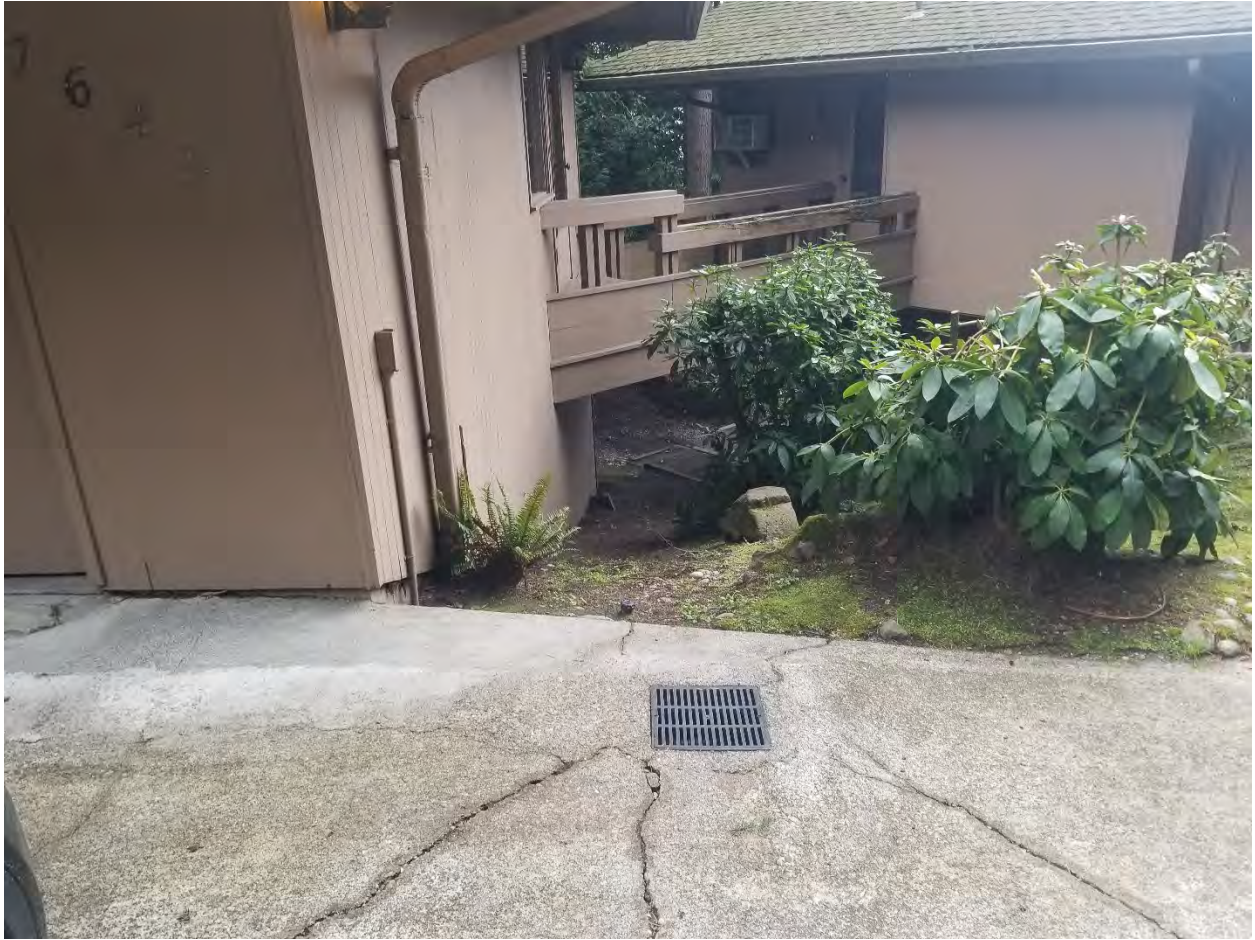
A pipeline company attempted to locate the pipeline that was supposed to be present along the south side of the garage, and discharges into the lake. They were unable to locate this pipeline, including the inlet and outlet. They confirmed that hydrology from the neighbor’s rock lined swale, is diverted to a wood lid box structure next to the driveway, crosses under the driveway in front of the garage, runs along the side of the garage, under the walkway between the garage and house, then is located under the gravel walkway, until it discharges into the wetland. The pipeline does not discharge directly into the lake but ends in the wetland. The pipe size is 6 inches in diameter. It does not appear to be a piped watercourse, but rather part of a residential drainage system for runoff from impervious surfaces.

There is a pipeline onsite located between the neighbor's rock lined swale and Wetland A. The pipeline is undersized and should be replaced. The code allows for a 10-foot setback from the centerline of the pipe.

Surface Inlet to Pipeline at Corner of Garage, Pipeline Runs Downhill Under Wood Bridge

The Mercer Island City Code, Section 19.07.070.B.4.a, does not allow piped conveying watercourses to be removed that may result in an increased threat of erosion. A piped watercourse does not have a buffer requirement. It is required to have a setback of 45 feet from the centerline of the pipe. However, when the pipeline cannot be daylighted due to risk of environmental damage, the buffer may be reduced to 10 feet on lots with a width of 50 feet or more. The slope is too steep for an open channel without significant risk of erosion. In this case we recommend that the pipeline be replaced and sized to carry peak flows from the rock lined swale. The pipe location could be adjusted slightly to provide a 10-foot setback for all structures, which it currently does not have for the existing structures. If it is not replaced, there is a risk that the pipe capacity will be exceeded and cause erosion.

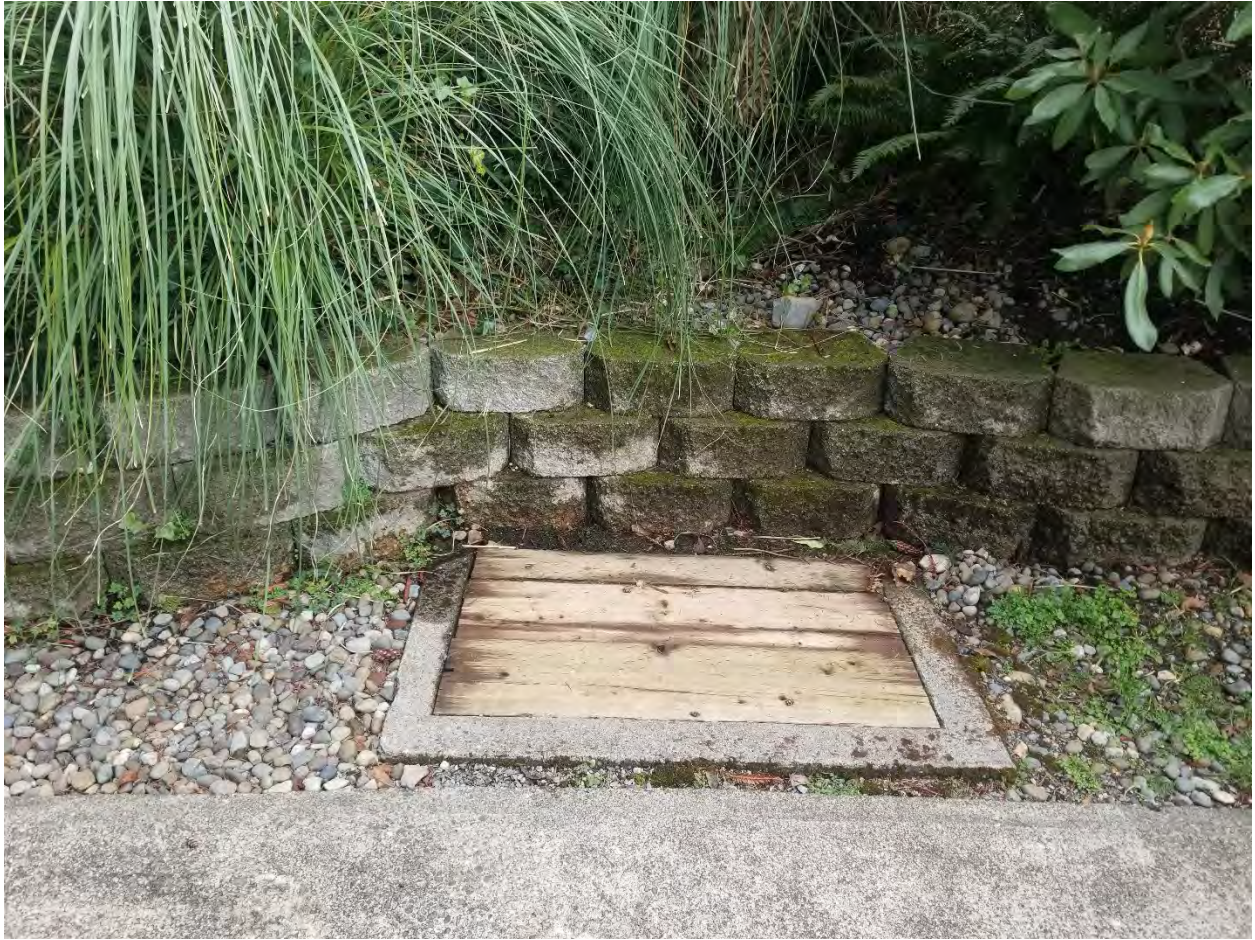
Wood Lid Pipeline Box

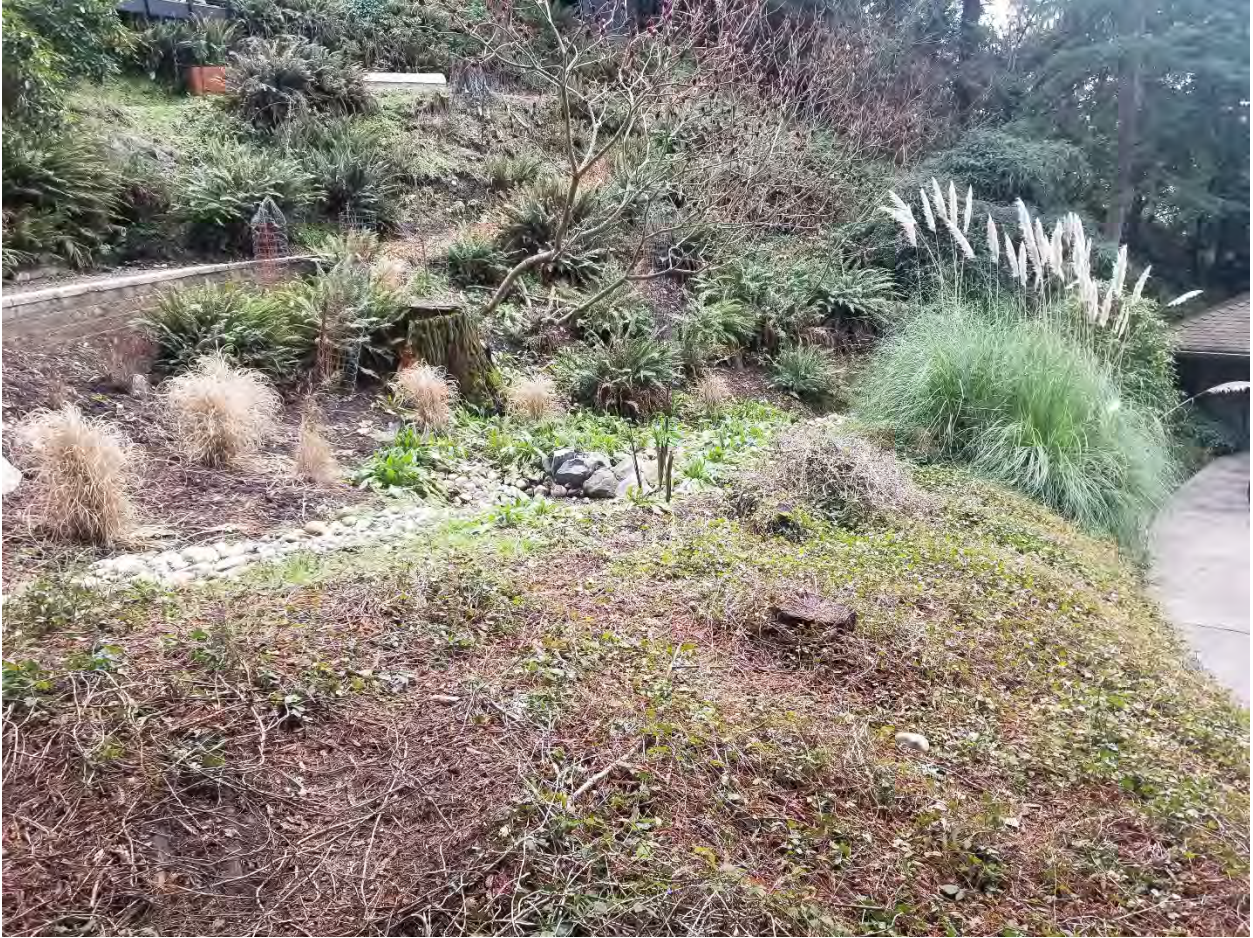
The rock lined swale, above the driveway and on the neighbor’s property, is a Type Ns stream. A Type Ns stream is seasonal non-fish bearing. Surface water was observed in the swale. It is not possible for fish to access this stream because the piped outlet is above the lake and the slope is too steep.

There are no streams onsite. However, the neighbor's rock lined swale, located above the driveway is a Type Ns stream. The buffer requirement for a Type Ns stream is 60 feet.

Rock Lined Swale on Neighbors Property Above Driveway
