Memo

From: **Urban Forestry Services | Bartlett Consulting**
Tyler P. Holladay, Consulting Arborist - GIS Specialist
ISA Certified Arborist® #PN-8100A
ISA Tree Risk Assessment Qualified

Re: **85th Ave SE Sewer Pump Station 20 Replacement Project
Tree Inventory, Assessment, and Tree Protection Planning**

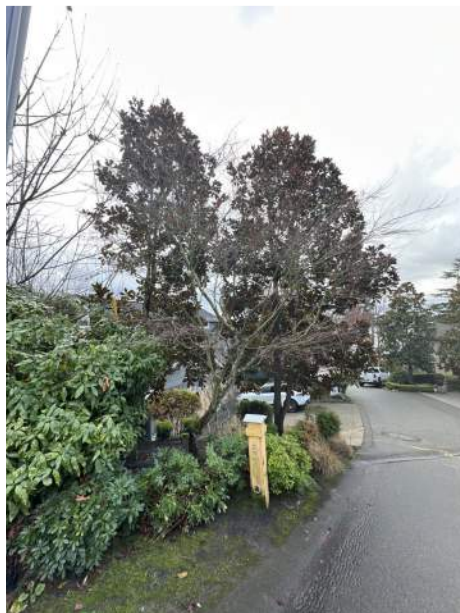
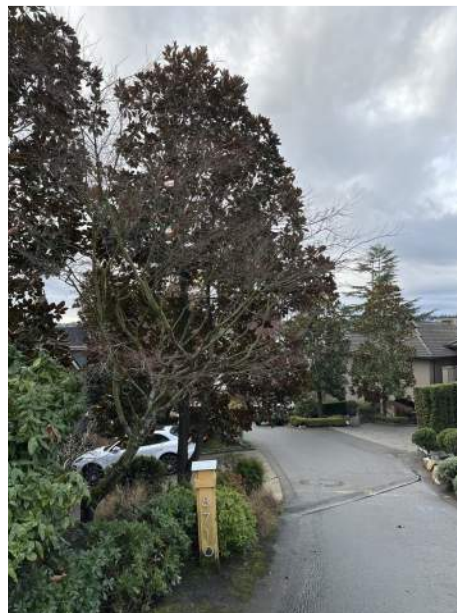
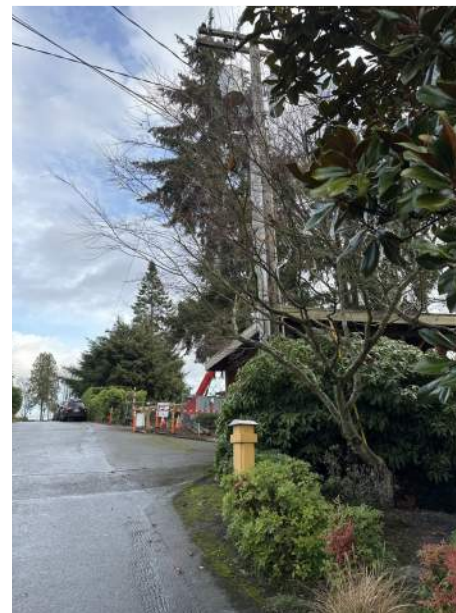
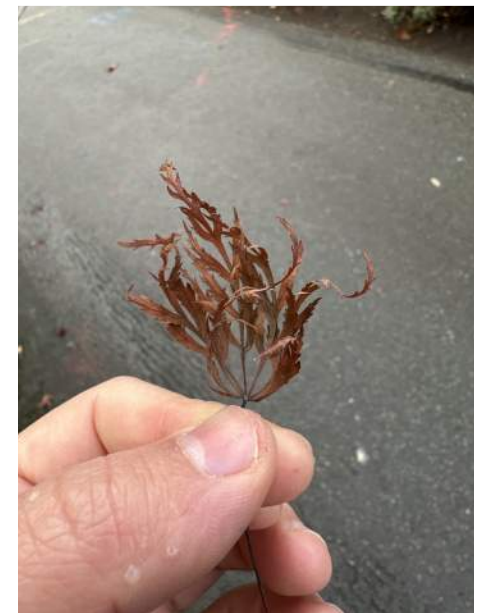
Condition Rating: Good

Notes: Branches from this tree overhang the roadway. Some branches already show signs of tissue injury from contact with passing vehicles.

Recommendations: Protect - Restrict access beyond the roadway. Install tree protection fencing. Prune or tie back branches that overhang the roadway to prevent injury from vehicles/equipment during construction.

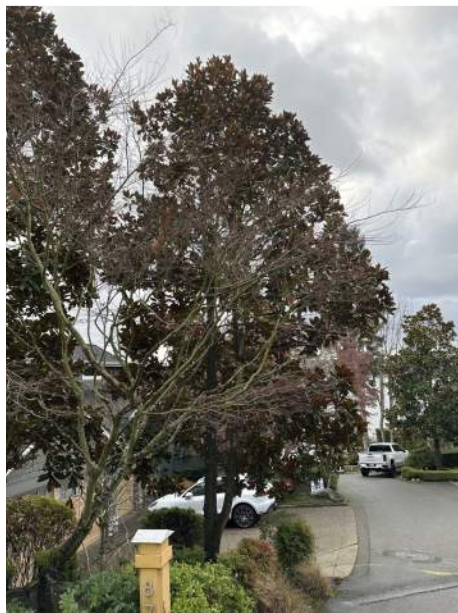
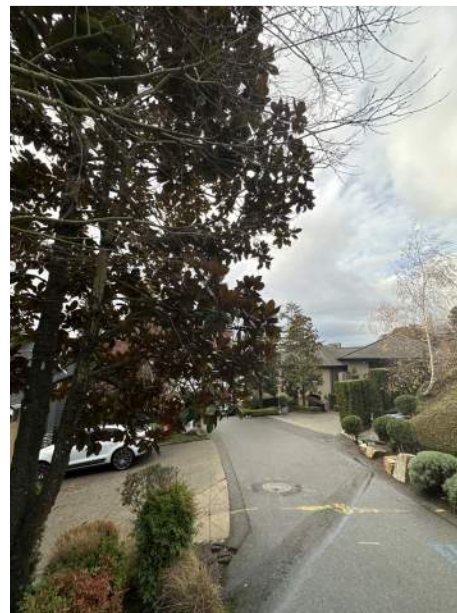
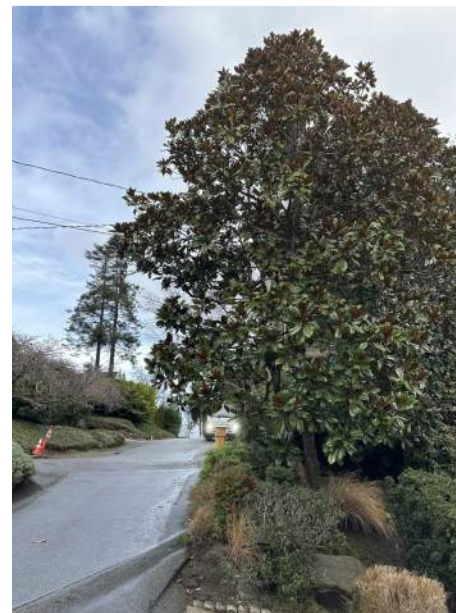
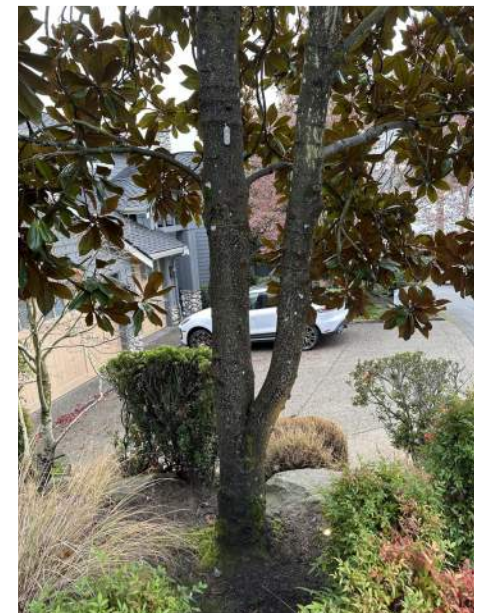
Species: Evergreen magnolia (*Magnolia grandiflora*)

Condition Rating: Good

Notes: This tree has branches that overhang the roadway, which could potentially be damaged during construction by vehicles/equipment traveling to and from the site.

Recommendations: Protect - Restrict access beyond the roadway. Install tree protection fencing. Prune or tie back branches that overhang the roadway to prevent injury from vehicles/equipment during construction.

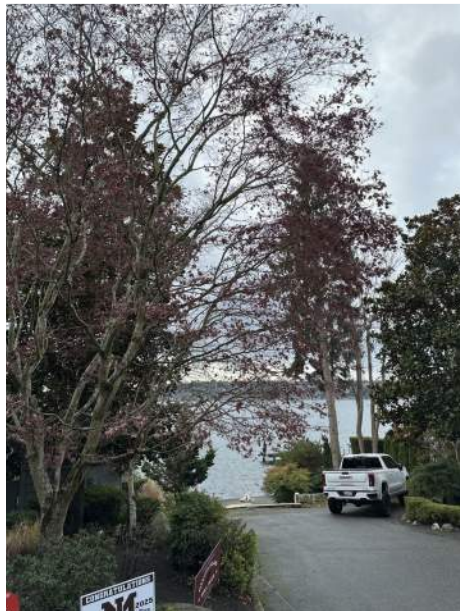
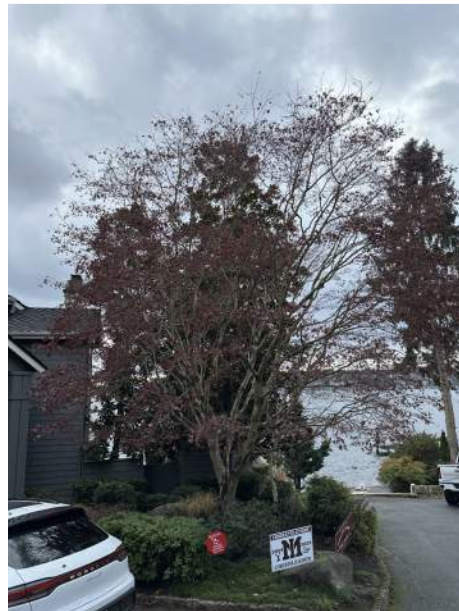
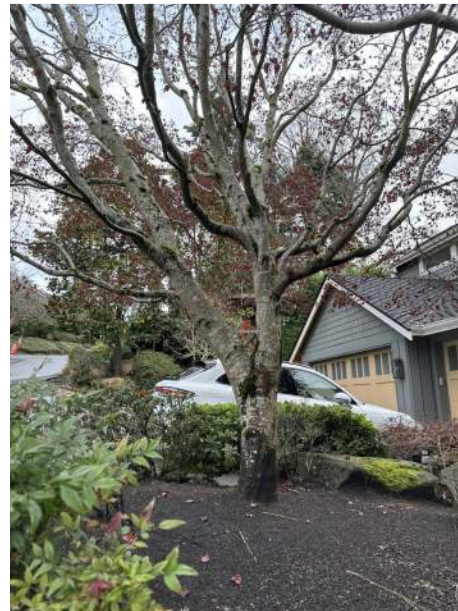
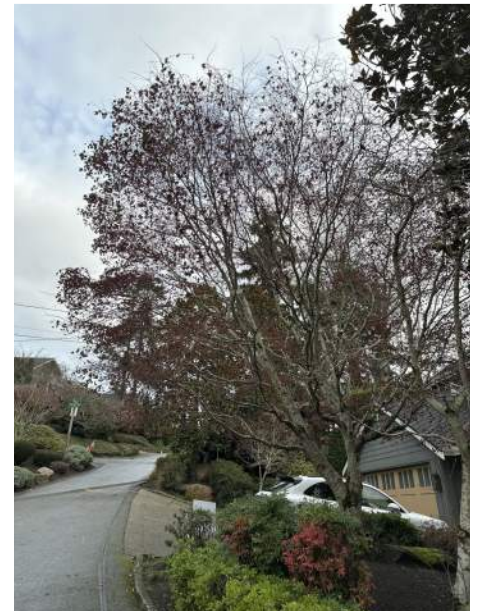
Species: Japanese maple (Acer palmatum)

Condition Rating: Fair

Notes: This tree has branches that overhang the roadway, which could potentially be damaged during construction by vehicles/equipment traveling to and from the site.

Recommendations: Protect - Restrict access beyond the roadway. Install tree protection fencing. Prune or tie back branches that overhang the roadway to prevent injury from vehicles/equipment during construction.

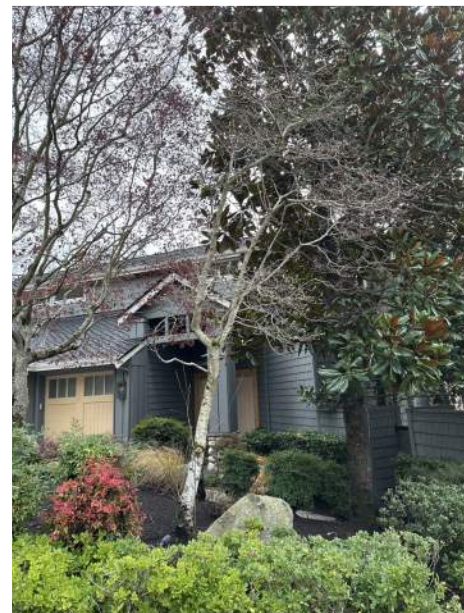
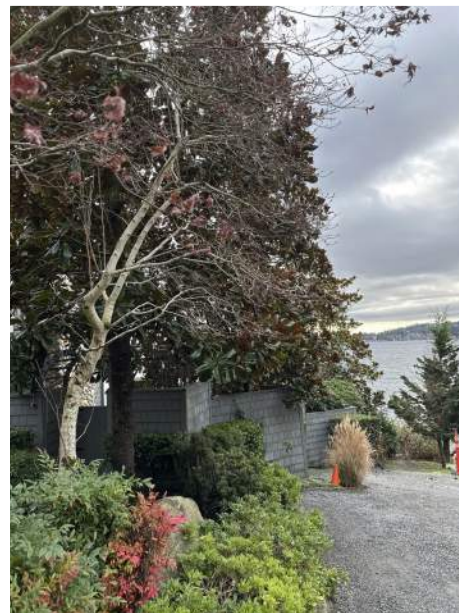
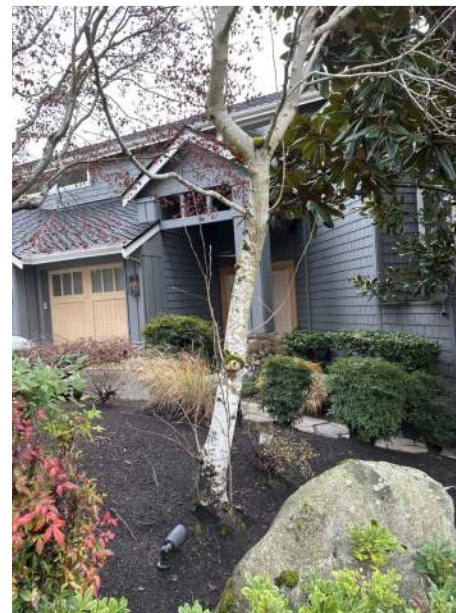
Tree ID:
64

Species: Star magnolia (*Magnolia stellata*)

Condition Rating: Fair

Health	Structure	Form
Good	Good	Fair

Notes: This tree is not shown/located on the provided survey/plan set. The tree has branches that overhang the roadway which could potentially be damaged during construction by vehicles/equipment traveling to and from the site.

Recommendations: Protect - Restrict access beyond the roadway. Install tree protection fencing. Prune or tie back branches that overhang the roadway to prevent injury from vehicles/equipment during construction.

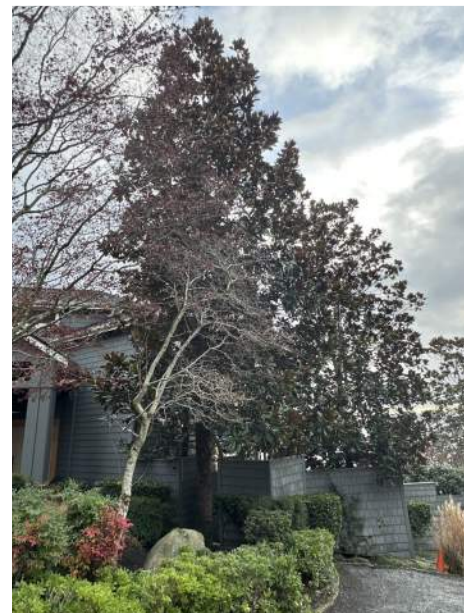
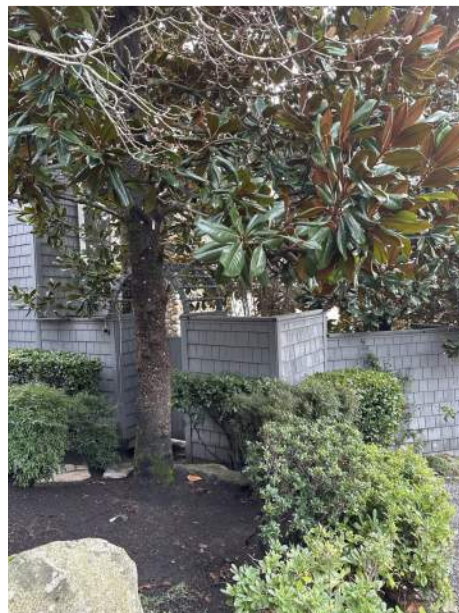
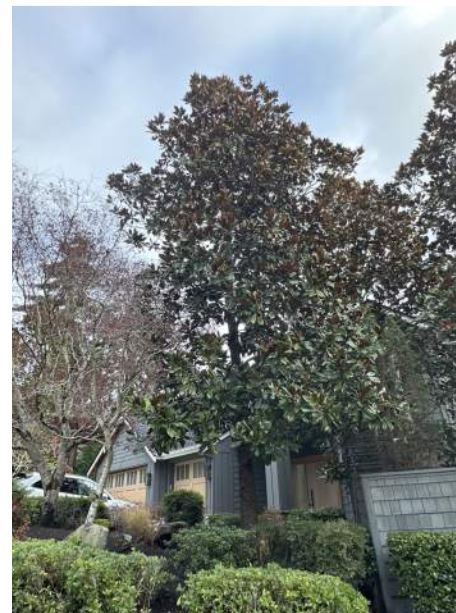
Tree ID:
65

Condition Rating: Good

Health	Structure	Form
Good	Good	Good

Notes: This tree has branches that overhang the parking area which could potentially be damaged during construction by vehicles traveling to and from the site and from idling/exhaust.

Recommendations: Protect - Restrict access beyond the roadway/parking areas. Install tree protection fencing. Prune or tie back branches that overhang the roadway to prevent injury from vehicles/equipment during construction.

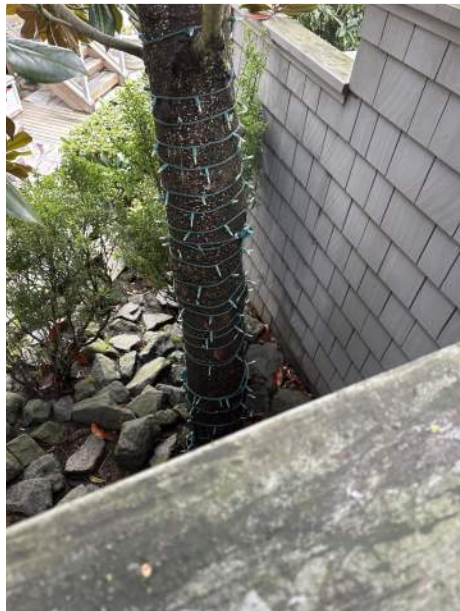
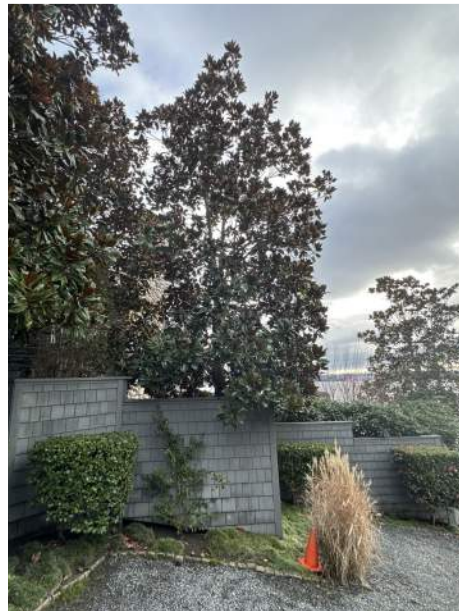
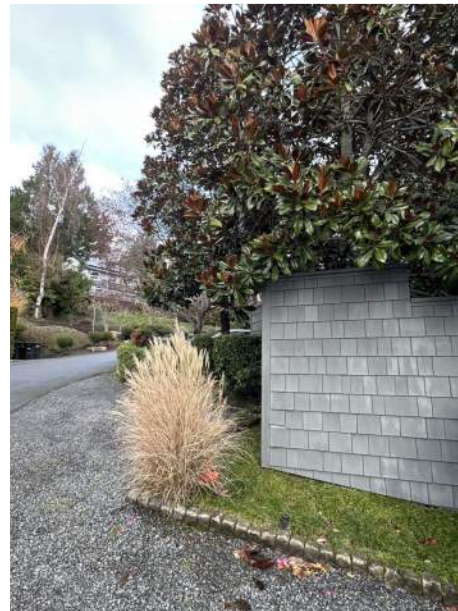
Condition Rating: Good

Notes: This tree is not shown/located on the provided survey/plan set. DBH is an estimate due to site access restrictions. This tree has branches that overhang the parking area, which could potentially be damaged during construction by vehicles traveling to and from the site and from idling/exhaust.

Recommendations: Protect - Restrict access beyond the roadway/parking areas. The existing fence can be used as protection fencing. Prune or tie back branches that overhang the roadway to prevent injury from vehicles/equipment during construction.

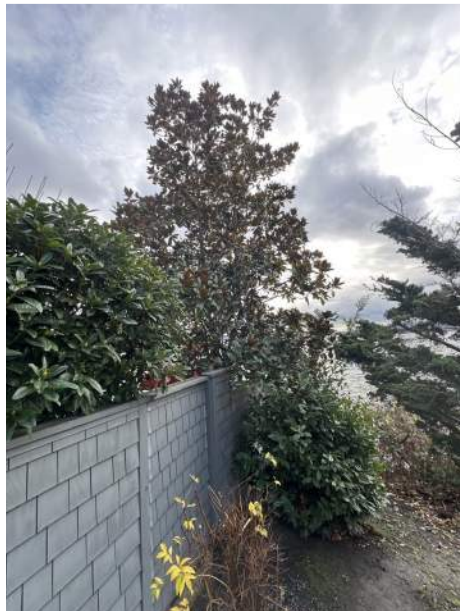
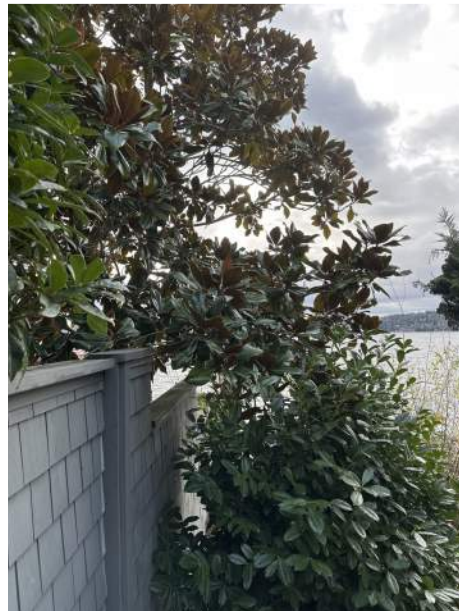
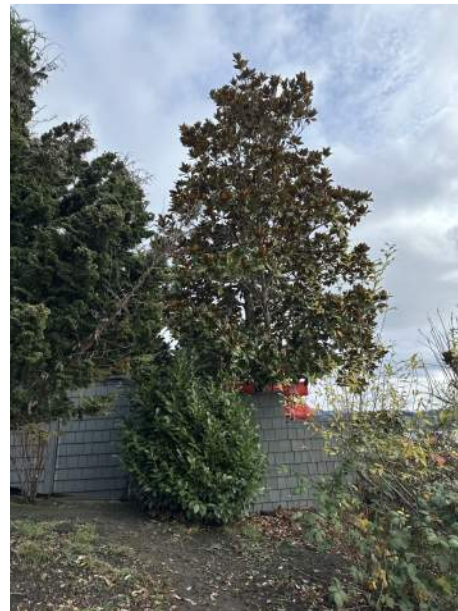
Species: Evergreen magnolia (*Magnolia grandiflora*)

Condition Rating: Good

Notes: This tree is not shown/located on the provided survey/plan set. DBH is an estimate due to site access restrictions. This tree has branches that overhang the parking area, which could potentially be damaged during construction by vehicles traveling to and from the site and from idling/exhaust.

Recommendations: Protect - Ground protection will be needed if equipment access/travel is required within 8 feet of the fence line. The existing fence can be used as protection fencing. Prune or tie back branches that overhang the roadway to prevent injury from vehicles/equipment during construction.

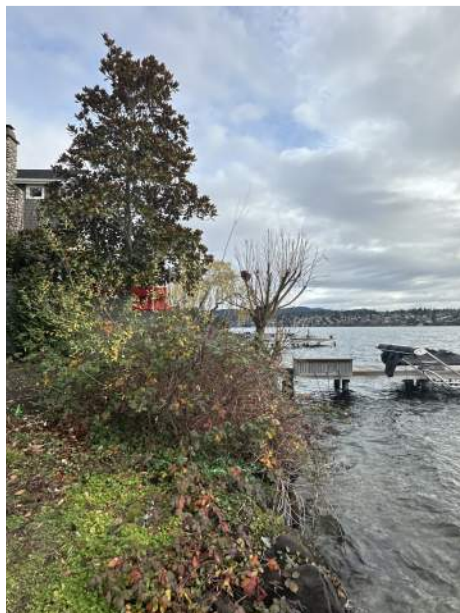
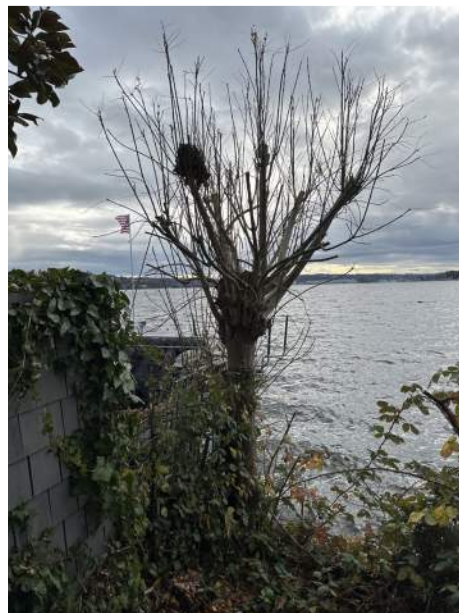
Species: Green ash (Fraxinus pennsylvanica)

Condition Rating: Poor

Notes: This tree is not shown/located on the provided survey/plan set. This tree is within the boundaries of the work area and could potentially be damaged during construction by equipment travel and idling. The tree has a low retention value due to repeated topping. The tree is at the edge of the shoreline.

Recommendations: Protect - Install tree protection fencing and Ground protection in areas shown on the Tree Protection Site Plan.

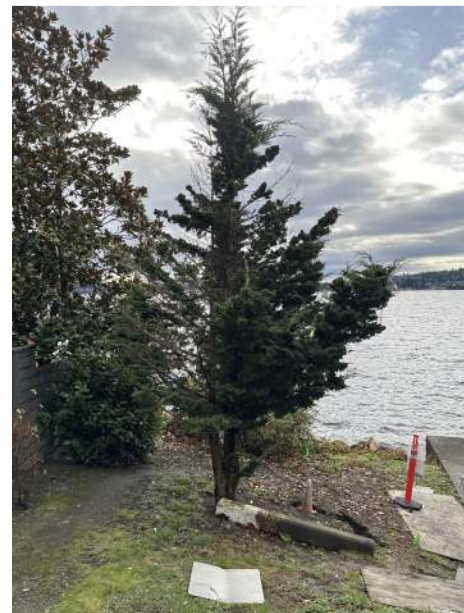
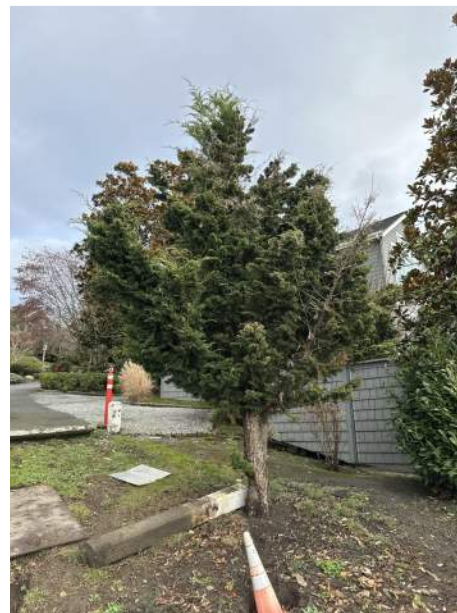
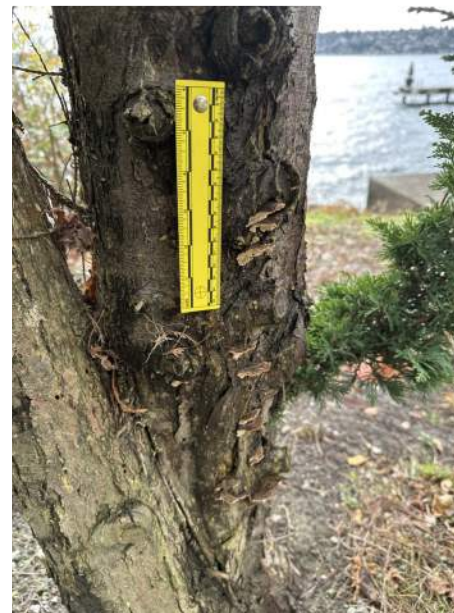
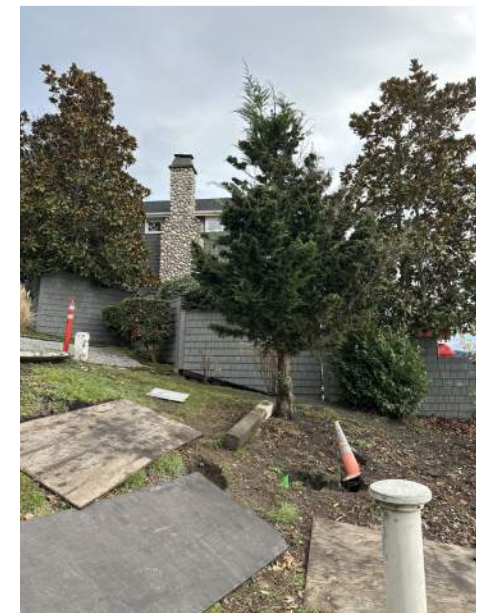
Tree ID:
69

Species: Arborvitae (*Thuja occidentalis*)

Condition Rating: Poor

Health	Structure	Form
Poor	Poor	Poor

Recommendations: Remove - poor overall condition and unsustainable impacts expected.

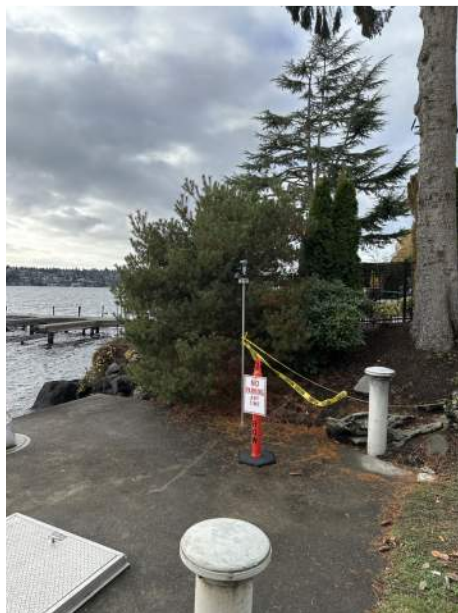
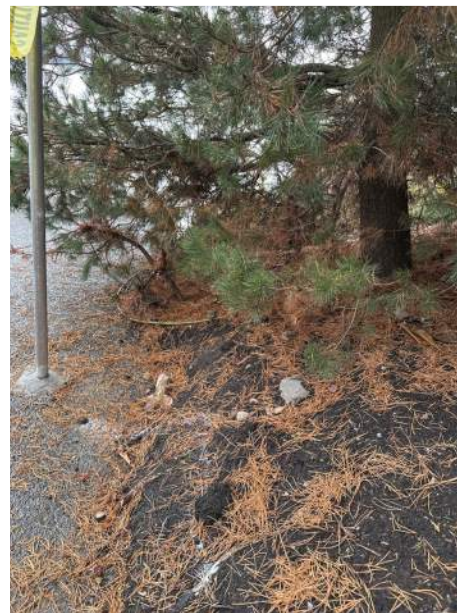
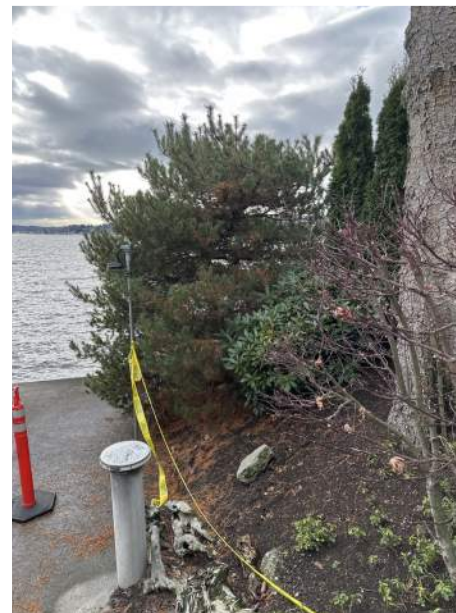
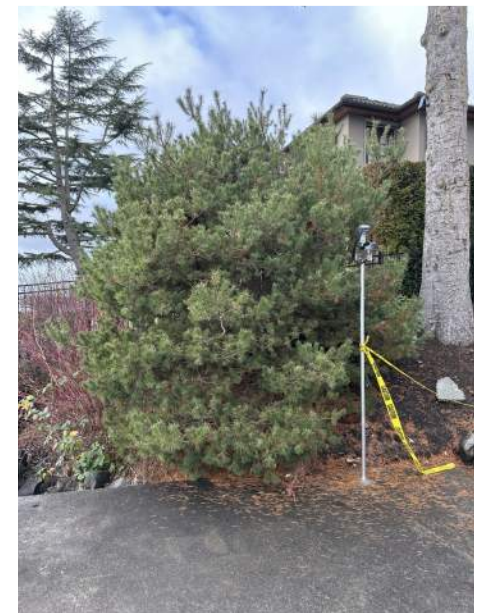
Condition Rating: Good

Notes: This tree is directly next to the work area and branches overhang the existing concrete structure by roughly 4 feet. It appears that improvements will not significantly impact this tree; the removal of other trees nearby may pose some degree of impact.

Recommendations: Protect - Install tree protection fencing as shown on the Tree Protection Site Plan. If needed, prune or tie back branches overhanging the work area to prevent injury during construction.

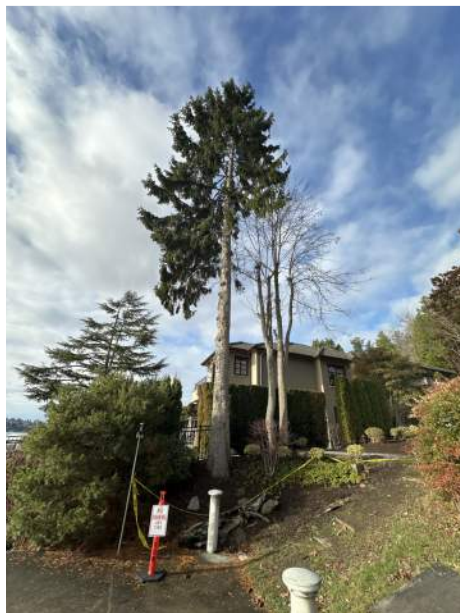
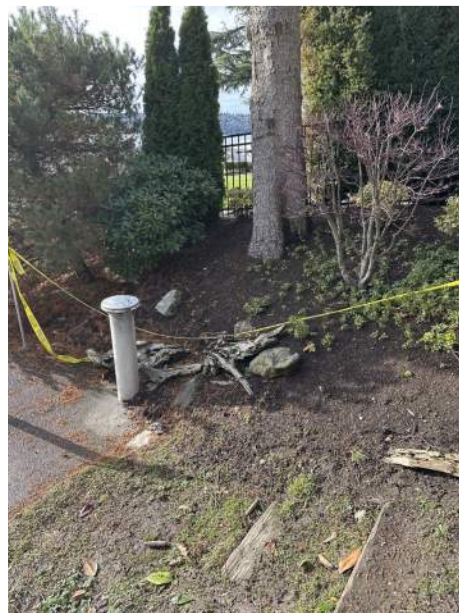
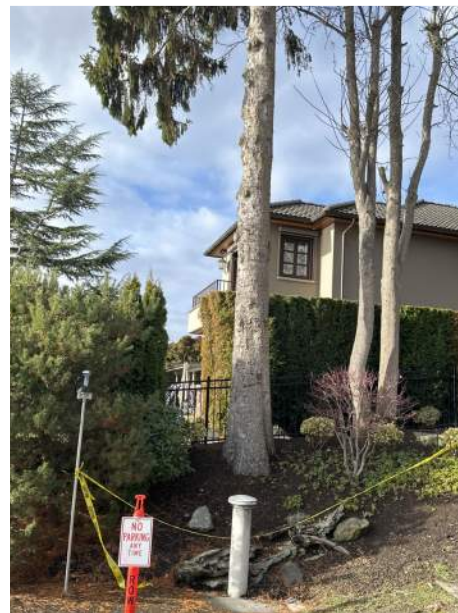
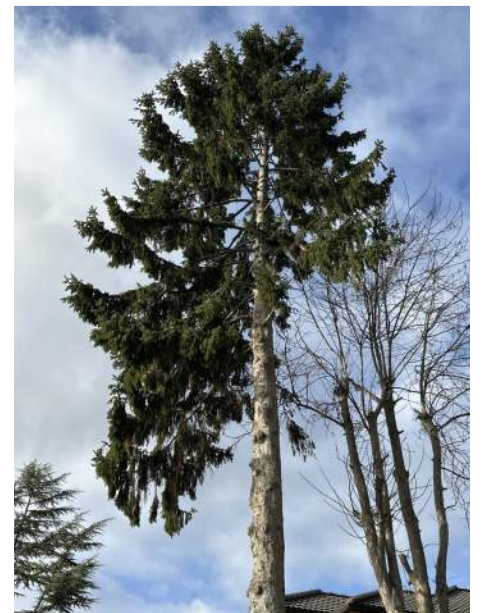
Species: Norway spruce (*Picea abies*)

Condition Rating: Fair

Notes: This tree has been limbed up significantly in the past. It appears spurs were used to climb the tree, as is evident by spur injuries on the trunk. This tree is directly next to planned improvements and will likely experience significant to severe and unsustainable impacts. The tree may potentially be destabilized as well due to root severance.

Recommendations: Remove - unsustainable impacts expected

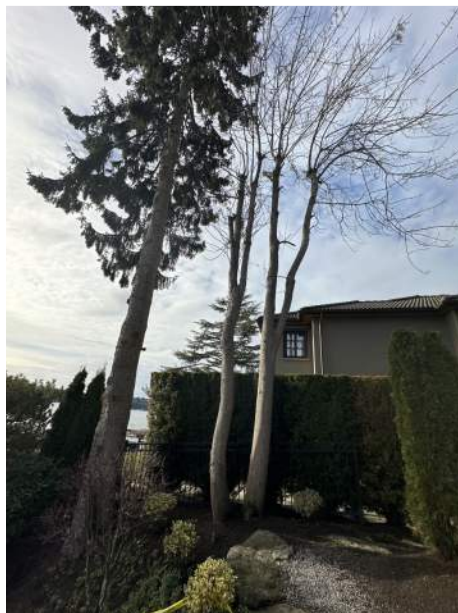
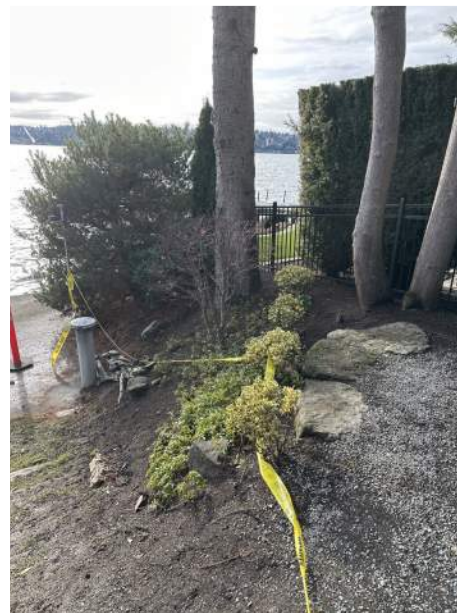
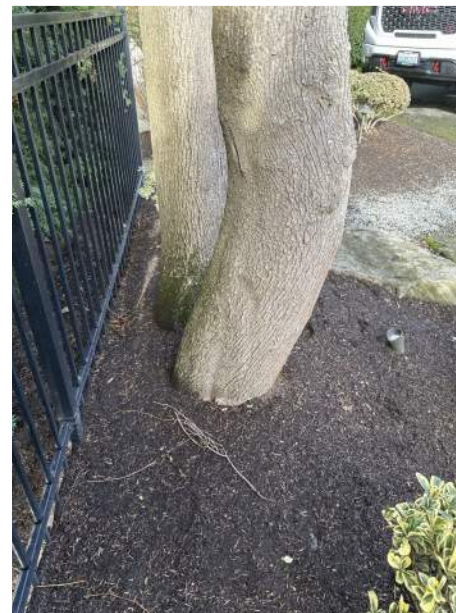
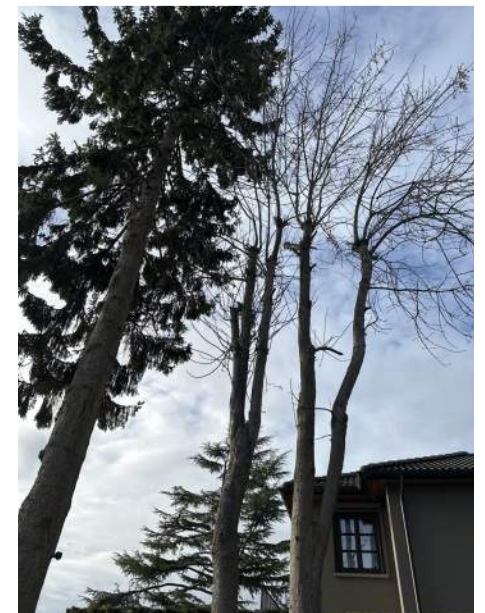
Species: Green ash (Fraxinus pennsylvanica)

Condition Rating: Poor

Notes: This tree has been topped multiple times in the past as well as limbed up significantly. The root collar of this tree is buried significantly. The tree has dead, dying, and sluffing bark in the upper canopy. Impacts are within 4 feet to the east and will likely significantly impact this tree and potentially destabilize the tree.

Recommendations: Remove - poor condition combined with unsustainable impacts.

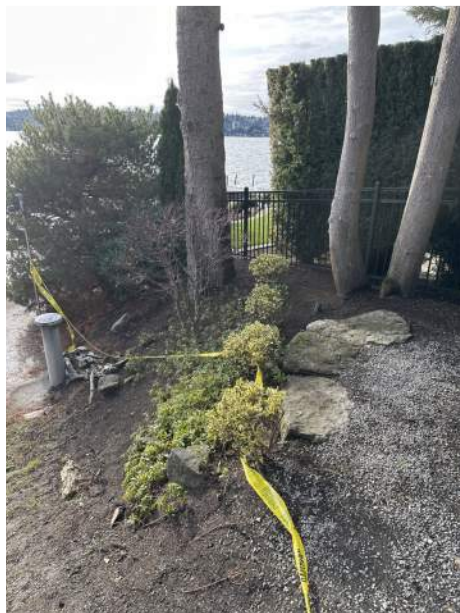
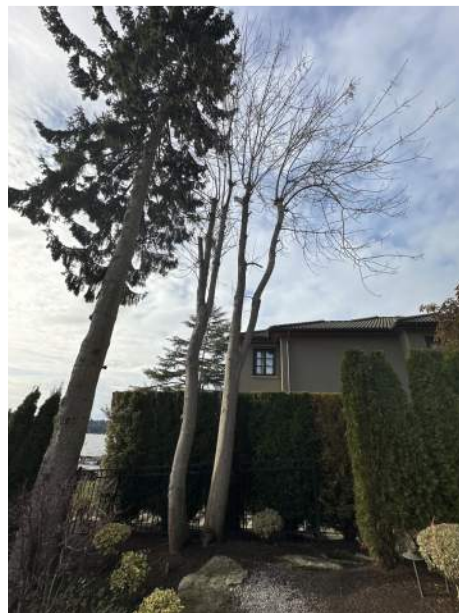
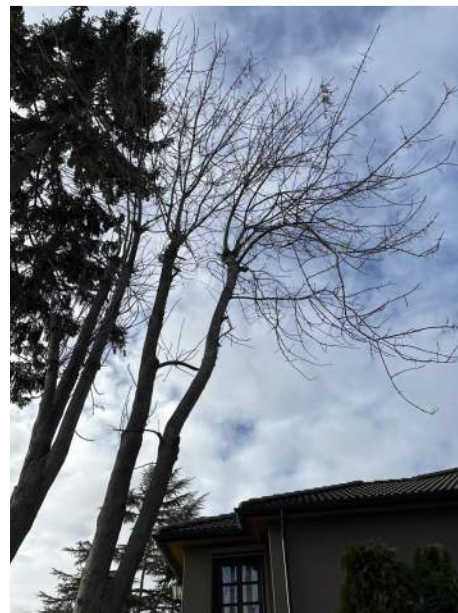
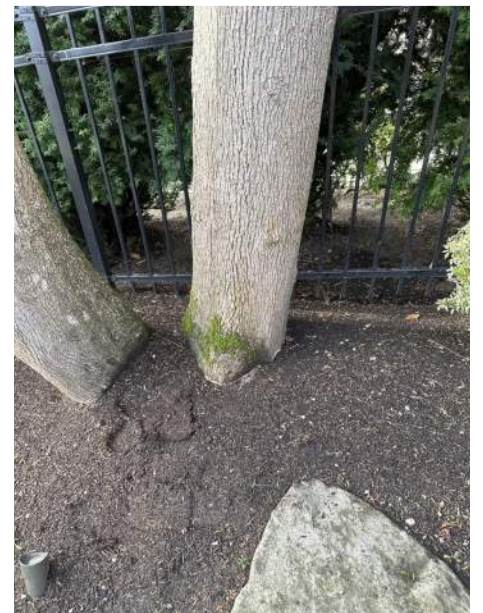
Species: Green ash (Fraxinus pennsylvanica)

Condition Rating: Poor

Notes: This tree has been topped multiple times in the past as well as limbed up significantly. The root collar of this tree is buried significantly. The tree has dead, dying, and sluffing bark in the upper canopy. Impacts are within 5 feet to the east and will likely significantly impact this tree and potentially destabilize the tree.

Recommendations: Remove - poor condition combined with unsustainable impacts.

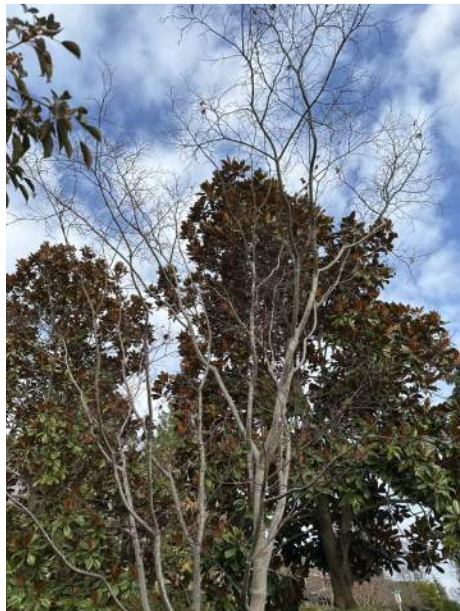
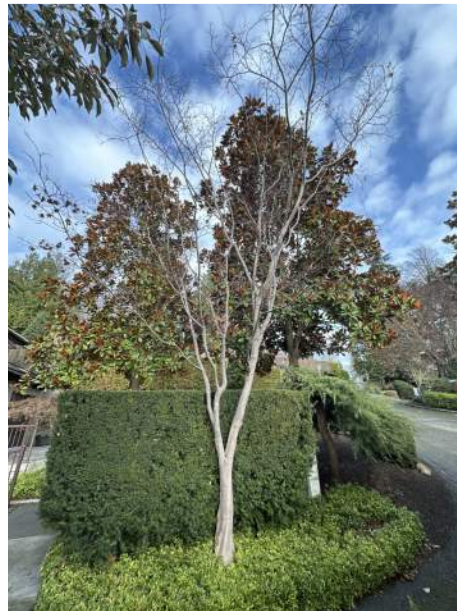
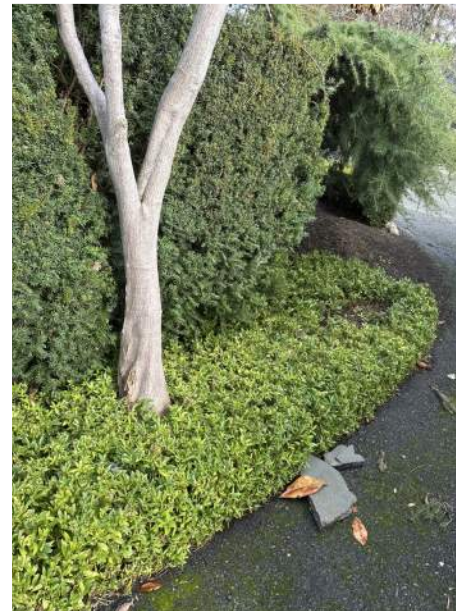
Species: Japanese maple (Acer palmatum)

Condition Rating: Good

Notes: The trunk of this tree is within 1 foot of the driveway surface to the south. The lower trunk contains swollen areas likely from repeated vehicle-related damage. There are a couple of lower branches that could come into conflict with construction vehicles/equipment.

Recommendations: Protect - Restrict access beyond the roadway/parking areas. Install tree protection fencing. Trunk protection may also be needed. Prune or tie back branches that overhang the parking area to prevent injury from vehicles/equipment during construction.

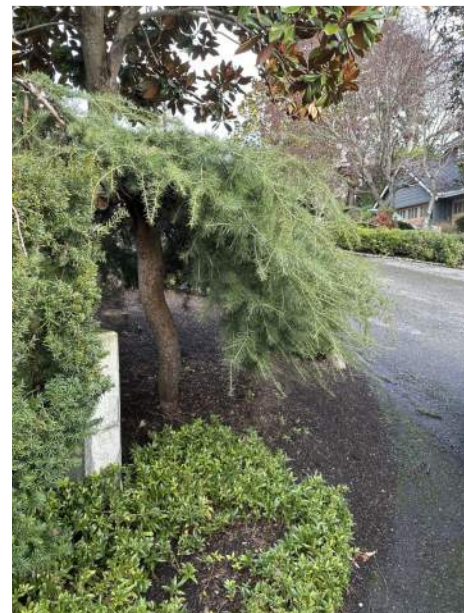
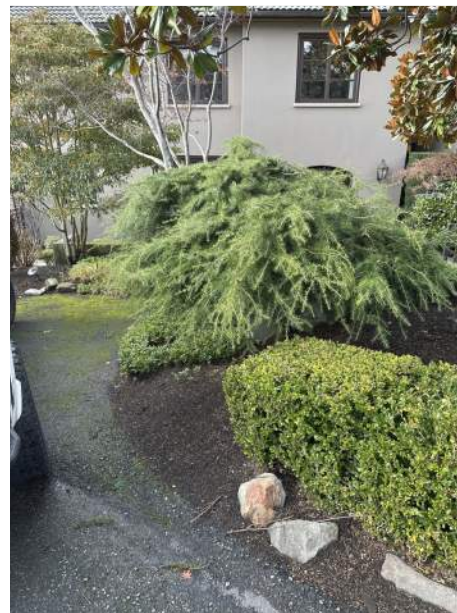
Tree ID:
75

Species: Deodar cedar (Cedrus deodara)

Condition Rating: Good

Health	Structure	Form
Good	Good	Good

Recommendations: Protect - Restrict access beyond the roadway/parking areas. Install tree protection fencing. Prune or tie back branches that overhang the roadway to prevent injury from vehicles/equipment during construction.

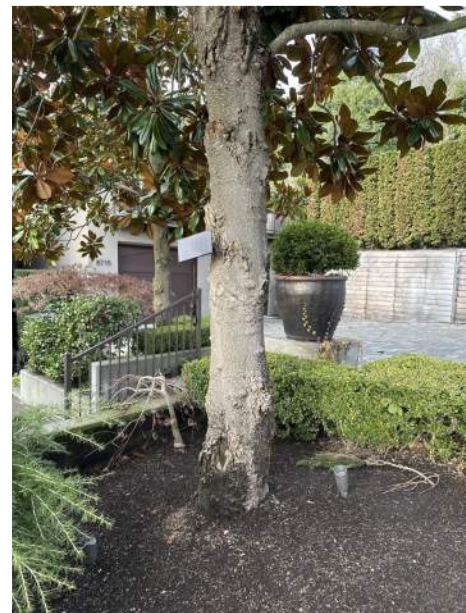
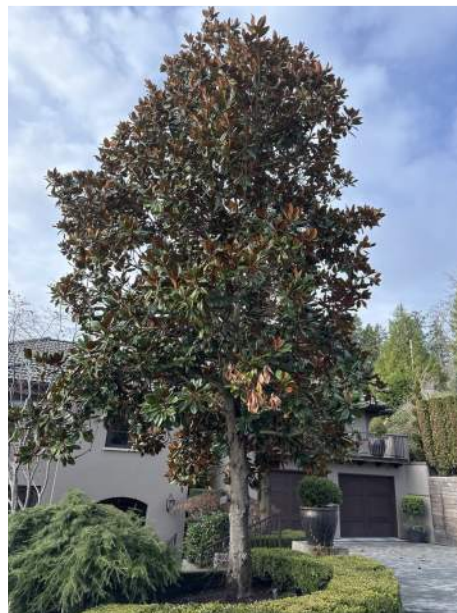
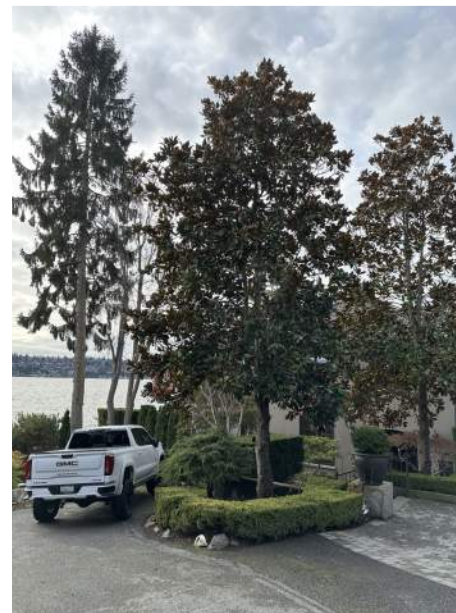
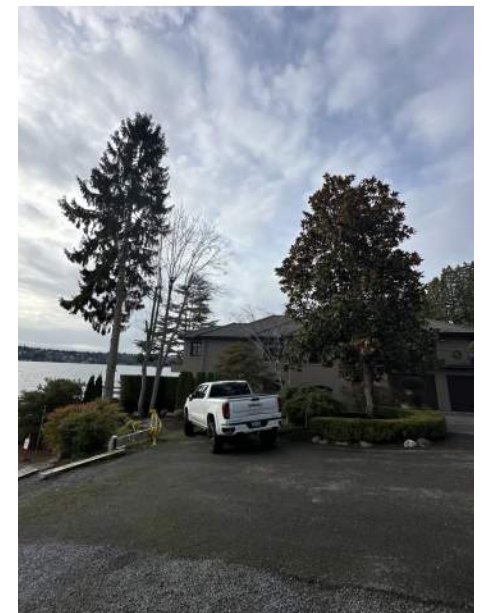
Tree ID:
76

Condition Rating: Good

Health	Structure	Form
Good	Good	Good

Notes: This tree has branches that overhang the parking area which could potentially be damaged during construction by vehicles traveling to and from the site and from idling/exhaust.

Recommendations: Protect - Restrict access beyond the roadway/parking areas. Install tree protection fencing. Prune or tie back branches that overhang the roadway to prevent injury from vehicles/equipment during construction.

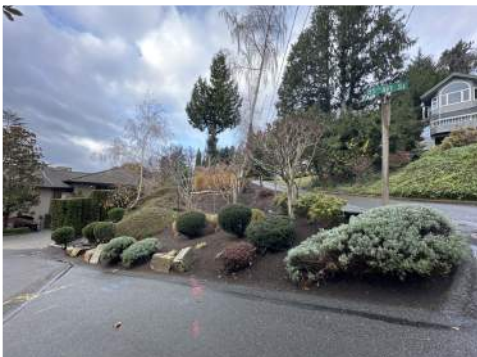
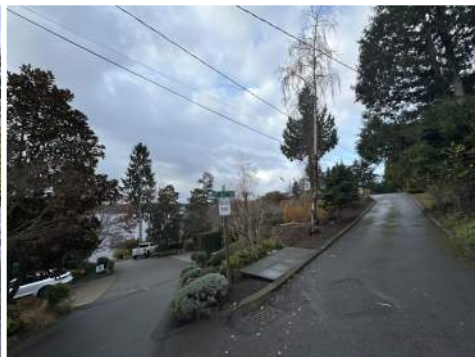
Condition Rating: Fair

Failure Likelihood	Impact Likelihood	Consequences
Possible	Medium	Significant

Notes: There are 8 small to large trees in this group - 1 - western red cedar, 2 - Birch species, 2 - Camelia species, 3 - Japanese maple species, and various shrubs and woody ornamentals. According to the plans provided, none of these trees appear to be potentially impacted by construction. None of these trees have branches that extend over the roadway. These trees have not been individually inventoried due to the low likelihood of impact during construction.

Recommendations: Protect this area during construction to prevent vehicles from driving on the edge of the landscape.

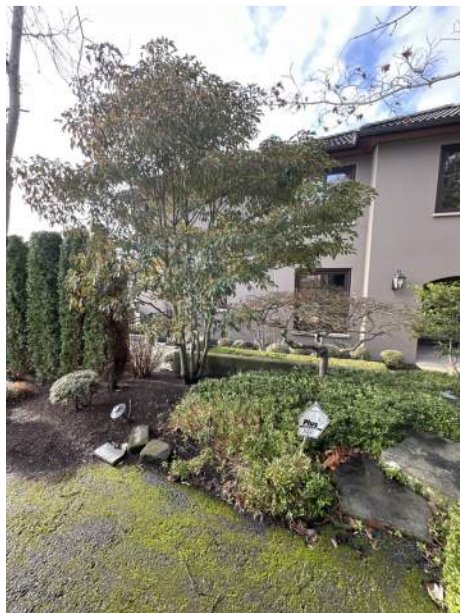
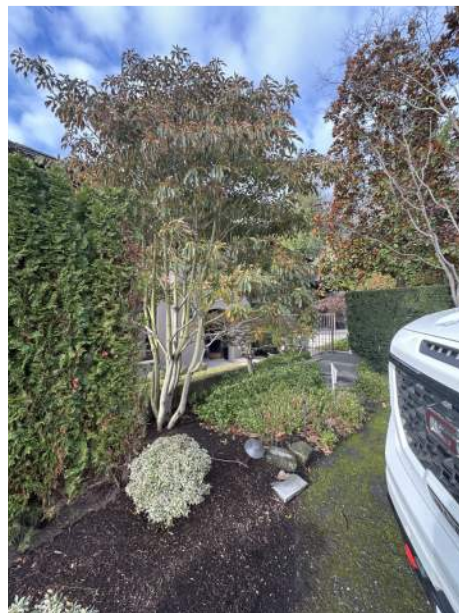
Species: Mix - Broadleaf Dominant

Condition Rating: Good

Notes: There are 2 small trees in this group - 1 - Trochodendron, 1 - Japanese maple. According to the plans provided, none of these trees appear to be potentially impacted by construction. None of these trees have branches that extend over the roadway. These trees have not been individually inventoried due to the low likelihood of impact during construction.

Recommendations: Protect this area during construction to prevent vehicles from driving on the edge of the landscape.
