# **CRITICAL AREA STUDY & NO NET LOSS PLAN**

## **COVENANT LIVING AT THE SHORES** ***MERCER ISLAND, WA***

*Wetland Resources, Inc.* Project #24361

Date: August 21, 2025

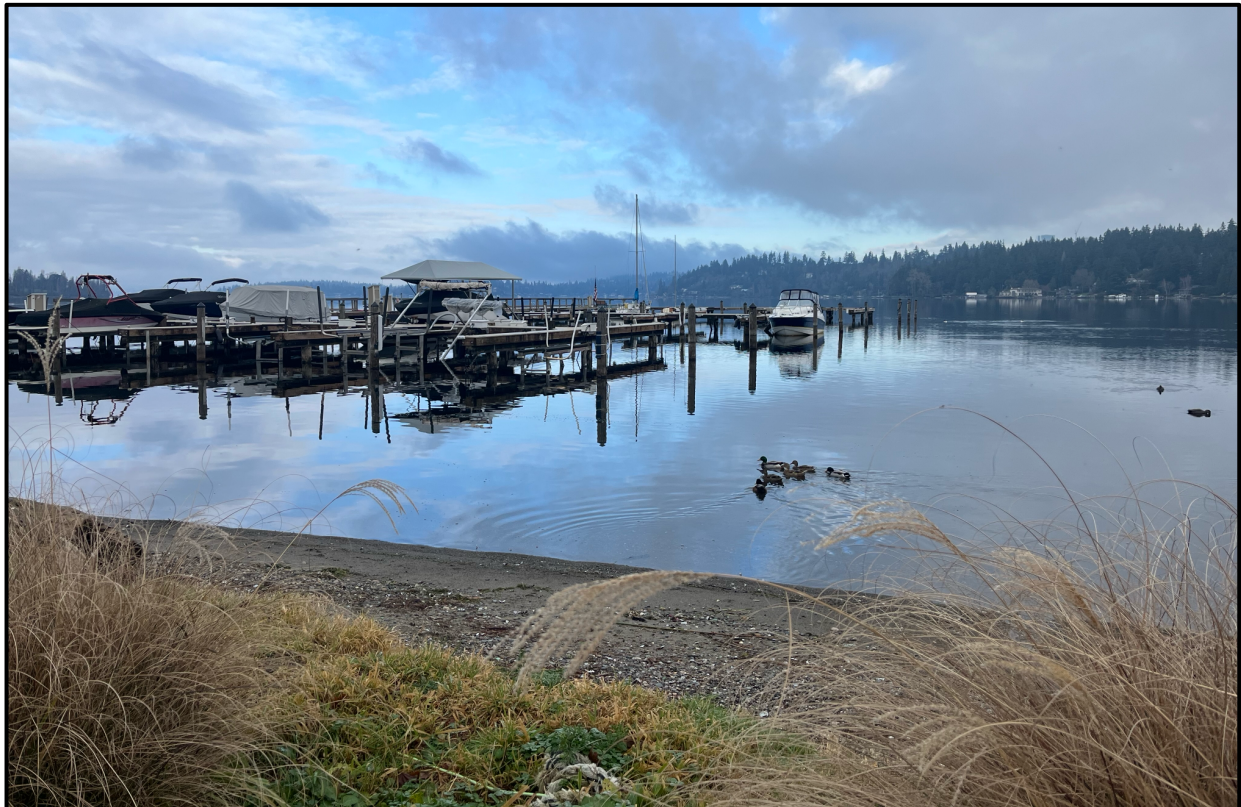
**Figure 5** - Looking North Towards Lake Washington.

Lake Washington is regulated as a Shoreline of Statewide Significance. The ordinary high water mark (OHWM) of the lake was determined by the project surveyor based on the surface elevation of the lake on August 13, 2022. Pursuant to MICC 19.13.050, Lake Washington requires a 25-foot setback to be measured landward from the OHWM. Lake Washington provides habitat for several federally listed species including Chinook salmon, steelhead trout, and bull trout.

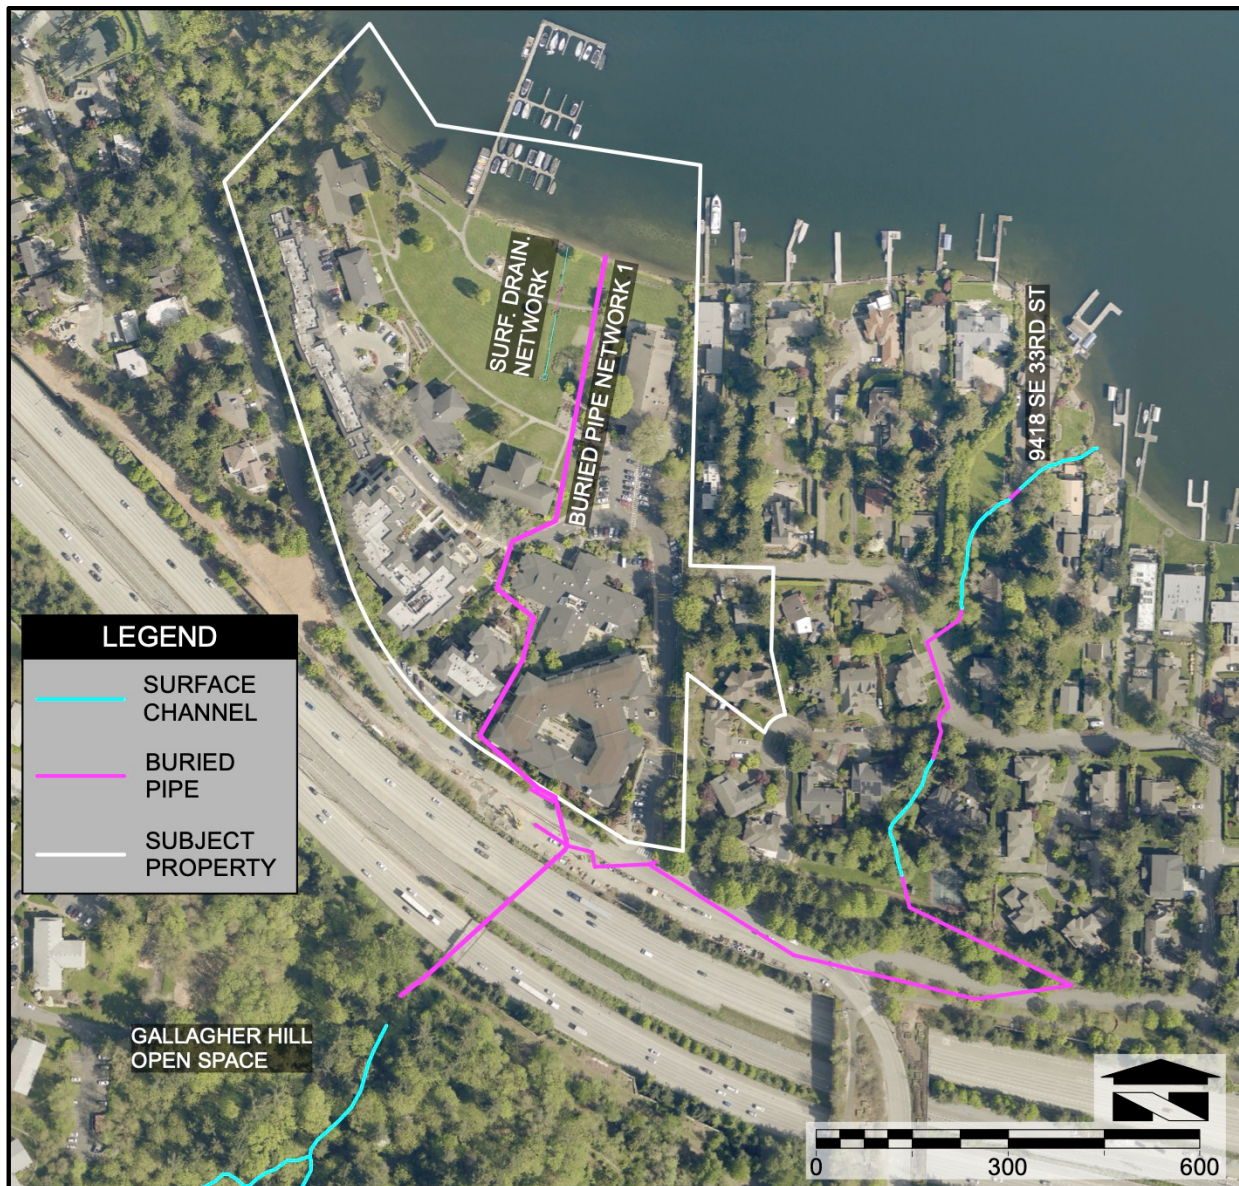
**Figure 6** - Buried Pipe Network 1 and Historic Route

Figure 6 below provides a more accurate depiction of existing public stormwater infrastructure based on the site survey and the findings presented in a document prepared by The Watershed Company titled Drainage Feature Evaluation. The Drainage Feature Evaluation is provided as Appendix A. The report finds that flows originating in Gallagher Open Space are conveyed northeast along a historic path that flows to Lake Washington in the vicinity of 9418 SE 33rd Street.

MICC 19.16.010.W provides the definition of a regulated watercourse. The definition excludes “storm water runoff devices,” except where they “convey waters that were naturally occurring prior to construction.” Based on review of historic aerials dating back as far as 1936 and the findings of the Drainage Feature Evaluation, no naturally occurring surface channel was ever present within the subject property. However, BPN1 may still be considered a regulated

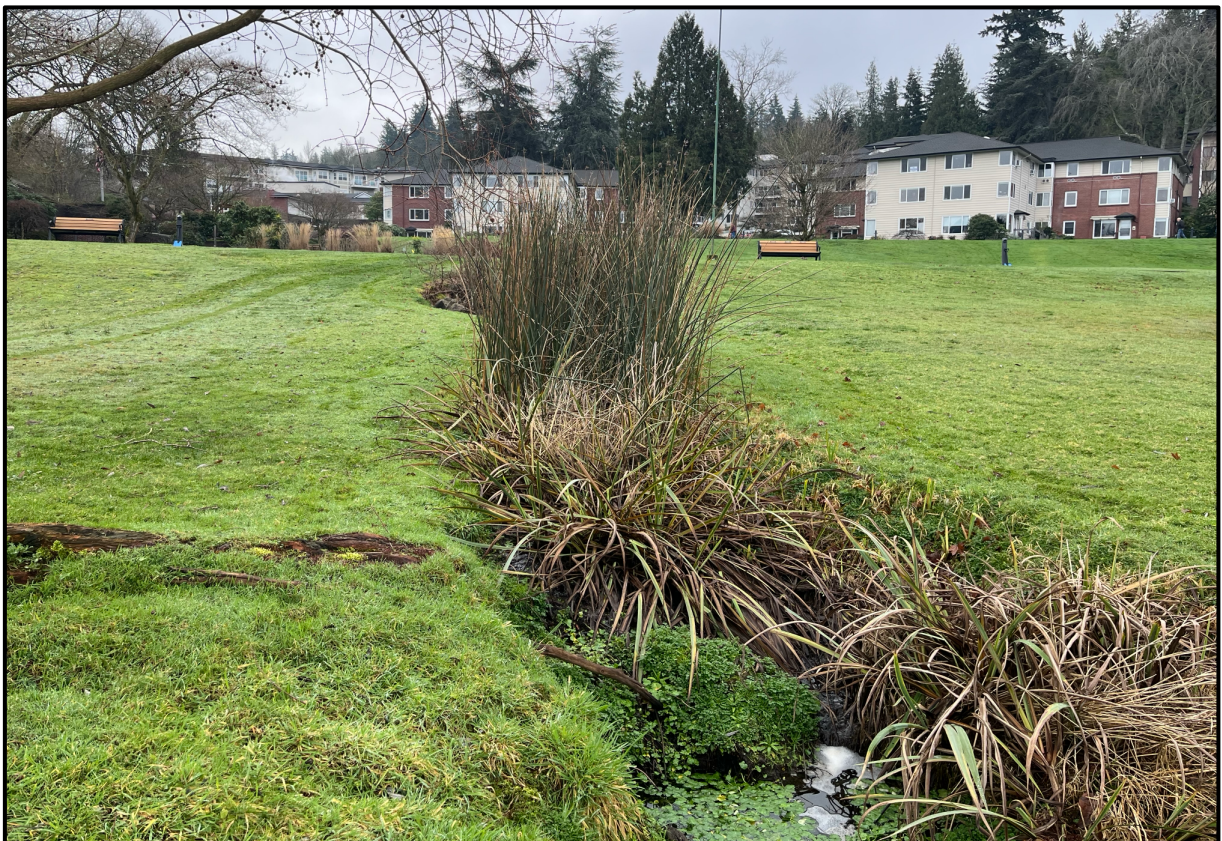
**Figure 7** - Looking South Towards Surface Drainage Network

Surface Drainage Network (SDN) is a City-owned open channel/pipe network within a private easement that outlets to Lake Washington between Wetland A and BPN1. Based on review of the site survey, the surface channel receives flows generated by the structures located at 9142, 9115, 9107, and 9105 Fortuna Drive via a privately owned network of buried pipes located entirely within the subject property. The pipe network daylights approximately 210 feet south of the lake. The network is depicted in Figure 1 above. The open channel is depicted in Figure 7 below.

Based on review of Mercer Island GIS Portal historic aerials, the SDN surface channel was constructed sometime between March 1992 and April 1999, which coincides with construction of the building labeled as 9107 Fortuna Drive. The surface channel became more prominent between April 1999 and Summer 2002, which coincides with construction of the building labeled 9115 Fortuna Drive.

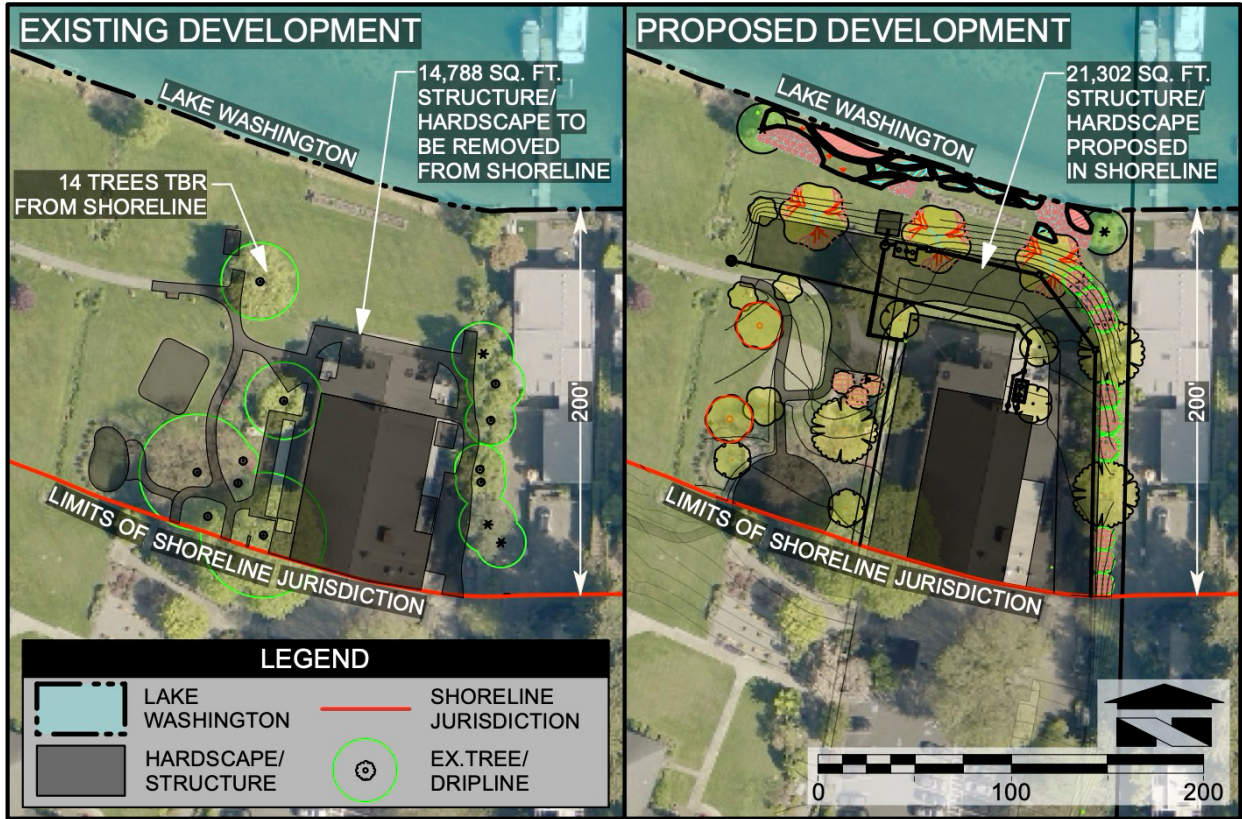
**Figure 11 - Existing Features and Proposed Development**

The project will re-configure the existing community center but will not alter the intensity of human land use. 6,514 square feet of hardscape and roof area will be added within 200 feet of the lake, which will replace existing grass and will result in the removal of 14 existing trees. New hardscape will be located closer to the lake but outside of the 25-foot shoreline setback. The outer 25 percent of the buffer associated with Wetland A will be slightly modified, which will result in a modest net increase in buffer area of three square feet and will provide protection to an existing deciduous tree. See Appendix D – Sheet 2/3.

The project will result in new woody shoreline planting totaling 3,780 square feet in close proximity to the shoreline. Removed trees will be replaced at a ratio of ~2:1 (29 new trees proposed).

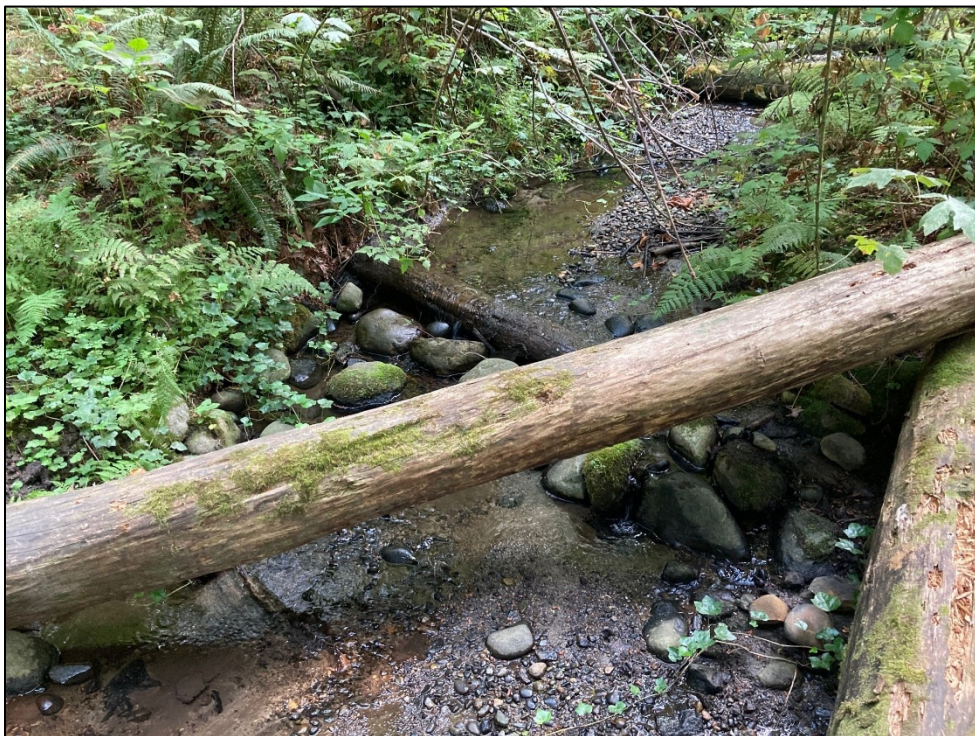
Figure 3: Watercourse A upstream of I-90. Note large size comparable to Drainage A (9/15/2022)

A simple comparison of the amount of flow contained in Watercourse A versus the amount contained in Drainage A is further evidence that the two features are not connected. As described above, Watercourse A averages six to eight feet in width, with an average of four inches of flow at the time of the inspections. Drainage A averages one foot in width and contained less than one inch of flow during the September 2022 inspection. Very low flow was confirmed in the stormwater catch basins on the subject property at the time of the September 2022 inspection, which is likely the source of the extremely low flows observed in the drainage channel at that time. Based on a combination of all these factors, it does not appear that Watercourse A and Drainage A are connected.

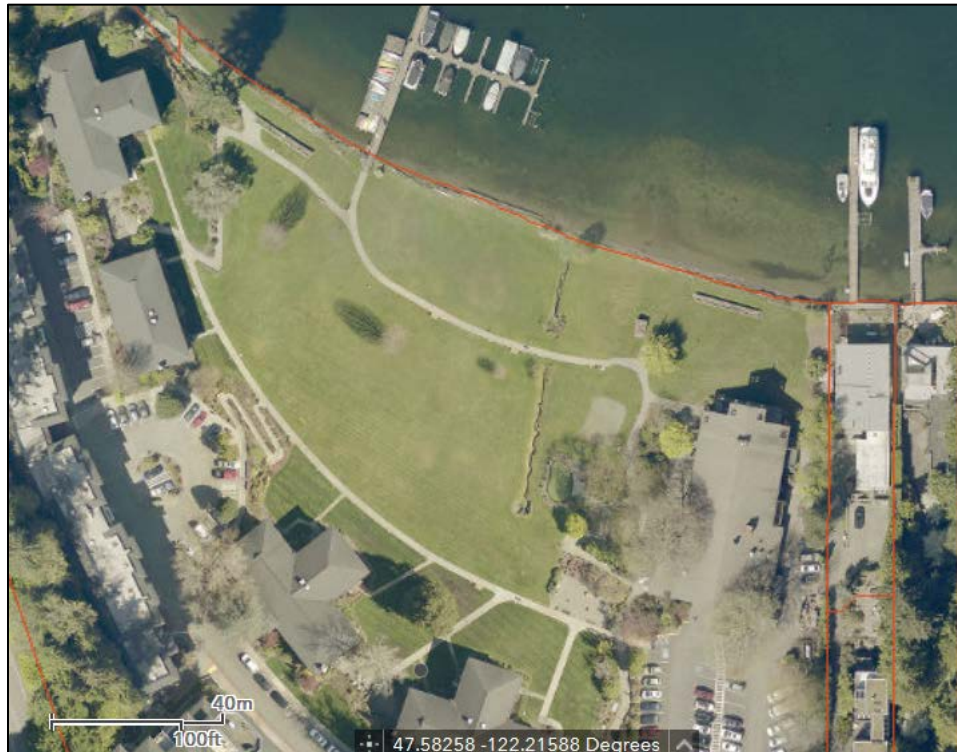
Figure 11: 2021 aerial photograph, channel present (source: King County iMap)

To ascertain whether a natural stream channel existed in the location of Drainage A, historically, a review of historic aerial photographs was conducted. The subject property has been generally cleared of woody vegetation since at least 1936, which allows for clear images of the property at that time. The 1936 aerial photograph clearly shows that no stream channel was present anywhere in the vicinity at that time (Figure 8). Similarly, the feature does not appear to be present in 1990 or 1998 aerial photographs (Figures 9 & 10). The earliest aerial photograph to clearly depict the drainage channel is from 2000 and is still visible currently (Figure 11).
