CRITICAL AREA STUDY & NO NET LOSS PLAN

COVENANT LIVING AT THE SHORES ***MERCER ISLAND, WA***

Wetland Resources, Inc. Project #24361

Revision 1: February 6, 2026

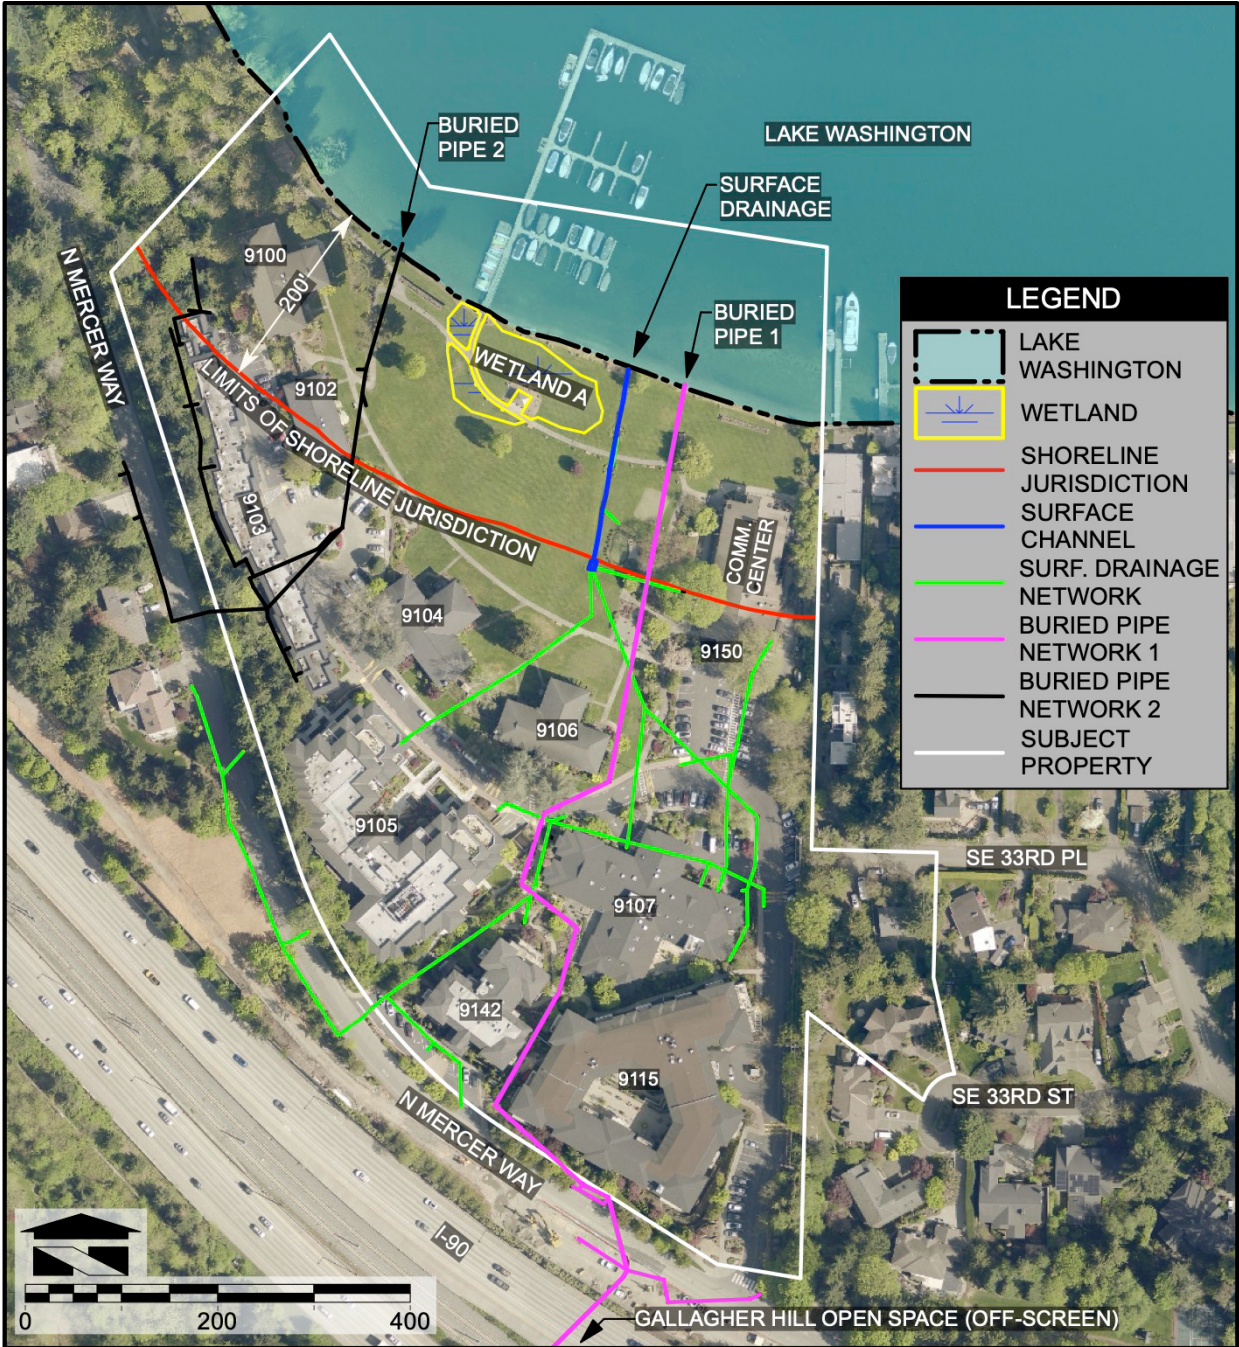
Figure 1 - Aerial Overview of Subject Property

Covenant Shores seeks to re-develop the community center at 9150 Fortuna Drive. The property is a retirement community known as Covenant Living at the Shores. Wetland Resources, Inc (WRI) was contracted to identify and evaluate wetlands, watercourses, and wildlife habitat conservation areas on and near the subject property, and to describe plan compliance with the Mercer Island City Code (MICC). Three regulated features were observed: Wetland A, Lake Washington, and Buried Pipe Network 1 (piped watercourse). Two unregulated drainage features were observed: Surface Drainage Network and Buried Pipe Network 2. See Figure 1.

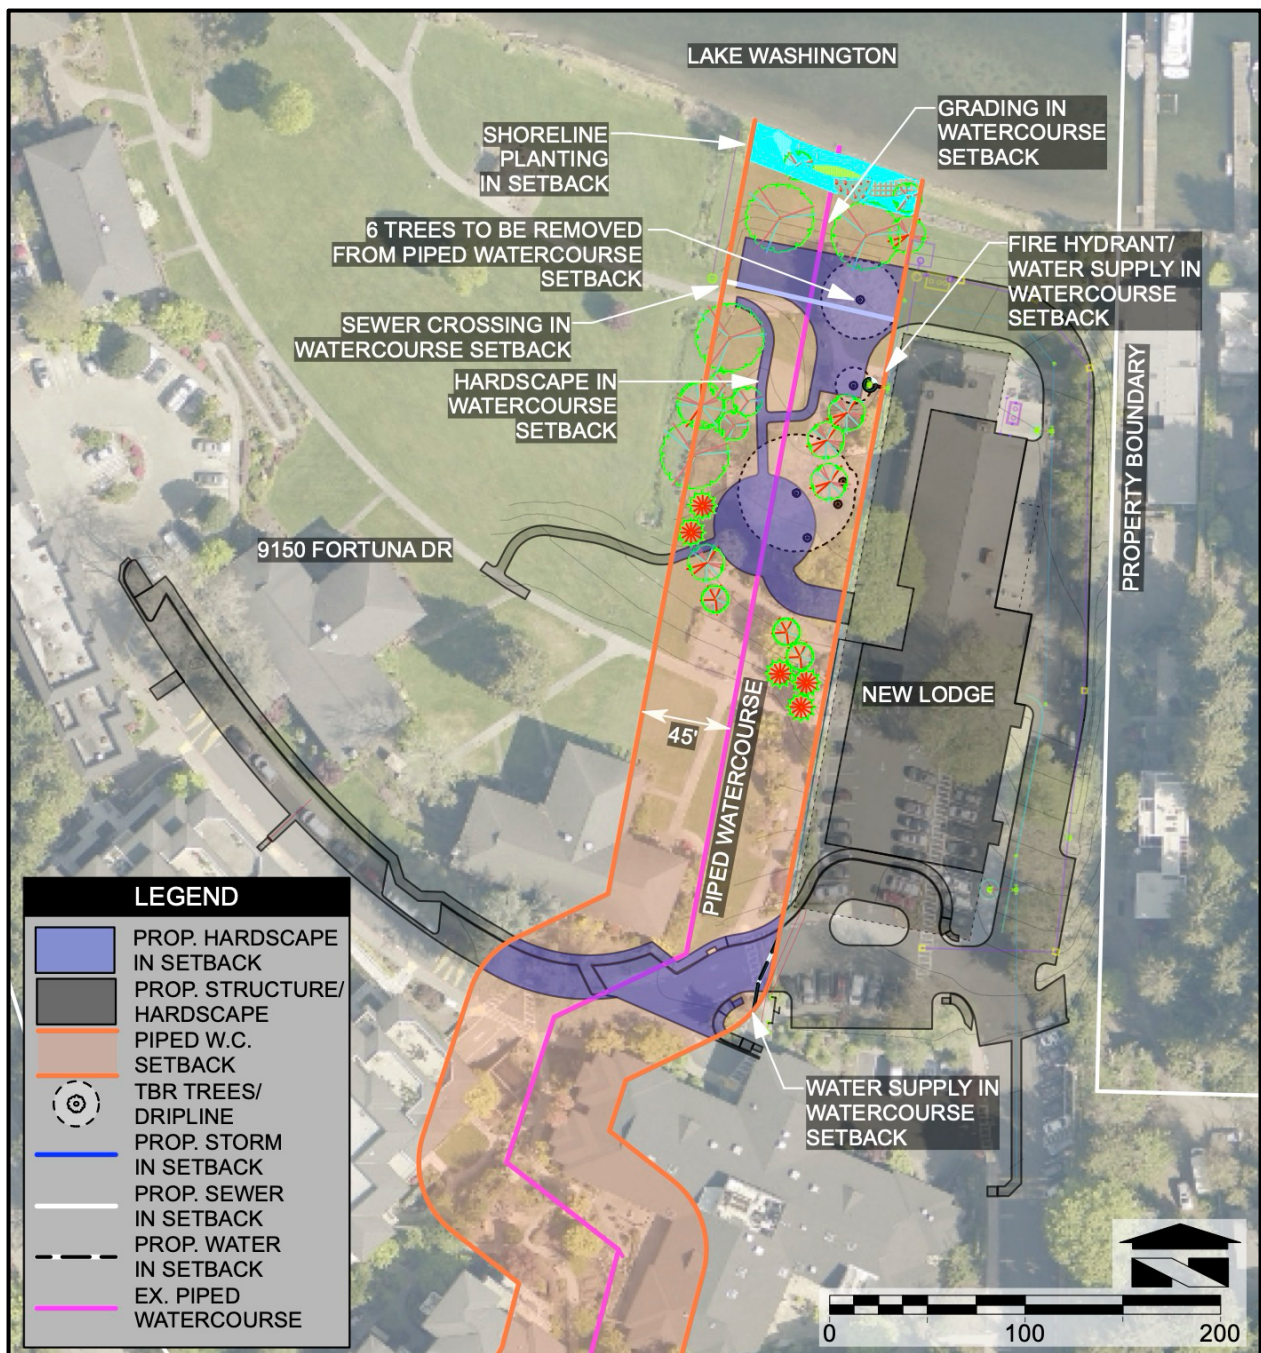
Figure 2 – Piped Watercourse Development Overview

The applicant is proposing to demolish the existing Fortuna Lodge structure, adjacent parking lot, walkways, and driveway areas to construct a new building in roughly the same location. See Figure 2. The project includes new parking and a new turnaround for emergency vehicle access. 32 trees will be removed throughout the site, and 93 replacement trees will be installed. Impact minimization measures (MICC 19.07.190.D.3) will be implemented to reduce the 100-foot Shoreline Master Program (SMP) wetland buffer to 40 feet.

Grading and hardscape are allowed in the watercourse setback pursuant to MICC 19.07.180.C.8. Reconstruction of legal nonconforming utilities is allowed in the watercourse setback pursuant to MICC 19.07.130.A.3. See Appendix D – Sheet 3/3. See also Figure 2.

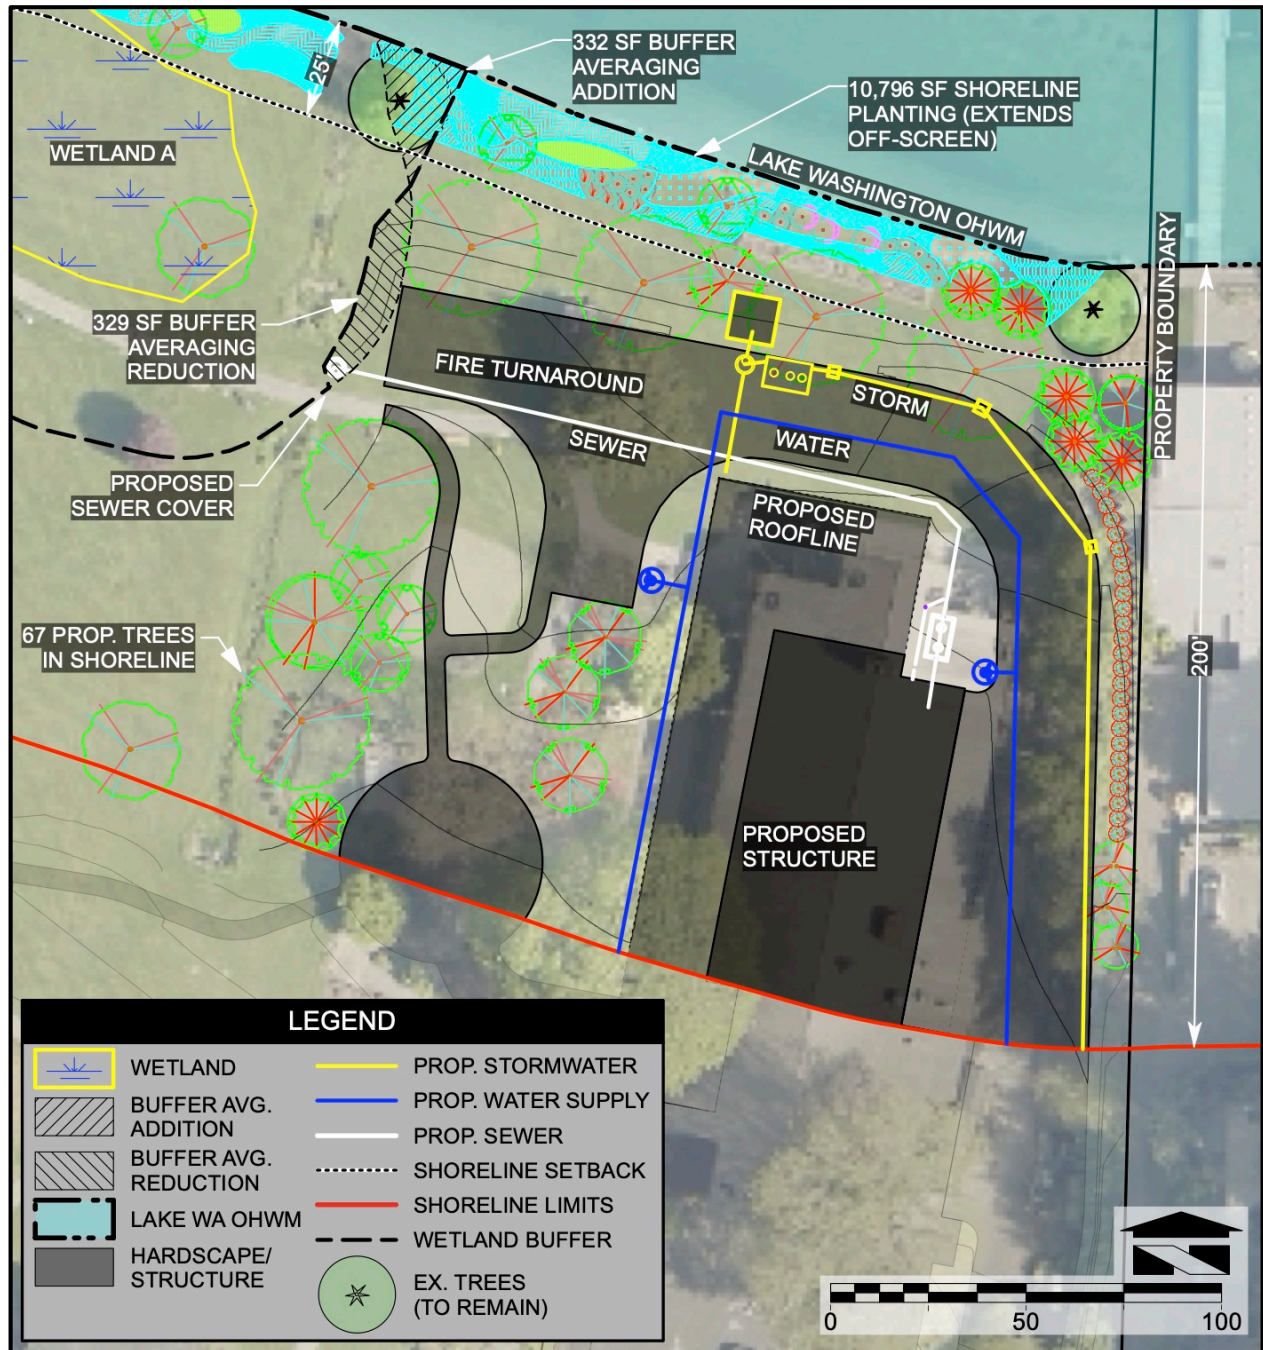
Figure 3 - Shoreline Development and Buffer Averaging Overview

Wetland buffer width averaging will be used to remove grading and new utilities from the wetland buffer in accordance with MICC 19.07.190.C.5. See Figure 3. See also Appendix D – Sheet 2/3.

The following shoreline alterations are proposed. See Figure 3 and Appendix D – Sheet 2/3

- Removal of 15 trees within 200 feet of Lake Washington
- 21,473 square feet of new hardscape/structure within 200 feet of Lake Washington (6,685 square-foot net increase)
- 35,479 square feet of new grading
- 373 lineal feet of new water line and two new fire hydrants
- 212 lineal feet of new sewer pipe and one sewer cover
- 269 lineal feet of new storm pipe, one storm cover, one storm outfall, and three catch basins

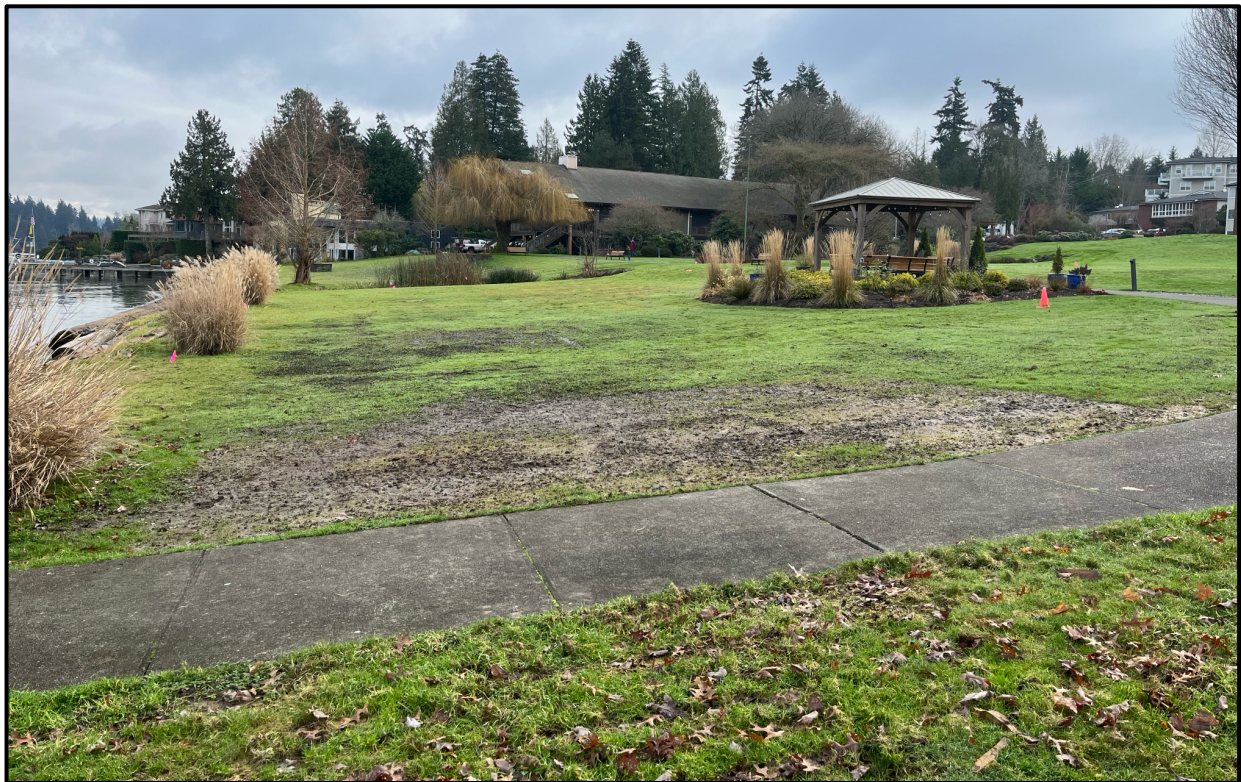
Figure 4 - Looking Southeast Towards Wetland A

Wetland A is a Category IV wetland located in the northern section of the property. The wetland unit does not connect to the Lake Washington OHWM. Wetland A has an emergent Cowardin class with a saturated hydroperiod. Vegetation is comprised of unidentified lawn grasses, creeping buttercup (*Ranunculus repens*, FAC), clover (*Trifolium spp.*), bird's-foot trefoil (*Lotus corniculatus*, FAC) American brooklime (*Veronica americana*, OBL), and yellow flag iris (*Iris pseudacorus*, OBL).

Soils within Wetland A are very dark brown (10YR 2/2) loamy sand from zero to four inches below the soil surface. From four to ten inches, soils are very dark gray (2.5Y3/1) loamy sand with three percent yellowish red (5YR4/6) redoximorphic features. From ten to twelve inches, soils are dark gray (2.5Y/4/1) sand. These soil characteristics meet the Redox Dark Surface (F6) hydric soil indicator. During the January 2025 site visit, soils met the following primary hydrology indicators: Saturation (seven inches below the mineral soil surface) and High Water Table (ten inches below the mineral soil surface). Wetland A received an overall wetland rating score of 14 points with a habitat score of four points. Category IV wetlands require a 40-foot critical area buffer and a 100-foot SMP buffer. Because Wetland A is greater than 1,000 square feet in total area, it requires an additional 10-foot building setback.

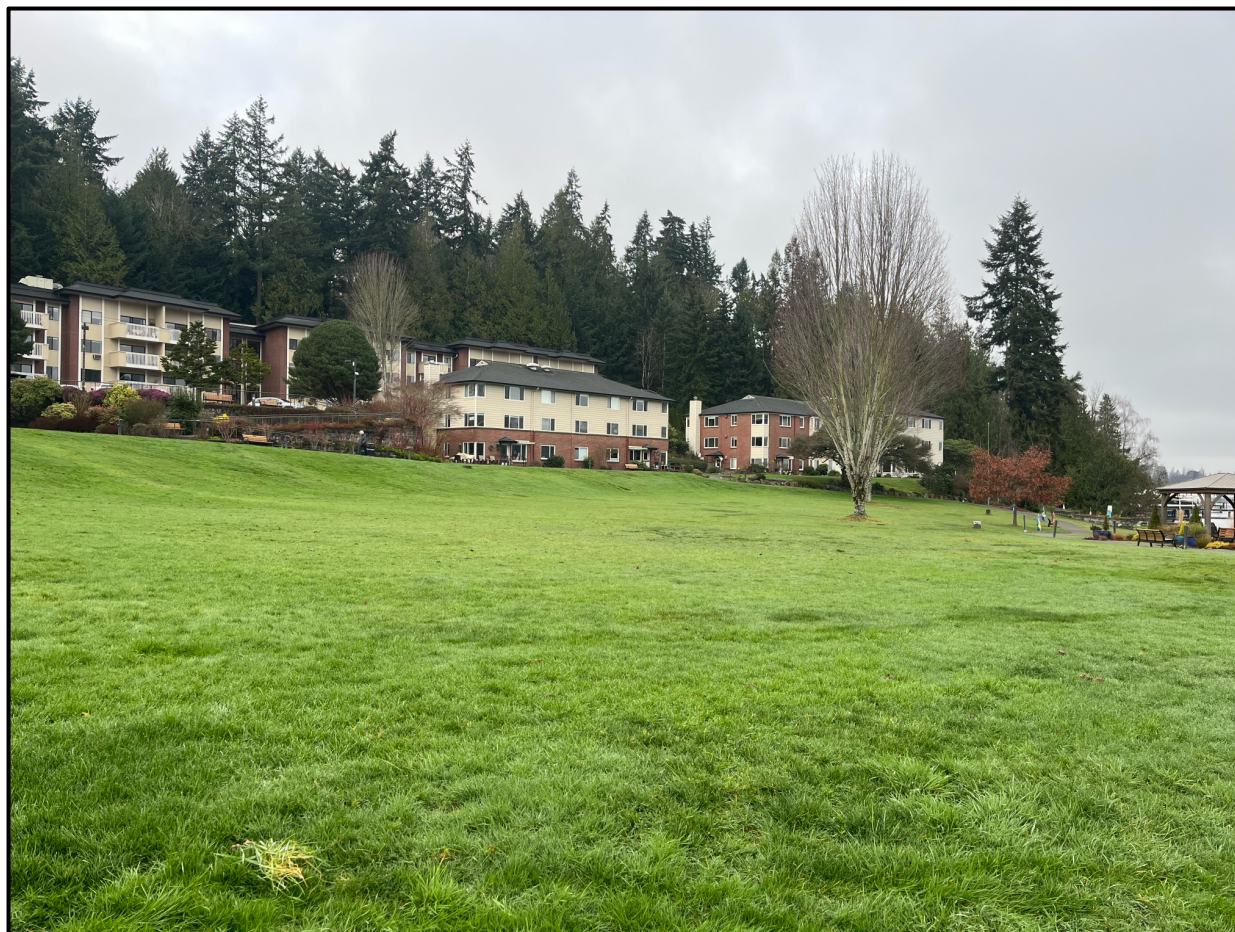
Figure 5 - Looking Northwest Towards On-Site Residential Structures

Vegetation in upland areas consists of ornamental species and lawn grasses across most of the property. There is a forested patch along the northwestern and western property boundary. Dominant vegetation communities within non-wetland areas are facultative upland (FACU).

The soils just outside of Wetland A are generally dark grayish brown (10YR4/2) loamy sand with dark yellowish brown redoximorphic features from zero to eight inches below the soil surface. From eight to twelve inches, soils are generally dark grayish brown (2.5Y4/2) with gray (2.5Y5/1) and dark yellowish brown (10YR3/6) components. No hydrology indicators were observed in these areas during the January 2025 site visit. Therefore, these areas do not meet wetland criteria.

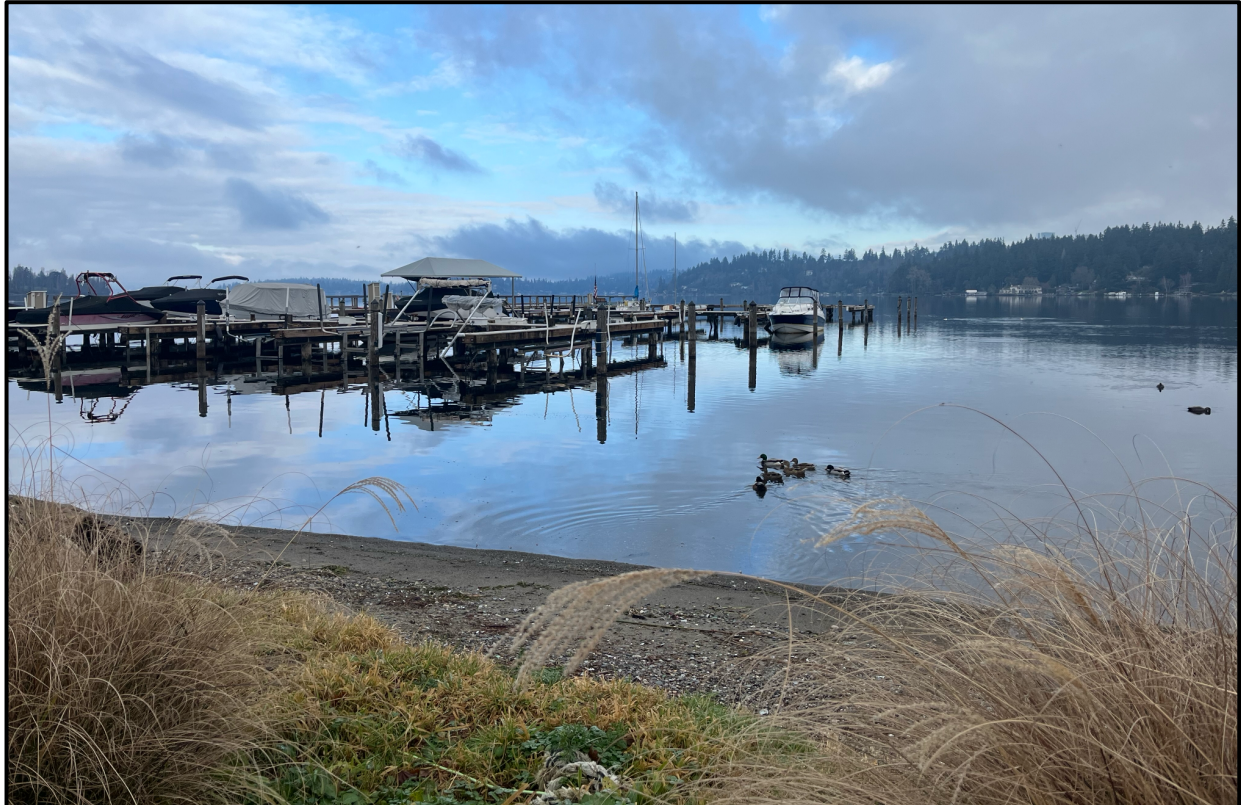
Figure 6 - Looking North Towards Lake Washington.

Lake Washington is regulated as a Shoreline of Statewide Significance. Pursuant to MICC 19.13.050, Lake Washington requires a 25-foot setback to be measured landward from the OHWM. Lake Washington provides habitat for several federally listed species including Chinook salmon, steelhead trout, and bull trout.

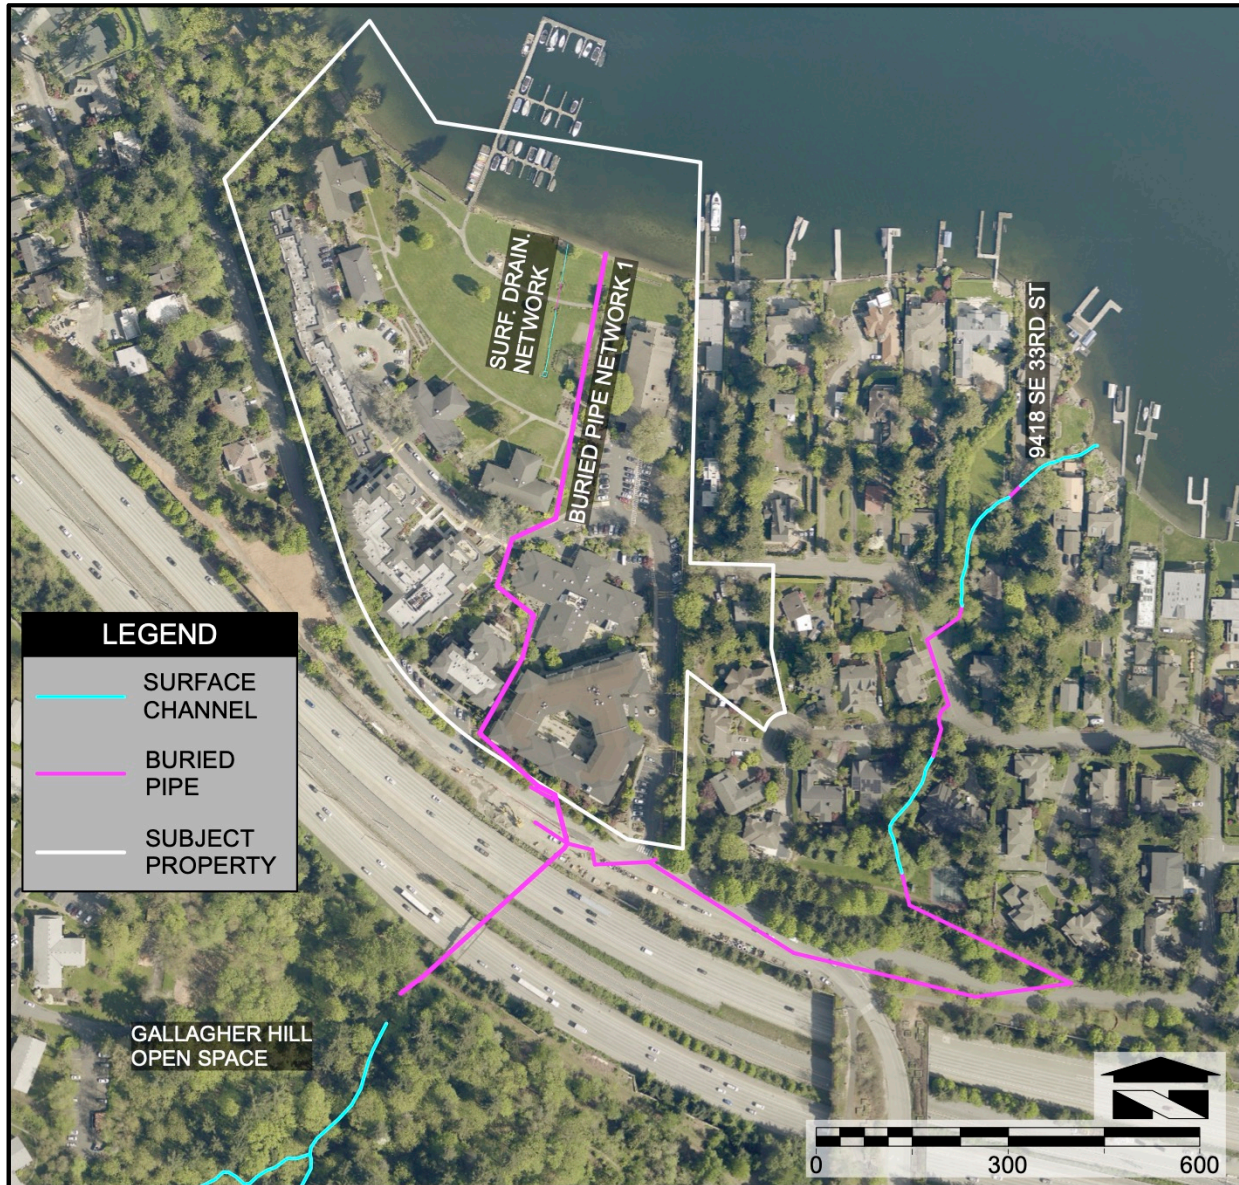
Figure 7 - Buried Pipe Network 1 and Historic Route

Buried Pipe Network 1 (BPN1) is a City-owned 18-inch concrete pipe that outlets to Lake Washington within the subject property. Based on review of the site survey, BPN1 conveys some portion of the surface channel that is mapped within Gallagher Open Space (south of I-90). This finding conflicts with the City's *Storm Utilities* GIS layer, which depicts the surface channel within Gallagher Open Space draining via the Surface Drainage Network described in Figure 1 in this report.

Figure 7 below provides a more accurate depiction of existing public stormwater infrastructure based on the site survey and the findings presented in a document prepared by The Watershed Company titled Drainage Feature Evaluation. The Drainage Feature Evaluation is provided as Appendix A. The report finds that flows originating in Gallagher Open Space are conveyed northeast along a historic path that flows to Lake Washington in the vicinity of 9418 SE 33rd Street.

MICC 19.16.010.W provides the definition of a regulated watercourse. The definition excludes “storm water runoff devices,” except where they “convey waters that were naturally occurring prior to construction.” Based on review of historic aerials dating back as far as 1936 and the findings of the Drainage Feature Evaluation, no naturally occurring surface channel was ever present within the subject property. However, BPN1 may still be considered a regulated watercourse simply because some portion of the flows conveyed to Lake Washington through BPN1 originated in a naturally occurring channel in Gallagher Open Space, which existed prior to construction of BPN1.

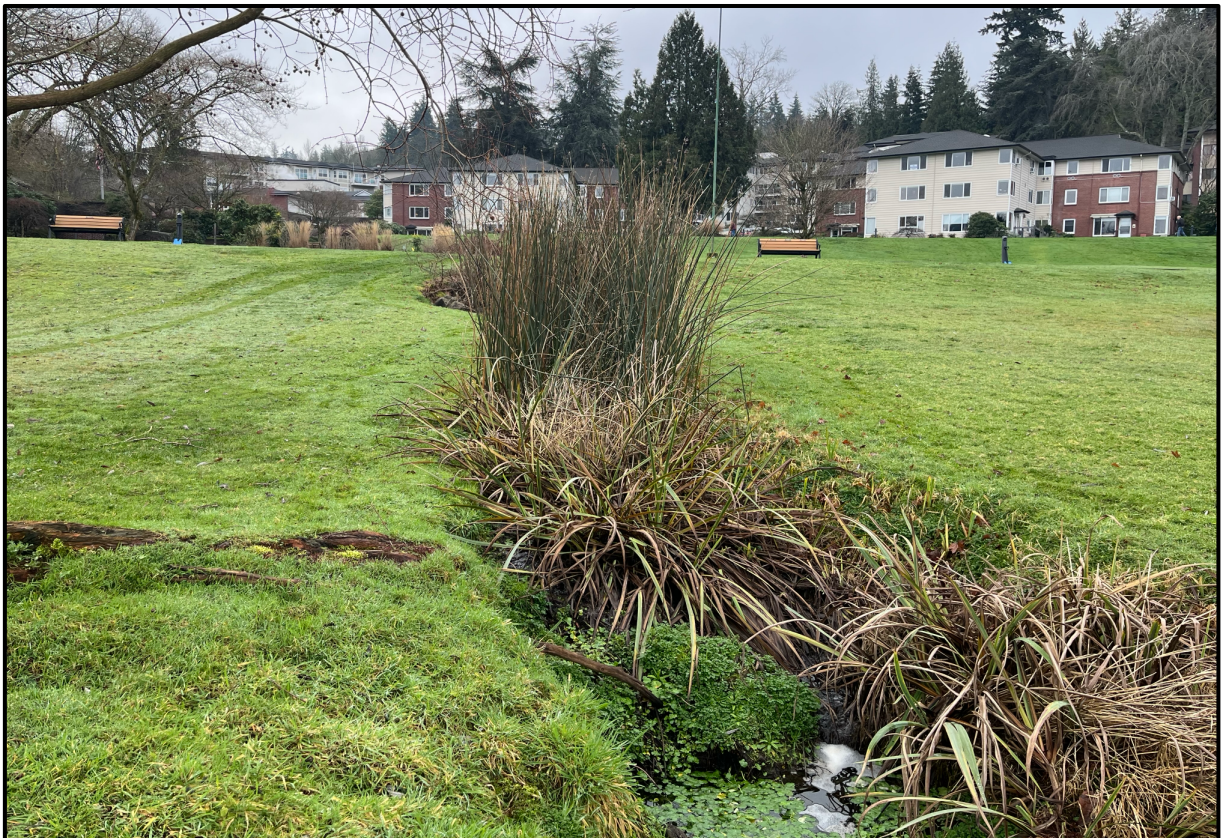
Figure 8 - Looking South Towards Surface Drainage Network

Surface Drainage Network (SDN) is a City-owned open channel/pipe network within a private easement that outlets to Lake Washington between Wetland A and BPN1. Based on review of the site survey, the surface channel receives flows generated by the structures located at 9142, 9115, 9107, and 9105 Fortuna Drive via a privately owned network of buried pipes located entirely within the subject property. The pipe network daylights approximately 210 feet south of the lake. The network is depicted in Figure 1 above. The open channel is depicted in Figure 8 below.

Based on review of Mercer Island GIS Portal historic aerials, the SDN surface channel was constructed sometime between March 1992 and April 1999, which coincides with construction of the building labeled as 9107 Fortuna Drive. The surface channel became more prominent between April 1999 and Summer 2002, which coincides with construction of the building labeled 9115 Fortuna Drive.

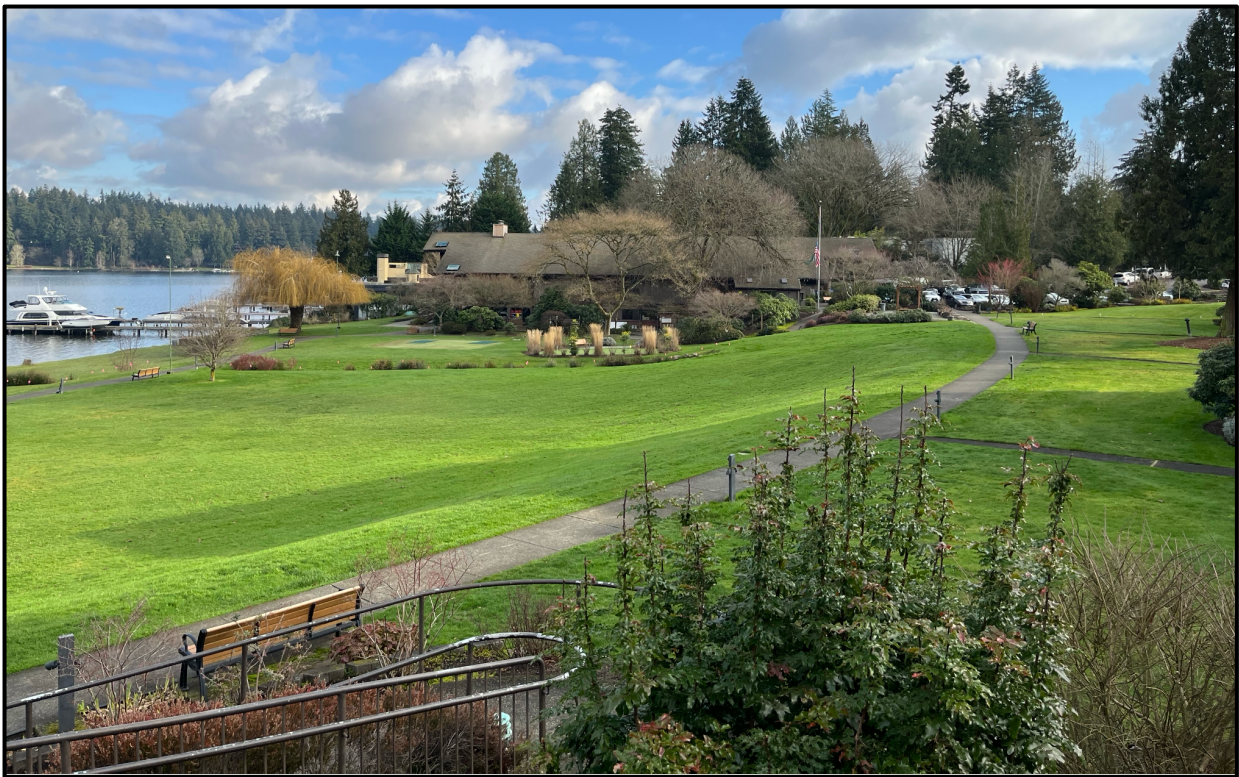
Figure 9 - Looking East Across the Property

The majority of the property is developed as a residential retirement community. Site development includes multiple residential buildings, a health center, community space, gardens, green spaces, and parking areas. These areas are comprised of structures, hardscape, maintained lawn, and ornamental gardens. See Figure 9 below.

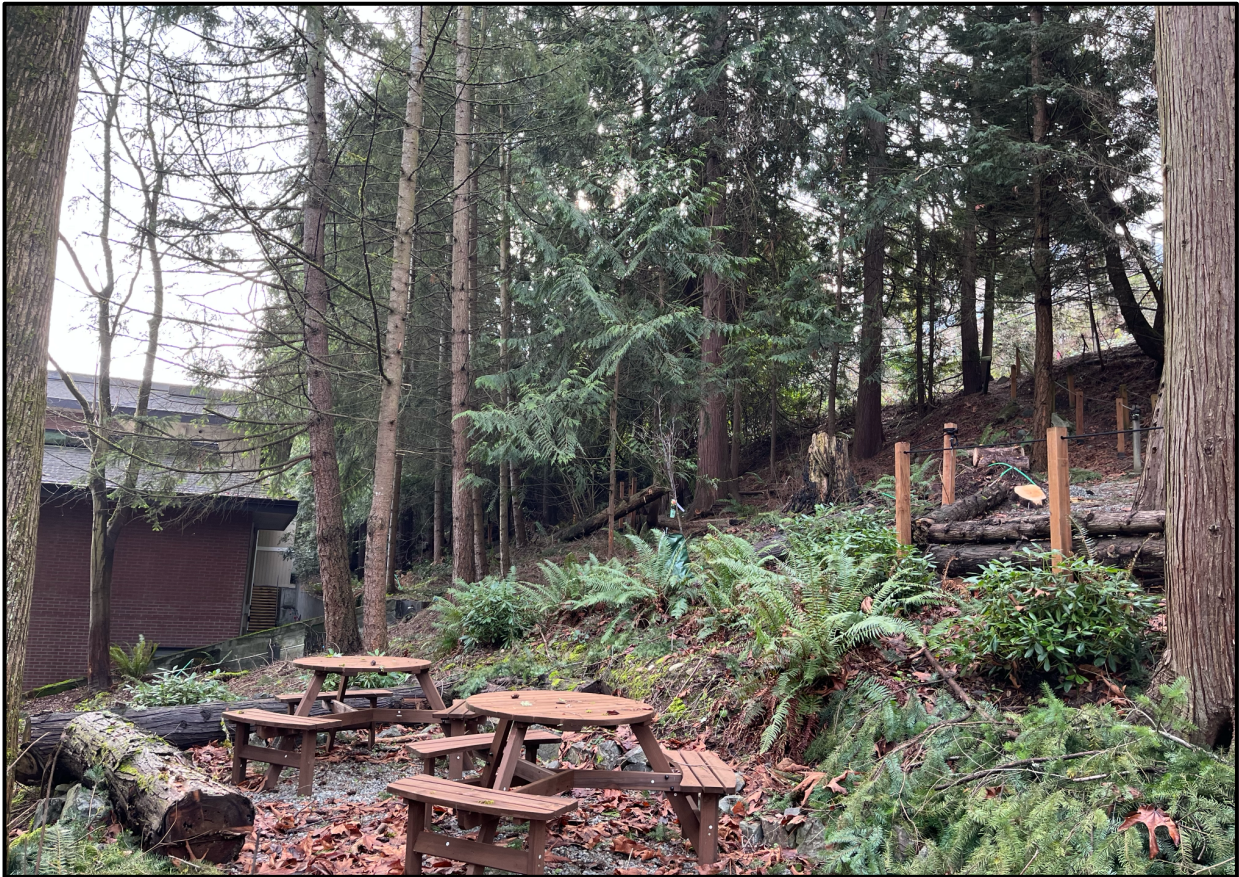
Figure 10 - Looking Southeast from the West Property Line

In the northwestern corner and along the western boundary of the property, there is a forested area with walking paths and picnic tables. See Figure 10 below. This area is comprised of Douglas fir (*Pseudotsuga menziesii*), western red cedar (*Thuja plicata*), bigleaf maple (*Acer macrophyllum*), Pacific madrone (*Arbutus menziesii*), Pacific dogwood (*Cornus nuttallii*), English laurel (*Prunus laurocerasus*), evergreen huckleberry (*Vaccinium ovatum*), English holly (*Ilex aquifolium*), low Oregon grape (*Mahonia nervosa*), English ivy (*Hedera helix*), salal (*Gaultheria shallon*), common sword fern (*Polystichum munitum*), and trailing blackberry (*Rubus ursinus*). One large snag and one tree with woodpecker activity were observed in this area.

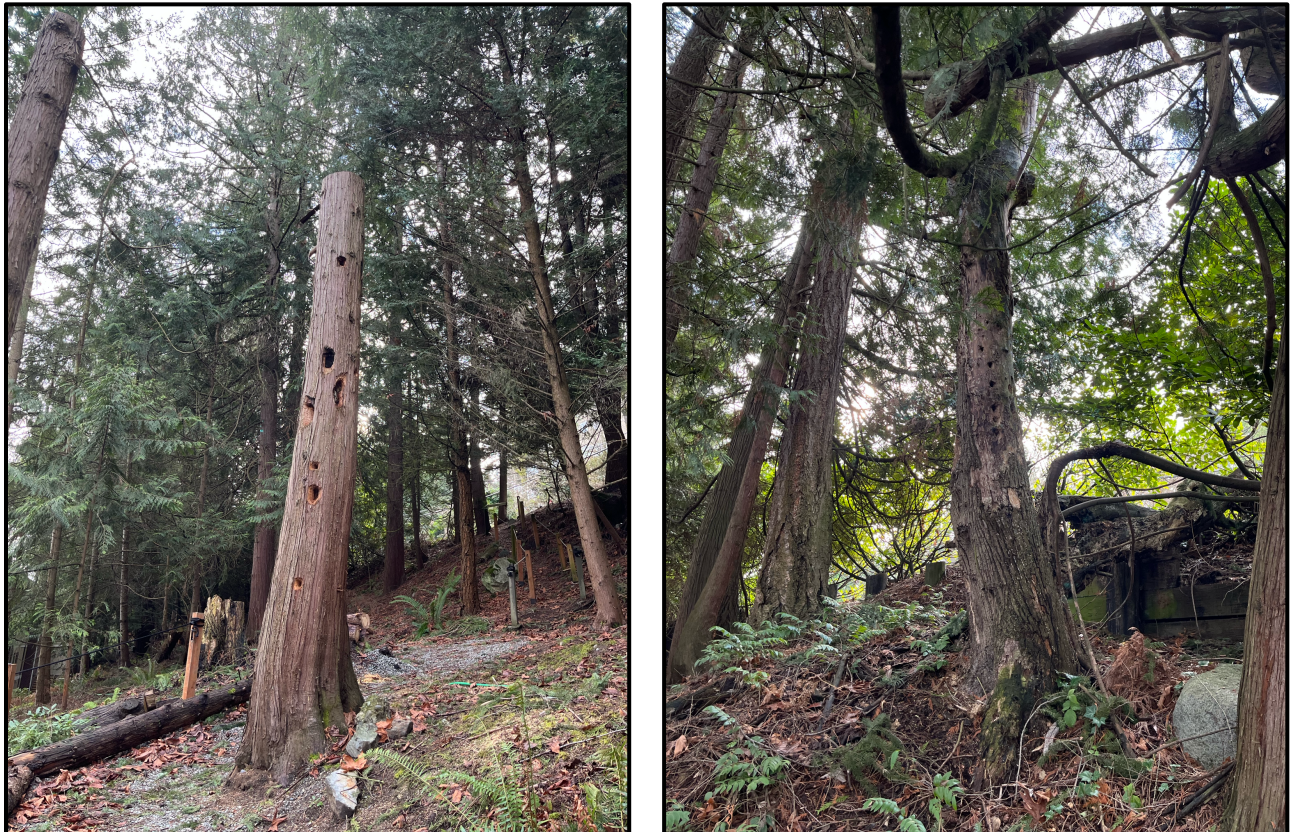
Figure 11 - Pileated Woodpecker Feeding Excavations

Avian species directly observed on site include Pacific Wren (*Troglodytes pacificus*), Song Sparrow (*Melospiza melodia*), Cormorant (*Phalacrocorax Carbo*), Gadwall (*Mareca strepera*), Townsend's Warbler (*Setophaga townsendi*), Anna's Hummingbird (*Calypte anna*), House Finch (*Haemorhous mexicanus*), American Crow (*Corvus brachyrhynchos*), Bald Eagle (*Haliaeetus leucocephalus*), American Wigeon (*Mareca americana*), Pine Siskin (*Spinus pinus*), Brown Creeper (*Certhia americana*), Pied-billed Grebe (*Podilymbus podiceps*), Mallard (*Anas platyrhynchos*), Common Merganser (*Mergus merganser*), American Goldfinch (*Spinus tristis*), Black-capped Chickadee (*Poecile atricapillus*), American Robin (*Turdus migratorius*), Dark-eyed Junco (*Junco hyemalis*), Golden-crowned Kinglet (*Regulus satrapa*), Northern Flicker (*Colaptes auratus*), and Red-breasted Nuthatch (*Sitta canadensis*). Indirect avian observations included Pileated Woodpecker (*Dryocopus pileatus*) feeding excavations on a snag and additional feeding signs on a tree most likely attributed to Hairy Woodpecker (*Dryobates villosus*) or Downy Woodpecker (*Dryobates pubescens*).

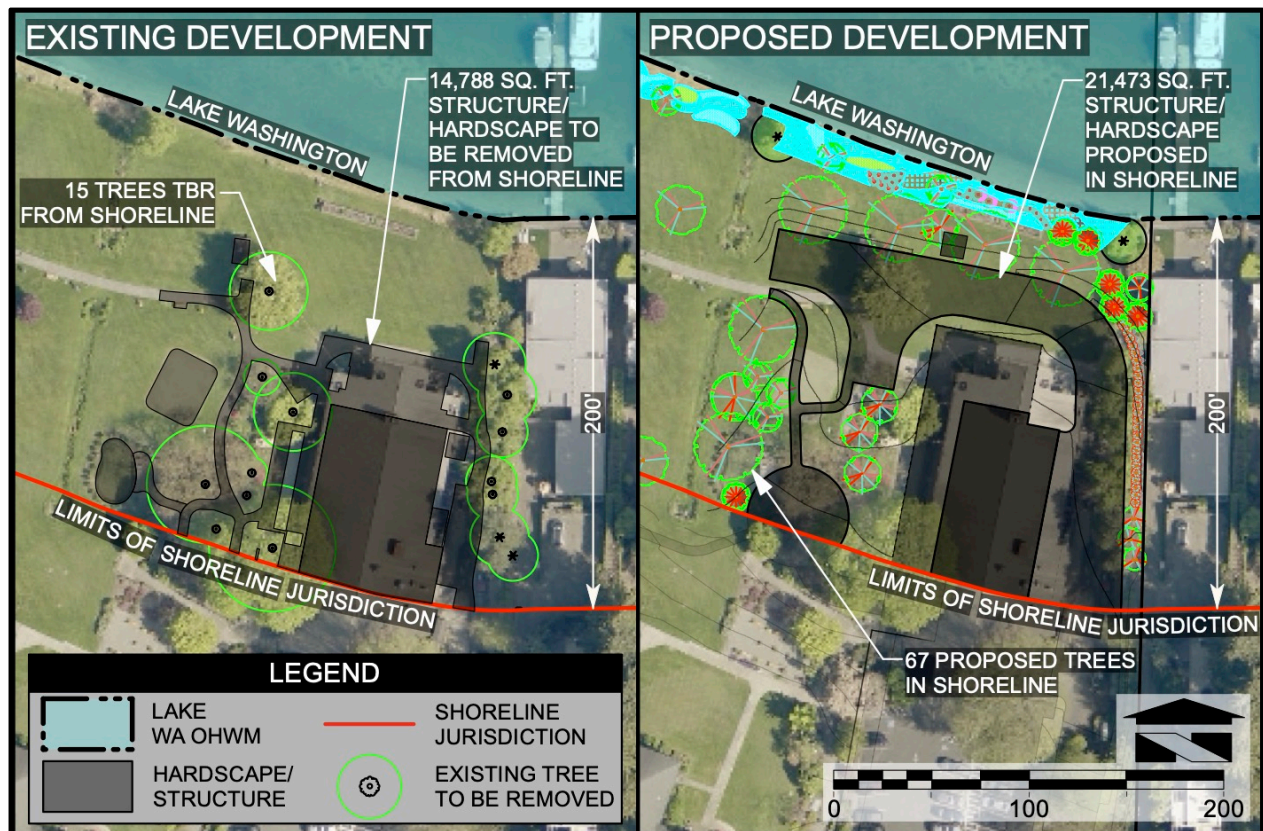
Figure 12 - Existing Features and Proposed Development

The project will re-configure the existing community center but will not alter the intensity of human land use. 6,685 square feet of new hardscape and roof area will be added within 200 feet of the lake (14,788 square feet of structure/hardscape to be removed and 21,473 square feet proposed), which will displace existing grass lawn and will result in the removal of 15 existing trees.

New hardscape will be located closer to the lake but still outside of the 25-foot shoreline setback. The outer 25 percent of the buffer associated with Wetland A will be slightly modified, which will result in a modest net increase in buffer area of three square feet and will provide protection to an existing deciduous tree.

The project will result in new shoreline planting totaling 10,796 square feet in close proximity to the shoreline. 15 trees will be removed from within shoreline jurisdiction and 67 trees will be installed.

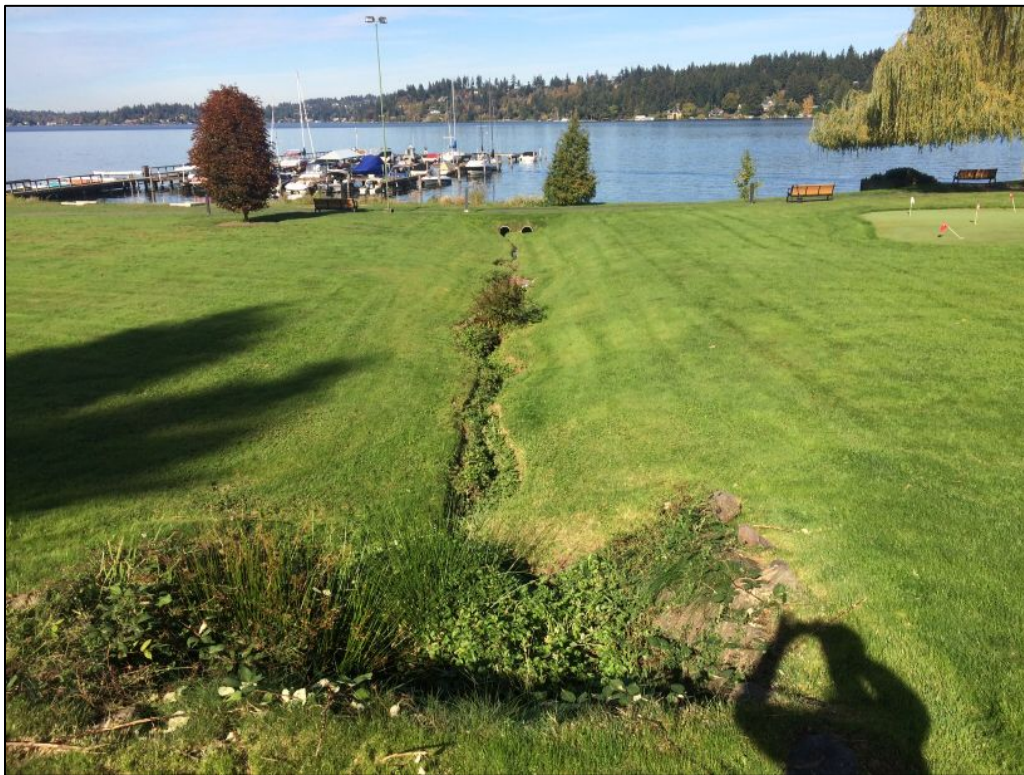
Figure 1: Drainage A facing north (downstream) (10/2016)

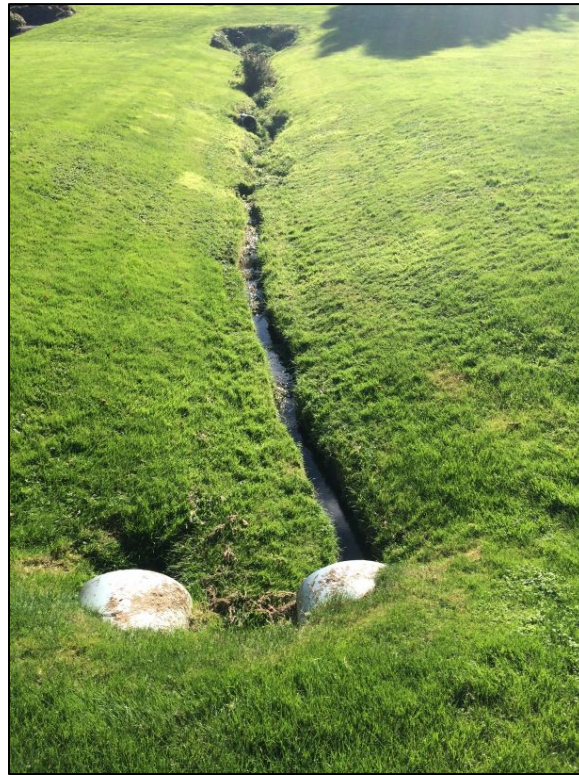
Figure 2: Drainage A facing south (upstream). Note small size (less than one foot) (10/2016)

A simple comparison of the amount of flow contained in Watercourse A versus the amount contained in Drainage A is further evidence that the two features are not connected. As described above, Watercourse A averages six to eight feet in width, with an average of four inches of flow at the time of the inspections. Drainage A averages one foot in width and contained less than one inch of flow during the September 2022 inspection. Very low flow was confirmed in the stormwater catch basins on the subject property at the time of the September 2022 inspection, which is likely the source of the extremely low flows observed in the drainage channel at that time. Based on a combination of all these factors, it does not appear that Watercourse A and Drainage A are connected.

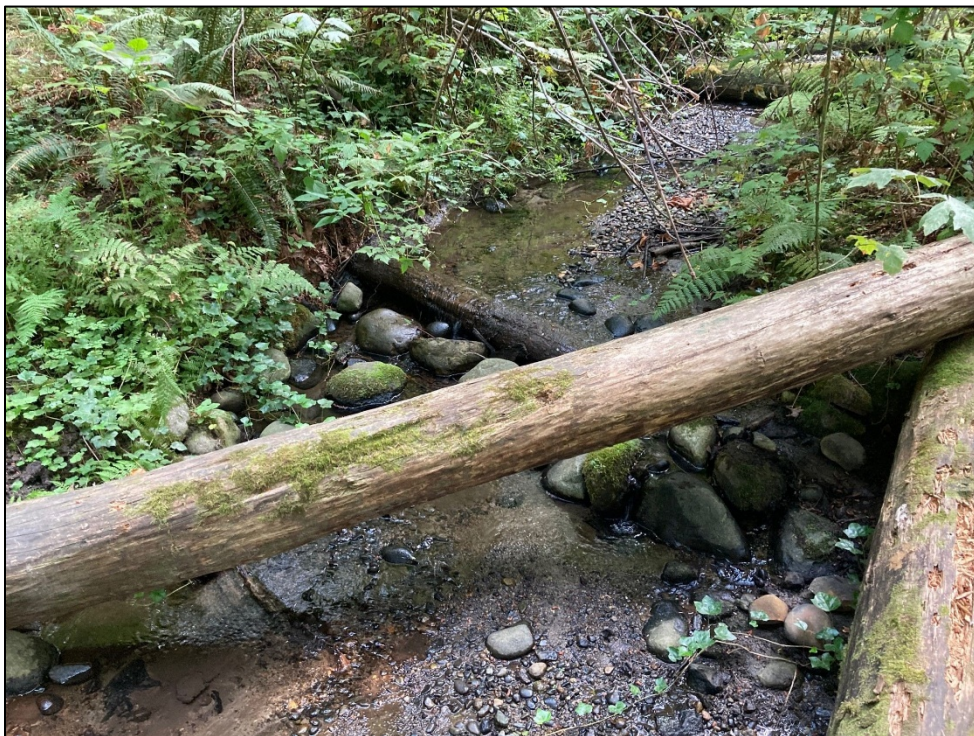
Figure 3: Watercourse A upstream of I-90. Note large size comparable to Drainage A (9/15/2022)

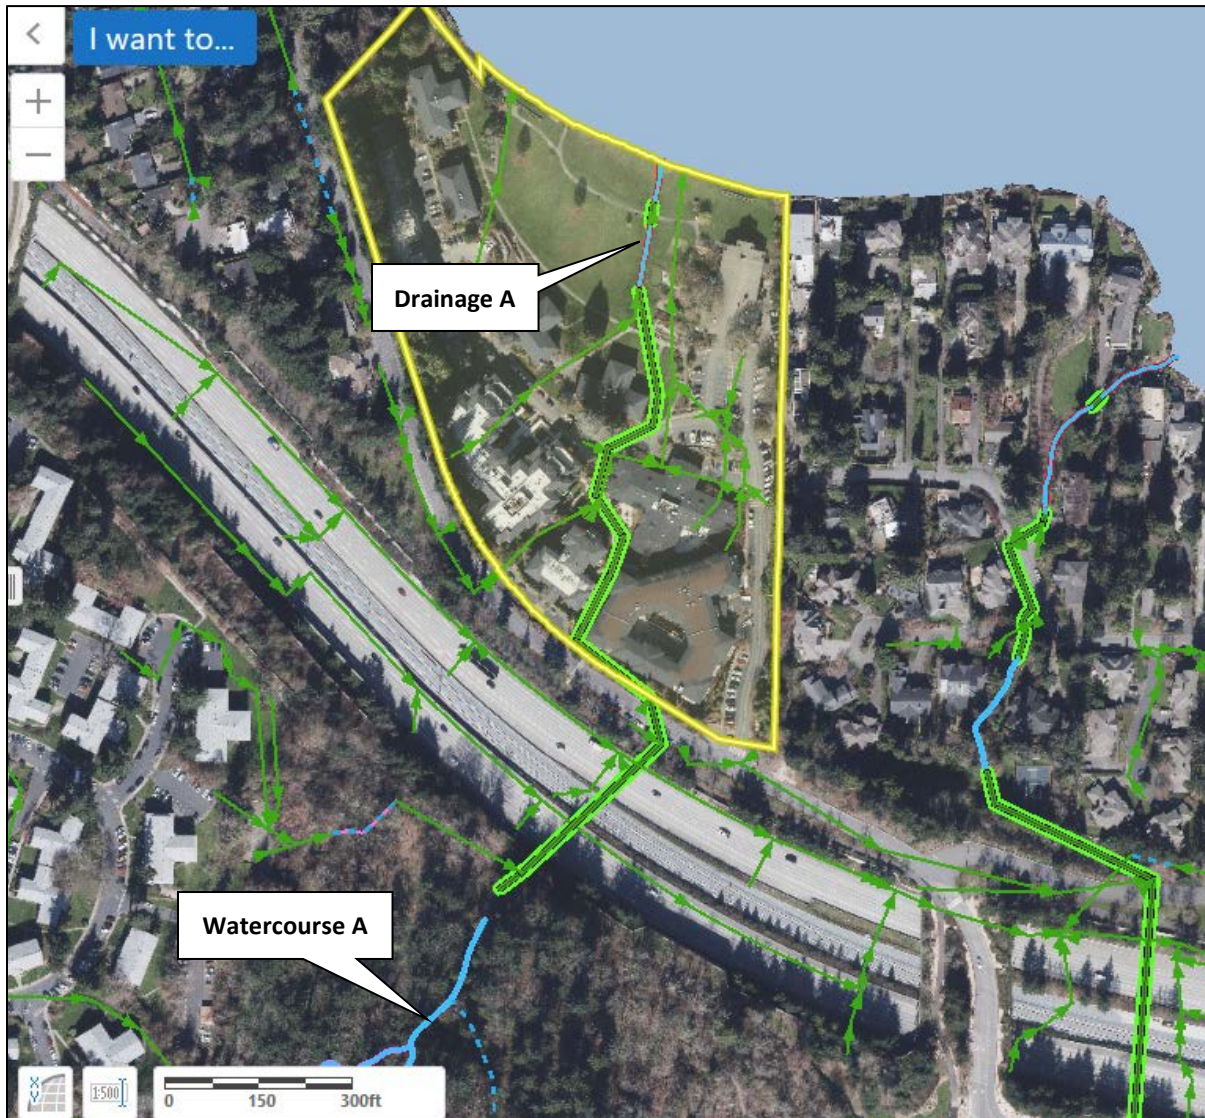
Figure 4: GIS Portal watercourse and stormwater mapping showing Watercourse A flowing north into Drainage A. Note extensive drainage network conveyed into the piped sections above Drainage A.

According to the City's GIS Portal, Drainage A is identified as a Type F watercourse, with a 100-foot buffer. GIS Portal's storm utility map shows a Type Np watercourse (Watercourse A) entering a pipe just south of Interstate 90 (I-90) on parcel #0724059117. This area was evaluated during the October 2016 and September 2022 inspections. The location of Watercourse A is confirmed south of I-90 (Figure 3). Watercourse A averages approximately six to eight feet in width and contained approximately four inches of flow, on average, at the time of the inspections. Watercourse A enters a vertical culvert approximately four feet in diameter just south of I-90. Per GIS Portal, the pipe conveys the watercourse flow northeast beneath I-90 then north beneath N. Mercer Way. Multiple stormwater drainage lines from north and south of I-90 are mapped as discharging into the piped segments and directly into Drainage A. The entire piped system is mapped as daylighting at the origin point of Watercourse A (Figure 4). This evidence suggests that Drainage A is the downstream segment of a natural watercourse feature (Watercourse A) that is piped for approximately 1,100 feet before daylighting on the subject property and supplemented by stormwater. Under such a scenario, the drainage feature would be regulated as a watercourse under the Mercer Island Municipal Code (MIMC). However, further investigation indicates that the stormwater mapping shown on GIS Portal is incorrect.

None of the other public inventories reviewed (aside from GIS Portal) depict Watercourse A as being redirected towards the north beneath N. Mercer Way towards Drainage A. Instead, these resources depict the piped segment of Watercourse A as continuing towards the northeast beyond I-90 and connecting with an open stream channel approximately 900 feet southeast of Drainage A (Figures 5, 6, & 7). This stream segment was visually confirmed near the intersection of SE 33rd Place and 94th Avenue SE.
