CRITICAL AREA STUDY & NO NET LOSS PLAN

COVENANT LIVING AT THE SHORES ***MERCER ISLAND, WA***

Wetland Resources, Inc. Project #24361

Revision 1: February 6, 2026

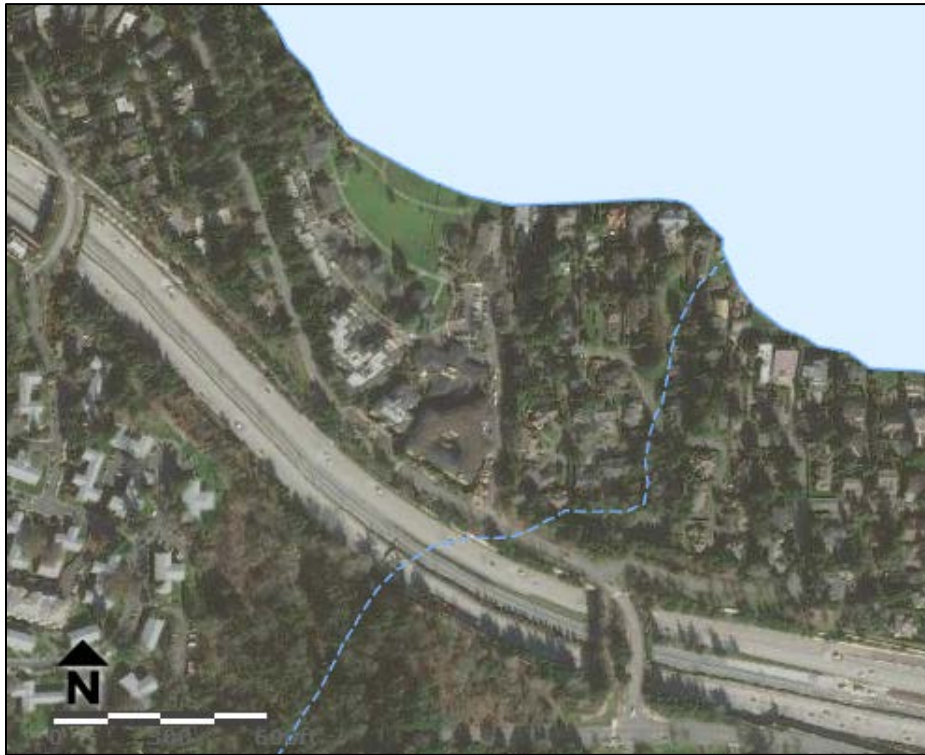
Figure 7: WDFW SalmonScape mapping showing Watercourse A directed east of the subject property

None of the other public inventories reviewed (aside from GIS Portal) depict Watercourse A as being redirected towards the north beneath N. Mercer Way towards Drainage A. Instead, these resources depict the piped segment of Watercourse A as continuing towards the northeast beyond I-90 and connecting with an open stream channel approximately 900 feet southeast of Drainage A (Figures 5, 6, & 7). This stream segment was visually confirmed near the intersection of SE 33rd Place and 94th Avenue SE.

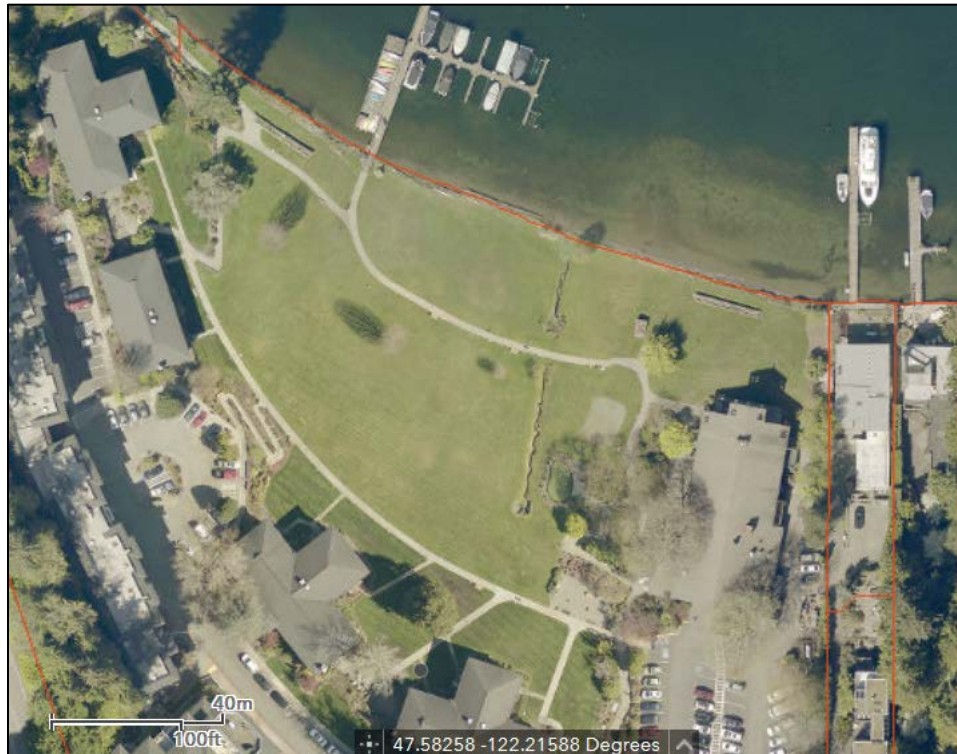
Figure 11: 2021 aerial photograph, channel present (source: King County iMap)

To ascertain whether a natural stream channel existed in the location of Drainage A, historically, a review of historic aerial photographs was conducted. The subject property has been generally cleared of woody vegetation since at least 1936, which allows for clear images of the property at that time. The 1936 aerial photograph clearly shows that no stream channel was present anywhere in the vicinity at that time (Figure 8). Similarly, the feature does not appear to be present in 1990 or 1998 aerial photographs (Figures 9 & 10). The earliest aerial photograph to clearly depict the drainage channel is from 2000 and is still visible currently (Figure 11).

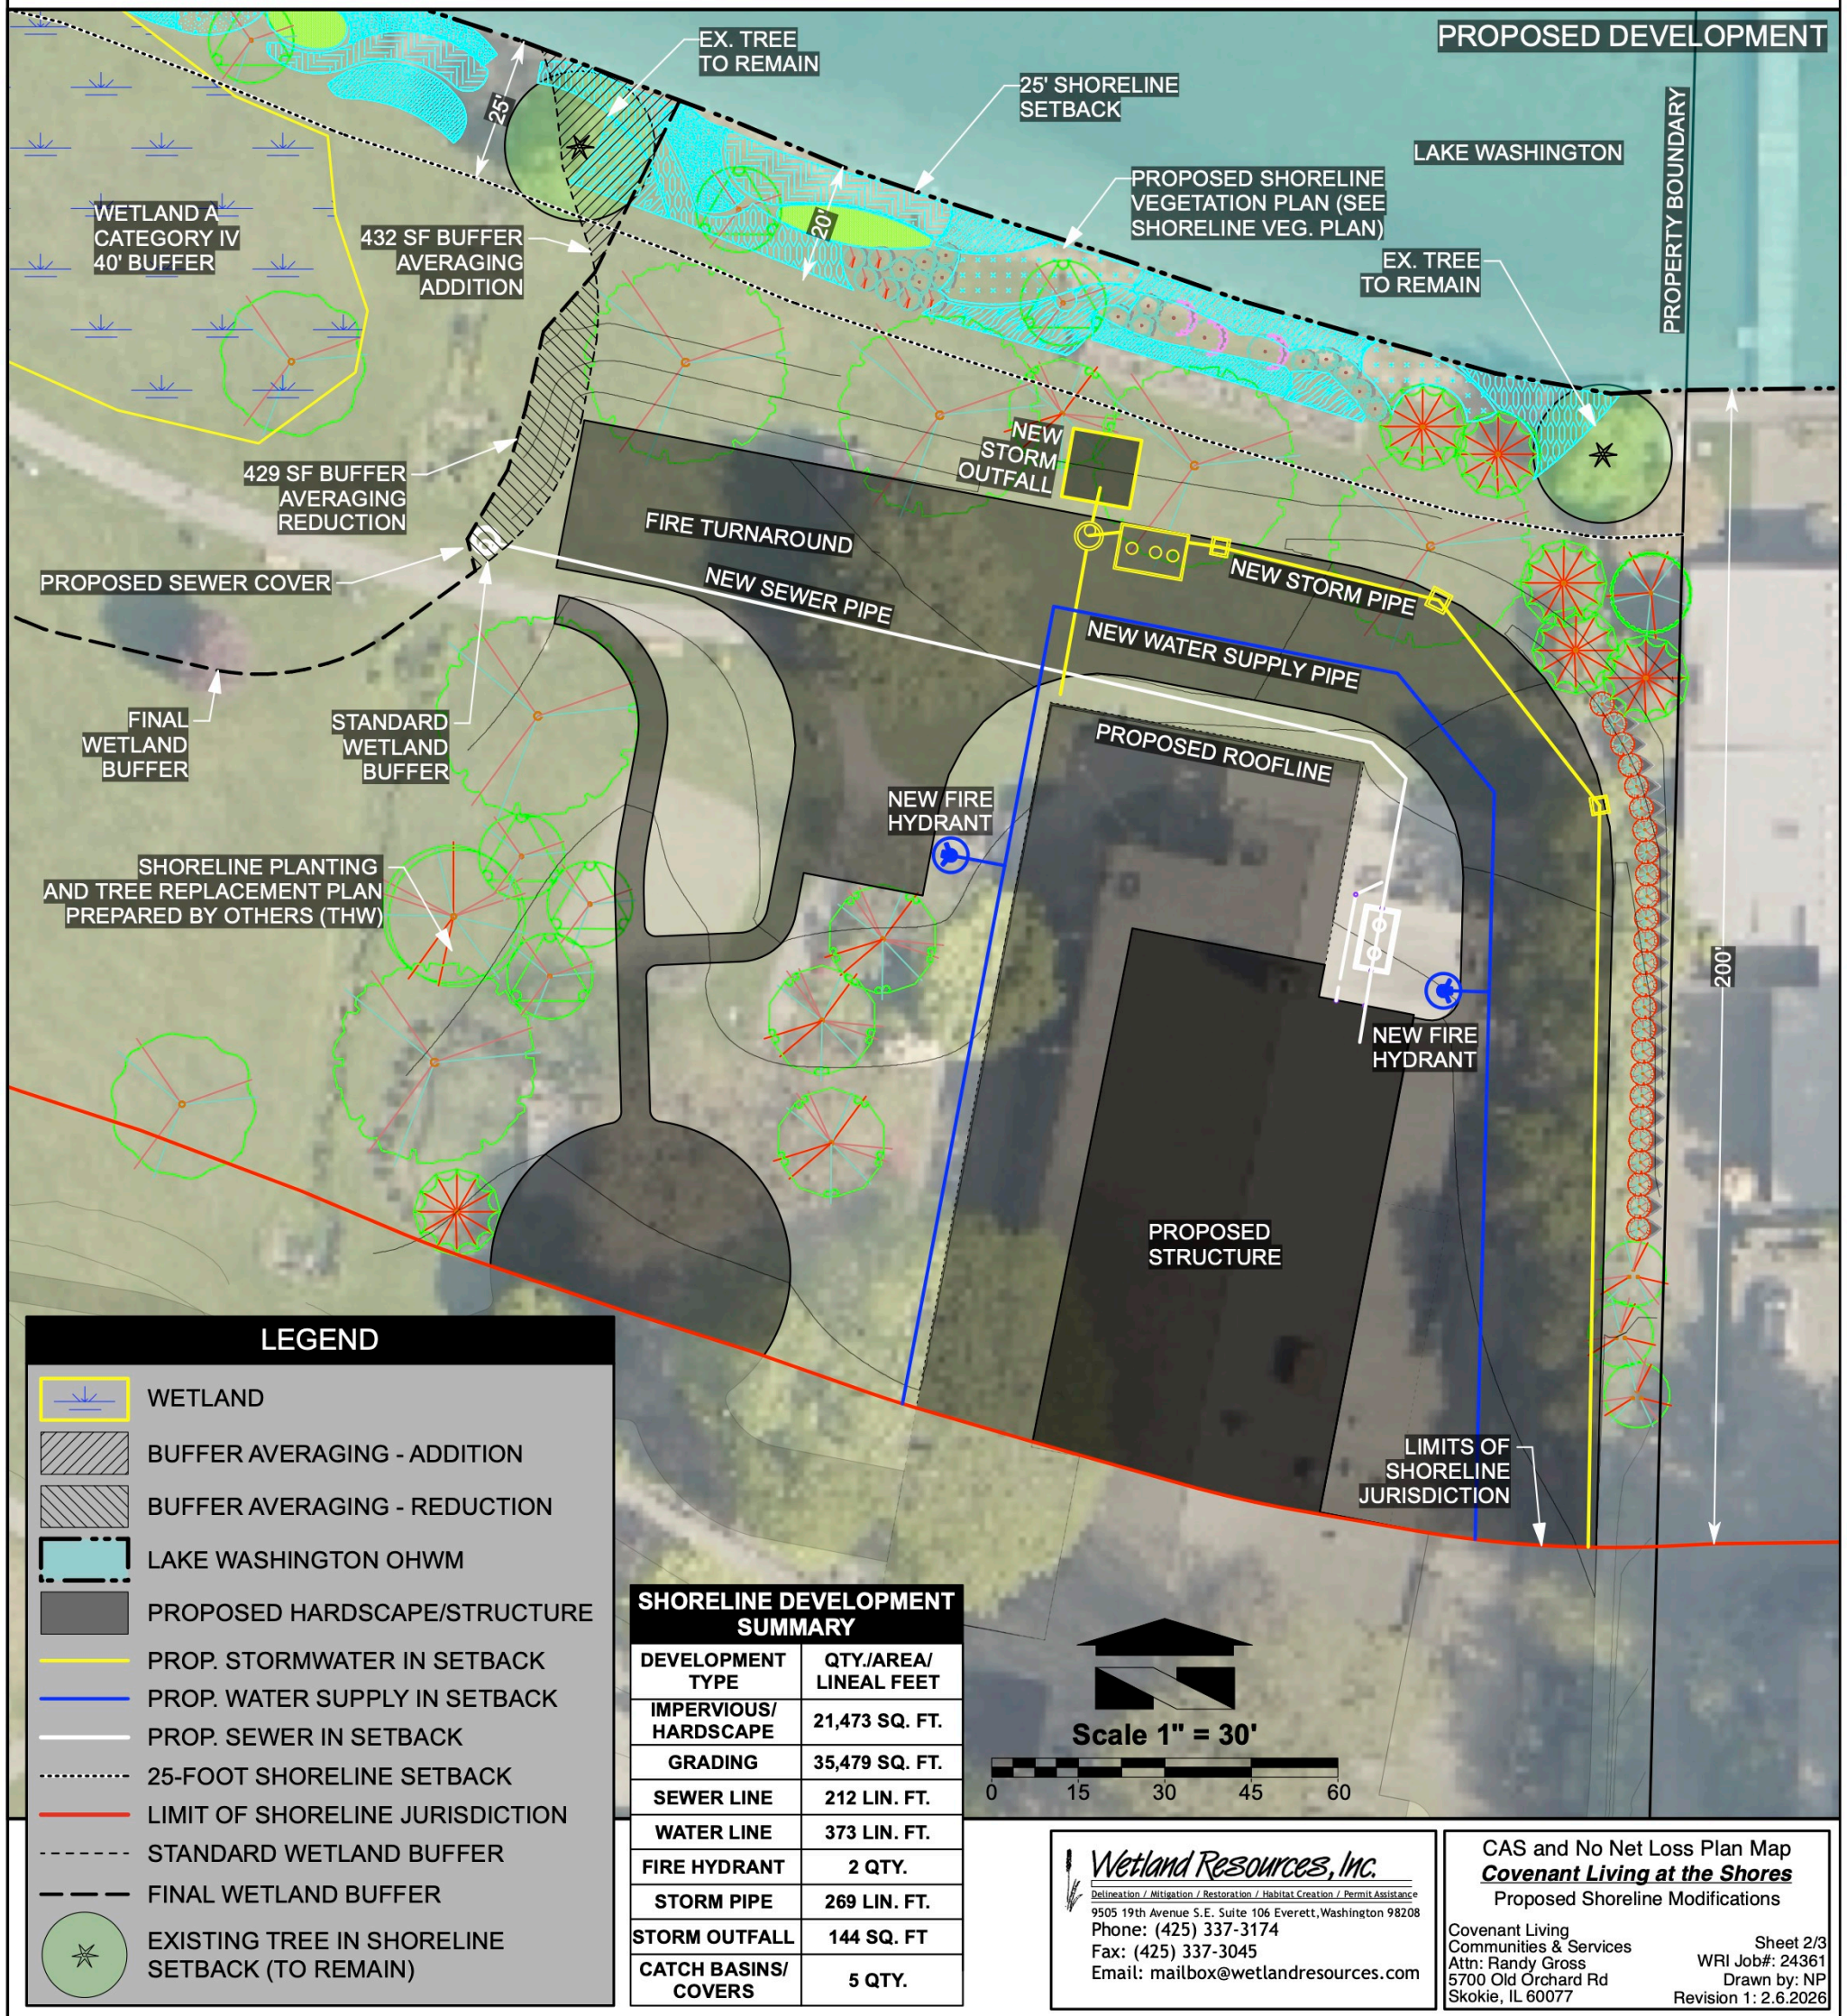
PLANTING AREA CALCULATIONS

| LOC. RELATIVE TO OHWM | PROPOSED PLANTING AREA | TOTAL AREA | PLANTING AREA (%) |
|---|---|---|---|
| 0'-20' | 10,796 SF | 14,029 SF | 77% |

WRI has reviewed the plan to determine compliance with MICC 19.13.050.K.4 and MICC 19.10.070. The Landscape Plan proposes planting 75% of the area between zero and five feet from the OHWM, and 77% of the area from five to 20 feet from the OHWM. All proposed shoreline vegetation plan species are native to Washington in accordance with MICC 19.16.010.N. The shoreline vegetation plan includes a variety of ground cover, shrubs, and trees. Three existing mature trees/shrubs will remain. Based on review of the arborist report prepared for the project, the overall tree replacement plan appears to meet all MICC ratio and location hierarchy requirements (32 trees removed, 93 trees installed).

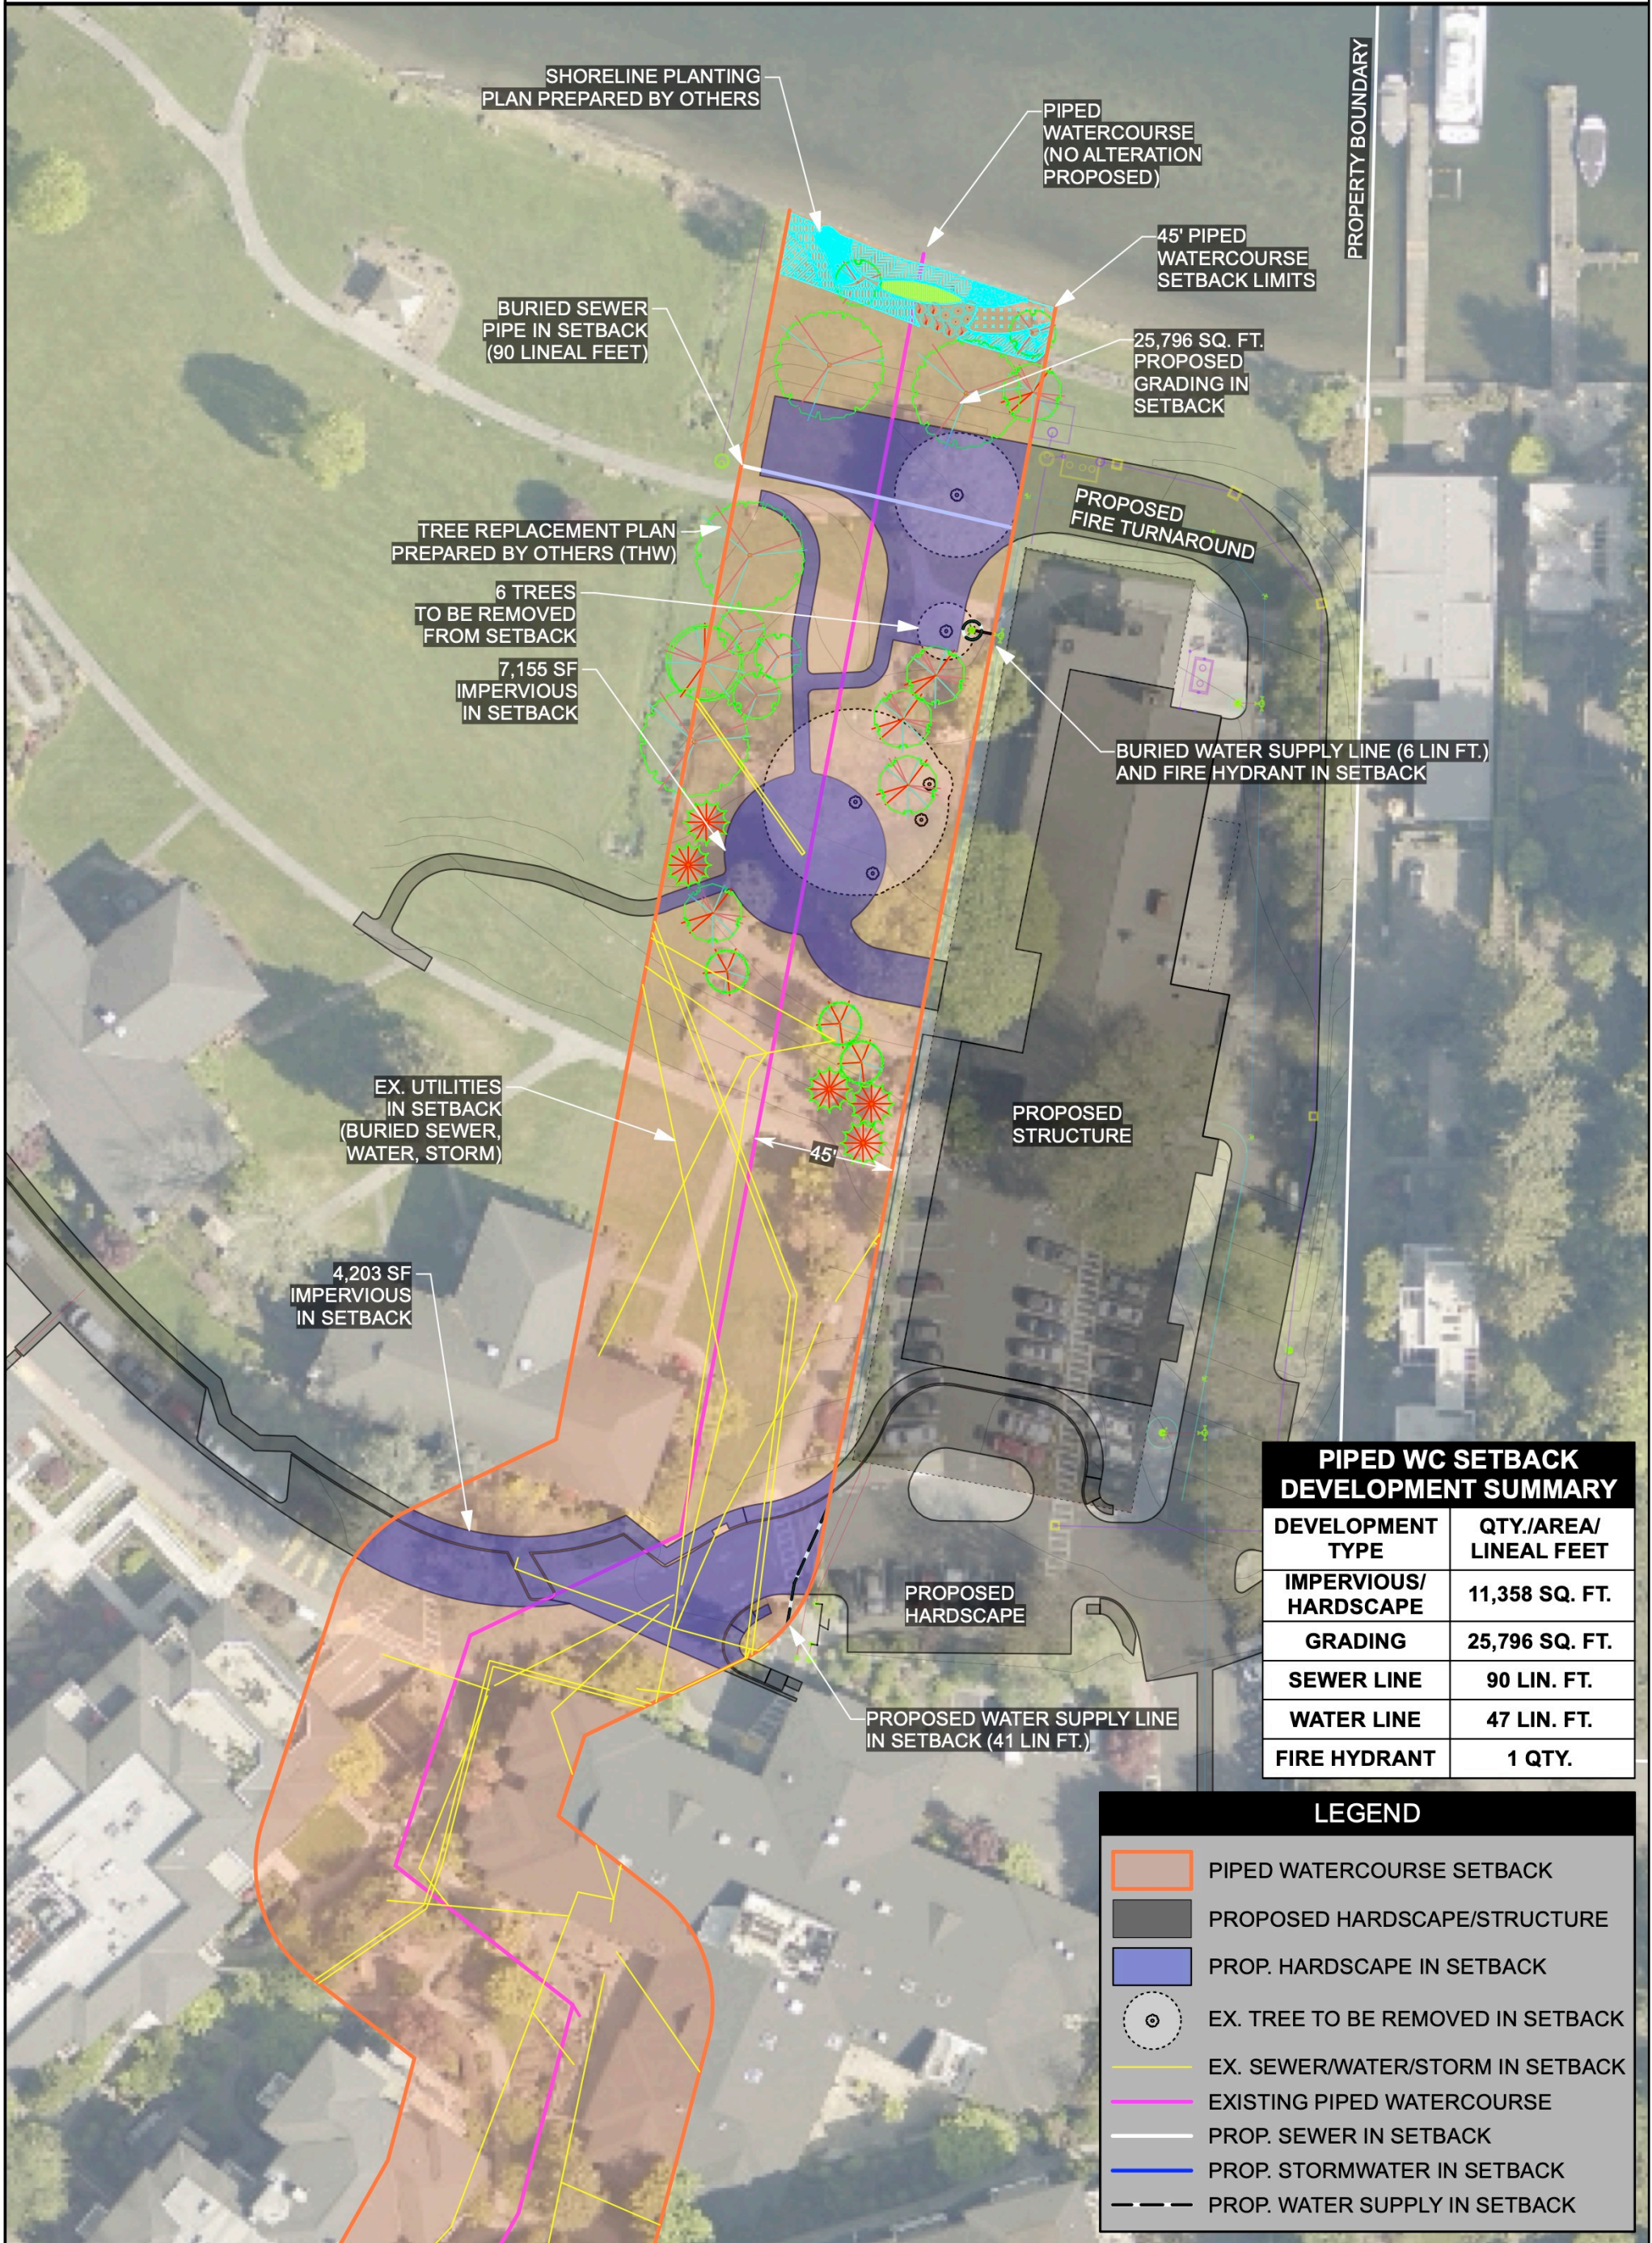
PIPED WATERCOURSE SETBACK DEVELOPMENT

| PIPED WC SETBACK DEVELOPMENT SUMMARY | |

Grading and hardscape are allowed in the watercourse setback pursuant to MICC 19.07.180.C.8. Reconstruction of legal nonconforming utilities is allowed in the watercourse setback pursuant to MICC 19.07.130.A.3. See Appendix D – Sheet 3/3. See also Figure 2.
