# **Ecological No Net Loss Assessment Report**

**Pisco Residence**  
**6000 SE 20<sup>th</sup> St**  
**Mercer Island, WA 98040**

**January 2026**

The property is being permitted for a bulkhead repair and creation of a beach cove.

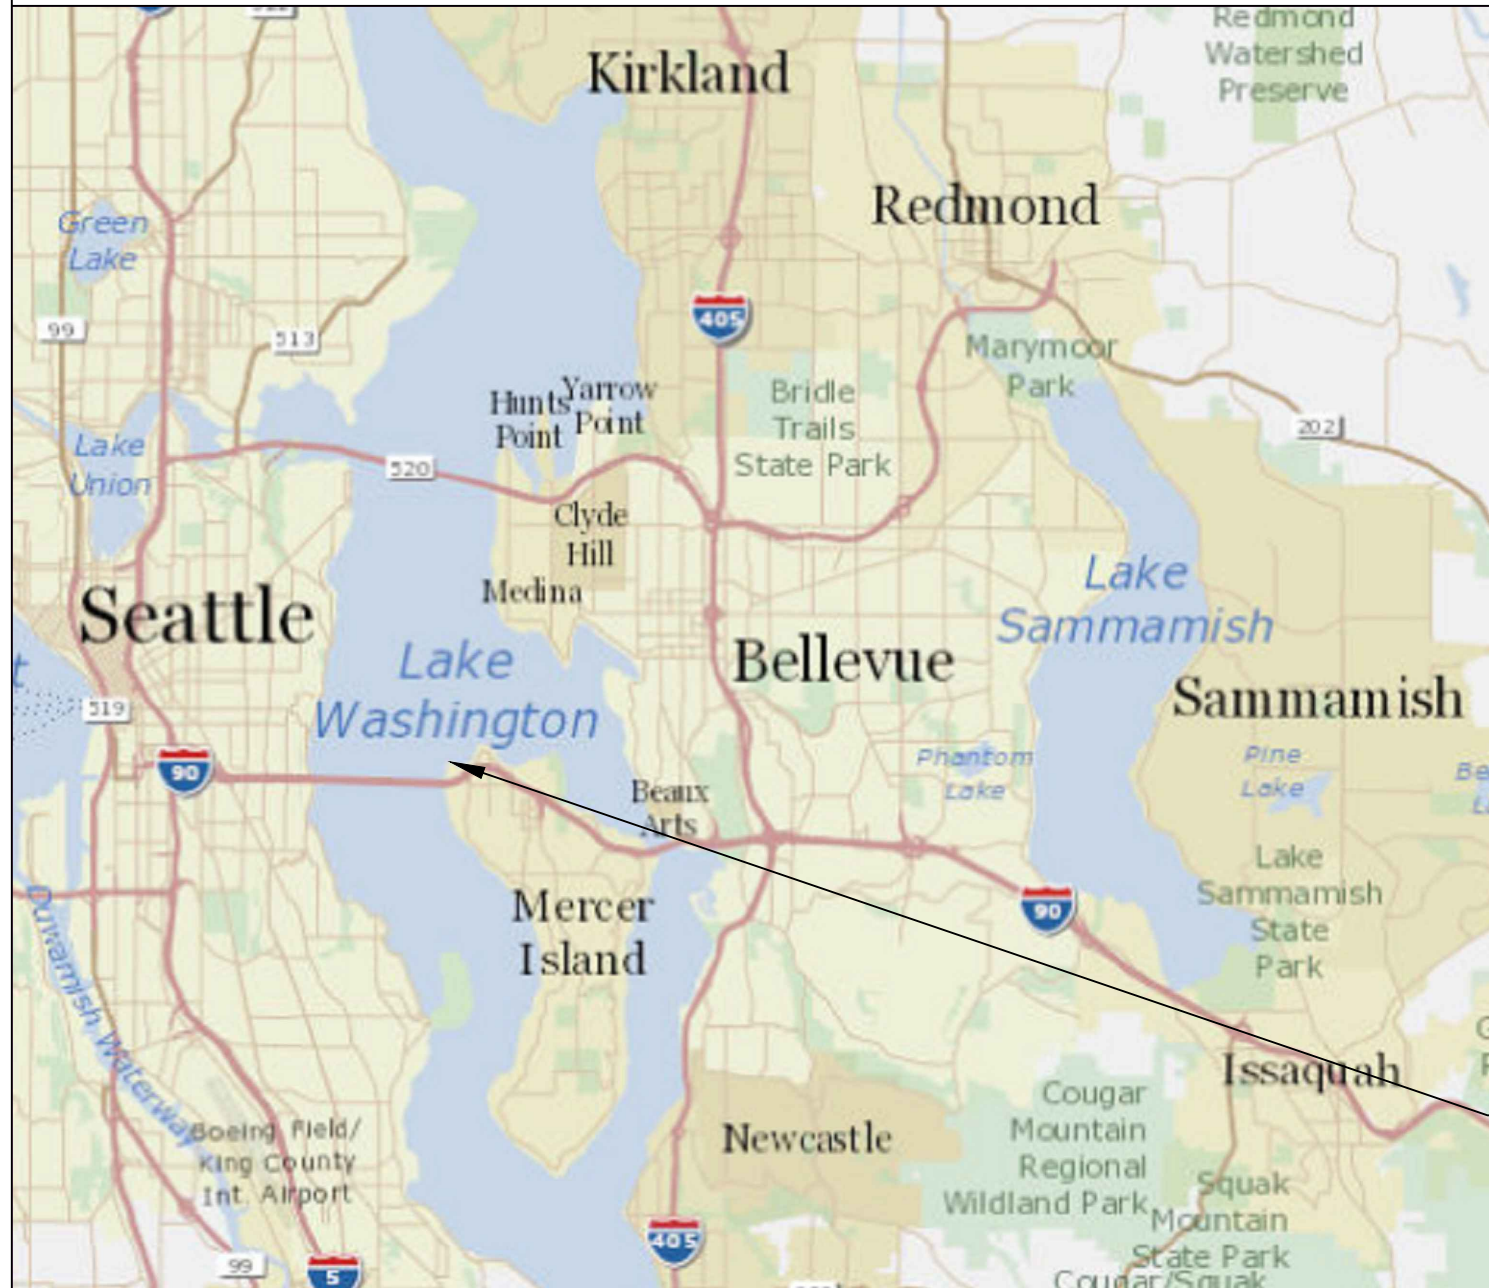
**SHEET  
1.0**

The subject property is located at 6000 SE 20<sup>th</sup> Street, Mercer Island, Washington (see Appendix A – Sheet A1.0). The parcel is on the waterfront of Lake Washington that contains several endangered fish species listed under the Endangered Species Act and Washington State designated priority fish species.

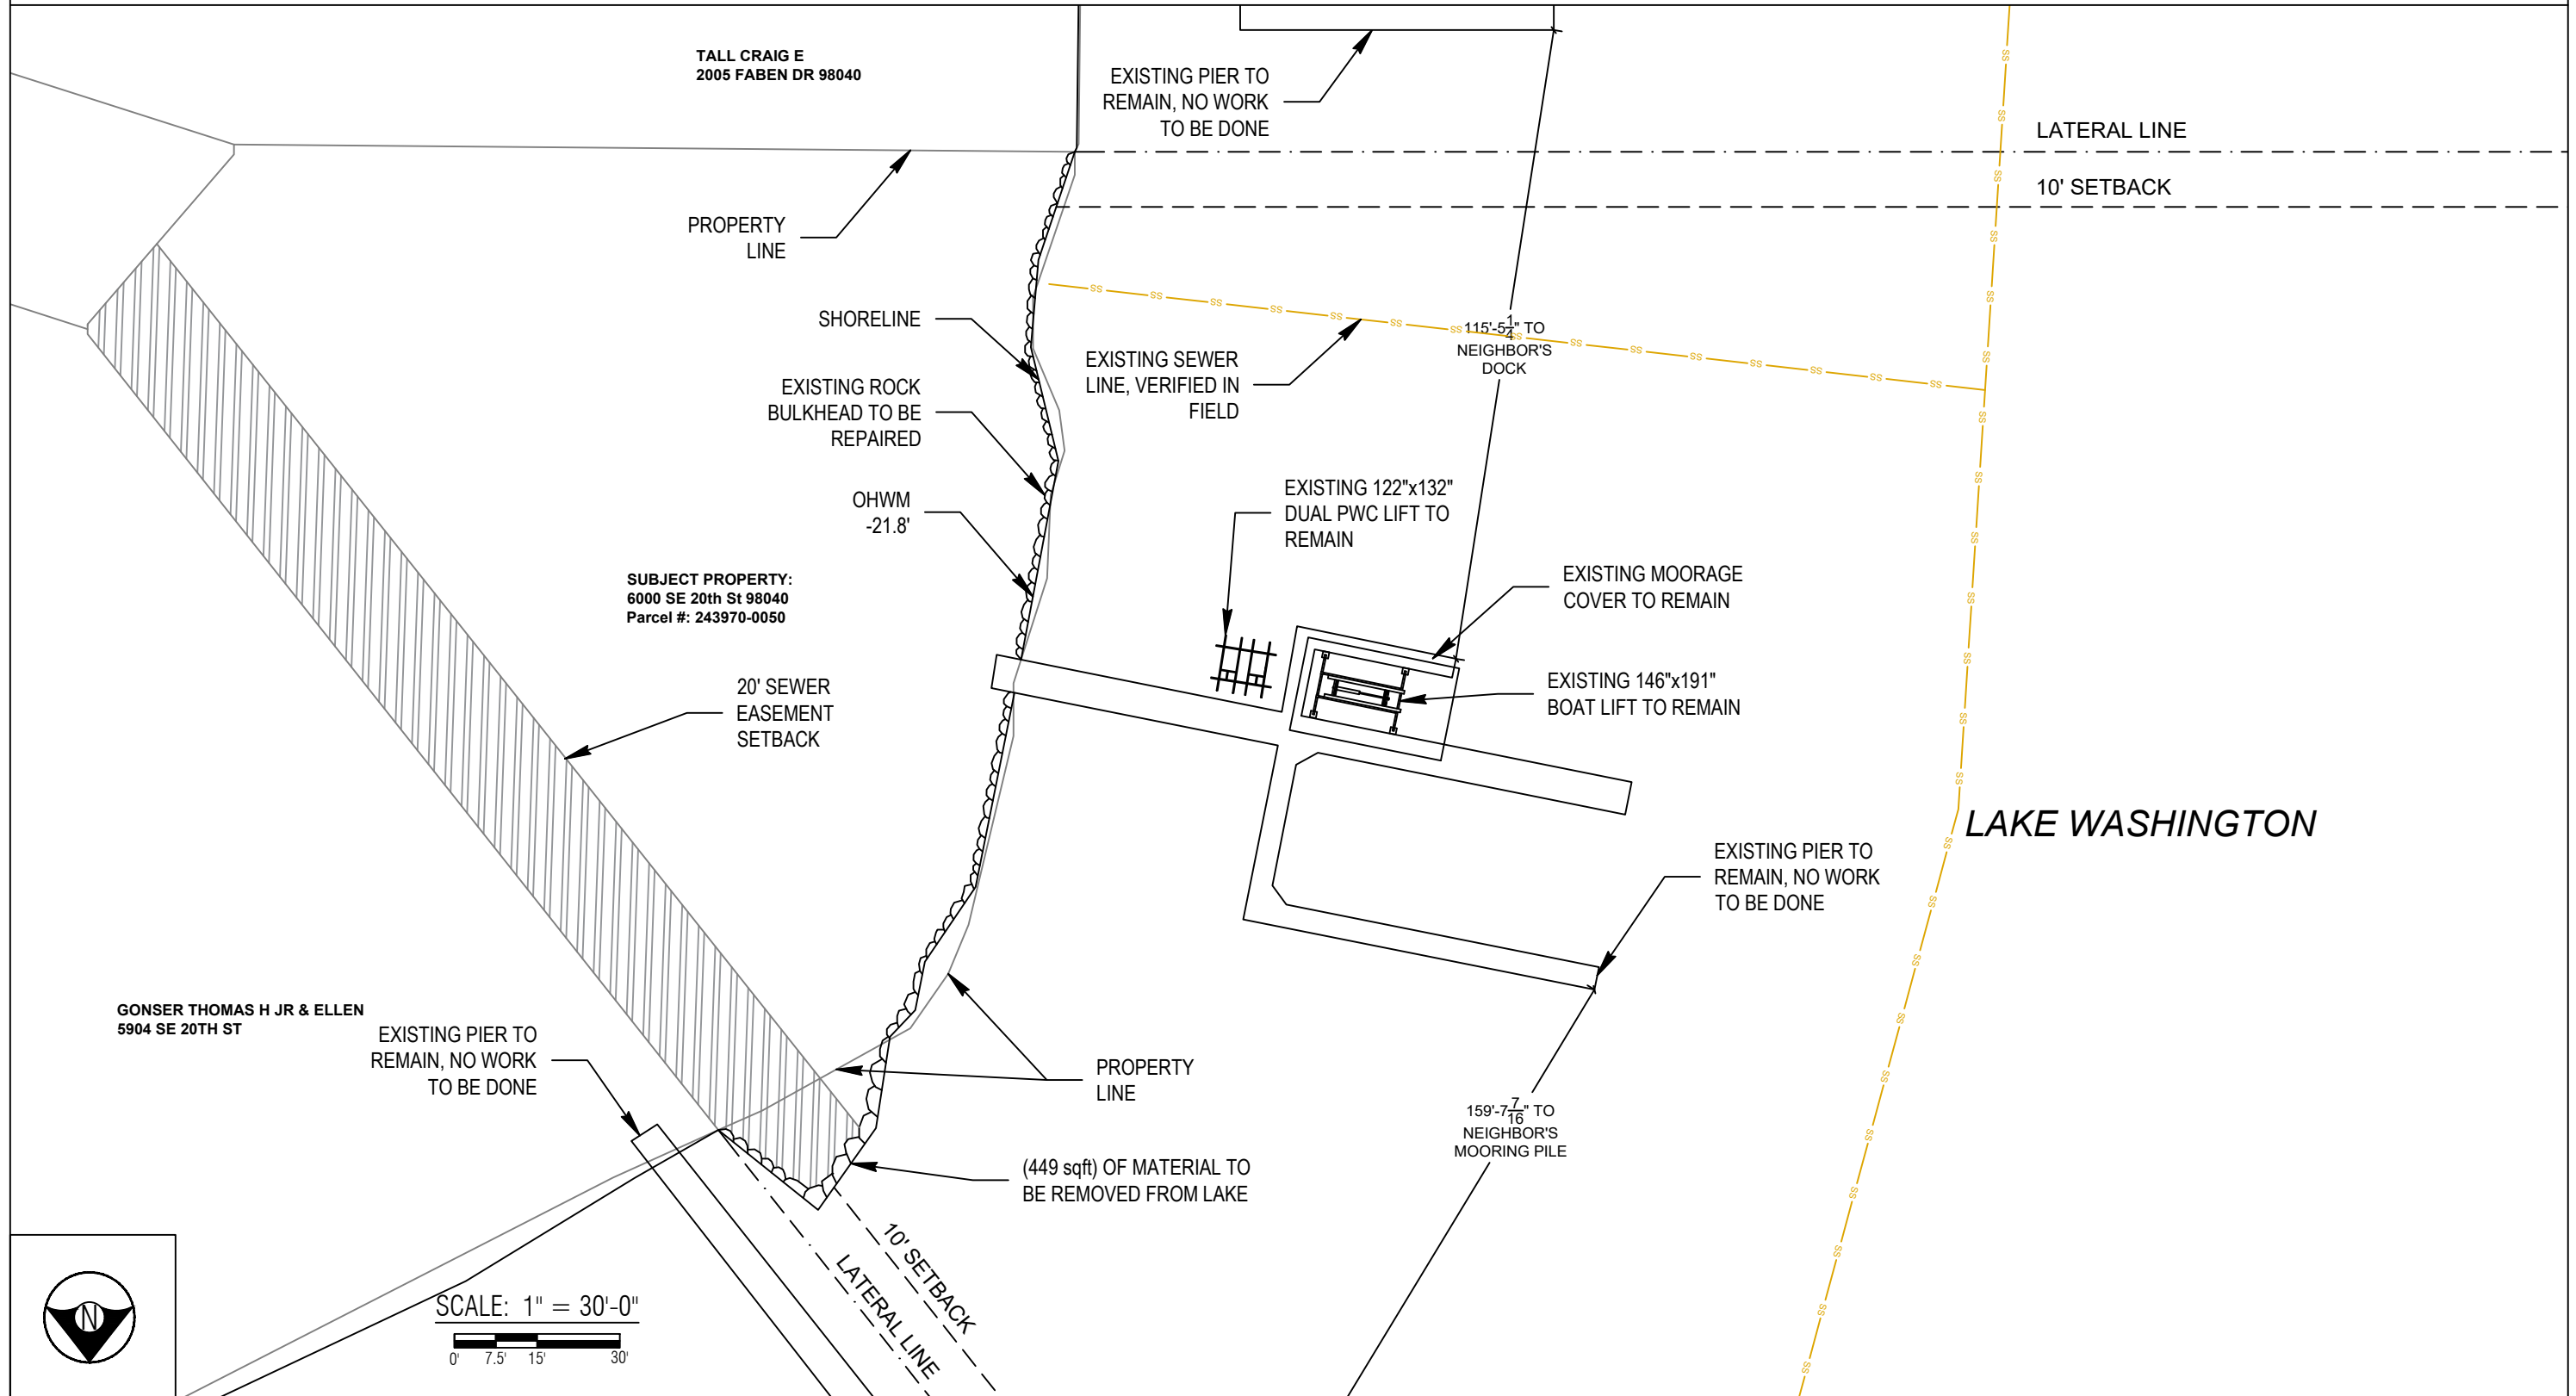
**SHEET**  
**3.0**

# EXISTING CONDITIONS

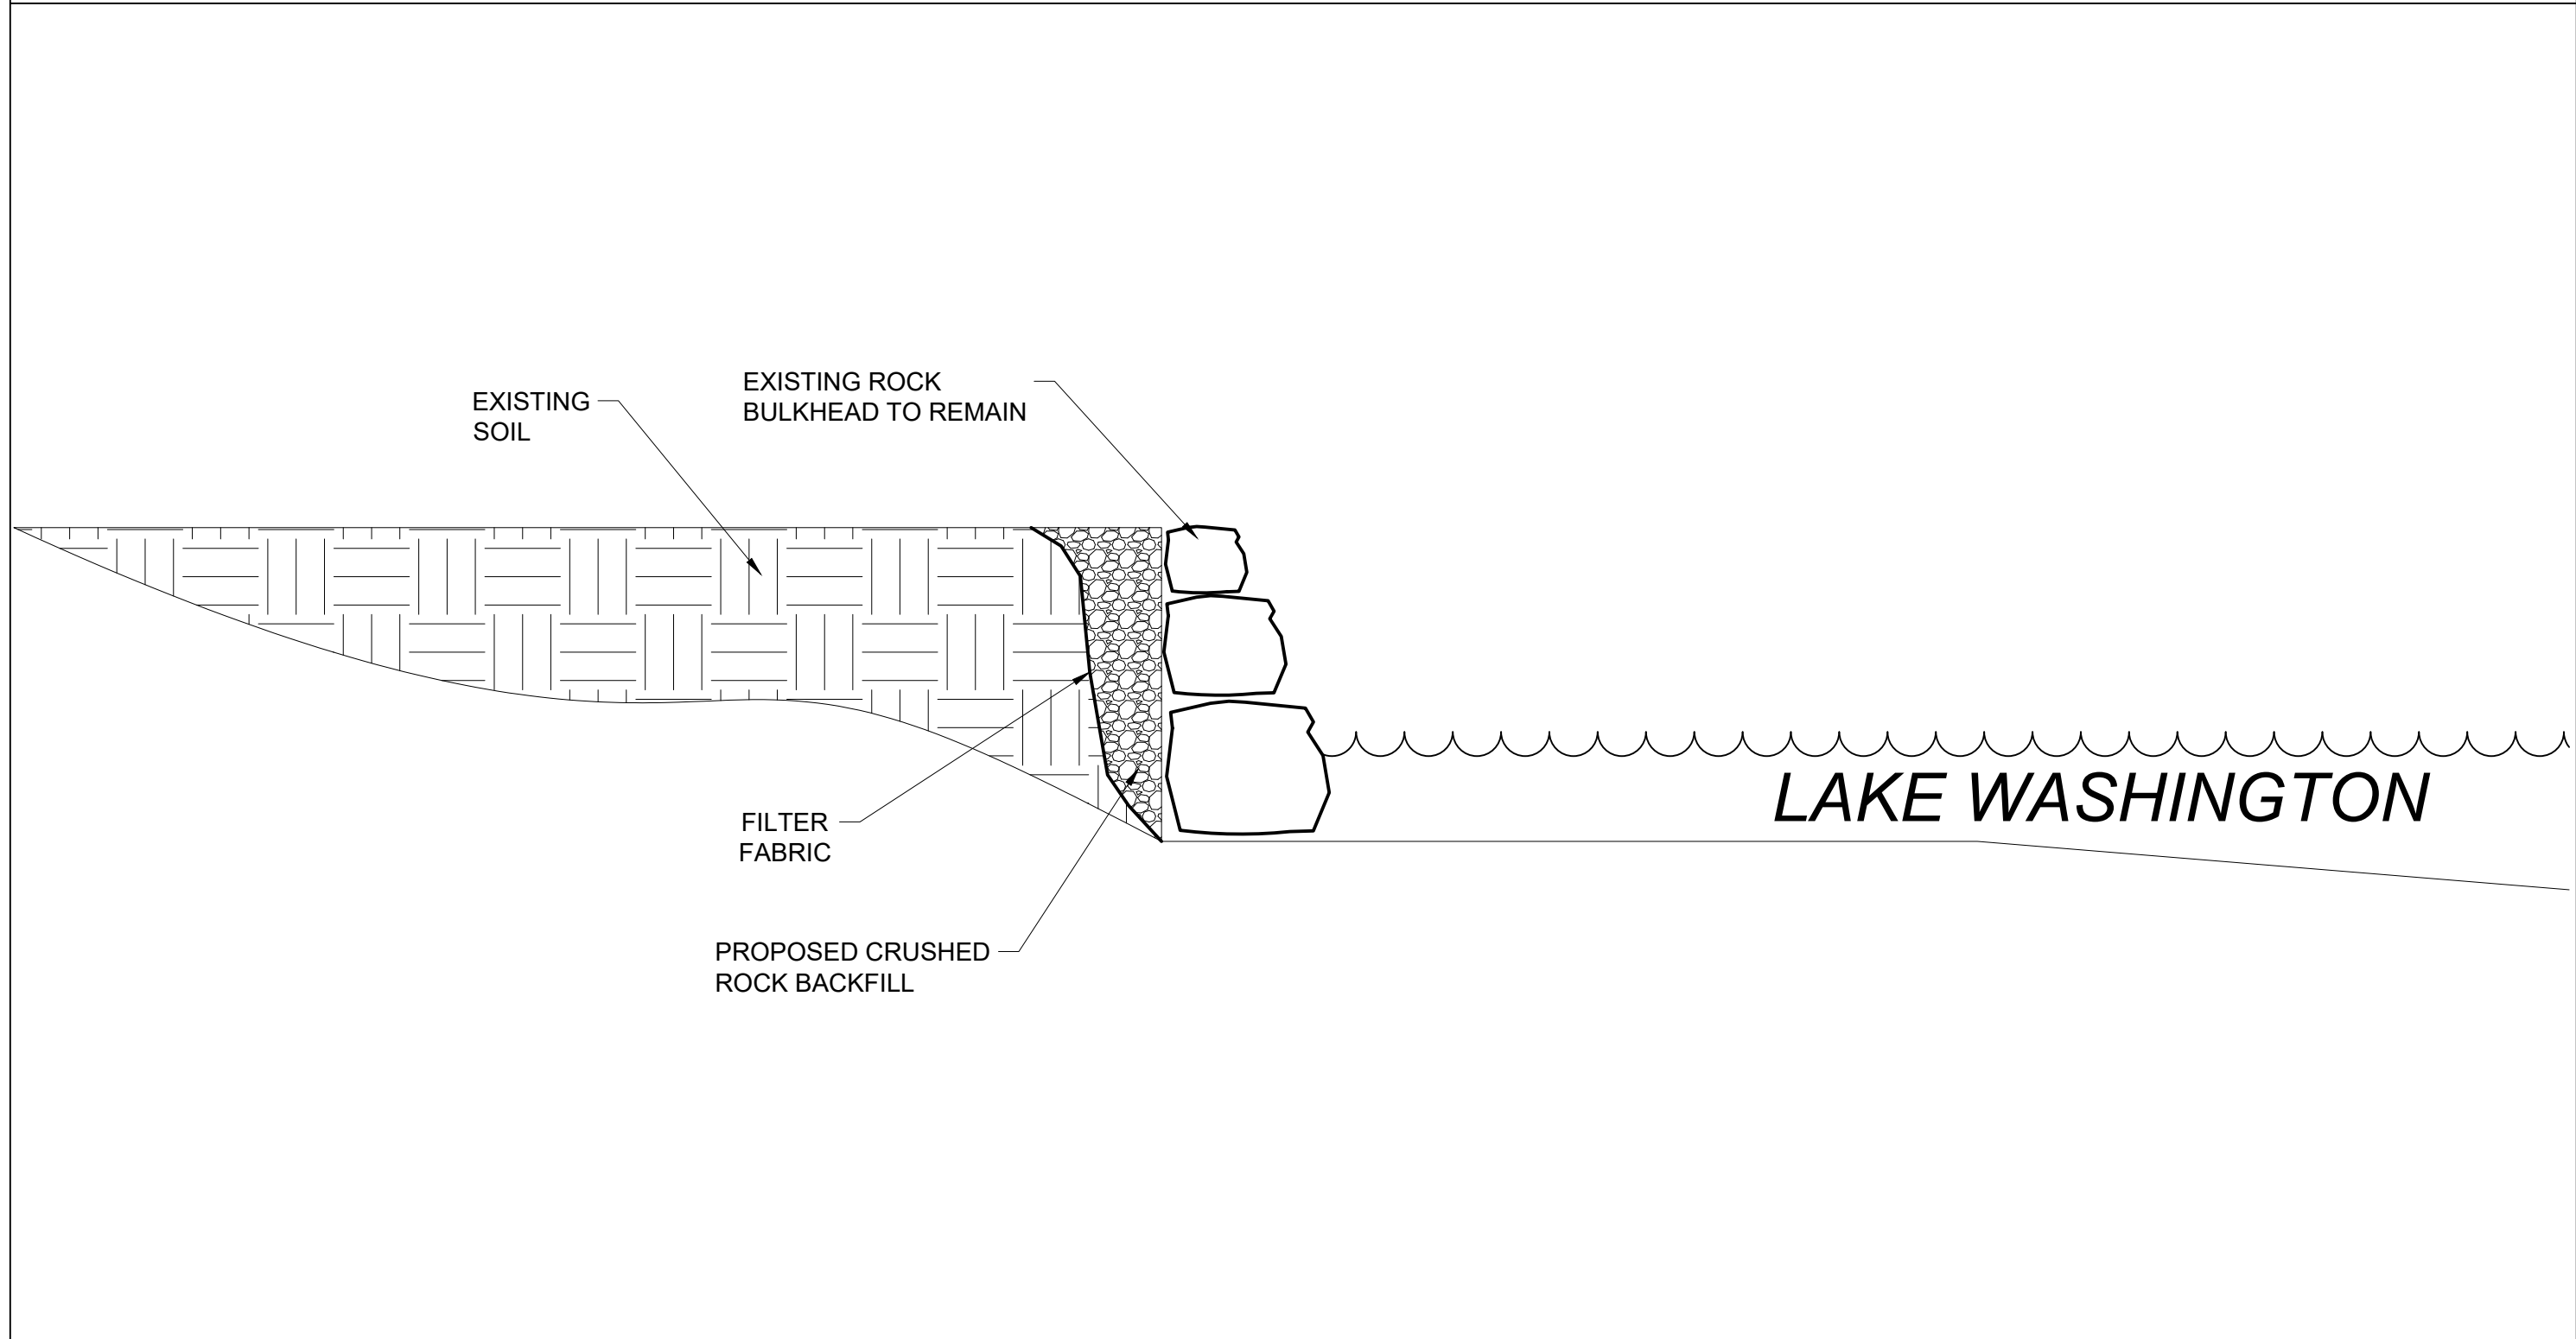
**SHEET**  
**5.0**

The proposed work includes repair of the existing 180.5-foot long rock bulkhead. The proposed work includes removal and replacement of the existing rocks as needed and adding crushed rock and filter fabric behind the bulkhead to allow proper drainage from behind the bulkhead.

# BULKHEAD SECTION

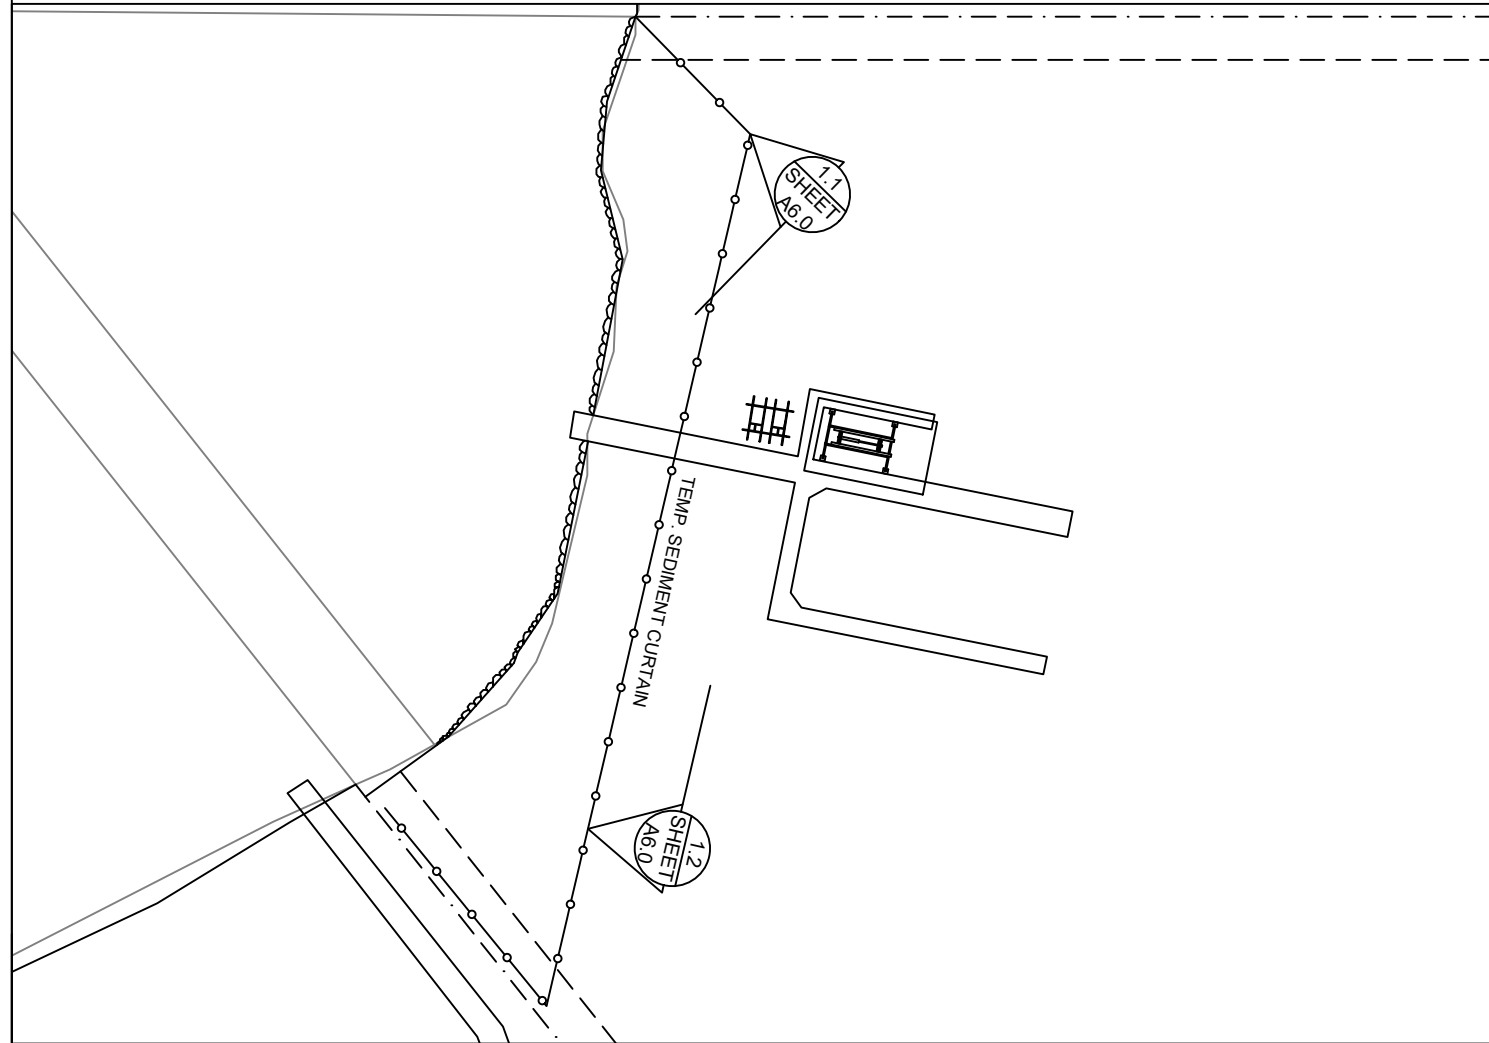
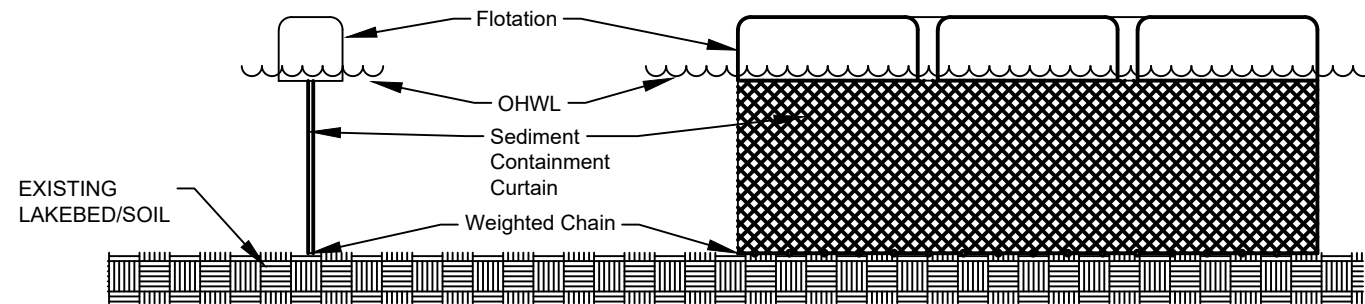
**SHEET**  
**6.0**

During construction, a floating boom and weighted silt curtain will surround the work barge and pier. See sheet A6.0.

# BMP INFORMATION

Juvenile salmonids could be temporarily displaced or stressed by increased turbidity. A floating boom will be placed around the pier to contain floating debris to the project site and a floating silt boom will be installed around in-water work areas to prevent turbidity from leaving the work area should it occur. The project will meet state water quality standards.

**Best Management Practices:** Applicable BMPs will be used such as a floating boom around the in-water work area that will contain any floating debris that may escape during demolition and construction. The barge will have a perimeter containment sock to absorb oil and grease

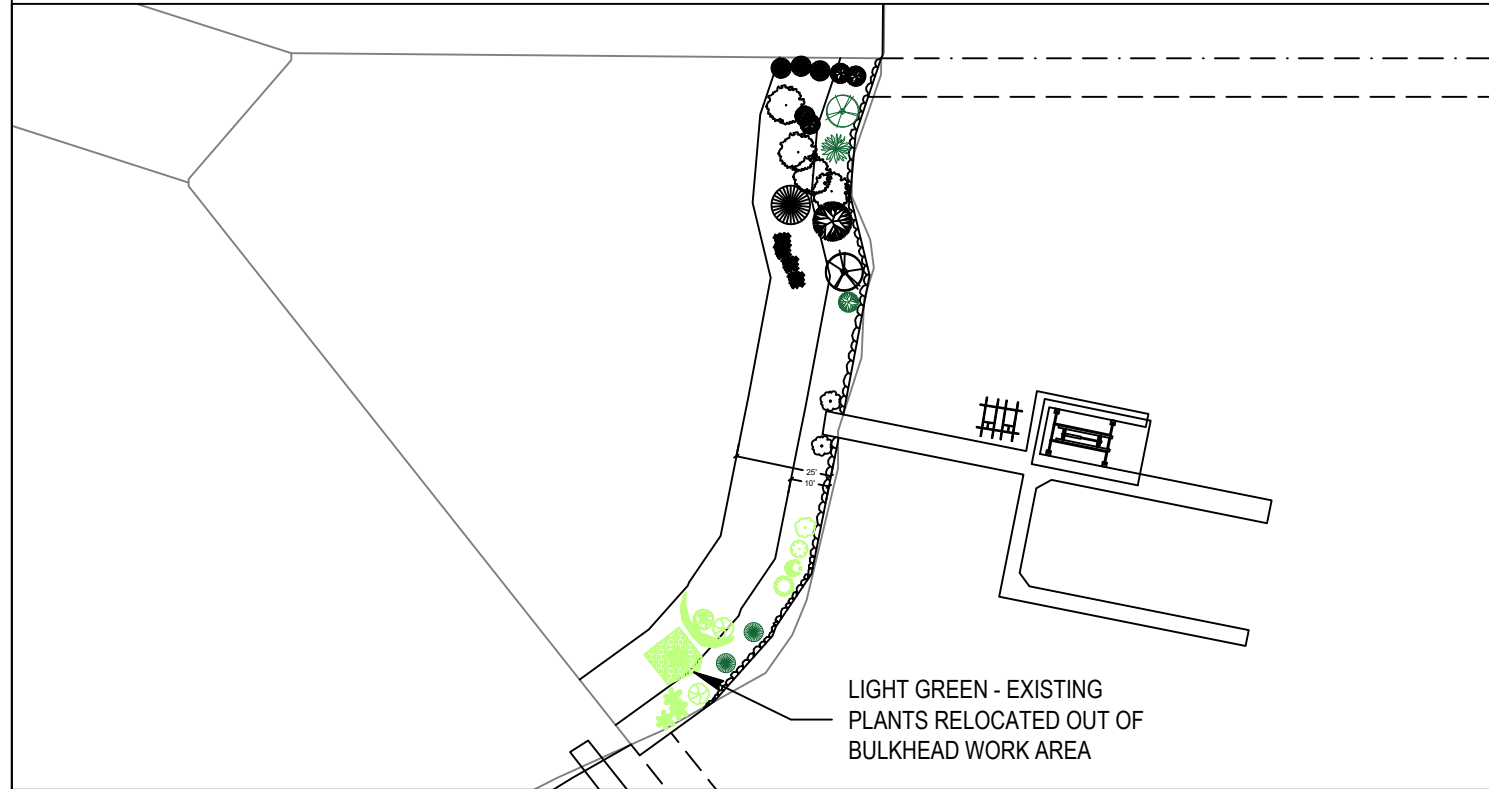
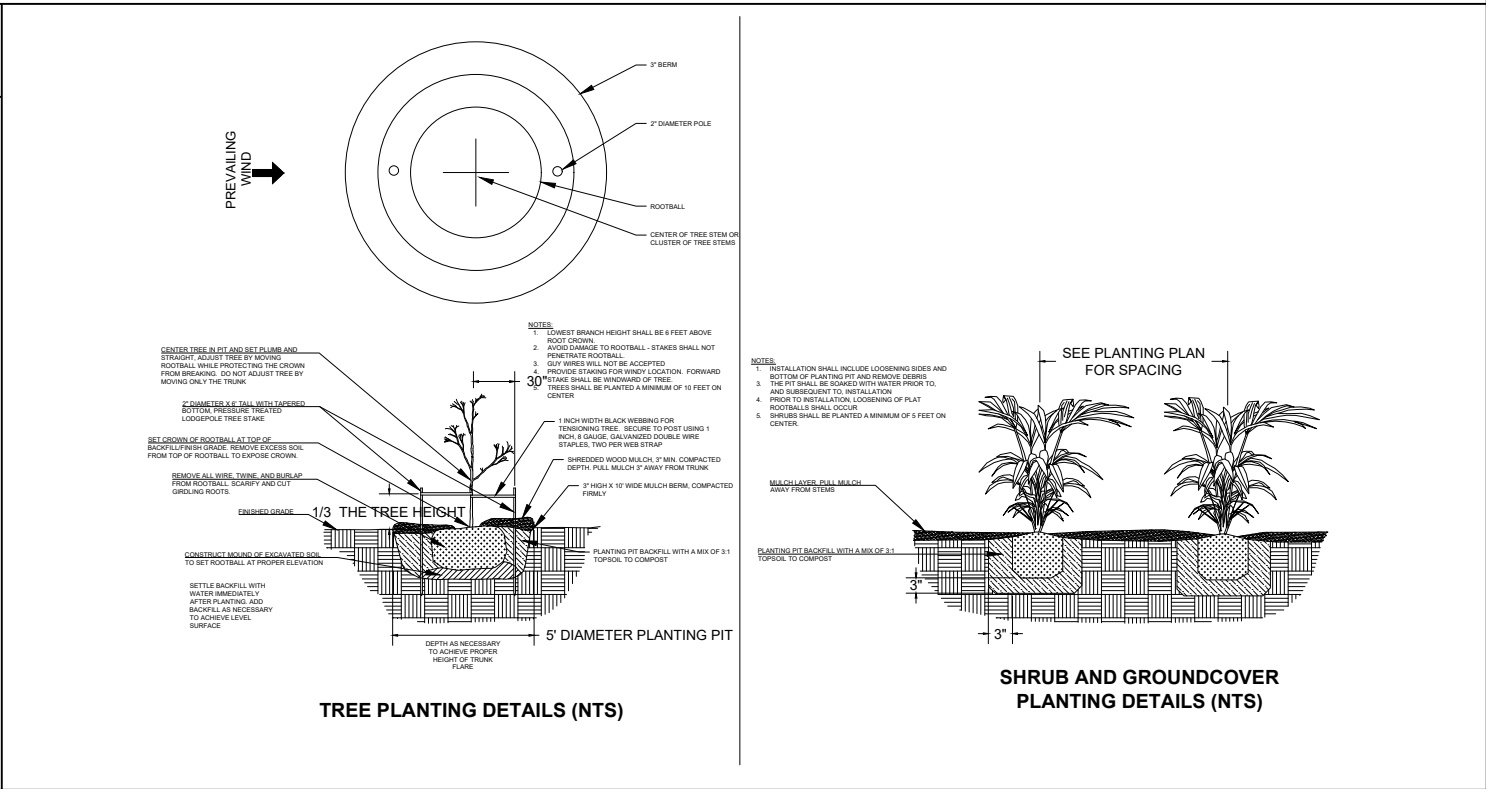
A planting plan will be installed using native plants as shown on Sheet A7.0 and A8.0

# MITIGATION PLAN

Planting native vegetation will increase the habitat functions of the shoreline by creating shade along the shoreline that will be an improvement from the existing baseline habitat conditions at the project site. The plantings will increase overhanging cover for fish, structural diversity for birds and wildlife, detritus for aquatic invertebrates and long-term recruitment of woody material and other allochthonous food sources. The proposed planting plan is included (see Appendix A - Sheet 7.0).

A shoreline planting plan will be implemented that will add a western red cedar and shorepine and three native shrubs. The native plantings will improve natural shading, create allochthonous

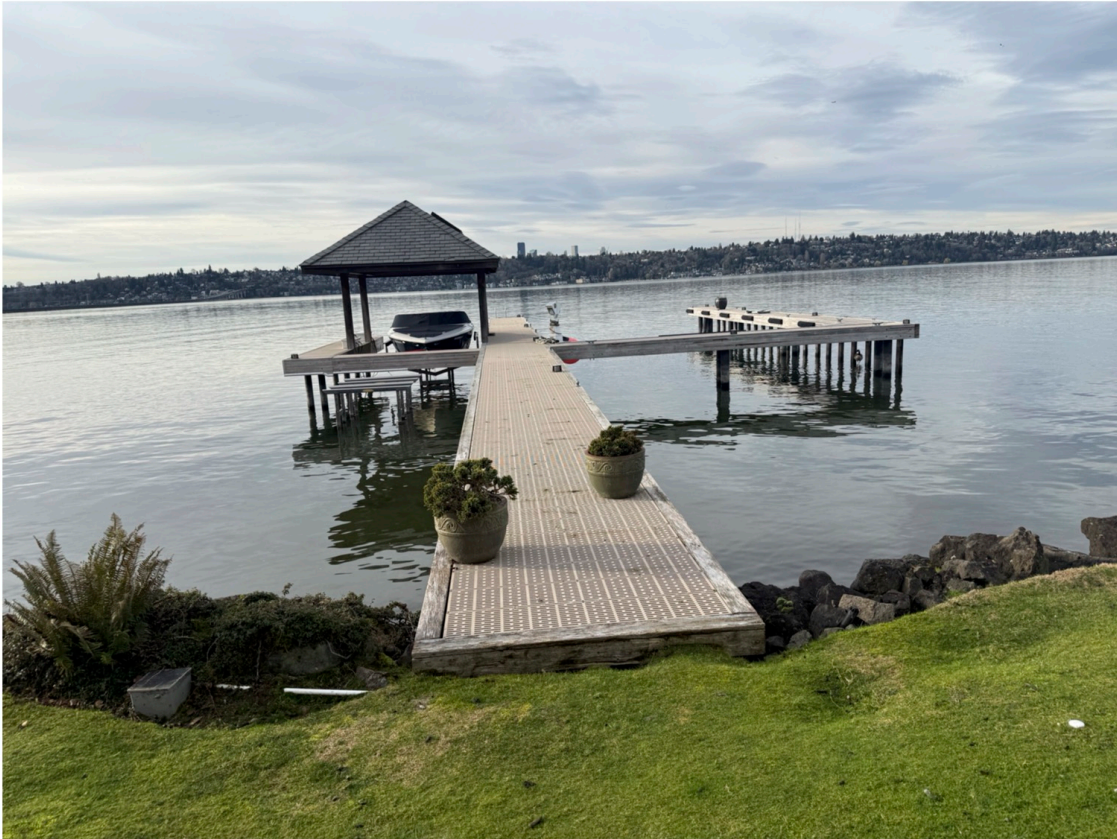
Photo 1 - Existing dock looking waterward.

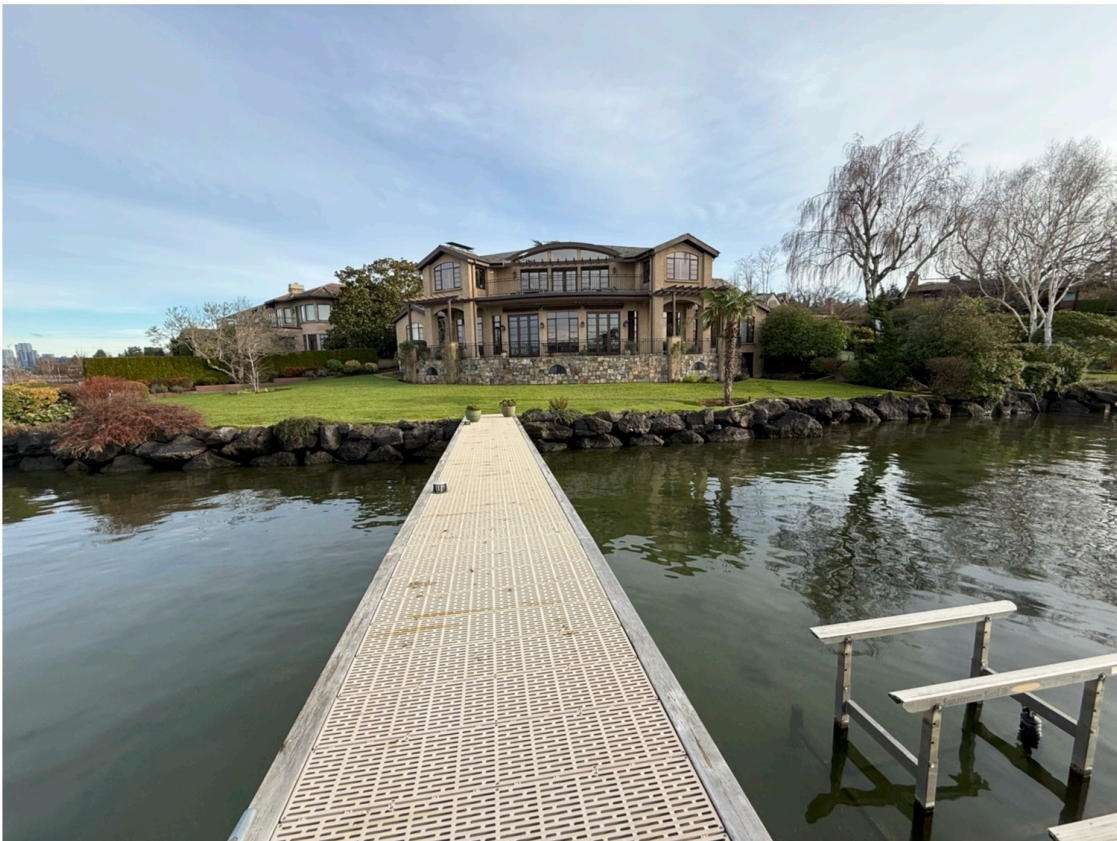
Photo 2 - Existing dock looking shoreward showing bulkhead to be replaced.

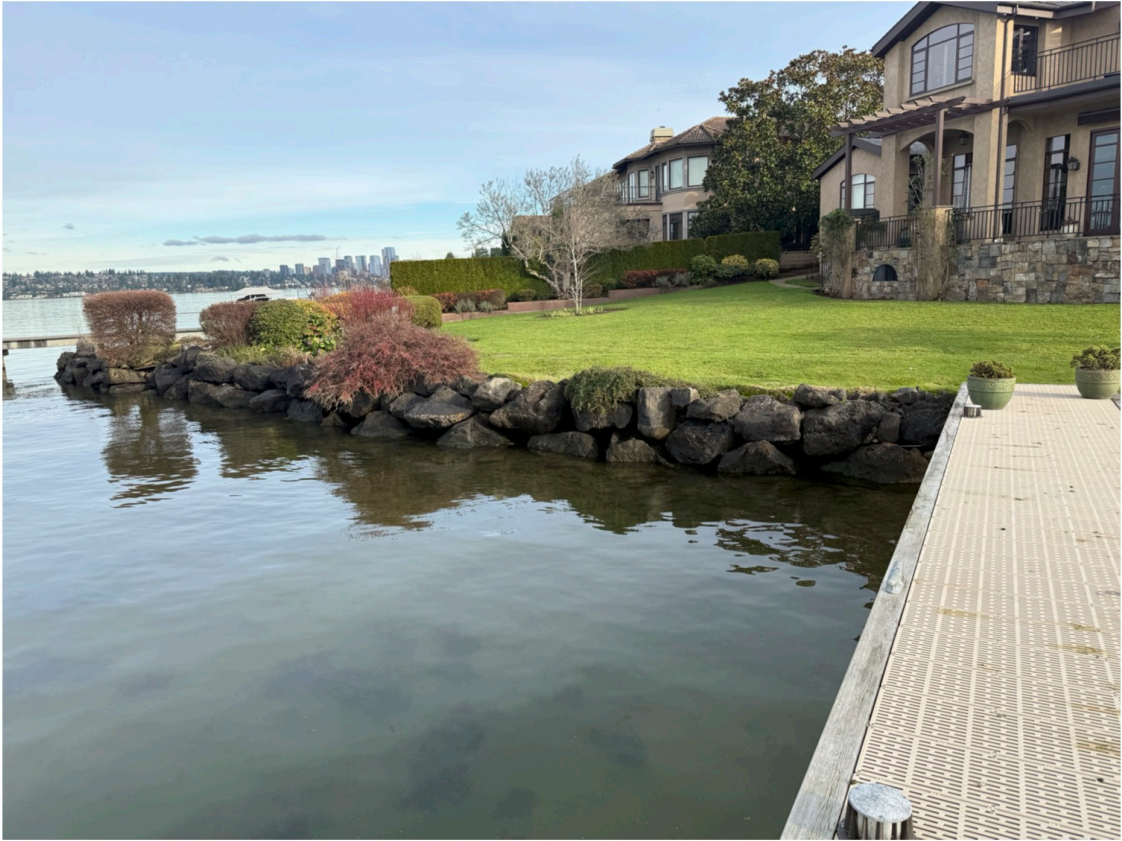
Photo 3 - Existing shoreline north of dock. The cove will be placed in this section.

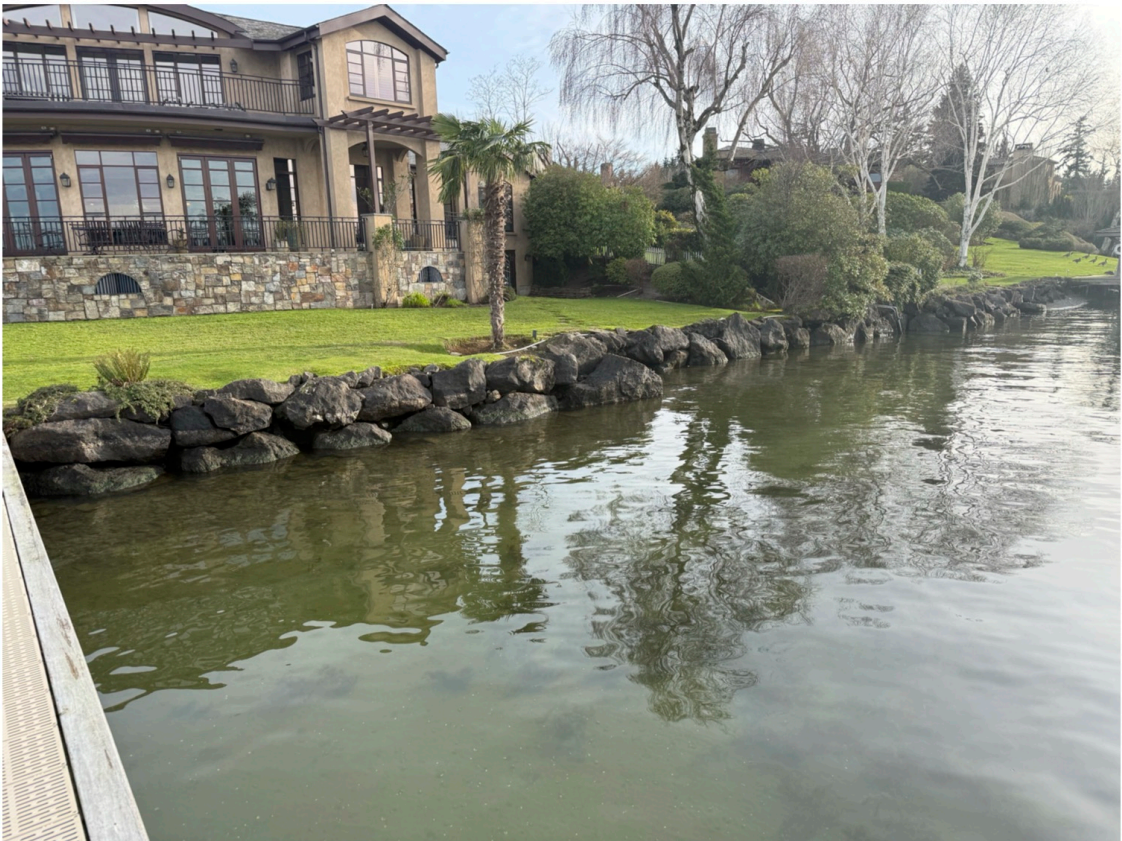
Photo 4 - Section of bulkhead to be repaired south of the dock.
