Eastside Environmental Pros

Project: EE-652

REFERENCE: King County Tax Parcel #192405-9134
SUBJECT: Critical Areas Study

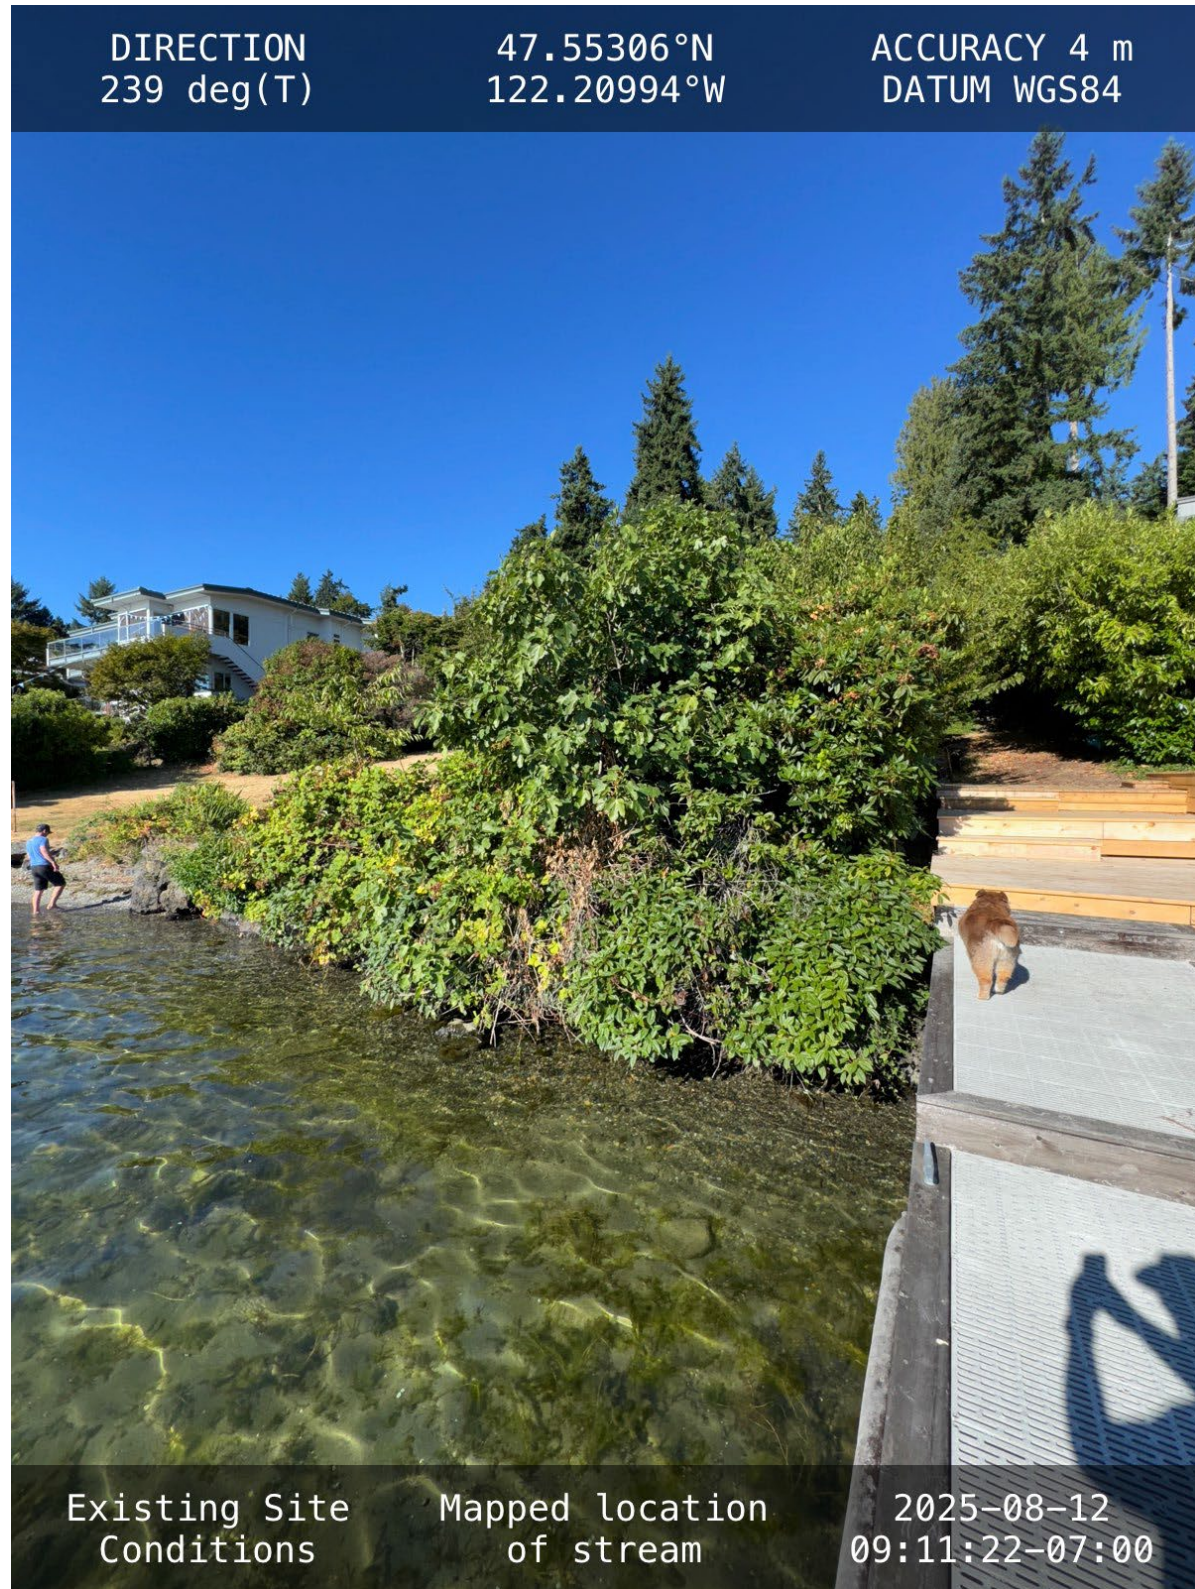
Photo 1. Photo of inaccurately mapped stream location south of the deck

Per the city GIS portal, a watercourse was mapped as adjacent to the Site. Eastside Environmental Pros, Inc. investigated the property and identified a stormwater pipe but did not locate a defined stream channel with a bed and bank. Per the city GIS portal, the stormwater pipe is also mapped in the same location as the potential watercourse, and according to a LiDAR Watercourse and Stormwater Conveyance Analysis (Herrera 2019), the feature is an unregulated drainage feature. Therefore, the feature will be maintained as a constructed drainage conveyance.

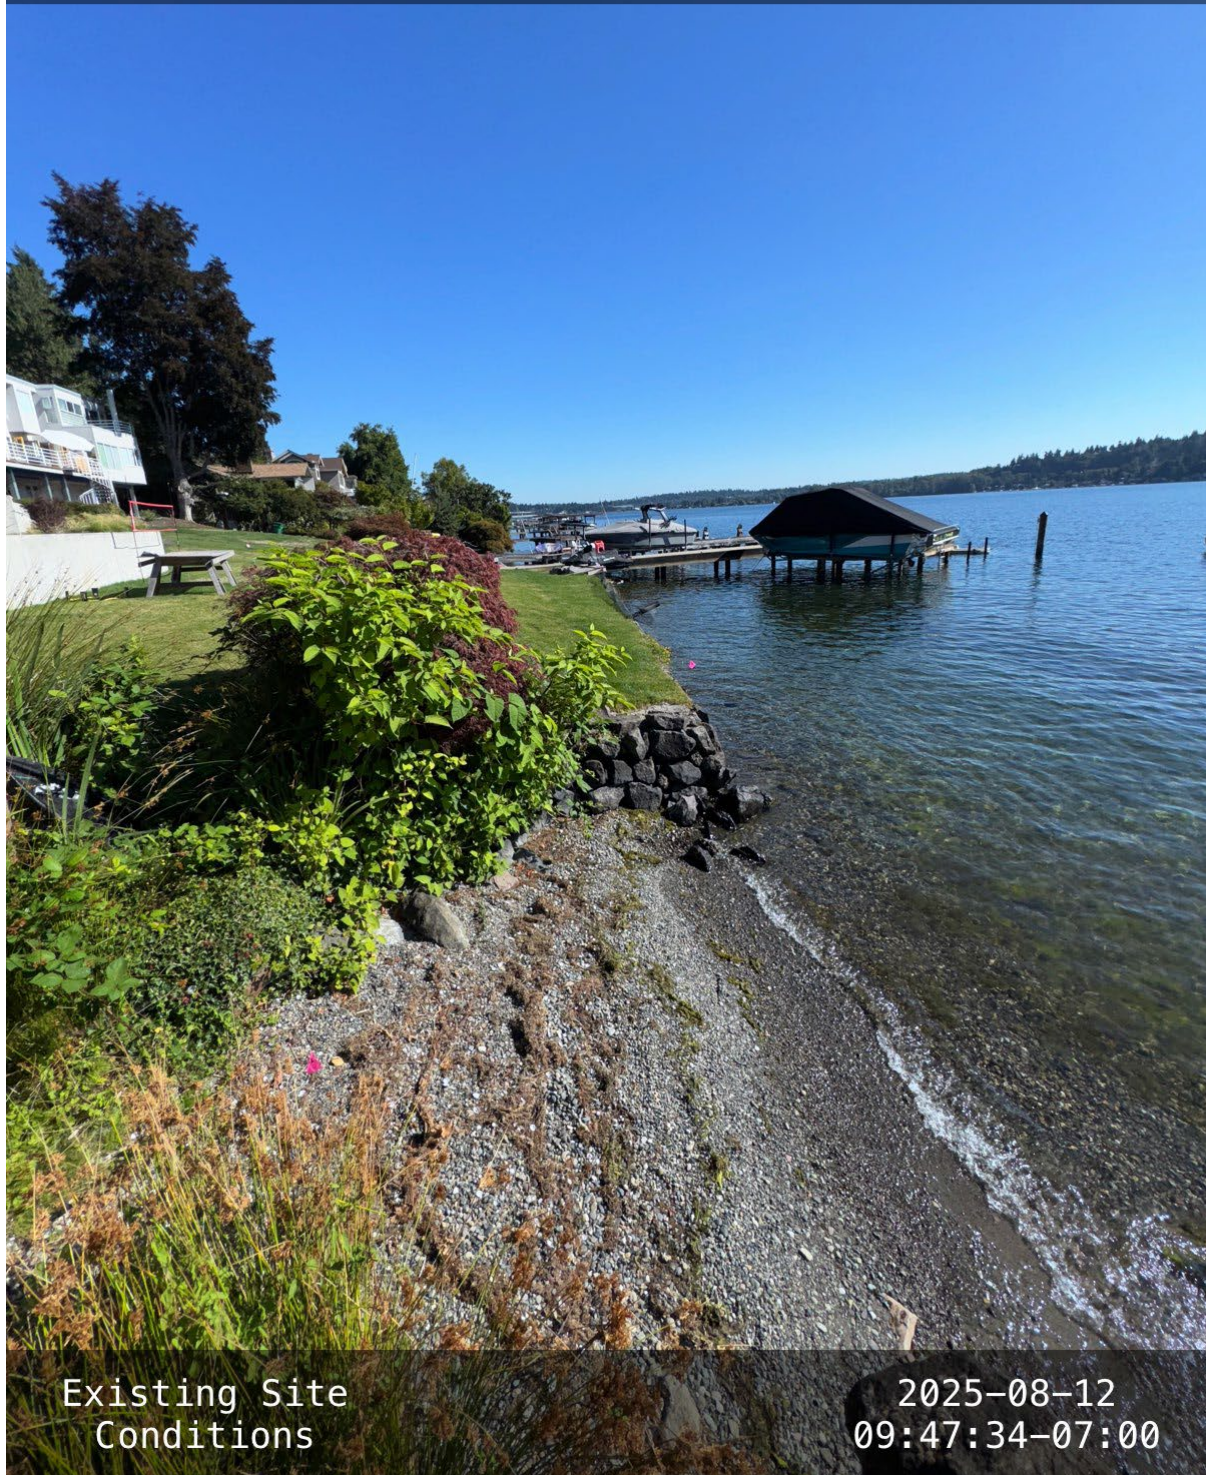
Photo 2. Photo of the OHWM of Lake Washington, photo taken facing to the north.

Lake Washington borders the eastern portion of the Site and the OHWM was delineated during the 12 August 2025 Site visit. In addition, a potential landslide hazard area is depicted on the City of Mercer Island’s Geospatial Hub. Therefore, per section 19.07.160.B(1)-

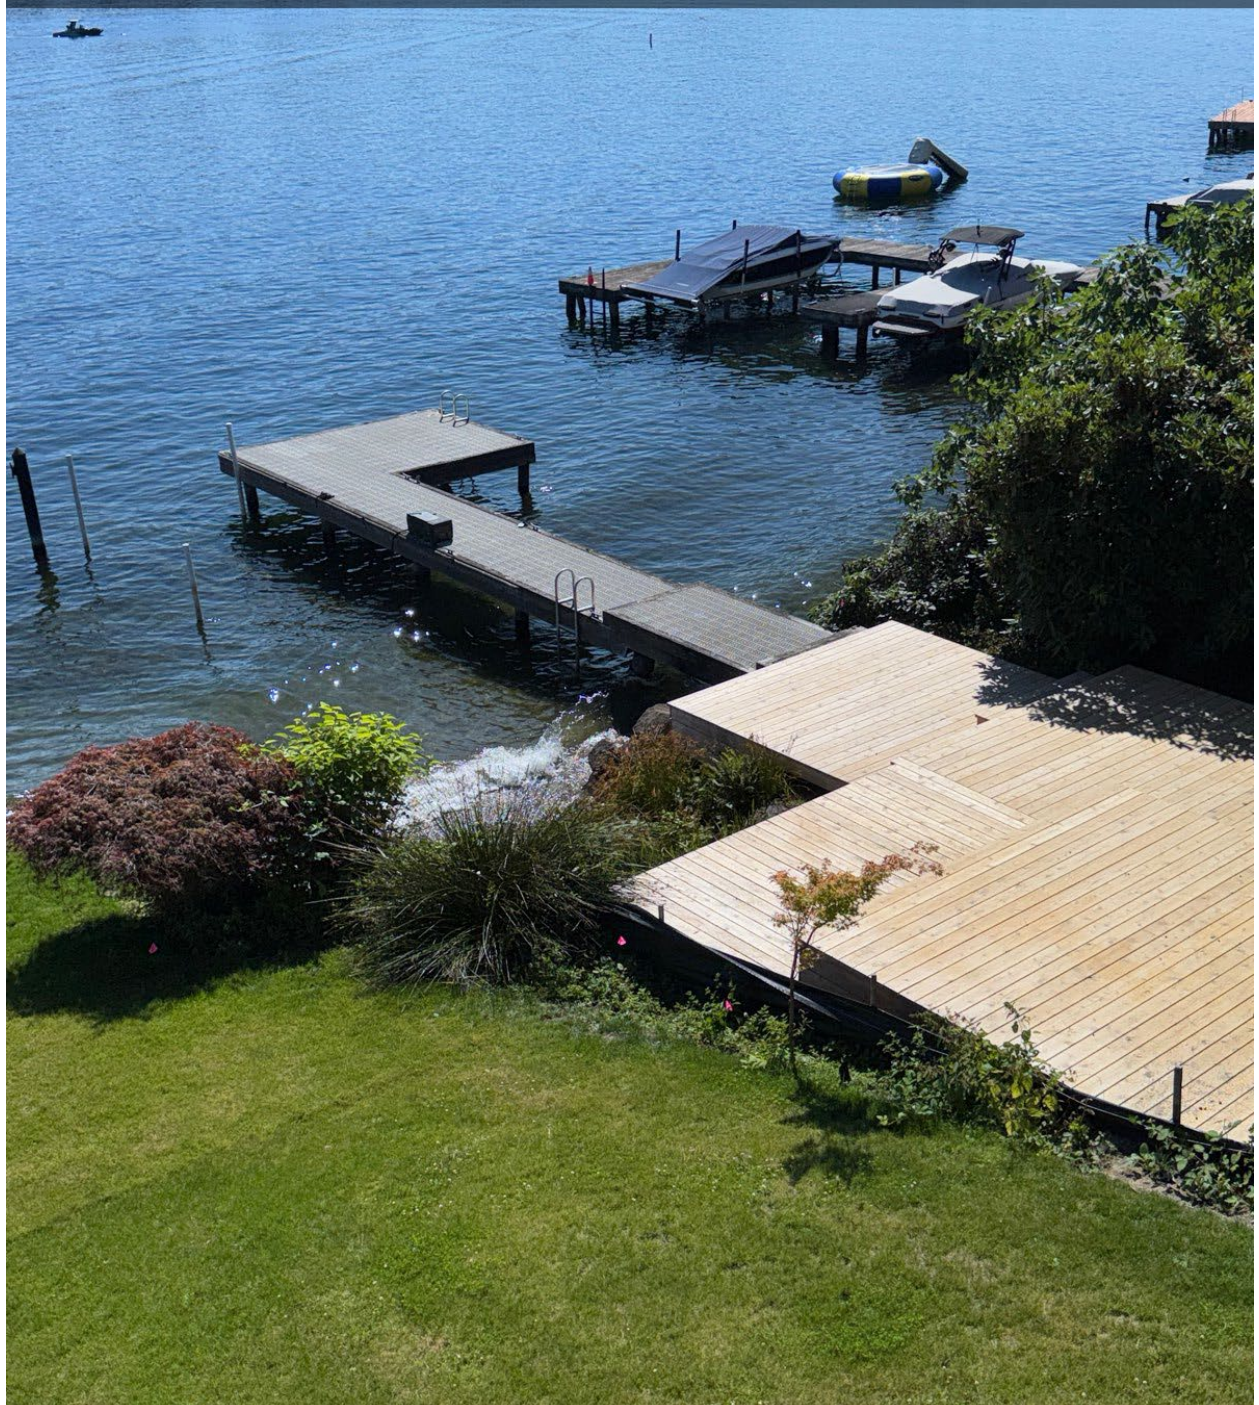
Photo 3. Photo of the Non-Regulated Wetland along deck, photo taken facing to east.

Eastside Environmental Pros, Inc. investigated the property and identified a suspected wetland onsite, adjacent to the footprint of an existing deck. However, hydrology supplied to this feature is entirely supplied by the unregulated stormwater drainage conveyance discussed in the previous section. According to previous geotechnical studies conducted on parcels nearby, a perched aquifer water table is present in the area but occurs 4–9 feet below the surface, which does not provide the shallow saturation or inundation within 12 inches of the surface that would be necessary to sustain natural wetland hydrology. In addition, according to the City’s GIS mapping and LiDAR Watercourse and Stormwater Conveyance Analysis (Herrera 2019) the area is a location for stormwater conveyance discharges. The observed wetland indicators are therefore attributable to artificial groundwater created by an evidenced stormwater drain line that disperses beneath the deck and to the lake rather than a naturally occurring system. Therefore, this feature does not meet wetland criteria and is not regulated per the USACE definition.

Mercer Island’s critical areas regulations are intended to protect wetlands that provide natural hydrologic, biologic, and ecological functions; however, wetlands maintained only by artificial water sources fall outside the scope of regulation unless specifically created for mitigation or development requirements. Since this wetland’s hydrology is not naturally occurring and is sustained solely by artificial stormwater conditions, it should be designated as non-regulated.

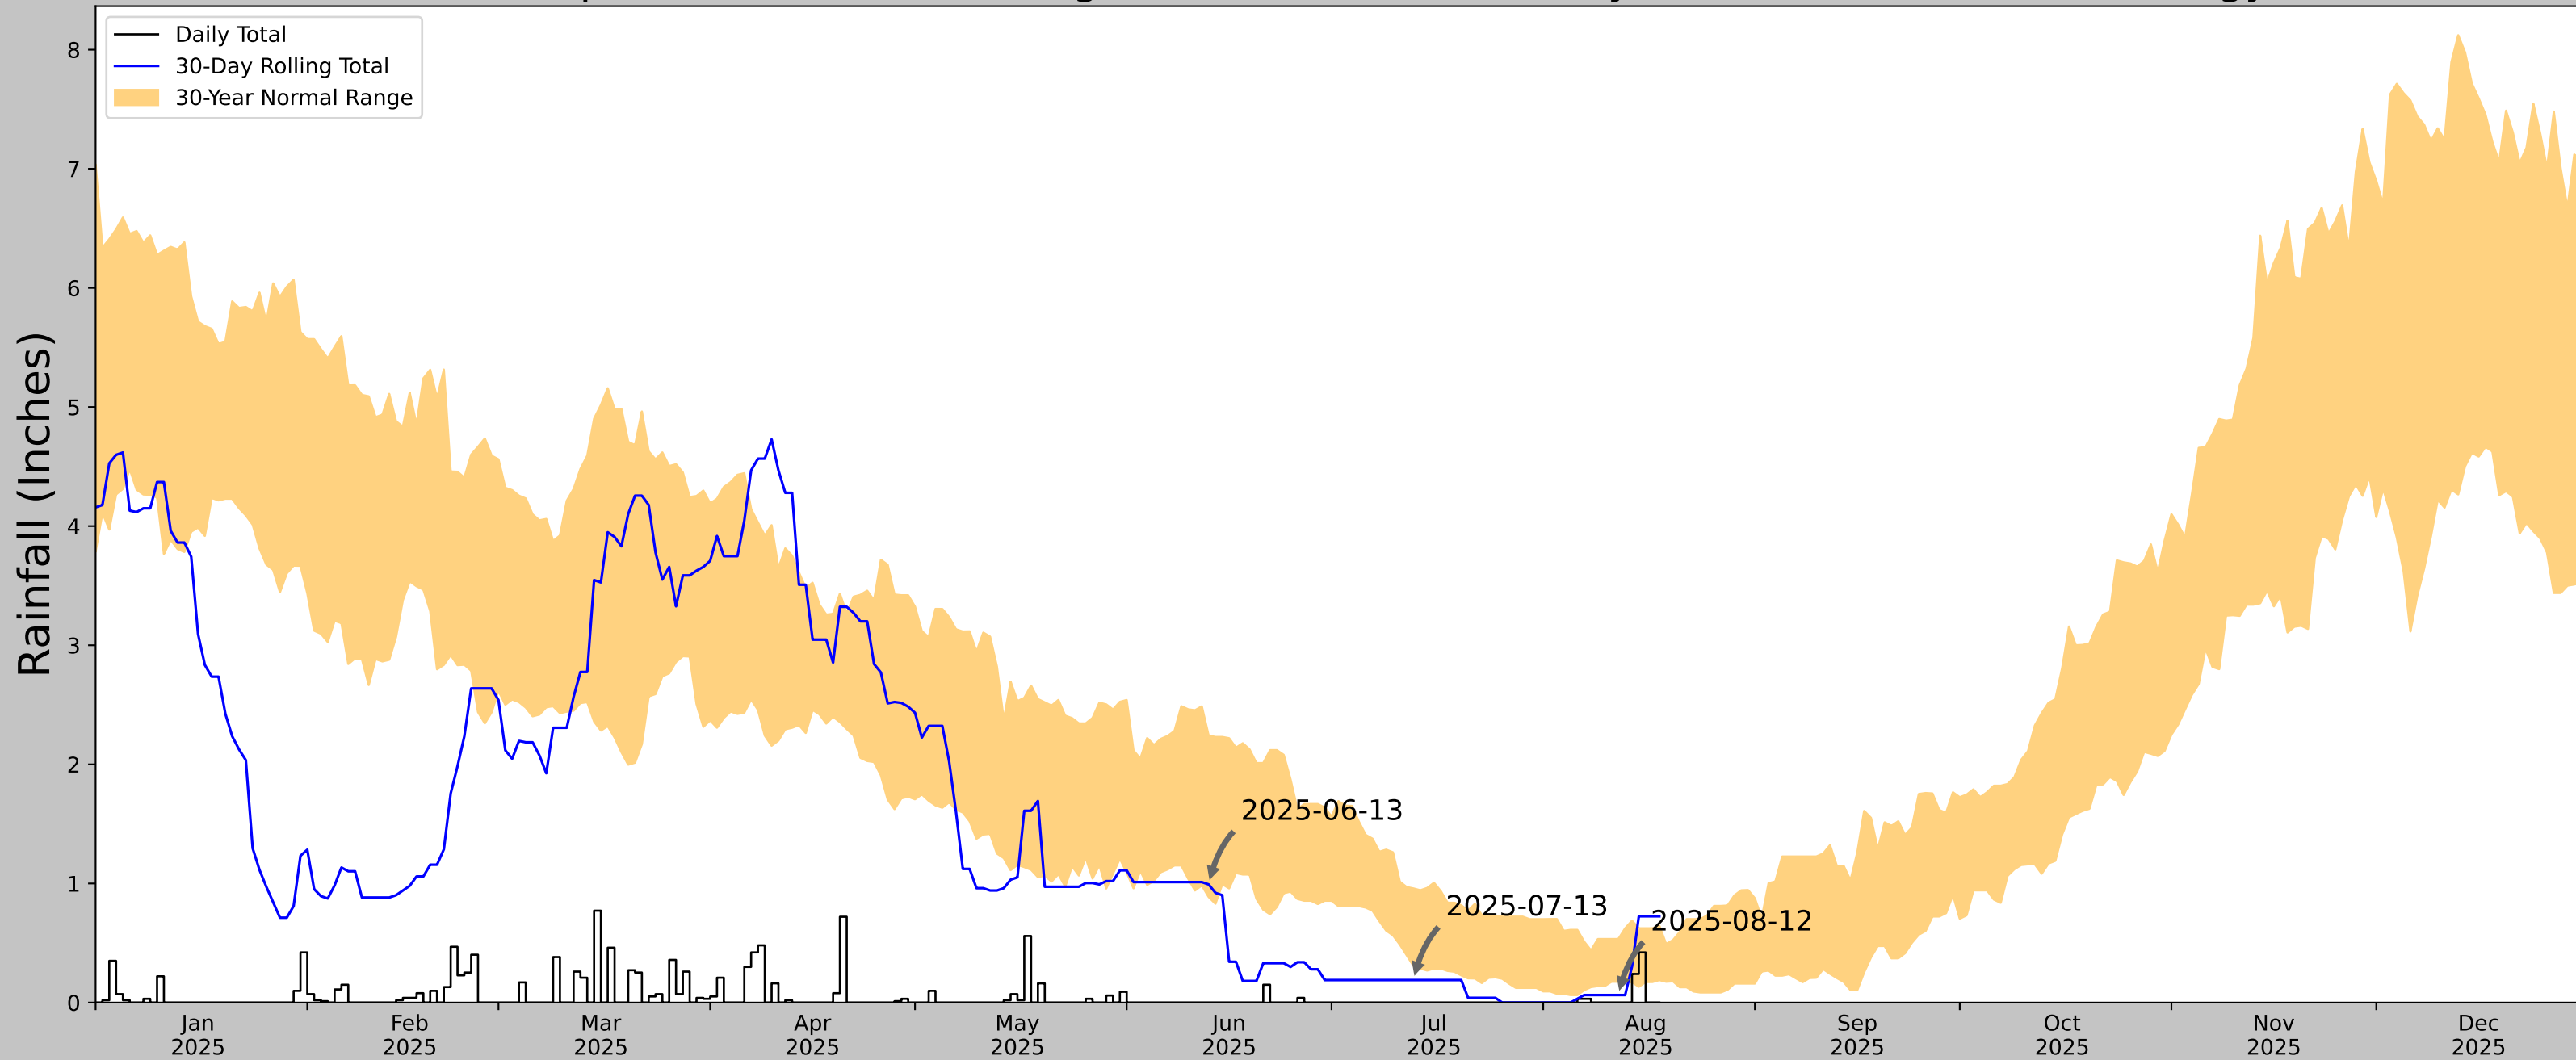
Antecedent Precipitation vs Normal Range based on NOAA's Daily Global Historical Climatology Network

Coordinates	47.55322, -122.21025
Observation Date	2025-08-12
Elevation (ft)	36.23
Drought Index (PDSI)	Severe drought (2025-07)
WebWIMP H ₂ O Balance	Dry Season

30 Days Ending	30 th %ile (in)	70 th %ile (in)	Observed (in)	Wetness Condition	Condition Value	Month Weight	Product
2025-08-12	0.174803	0.533465	0.062992	Dry	1	3	3
2025-07-13	0.307874	0.958268	0.188976	Dry	1	2	2
2025-06-13	0.887008	2.241732	0.992126	Normal	2	1	2
Result							Drier than Normal - 7

This normal precipitation analysis follows the methodology described by Sprecher and Warne (2000). The Corps Antecedent Precipitation application tool was used to determine that drier than normal climatic conditions were present during the 12 August 2025 Site Evaluation.

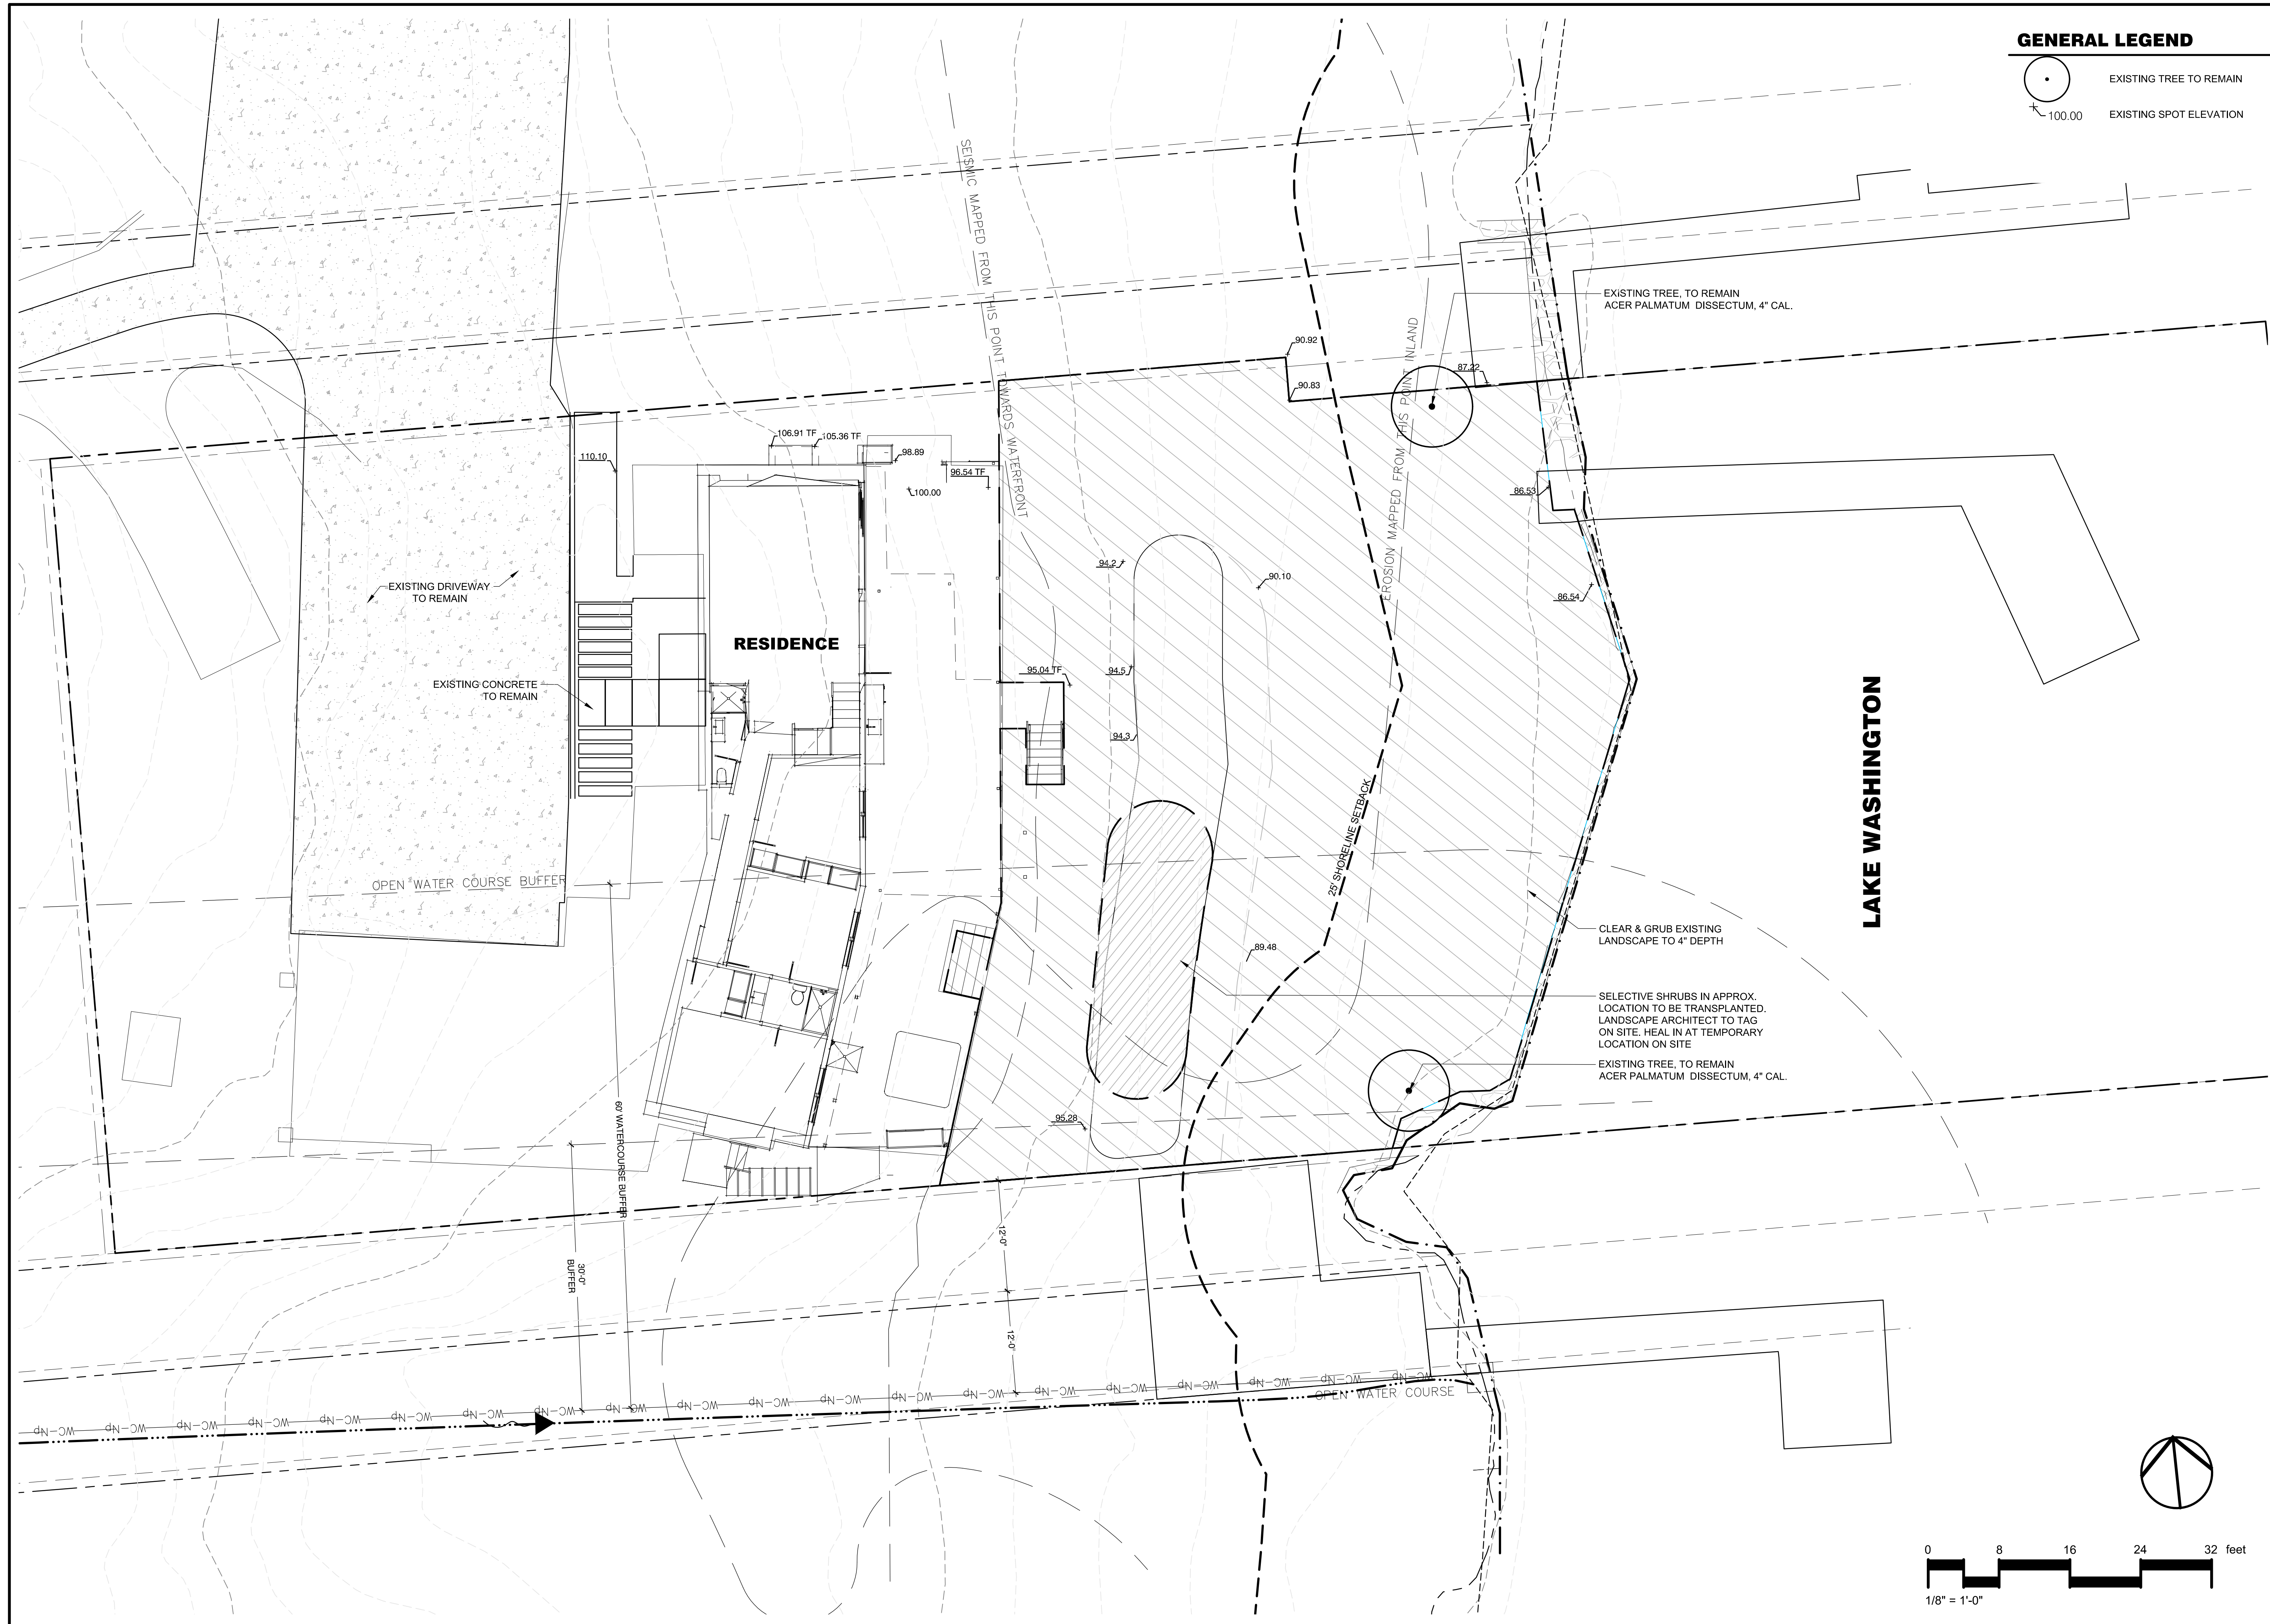
L1.0

LAMB RESIDENCE
EXISTING CONDITIONS & DEMO PLAN
5450 E MERCER WAY MERCER ISLAND, WA 98040
