CRITICAL AREAS STUDY AND NO NET LOSS REPORT

Mercer Island Dock System Maintenance Project

**6830 96th Avenue SE
Mercer Island, WA 98040
Parcel #258070-0030**

January 2026

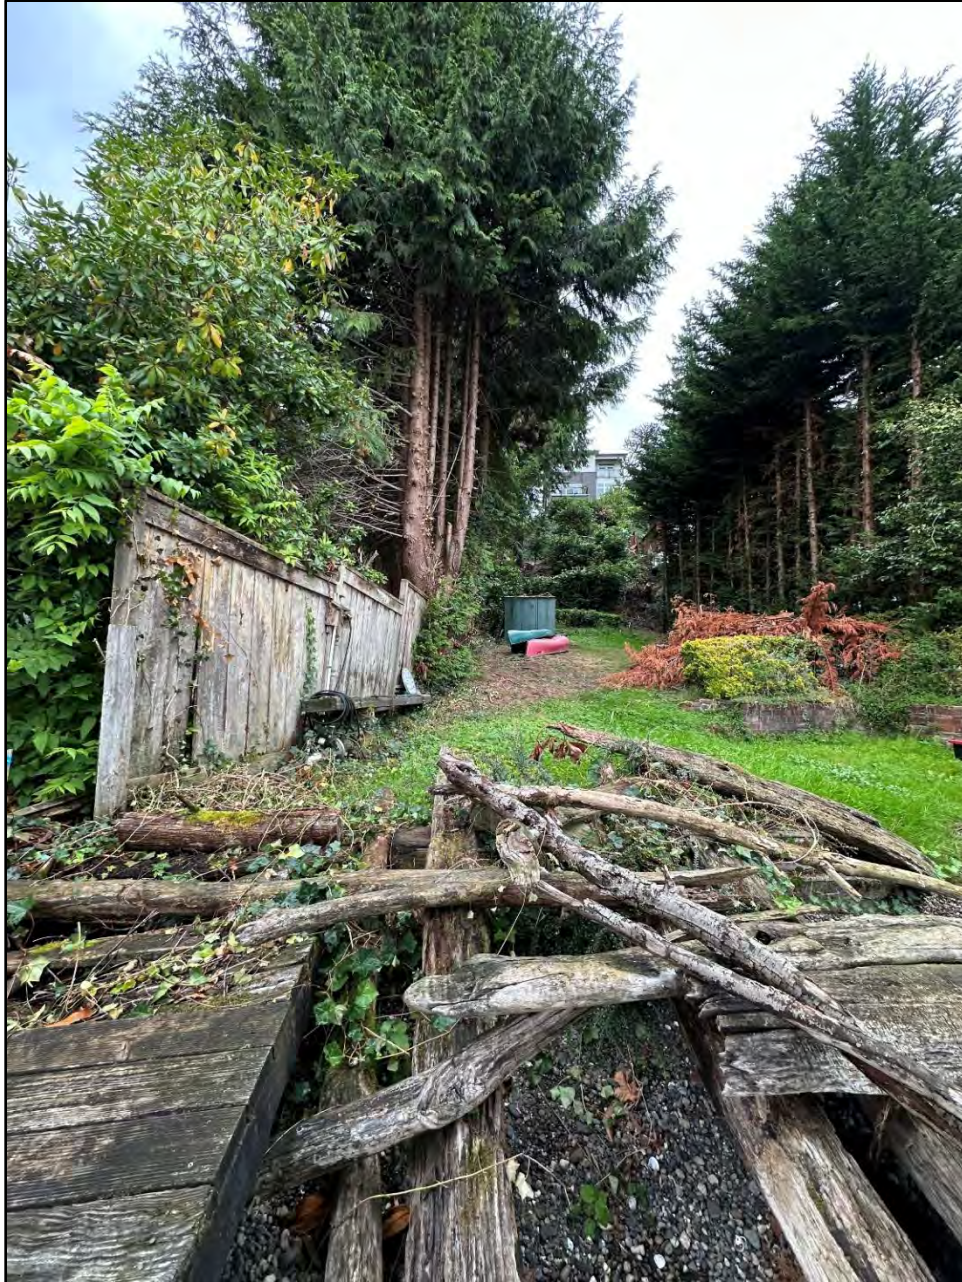
The eastern half of the parcel is largely undeveloped, apart from a small shed, and a brick patio located within 16 feet of the concrete bulkhead. This area is primarily lawn, with several areas of exposed soil resulting from repeated foot traffic to and from the shoreline. Several pieces of large woody material (LWM) and a notable quantity of anthropogenic debris were observed along the shoreline. Vegetation along the shoreline, and within approximately 20 feet upland of the bulkhead, includes English ivy (*Hedera helix*), horsetail (*Equisetum arvense*), white clover (*Trifolium repens*), creeping buttercup (*Ranunculus repens*), Himalayan blackberry (*Rubus bifrons*), common plantain (*Plantago major*), herb Robert (*Geranium robertianum*), kinnikinnick (*Arctostaphylos uva-ursi*), morning glory (*Ipomoea lacunose*), and lawn (Figure 5).

Figure 5. Project Shoreline Habitat
Photograph facing west towards the upland.

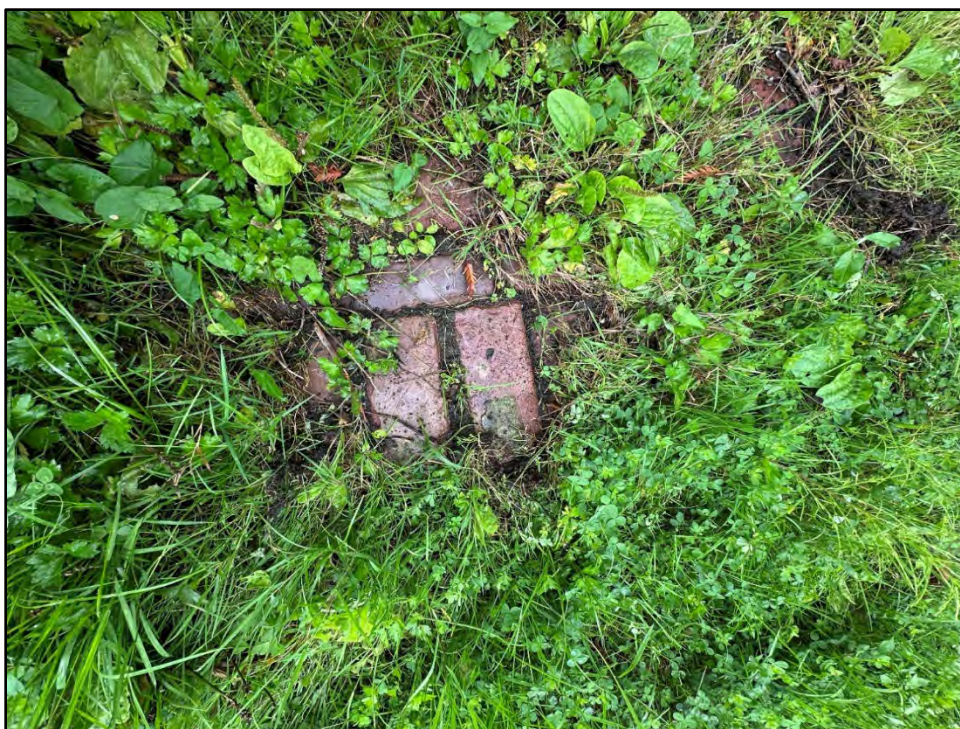
Figure 6. Vegetation Covered Brick Patio Immediately Landward of Shoreline

Although none of the soils on Site are mapped by NRCS as hydric, the area within 25 feet landward of the concrete bulkhead (lowest elevation on Site), contained the highest probability for any wetland indicators to be present. Within this area, the L-E biologist did observe marginal wetland vegetation species (e.g., *Ranunculus repens* and *Equisetum arvense*). However, there were multiple facultative upland species¹ resulting in a conclusion that the wetland species present were incidental. Most importantly, the soils in this area were unable to be investigated due to the presence of an old brick patio beneath the existing vegetation (Figure 6) and immediately upland of the bulkhead. Wetland hydrology and hydric soil indicators were not observed during the Site visit. No streams (ephemeral or perennial) were observed during the Site visit. Therefore, no wetlands or streams were identified on or immediately adjacent to the Site.

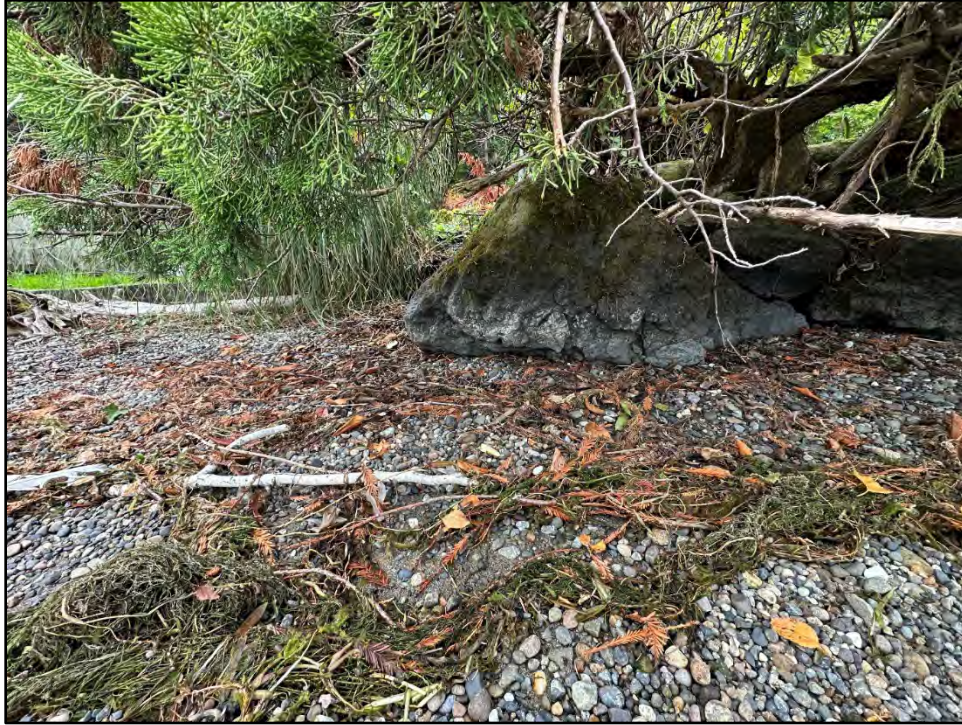
Figure 7. OHW Indicators

The Site immediately abuts the shoreline of Lake Washington. The OHW of Lake Washington is hydraulically controlled by the USACE at the Hiram M. Chittenden Ballard Locks, resulting in fluctuating seasonal lake elevations between 20 and 22 feet above sea level (USACE 2025). During the October 2025 Site visit, a distinct wrack line was observed ranging one to four feet waterward of the existing concrete bulkhead, along with additional OHW indicators including water staining on LWM and a boulder near the northern property boundary, and a clear transition from

unvegetated shoreline waterward the bulkhead to established upland vegetation landward of it (Figure 7). Given the controlled, non-tidal water level fluctuations and the presence of well-established upland vegetation immediately landward of the bulkhead, OHW is assumed to be no higher than the face of the bulkhead for this Project.

OHW indicators include the wrack line and discoloration.

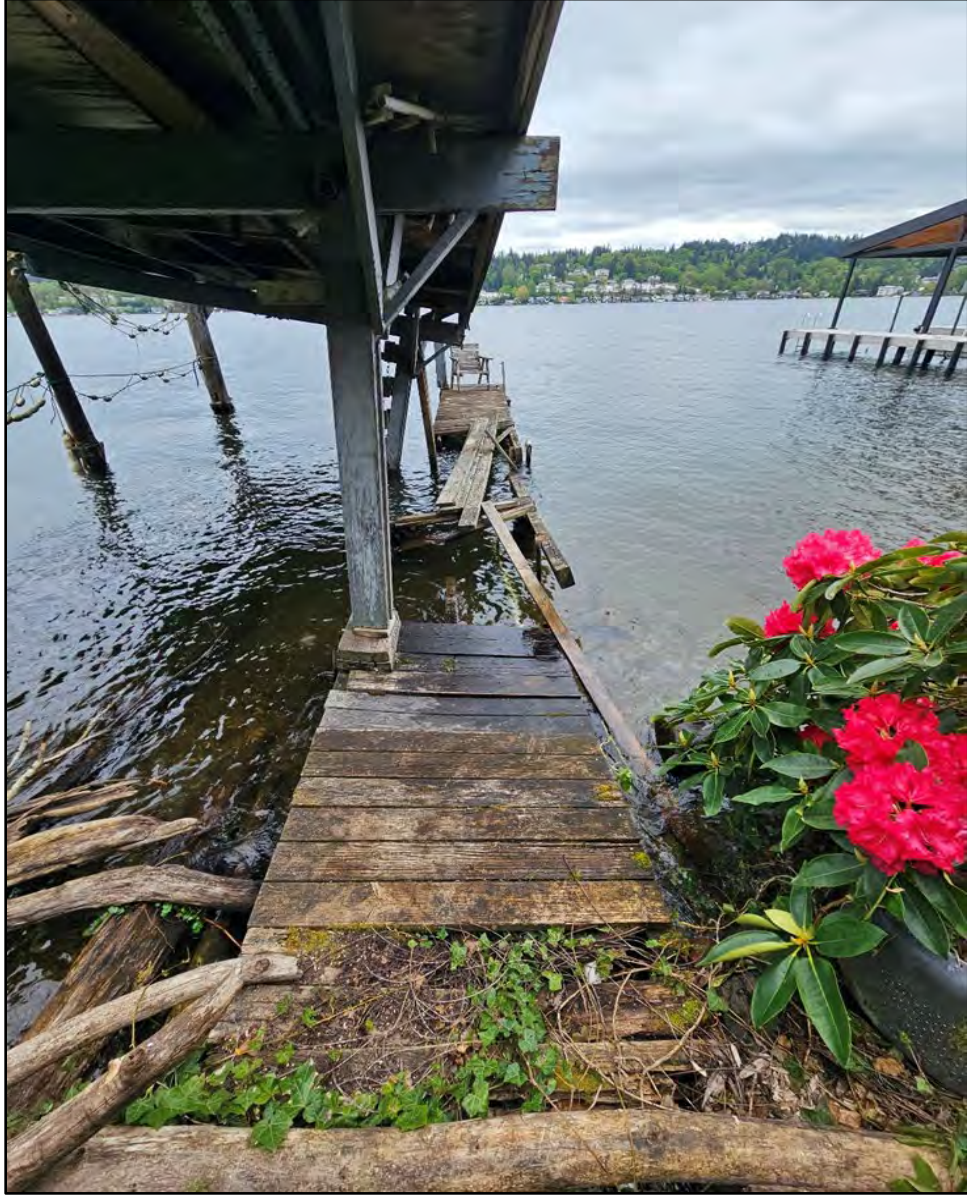
Figure 8. Existing Covered Dock System

The existing creosote-treated timber covered dock system is significantly deteriorated with several boards missing and parts of the structure leaning, making access unsafe. To avoid further degradation and to remove harmful creosote from this freshwater aquatic environment (Lake Washington), the Project proposes replacing approximately 754 square feet (SF) of creosote-treated decking with an approximately 398 SF premanufactured system. This system will be comprised of fully grated fiberglass decking, aluminum framing, and steel pin piles. The replacement pier and float system will effectively reduce the overwater coverage by nearly 50 percent (approximately 356 SF). The existing 14- to 16-inch diameter creosote-treated piles will be replaced with 16 eight-inch steel pin piles. The new dock will attach to, and not extend upland of, the existing concrete bulkhead, consistent with the current configuration, and will be constructed entirely within the footprint of the existing covered dock along the Site's 29 linear feet (LF) of shoreline.

The existing creosote treated wood covered dock system has significantly deteriorated making access unsafe. To avoid further degradation and to remove harmful creosote from the freshwater aquatic environment, this maintenance Project proposes to replace the existing 754-SF creosote-treated decking with a 398-SF fully grated, premanufactured system. The existing 14- to 16-inch diameter creosote timber piles will be replaced with steel pin piles, and the proposed replacement dock system will be attached to the existing concrete bulkhead in a similar manner to its current attachment (Tables 3 and 4; Figures 8 and 9; Appendix A). The proposed maintenance Project will occur entirely within the footprint of existing covered dock system. No shoreline, riparian or upland vegetation will be impacted or removed, and no upland soil disturbance will occur as a result of the Project. In Figure 9, the Project parcel is outlined in yellow and proposed replacement dock system is highlighted in red.

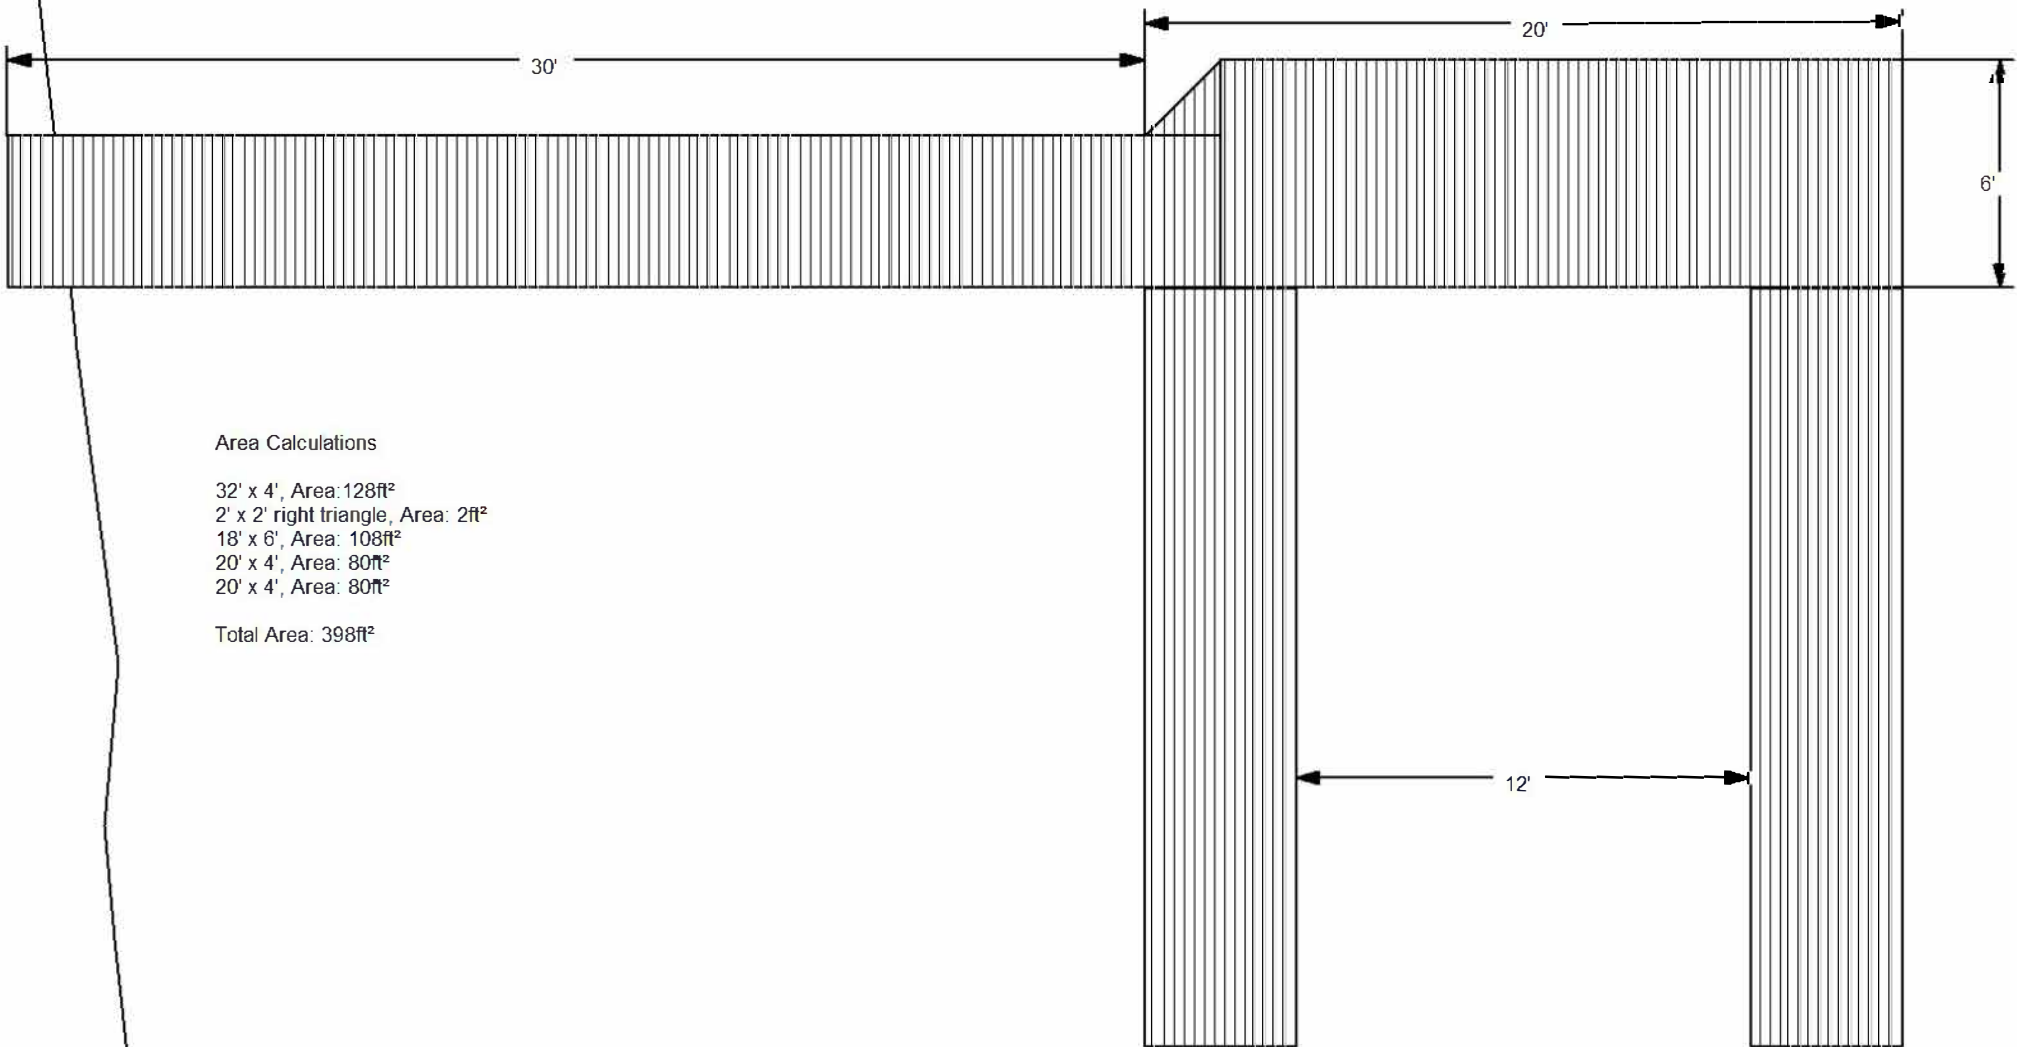
Area Calculations

- 32' x 4', Area: 128ft²
- 2' x 2' right triangle, Area: 2ft²
- 18' x 6', Area: 108ft²
- 20' x 4', Area: 80ft²
- 20' x 4', Area: 80ft²

Total Area: 398ft²
