SUBJECT: ARSENIC IN SOIL CLEANUP ACTION
Saintfield Property
7414 78th Avenue Southeast
Project Number: 1673-001

Sound Earth Strategies, Inc. (SoundEarth) has prepared this letter report on behalf of Atlin Investments to document the results of a cleanup action completed at the Saintfield Property located at 7414 78th Avenue Southeast in Mercer Island, Washington (the Property: Figure 1) on February 13, 2025, and March 5, 2025. The purpose of the cleanup action was to remove and properly dispose of an isolated pocket of near-surface soil with arsenic concentrations exceeding the applicable Washington State Model Toxics Control Act (MTCA) Method A cleanup level.

SAINTFIELD PROPERTY
 7414 78TH AVENUE SOUTHEAST
 MERCER ISLAND, WASHINGTON
 SOUNDEARTH PROJECT #: 1673-001

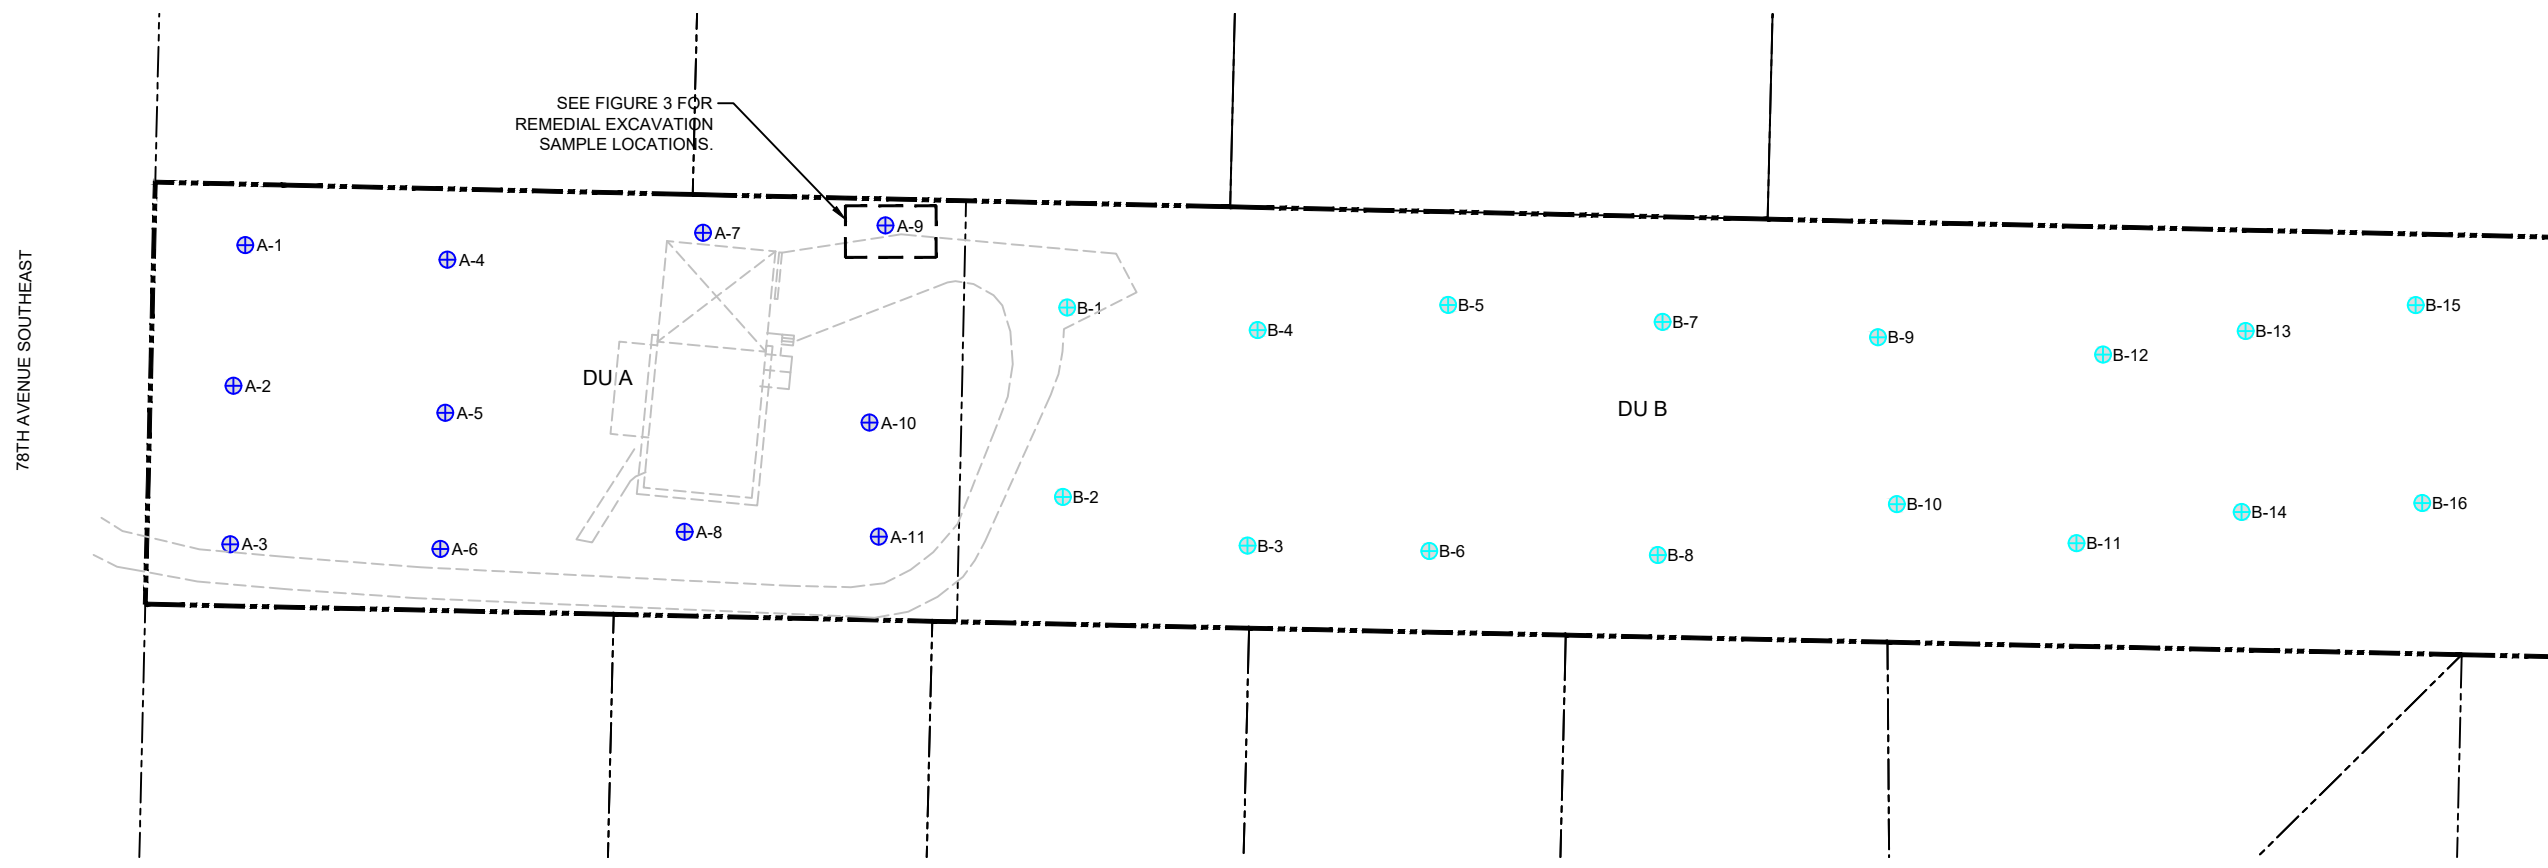
FIGURE 2

INDEX LOCATION PLAN

APPROXIMATE NORTH PROPERTY LINE

APPROXIMATE LIMITS OF EXCAVATION

SHADED AREA INDICATES SOIL MIXED IN PLACE

The Property consists of one tax parcel (King County Parcel No. 252404-9075) that covers approximately 68,825 square-feet (1.58 acres) of land (Figure 2) and is currently in the final stages of mass grading for redevelopment into four residential lots. A release of arsenic to near-surface soil exceeding the applicable MTCA Method A cleanup level was identified during a recent Tacoma Smelter Plume (TSP) Assessment of the Property by others (Terra Associates, Inc. [Terra] 2023). Locations of soil samples collected by Terra in two evaluation areas (Decision Units DU A and DU B) are shown on Figure 2. Terra's complete report is presented in Attachment A. The Washington State Department of Ecology (Ecology) reviewed the TSP Assessment and concluded that no soil remediation for contamination associated with the TSP was needed for the Property, but recommended the arsenic exceedance documented at Terra sample location A-9 (81 milligrams per kilogram [mg/kg]) be reported to Ecology's Environmental Report Tracking System (Ecology 2024; Attachment A). SoundEarth understands the City of Mercer Island required the arsenic exceedance to be remediated to below the MTCA Method A cleanup level prior to final Property redevelopment.

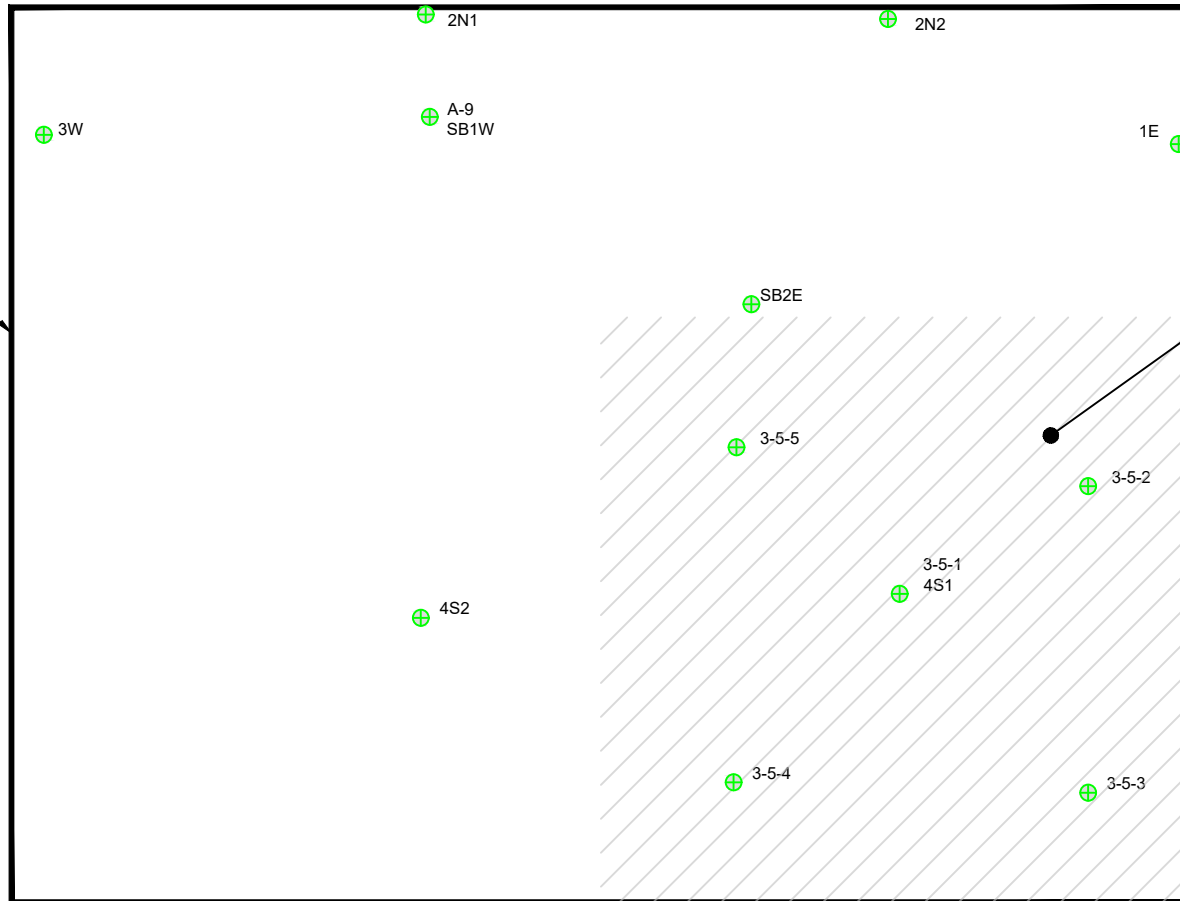
FIGURE 3

3-5-4 APPROXIMATE SAMPLE LOCATION

SAMPLE LOCATION SKETCH

excavation. Based on the results of prior sampling by others and field screening, SoundEarth collected soil samples in the excavation area from a rough grid of eight sampling locations around the location of Sample A-9 (Figure 3) and submitted the samples to OnSite Environmental, Inc of Redmond, Washington (OnSite) for laboratory analysis of total arsenic by US Environmental protection Agency (EPA) Method 6010D.

On March 5, 2025, under the observation of a SoundEarth geologist, an excavator operated by Lawson and Sons, LLC thoroughly bucket mixed an approximately 10-foot square area around the location of Sample ID 4S1 at a depth range of approximately 0 to 18 inches bgs. The mixing was performed in accordance with the TSP Model Remedies Guidance (Ecology, 2019). No visual indication of contamination was observed within the mixed soil. SoundEarth collected soil samples at five locations surrounding the location of Sample ID 4S1 (Figure 3) and submitted the samples to OnSite for laboratory analysis of total arsenic by EPA Method 6010D.

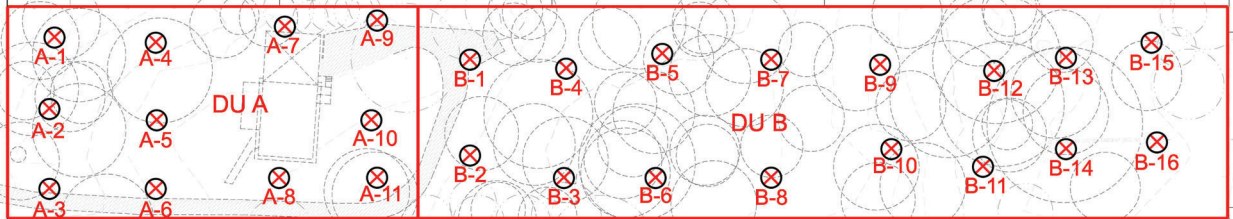
Soil sampling was conducted on May 16, 2023. For the sampling event, samples were obtained from a grid pattern superimposed on each of the two decision units for the site. Sample locations were offset around the existing residence and gravel driveway present within Decision Unit A. Soil was sampled at a total of 27 locations. Two composite duff samples, comprised of six subsamples each, were collected from Decision Unit B. A total of 35 individual samples were analyzed for lead and arsenic. Sampling proceeded in general accordance with Ecology Publication 19-09-101. Sample locations are presented in Figure 2 attached to this report.

⊗ Approximate Sample Location

The approximate location of the property is shown in Figure 1. Figure 2 is a Sample Location Plan showing existing site conditions.

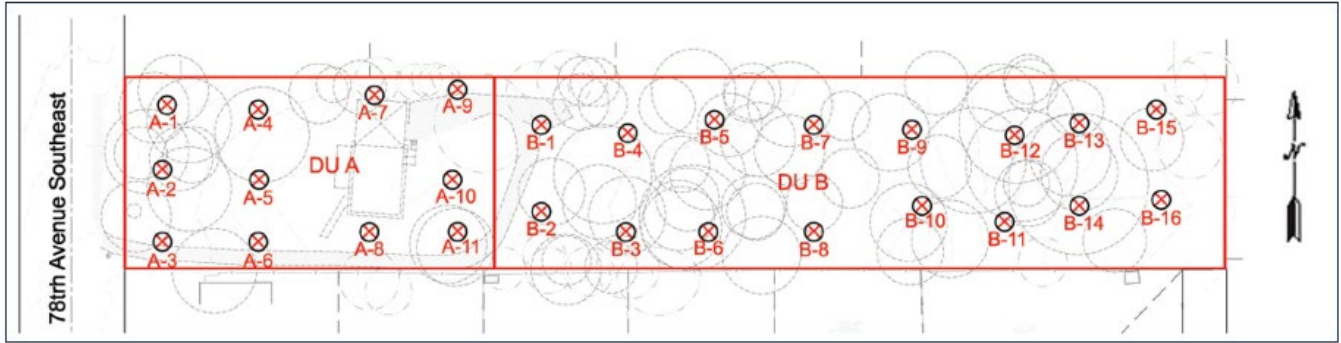
Figure 2. Soil Sampling Locations

However, location A-9 soil sample results indicate elevated arsenic. Ecology recommends filing an Environmental Report Tracking System (ERTS) report by contacting the ERTS Coordinator at the Northwest Regional Office at (206) 594-0000.
