Level 1 Downstream Analysis

Adams Residence

8035 SE 45th St.

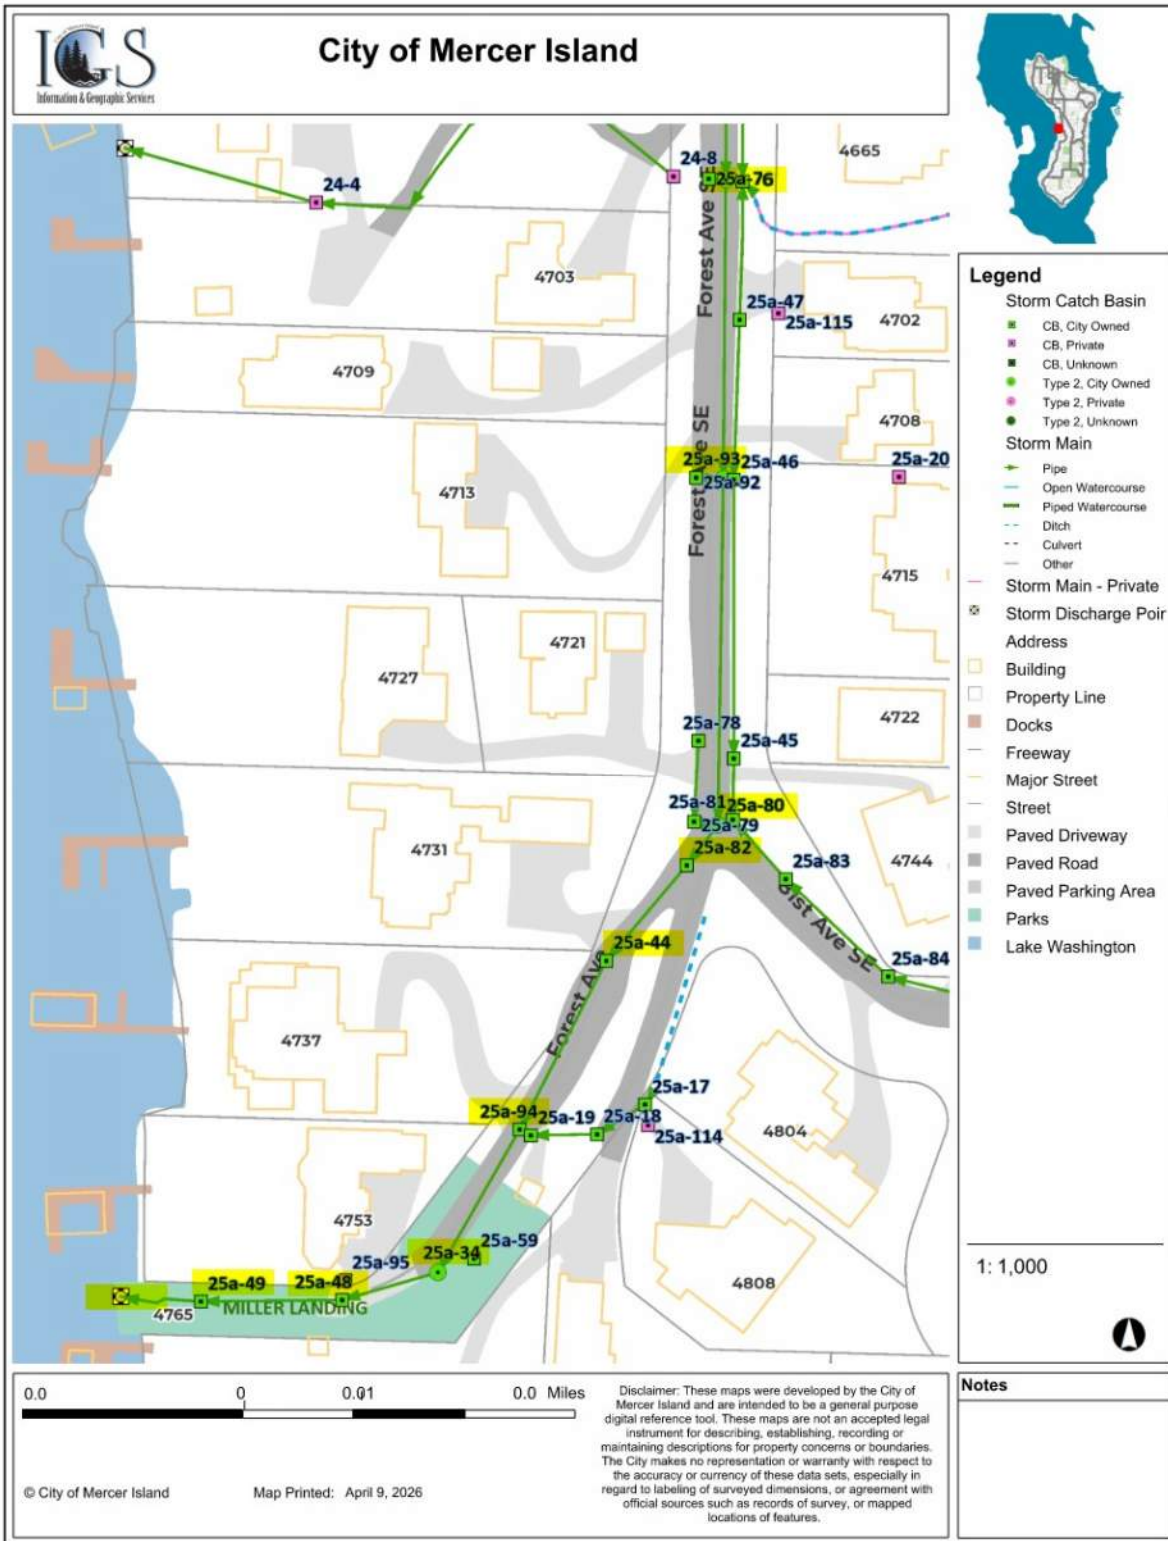
Standing on Forest Ave SE looking east towards project site. Existing 12" outfall, existing ditch, inlet pipe, and CB 24a-98.
