## Arborist Report

To: Yazan Aldehayyat  
Site: 2969 74<sup>th</sup> Ave SE, Mercer Island, WA 98040  
Re: Tree inventory  
Date: March 24, 2025  
Project Arborist: George White,  
ISA Certified Arborist PN-8908A  
ISA Qualified Tree Risk Assessor  
Reviewed By: Tyler Bunton  
ISA Certified Arborist PN-8715A  
ISA Qualified Tree Risk Assessor  
Referenced Documents: Site Plan A2 - Permit Set (Lane Williams Architects, 1.16.2025)  
Attached: Table of Trees  
Tree Site Map  
Statement of Objectivity

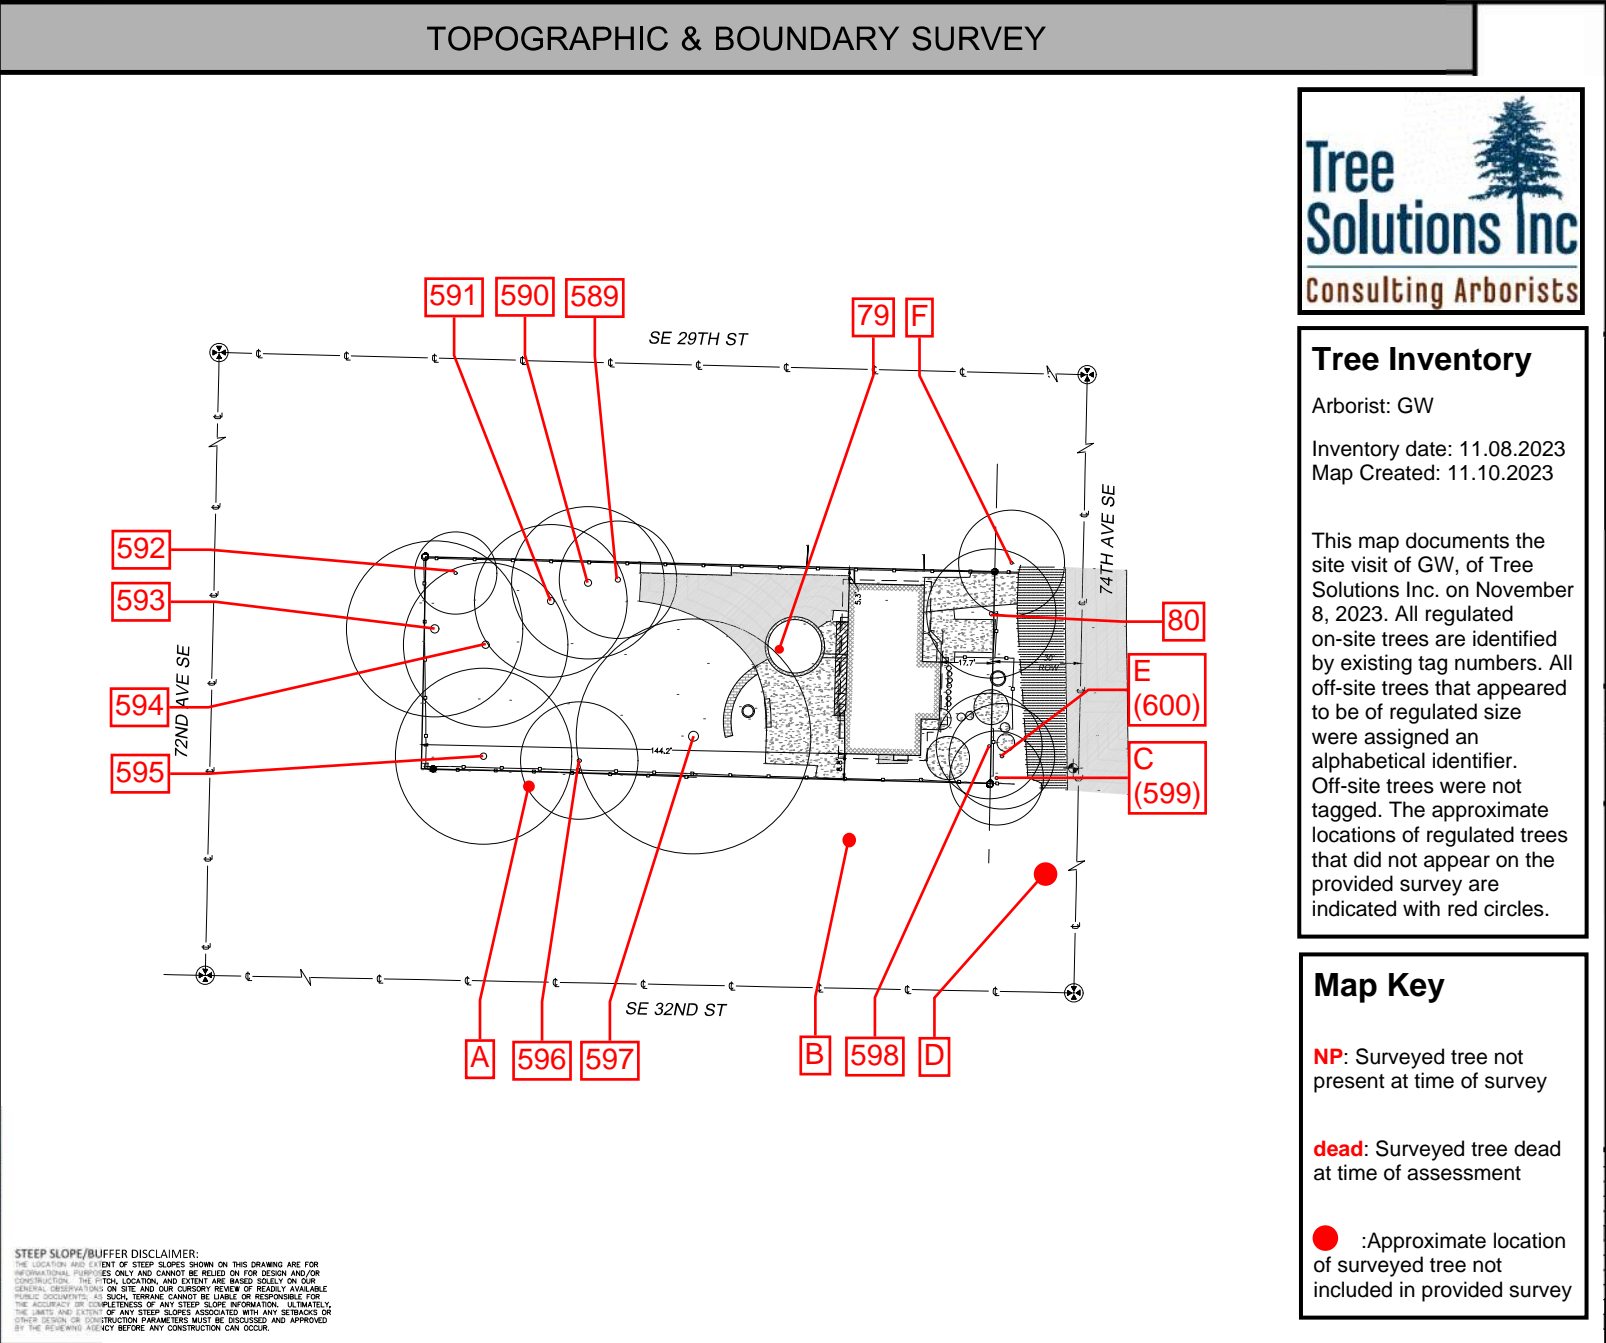
**Tree Inventory**  
 Arborist: GW  
 Inventory date: 11.08.2023  
 Map Created: 11.10.2023

This map documents the site visit of GW, of Tree Solutions Inc. on November 8, 2023. All regulated on-site trees are identified by existing tag numbers. All off-site trees that appeared to be of regulated size were assigned an alphabetical identifier. Off-site trees were not tagged. The approximate locations of regulated trees that did not appear on the provided survey are indicated with red circles.
