Arborist Report

Site: 4525 Forest Ave SE, Mercer Island, WA

Re: Tree Inventory and Assessment

Date: February 26, 2024

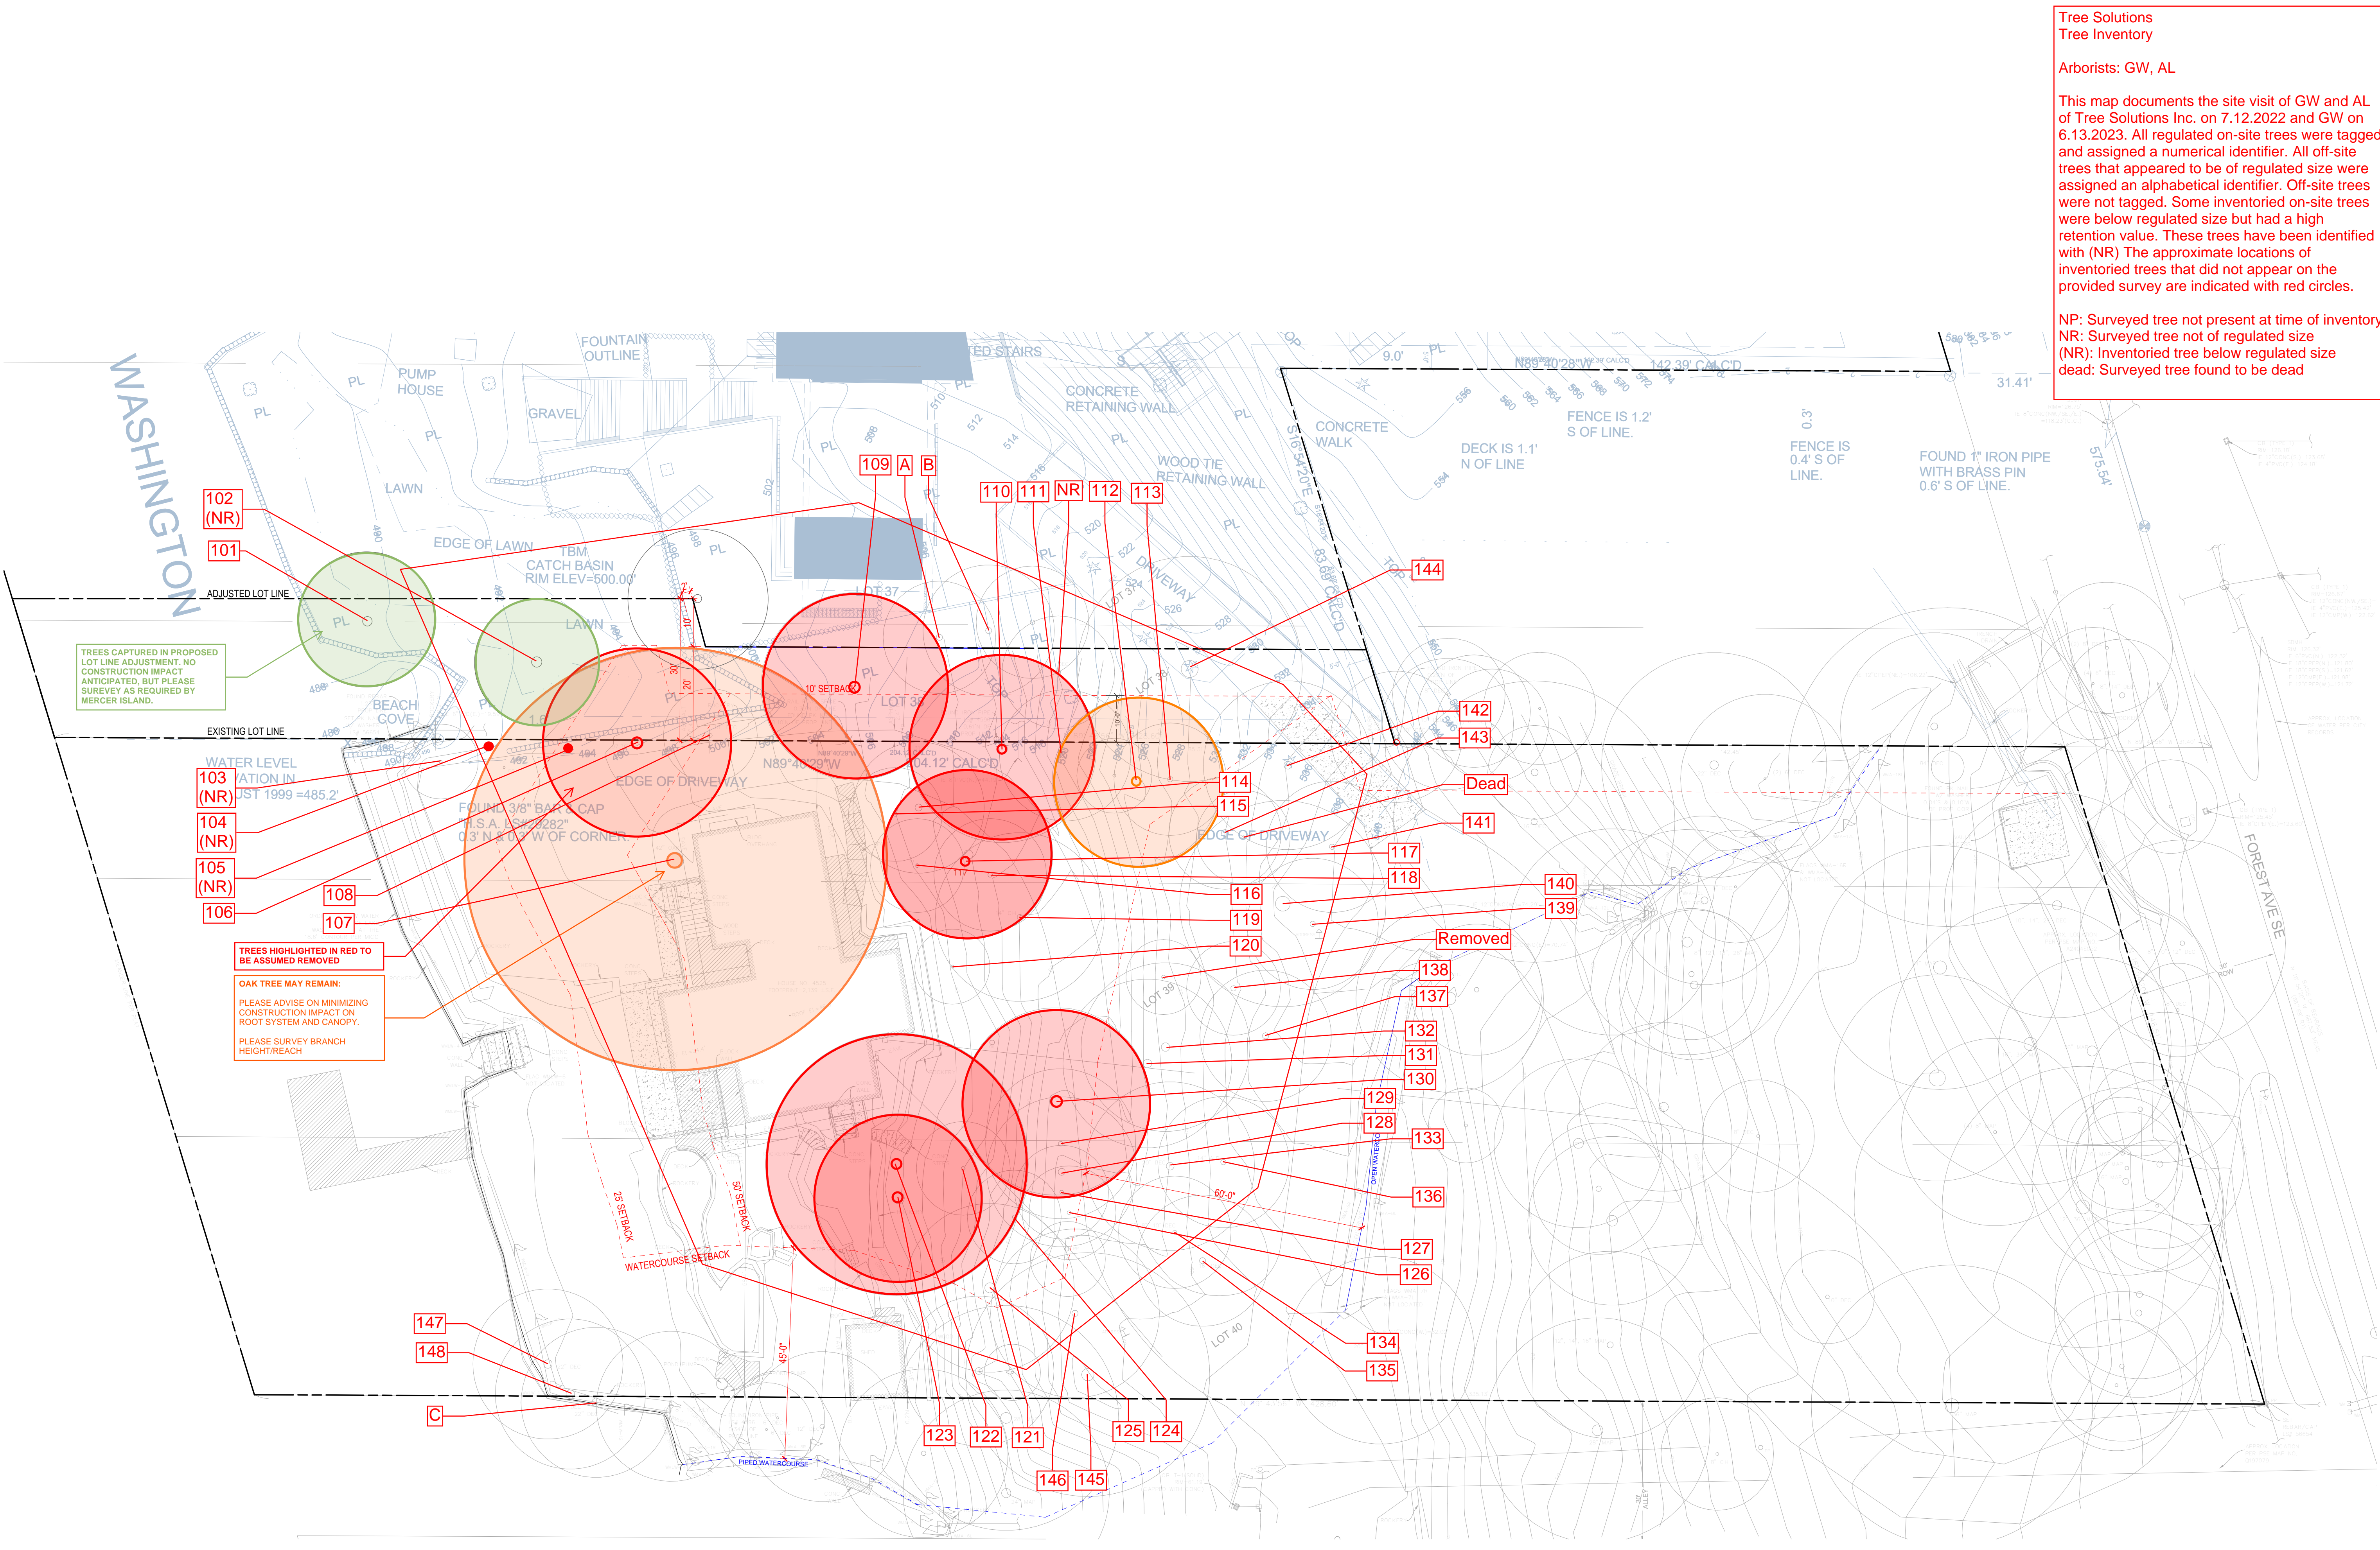
This map documents the site visit of GW and AL of Tree Solutions Inc. on 7.12.2022 and GW on 6.13.2023. All regulated on-site trees were tagged and assigned a numerical identifier. All off-site trees that appeared to be of regulated size were assigned an alphabetical identifier. Off-site trees were not tagged. Some inventoried on-site trees were below regulated size but had a high retention value. These trees have been identified with (NR) The approximate locations of inventoried trees that did not appear on the provided survey are indicated with red circles.

NP: Surveyed tree not present at time of inventory
NR: Surveyed tree not of regulated size
(NR): Inventoried tree below regulated size
Dead: Surveyed tree found to be dead

TREES CAPTURED IN PROPOSED LOT LINE ADJUSTMENT, NO CONSTRUCTION IMPACT ANTICIPATED, BUT PLEASE SURVEY AS REQUIRED BY MERCER ISLAND.
