ARBOR INFO LLC

**Tree Assessment
For
Sturman Architects
At
8413 SE 82nd St.
Mercer Island, Washington**

**Date
6/13/2024(rev 8/22/2024)**

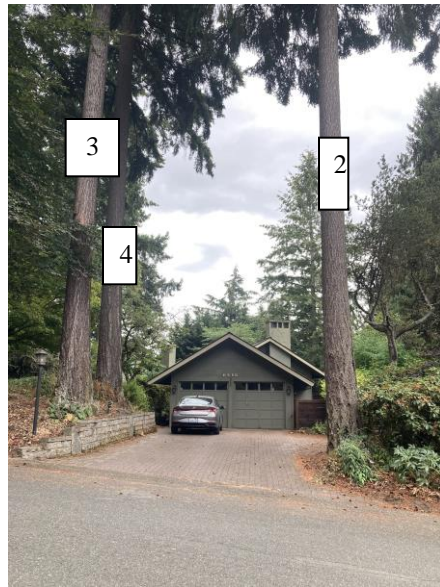
Tree 2:

The existing 30.5" Douglas Fir canopy and root zone overlap the existing driveway. There will be a new driveway installed and the concern is that the root system will crack the new concrete. We will not be expanding the driveway but will be following the existing footprint for the new concrete.
