DOWNSTREAM ANALYSIS
FOR
SINGLE FAMILY RESIDENCE
2419 72ND AVE SE
MERCER ISLAND, WA 98040

May 20, 2024

C2MY Engineers, LLC
P.O. Box 52883
Bellevue, WA 98015-2883
Contact: Choomeng Chin
(206) 451-7856
cmchin.c2my@gmail.com

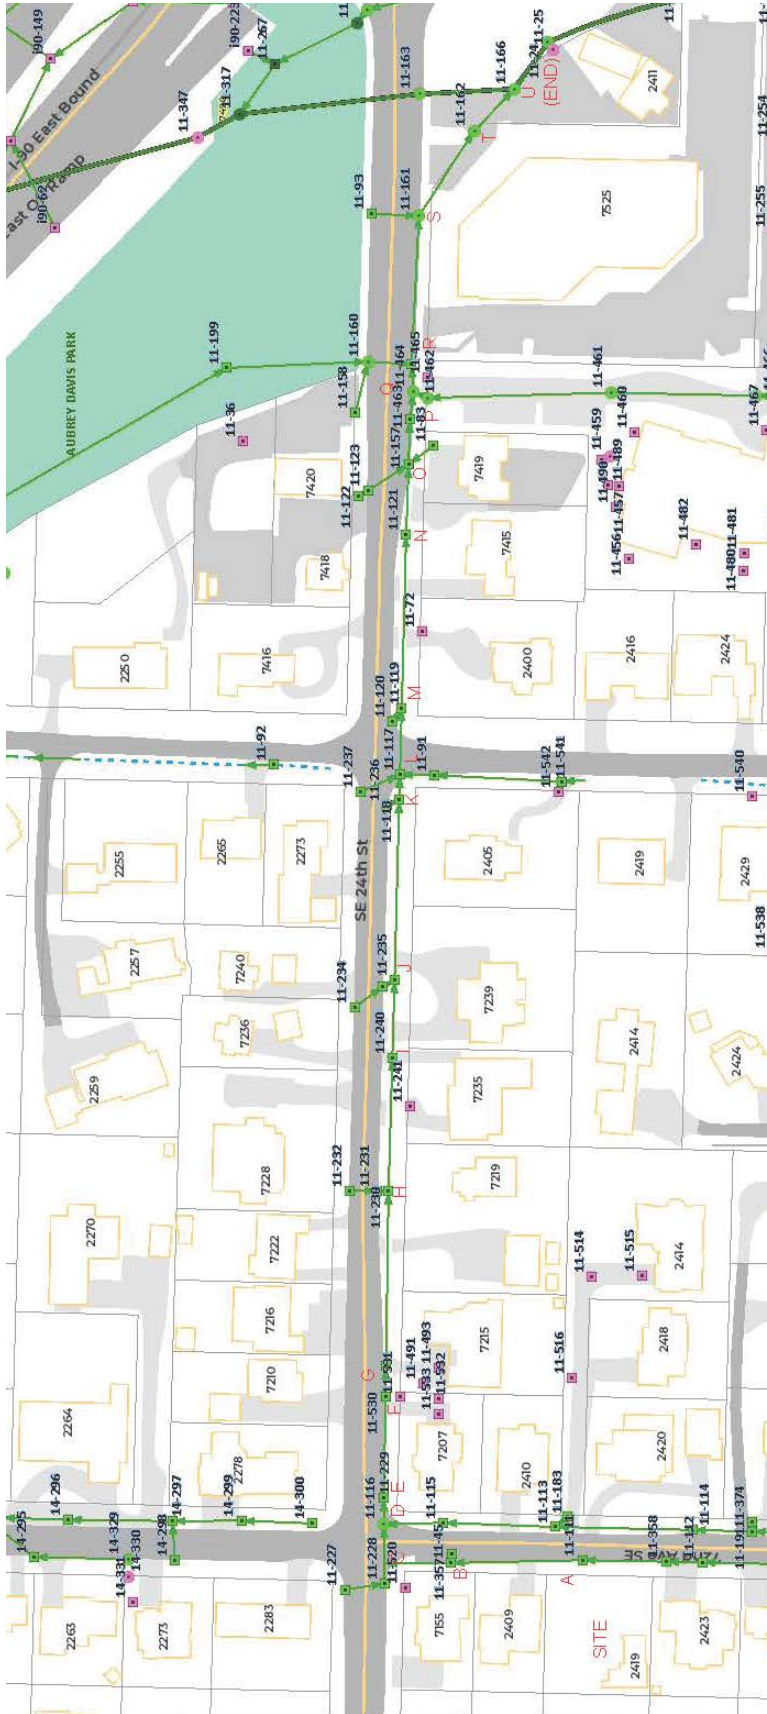
FIGURE 5: DOWNSTREAM MAP (NTS)

- Presently, site runoff discharges sheet flow at the east property line (**A**) to the street drainage system and flows northerly. Surface flow enters a Type 1 CB (**B**) with solid grade from an open grate catch basin next to it approximately 109 l.f. from the property (See Figure 5, Downstream Map). It continues in a 12" concrete pipe on the east edge of the street approximately 57 l.f. that connect to the SE 24th St drainage system at point (**C**) without a structure per GIS record. Then, it continues travels easterly approximately 33 l.f. to a CB (**D**) with vaned grate located near the southeast corner of the intersection, it then continues to another catch basin (**E**) with vaned grate located at the curb line approximately 22 l.f. From here, runoff travels approximately 85 l.f. in the same direction to a CB (**F**) with grate located at the driveway approach. Then, it continues approximately for another 22 l.f. to a solid grate CB (**G**) located at another driveway approach. At this point runoff continues through multiple catch basins (**H** to **L**) with solid grate located at the asphalt sidewalk approximately 502 l.f. to the southwest corner intersection of 74th Ave SE and SE 24th St. It then crosses 74th Ave SE approximately 56 l.f. to another solid grate catch basin (**M**) located at the sidewalk. From here, it continues at the similar fashion approximately 146 l.f. to another solid grate CB (point **N**). Then , it continues approximately 59 l.f. to another catch basin (**O**) with vaned grate located at the curb line. From here, it continues to another solid grate CB (**P**) approximately 38 l.f. It

then enters another catch basin (Q) approximately 23 l.f. located at the curb line of a driveway. It continues easterly approximately 22 l.f. to yet another solid grade CB (R) near the curb line. Then, it travels approximately 126 l.f. to another CB (S) with vaned grate located at the curb line. At this point, runoff continues southeasterly direction approximately 84 l.f. to a Type II CB (T) with round solid grate. Runoff continues southeasterly approximately 46 l.f. to discharge to a pipe water course in a Type II CB (U) with open round grate where the analysis is terminated for a total approximately distance of 1,380 l.f. During the downstream drainage field visit, no drainage issues were observed and no areas of any existing or potential major drainage problems were apparent.

The downstream drainage system as described above is not prone to stream bank erosion, siltation, and slide and does not threaten destruction of aquatic habitats. Catch basins as observed are mostly clean and sediment in the catch basins are below the invert of the outlet pipes. No open ditch existed along the route. Due to the fairly steep slope of the analysis route, the conveyance pipes system does not appear to have a capacity problem or show any sign of overtopping in any of the structure.

No off-site mitigation is necessary as there are no observed major drainage issues during the analysis for the downstream portion and runoff discharges from this site will be very minimal to downstream system.
