Arborist Report - Note to Reviewers

Project: **7615 E Mercer Way** (Cheshire Residence)

Note to Reviewers re: Following Arborist Report

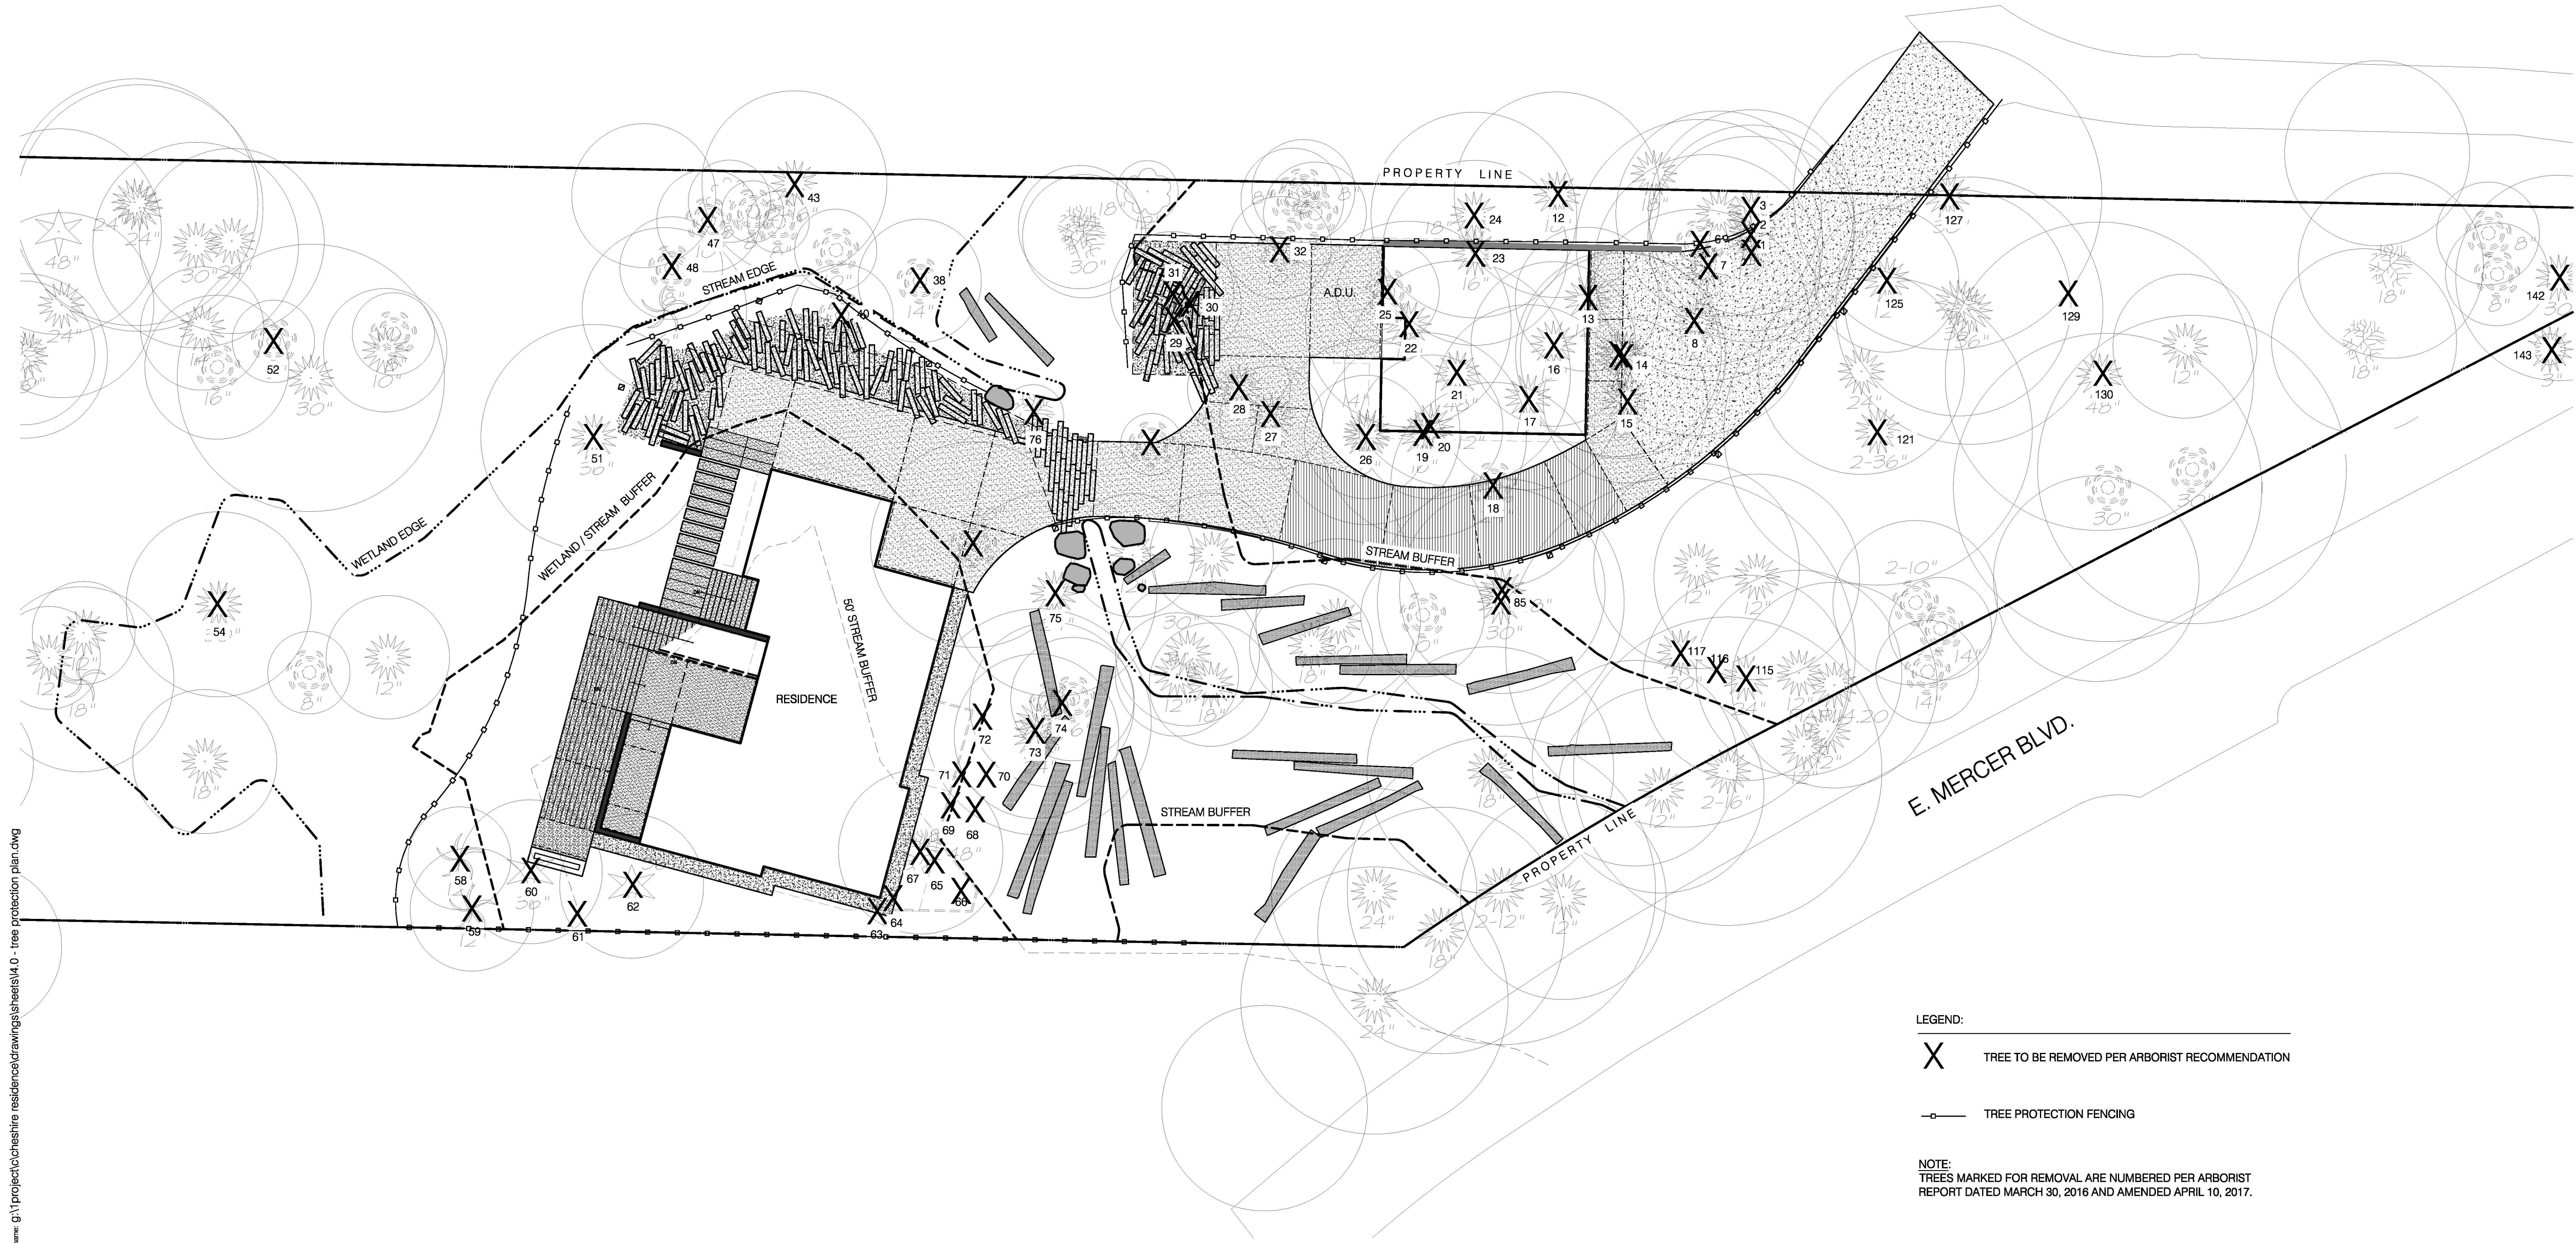
DRAWN-CHECKED:
 JMU/JH
 SHEET NAME:
TREE PROTECTION PLAN
 SHEET NUMBER:
L4.0

X TREE TO BE REMOVED PER ARBORIST RECOMMENDATION

NOTE:
TREES MARKED FOR REMOVAL ARE NUMBERED PER ARBORIST REPORT DATED MARCH 30, 2016 AND AMENDED APRIL 10, 2017.
