ARBORIST REPORT

4103 78th Avenue SE
Mercer Island, WA

July 31, 2025
Updated September 18, 2025

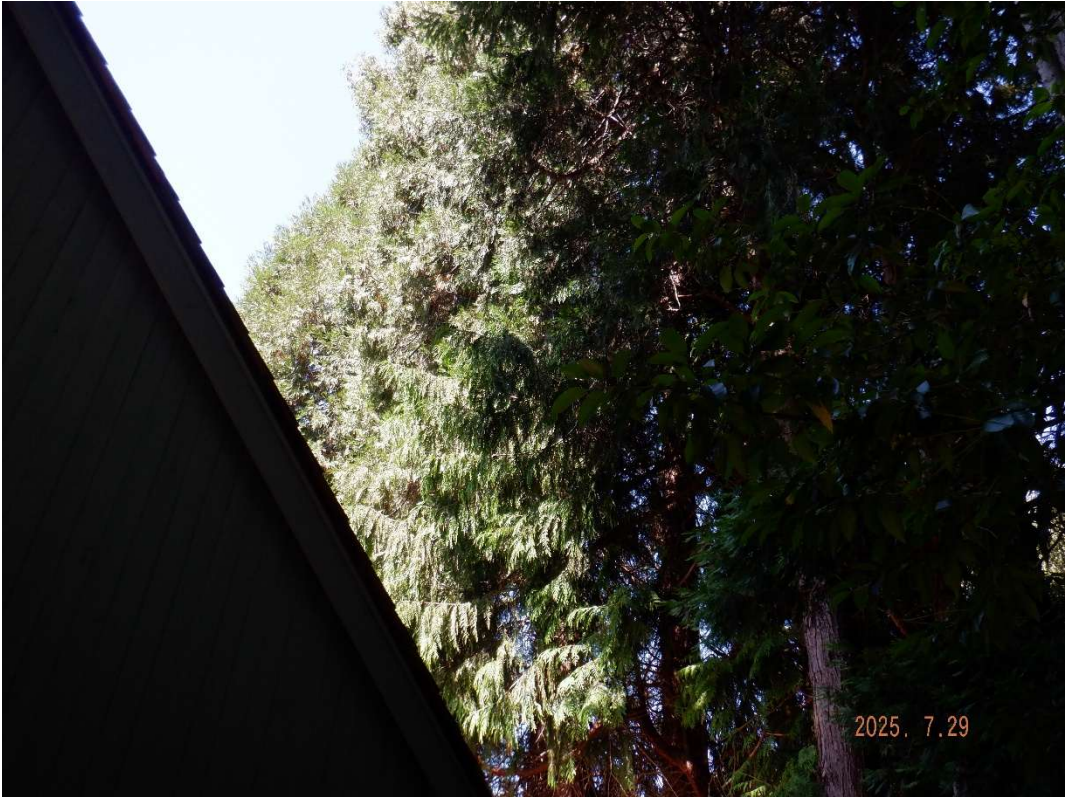
Back of house, neighboring cedar trees

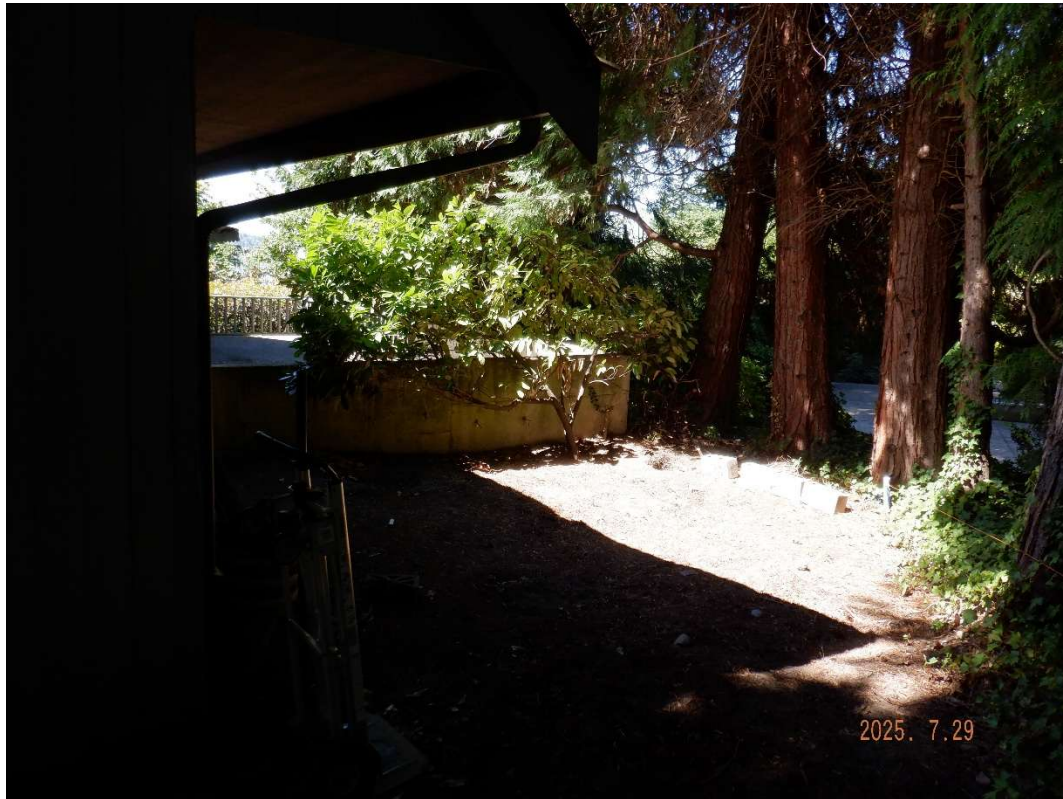
Looking southwest across backyard, crowns of neighboring cedar trees

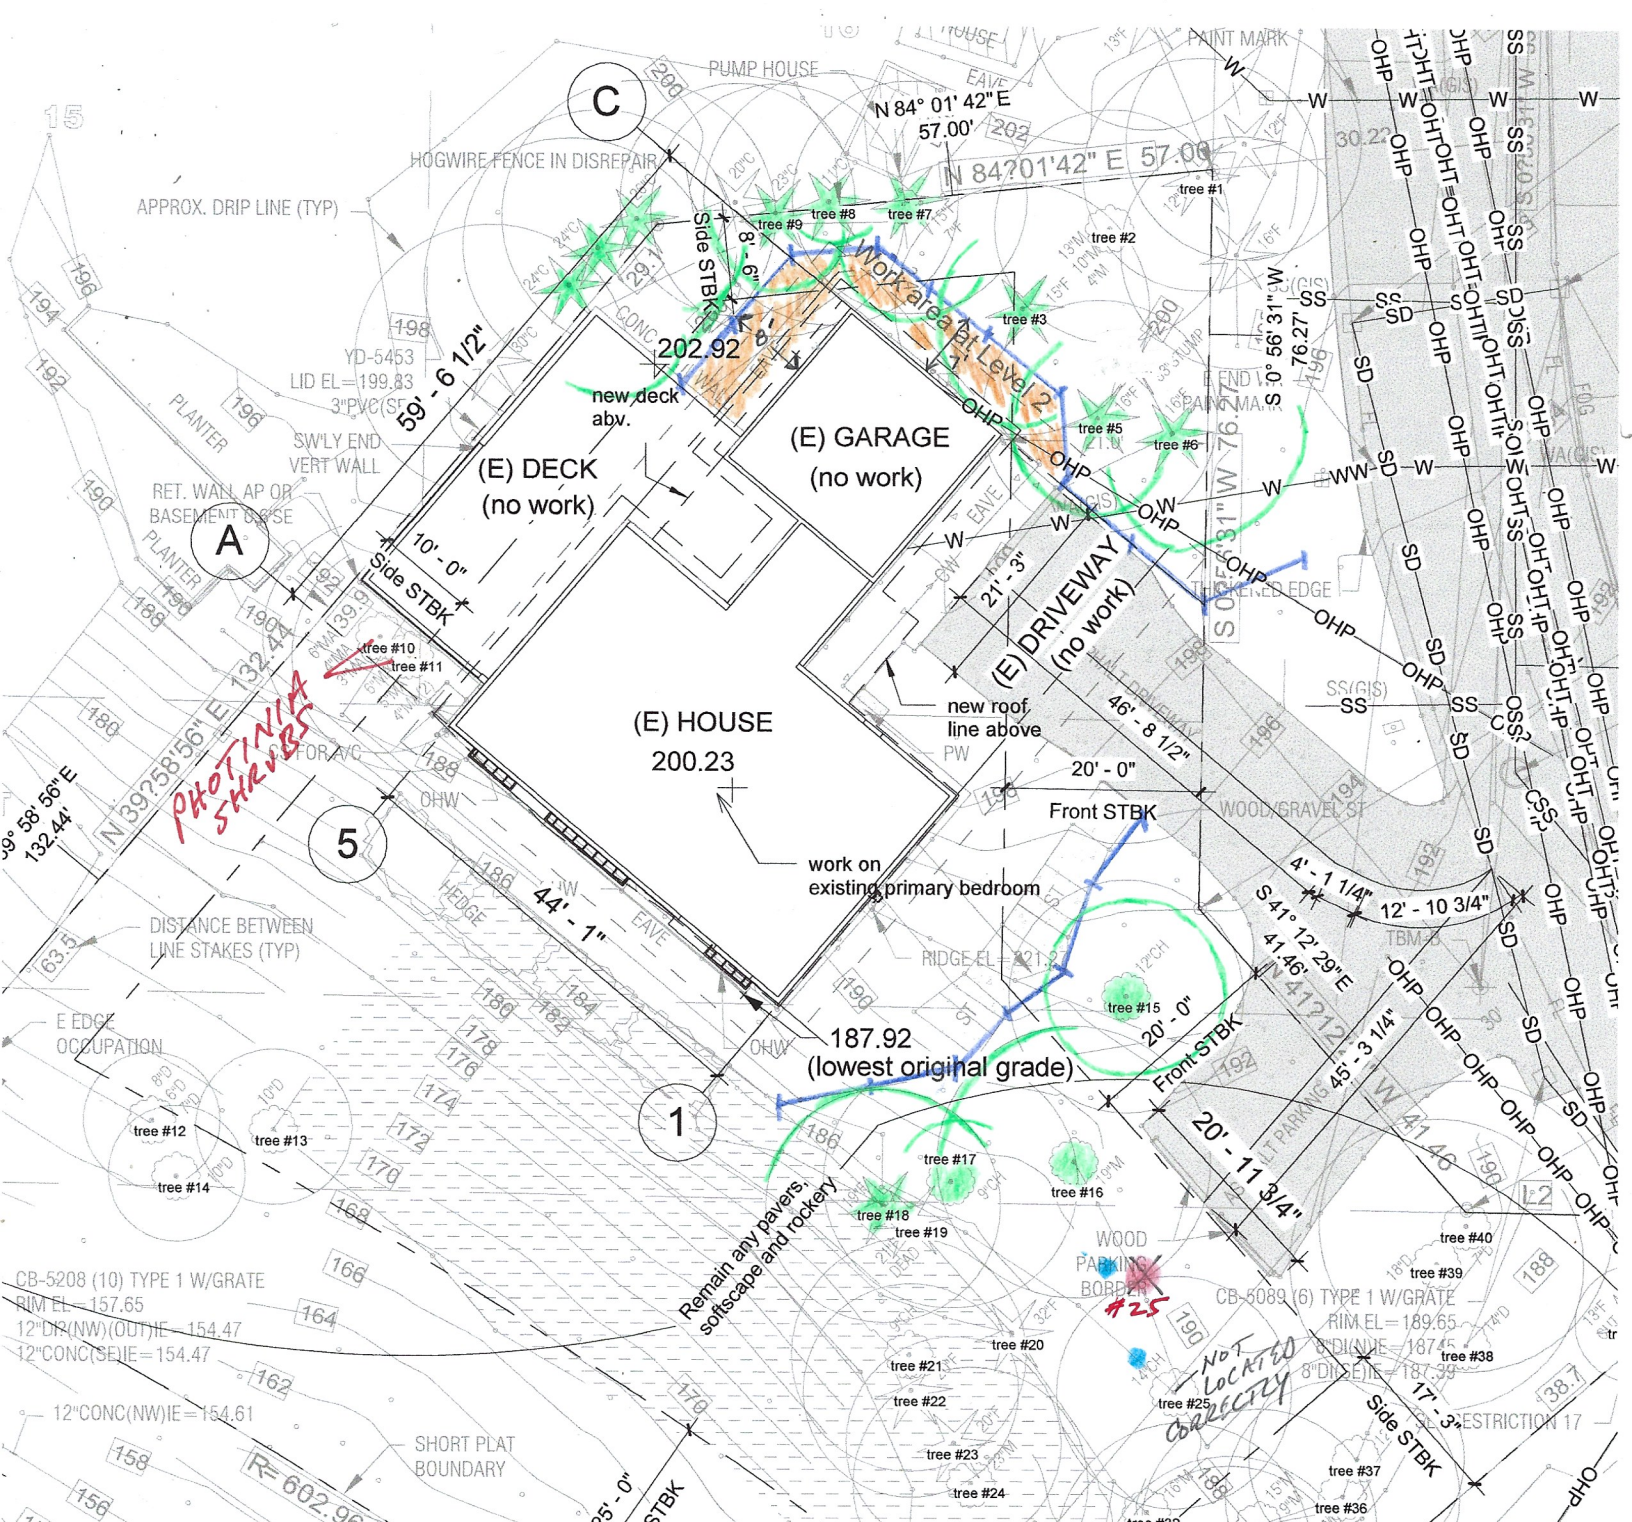
4103 78TH AVE SE
 TREE PLAN MAP

Tree #25 is a semi-mature native bitter cherry located near the south parking area. The top half of the tree is dead. It is in an ultimate state of decline. It is in poor condition and non-viable.

Tree #25 is mostly dead, and expected to be dead within a year. Dead top sections are likely to fall toward or onto the adjacent parking area. Removal is recommended to abate its hazard potential. Replacement will be required per MICC 19.07.10. The planting of two Western red cedar trees within a

proximity of it is recommended. See the attached tree plan map. Replacement trees shall be a minimum of 6-feet in height.
