**Washington Tree Experts**  
**16732 Broadway Ave**  
**Snohomish, WA 98296**  
**206-362-3380**  
**wtetree@yahoo.com**

**Job Address:** 8203 Avalon Drive  
**City, Zip:** Mercer Island, WA 98040  
**Parcel numbers:** 0321100090  
**C/O:** Wishwas Mohan

**Assignment**

Tree inventory with basic visual inspection and site specific limits of disturbance a home addition project.

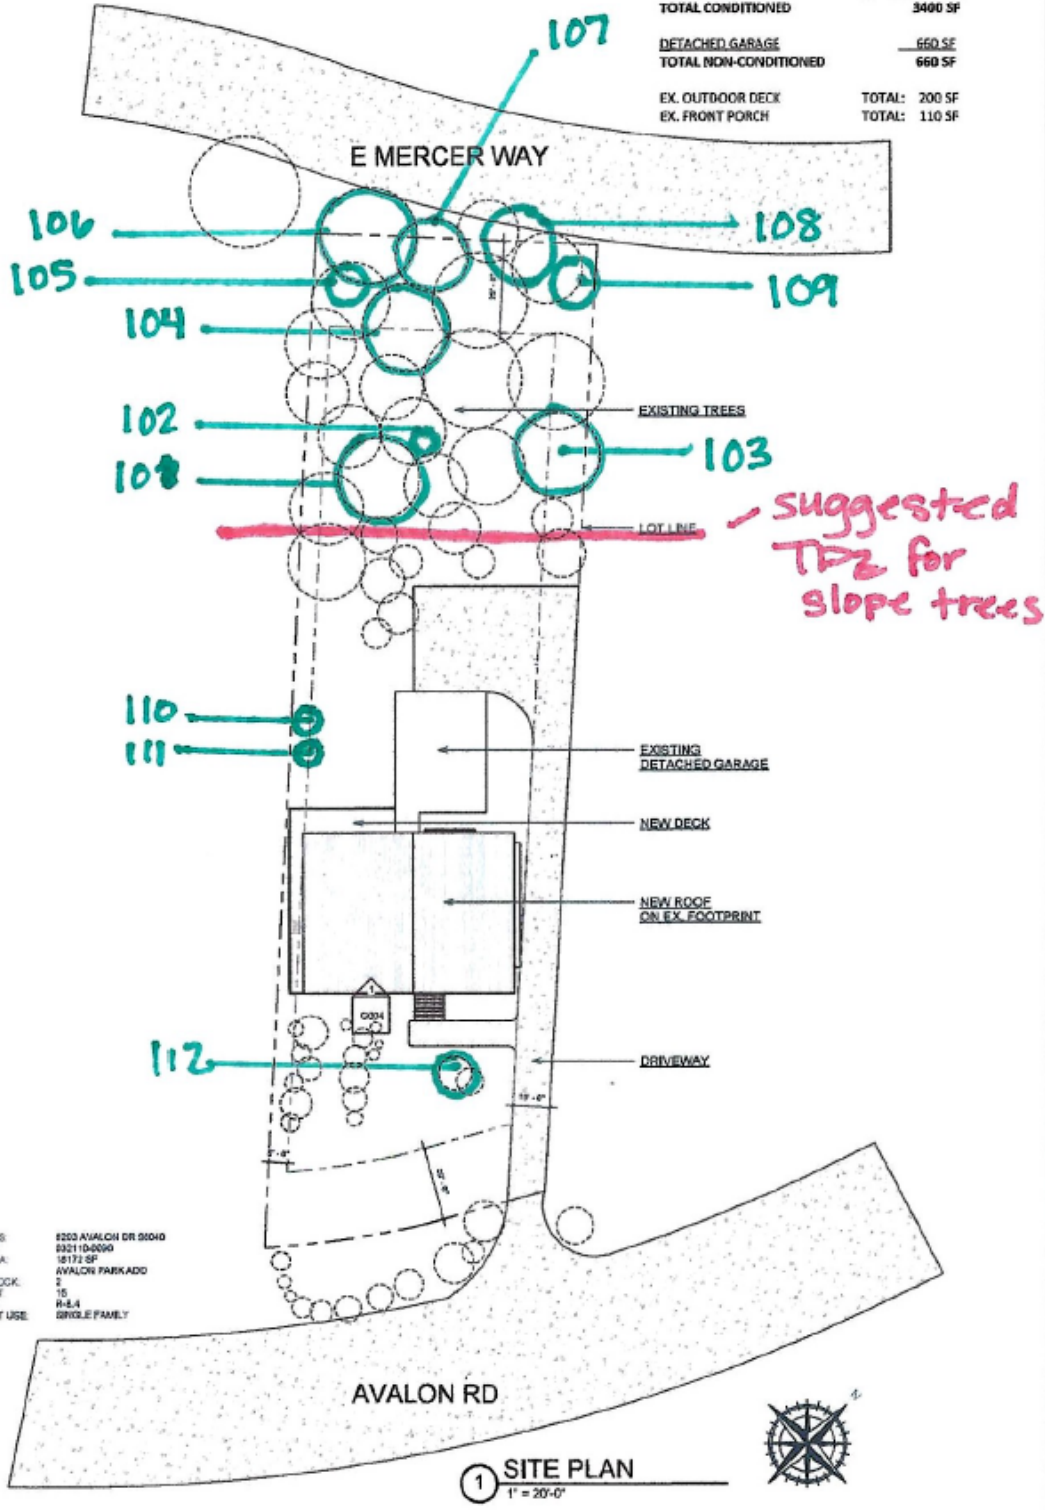
1 SITE PLAN  
 1" = 20'-0"

5 FEET BEYOND THE DRIP LINE OF SIGNIFICANT TREES TO BE PROTECTED PRIOR TO ANY LAND DISTURBANCE
