David Yusen
Mercer Island project

Pre-construction Arborist Report

Address: 3246 72nd PI SE, Mercer Island, WA

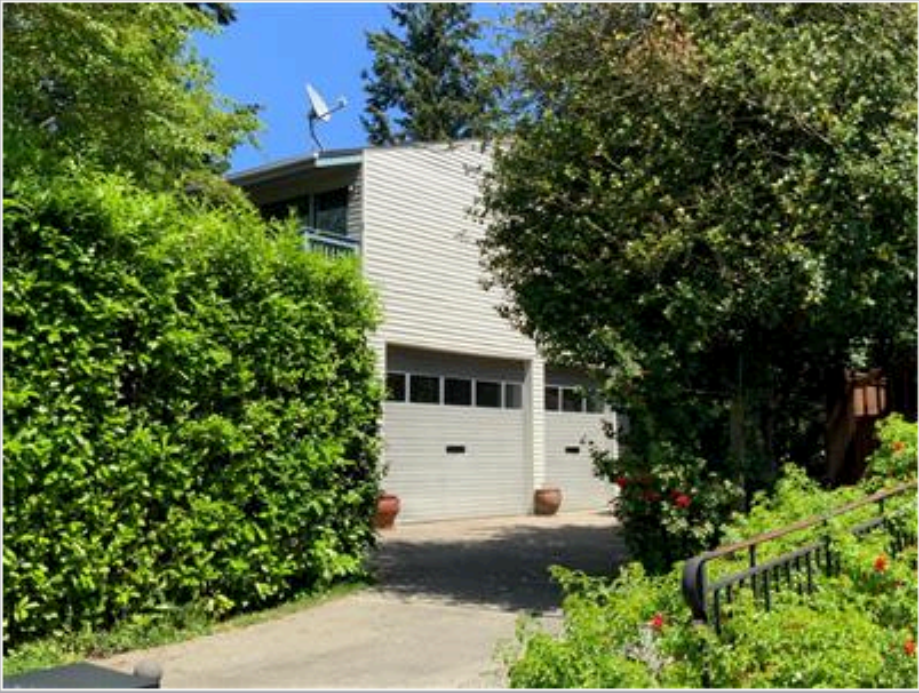
Site Photos from 06/25/2025

- **Tree #5067** – Western Red Cedar (landmark): This tree is located behind and in contact with the garage. It was previously topped and has large, sweeping branches resembling a pitchfork form. If removal is preferred, it can be considered a hazard tree due to proximity to the existing garage. A tree risk assessment will be required and we can provide that for you.

Right: Lilac (in front of garage) is not regulated and can be removed. Below: Cedar 5067 seen behind the garage could be designated a hazard tree due to the fact that it touches the structure of the garage. Remove.
