David Yusen  
Mercer Island project

## Pre-construction Arborist Report

Address: 3246 72nd Pl SE, Mercer Island, WA

Site visit date: 7/2/25

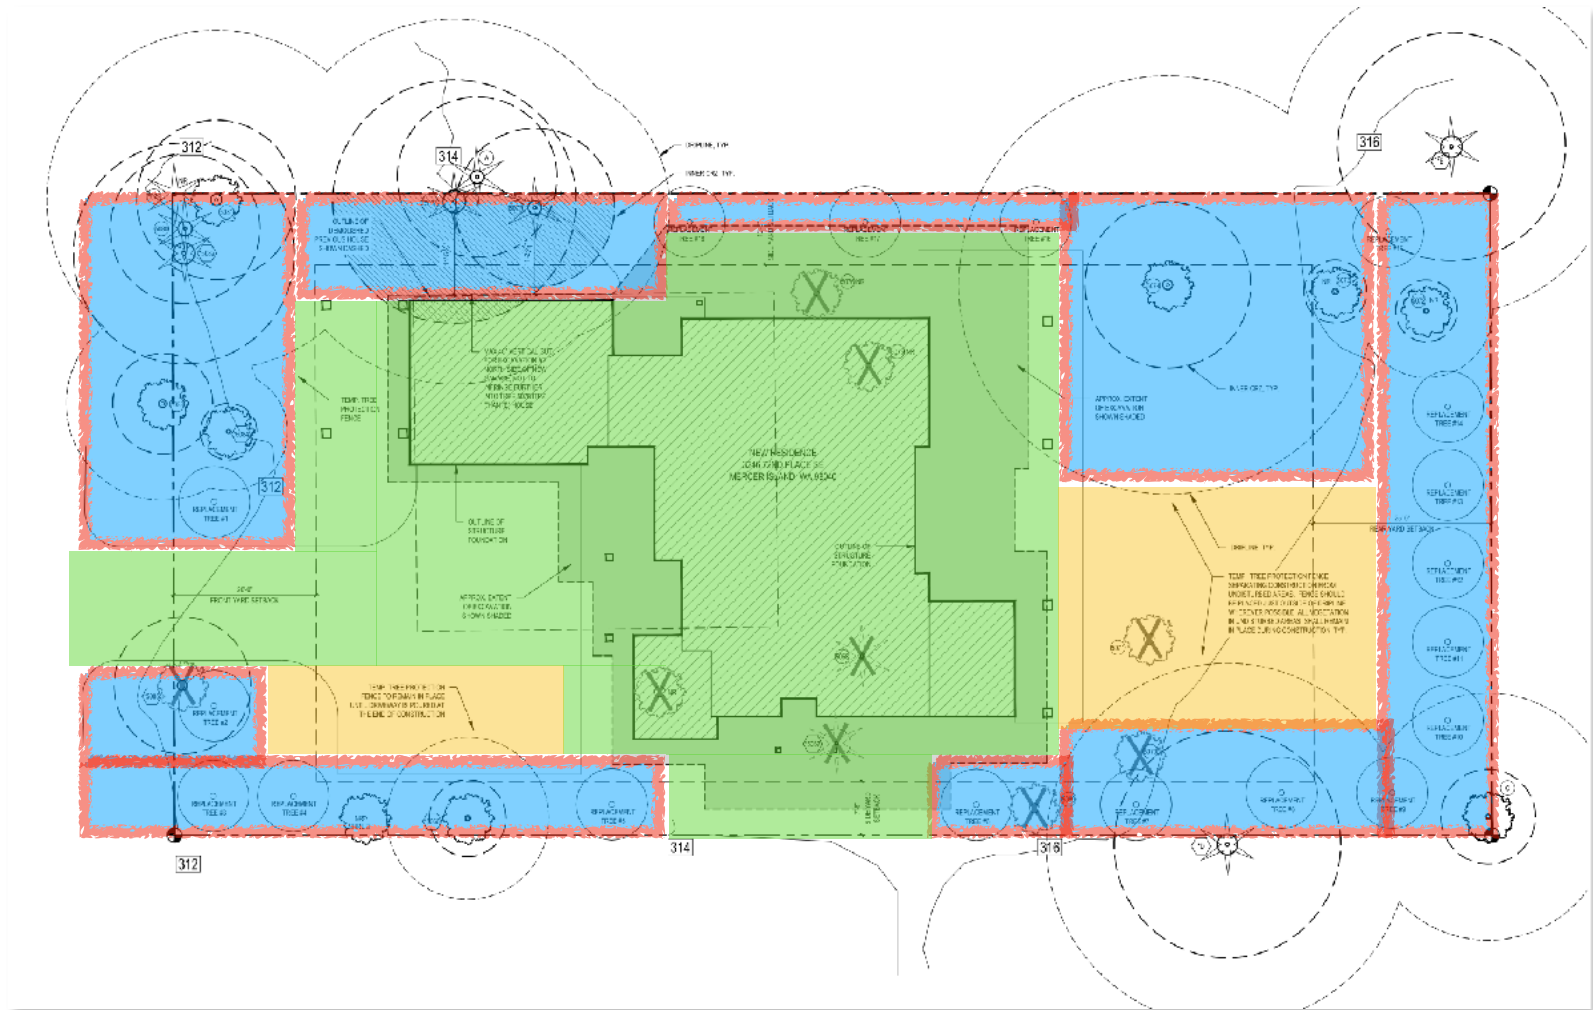
## Tree Protection Plan

**Red chalk lines** = tree protection zone fencing plan for retained and future planted trees. **Blue shaded area** = 6" deep arborist chip distribution area. **Green shaded area** = limited construction, staging and access zone. **Orange shaded area** = soils and concrete staging area away from critical root zones, ideally located on existing or future pavement.

Tree protection is required for all retained and adjacent trees. The recommended tree protection plan is shown below, but may be modified within the code requirements.

Arborist chip distribution is required in TPZ areas that are adjacent to construction, access and staging zones, and optional but recommend in other TPZs.

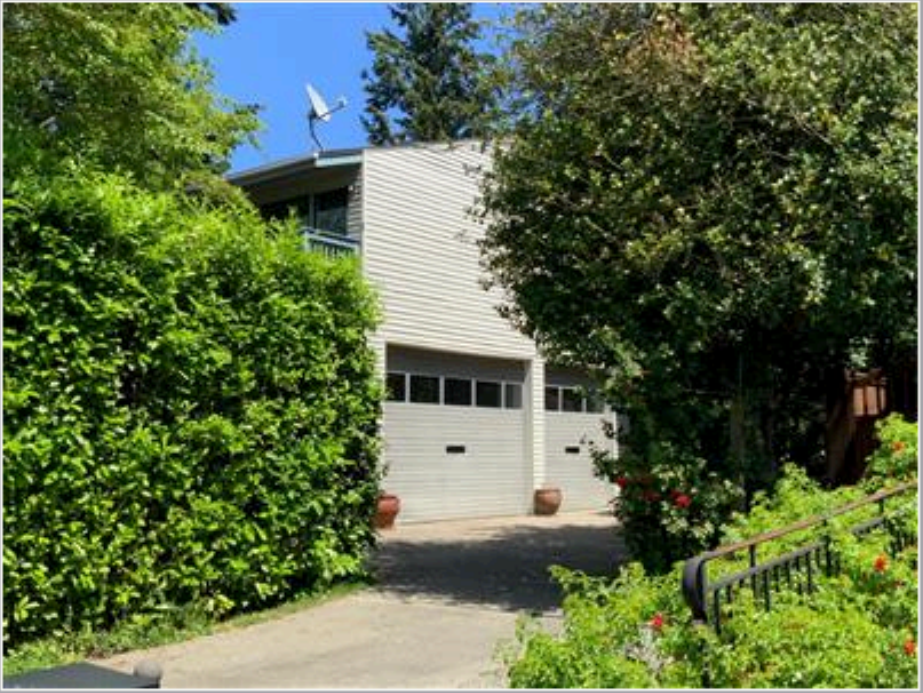
**Site Photos from 06/25/2025**

- **Tree #5067** – Western Red Cedar (landmark): This tree is located behind and in contact with the garage. It was previously topped and has large, sweeping branches resembling a pitchfork form. If removal is preferred, it can be considered a hazard tree due to proximity to the existing garage. A tree risk assessment will be required and we can provide that for you.

Right: Lilac (in front of garage) is not regulated and can be removed. Below: Cedar 5067 seen behind the garage could be designated a hazard tree due to the fact that it touches the structure of the garage. Remove.
