Tree Inventory Report

Bauman Residence

Facet Number: 2402.0436.01

September 2024

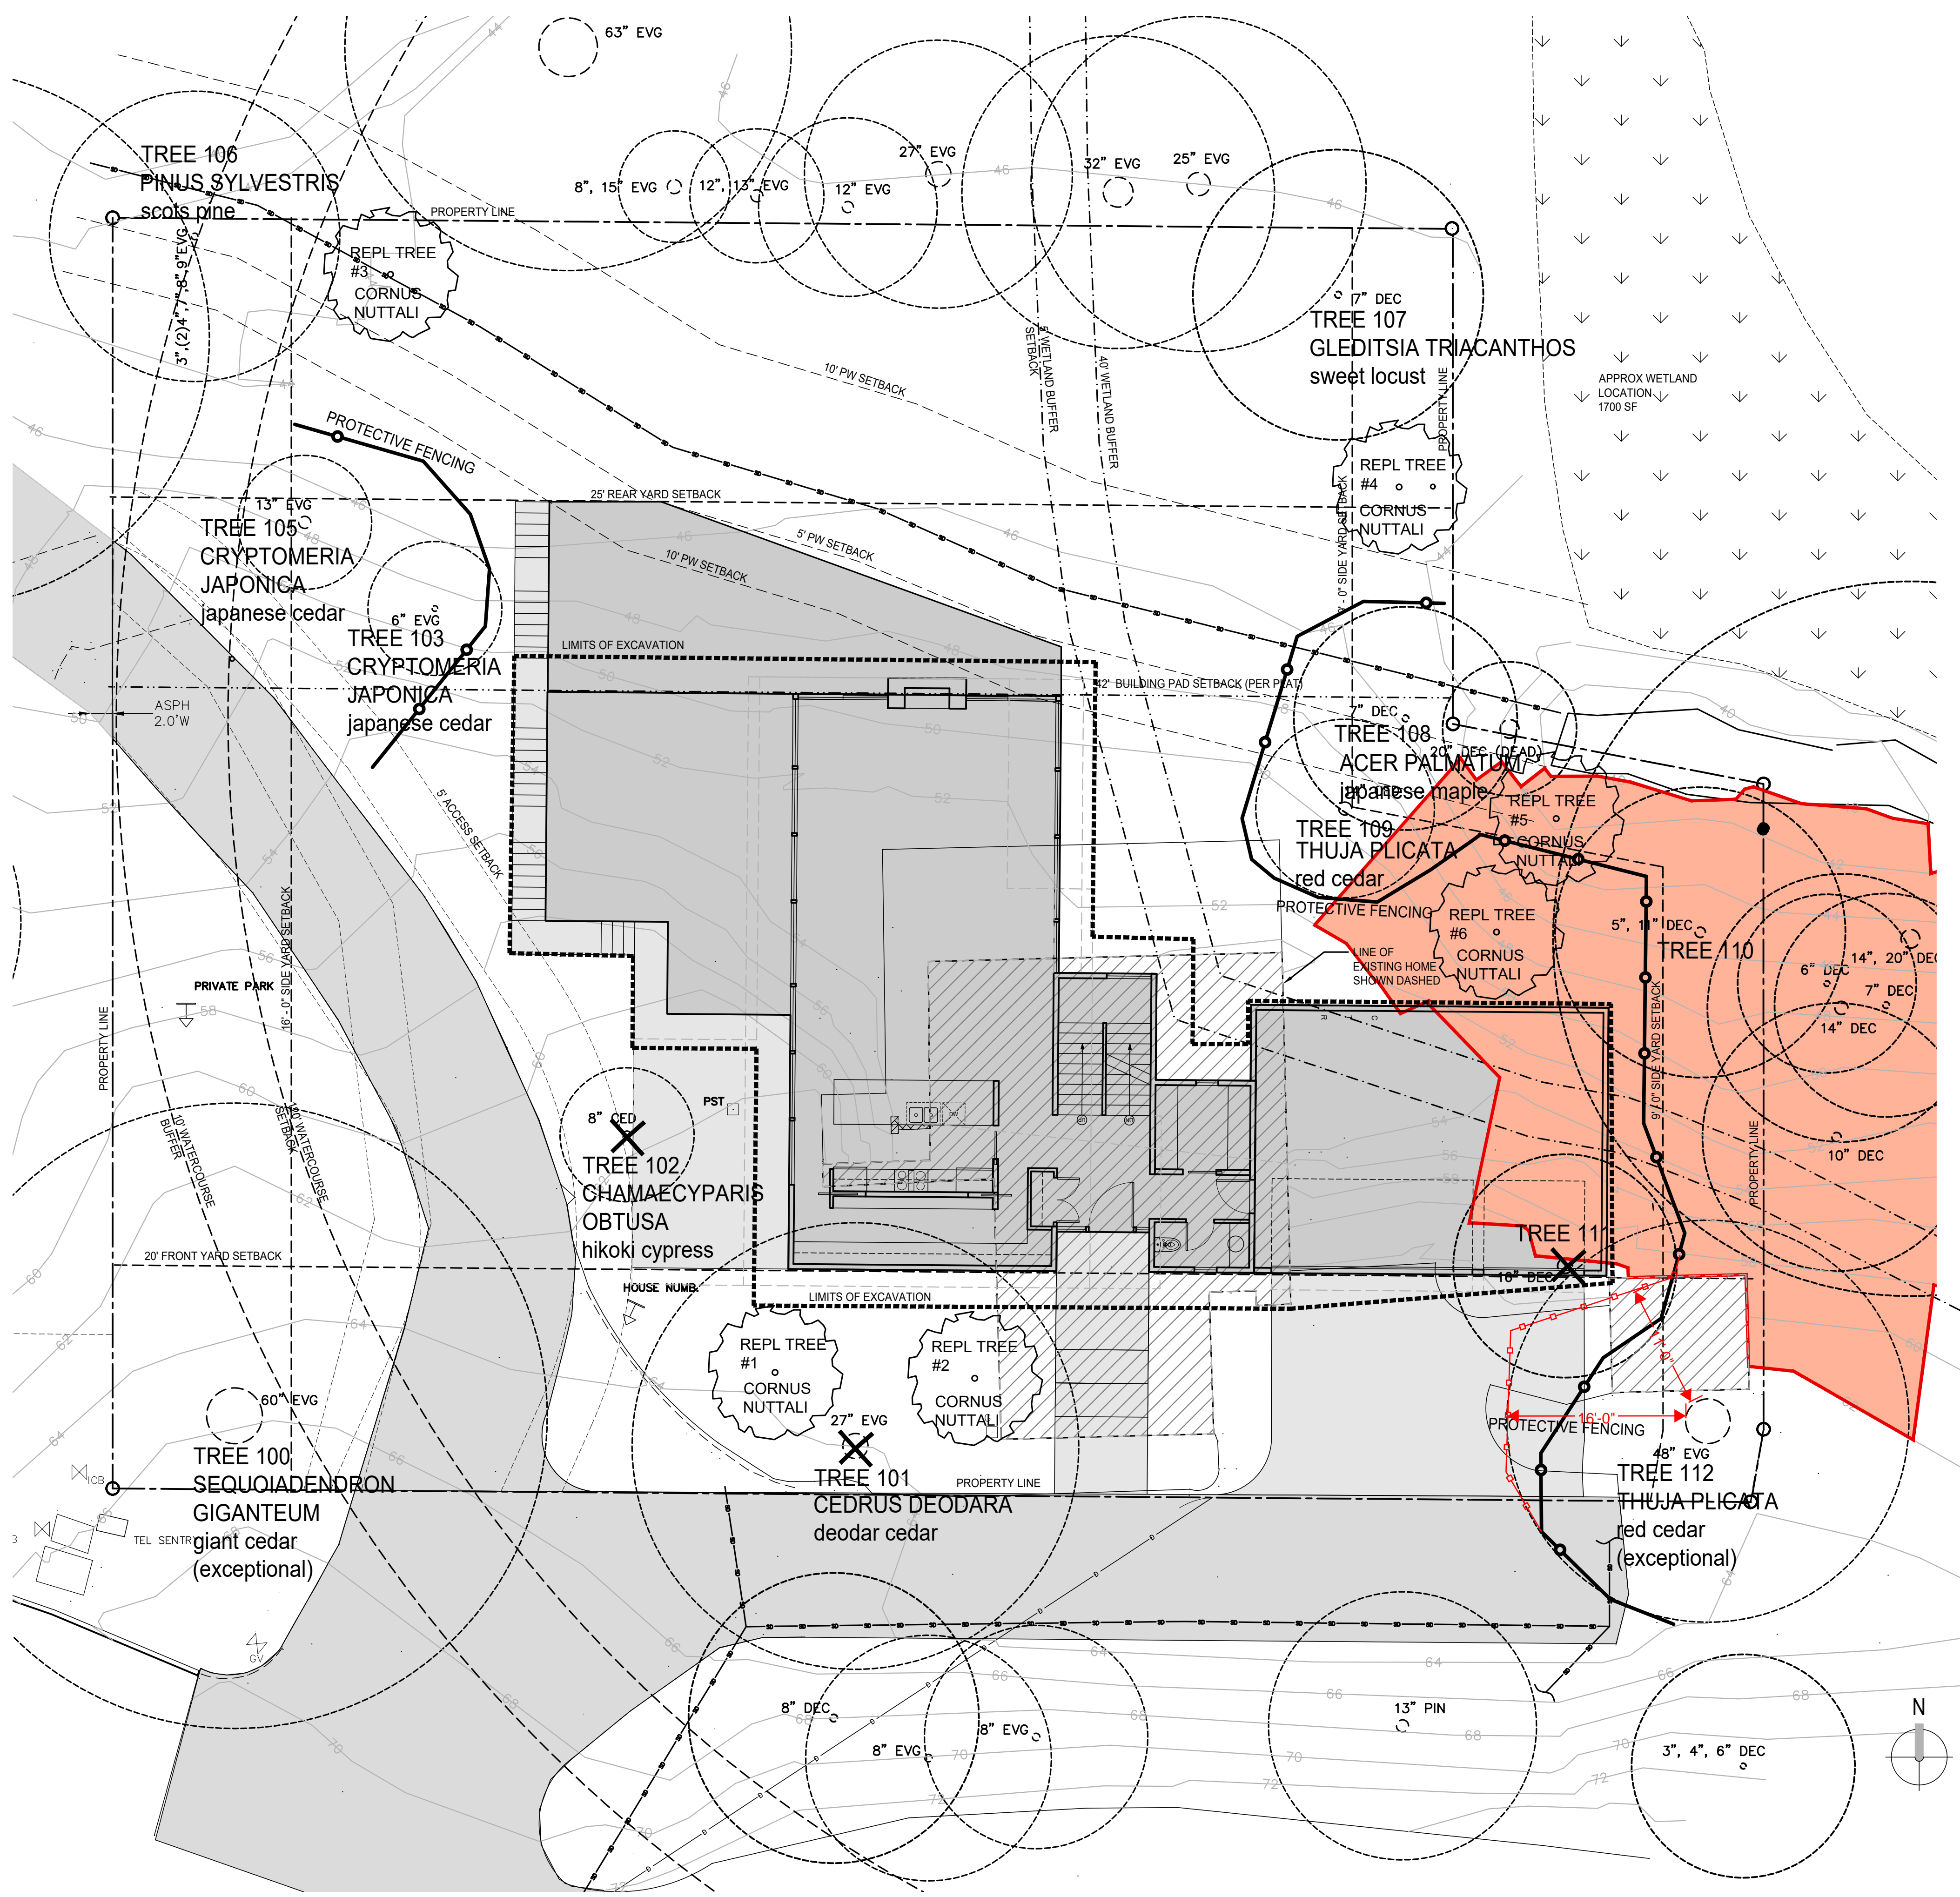
TREE NUMBER	TRUNK DIA -INCHES	NOTES	# OF REPLACEMENT TREES
100	60	EXCEPTIONAL	
101	27	REMOVE	3
102	8	REMOVE	1
103	6		
104		NOT USED	
105	13		
106	35 (3,4,4,7,8,9)	MULTI TRUNK	
107	7		
108	7		
109	14		
110	16 (5,11)	MULTI-TRUNK	
111	16	REMOVE	2
112	48	EXCEPTIONAL	
265 TOTAL			6 REPLACEMENT TREES
51% REMOVED TOTAL			
19% REMOVED TOTAL			
81% RETAINED TOTAL

ALL WORK WITHIN DRIFLINE OF TREE 610 & 612 (PER ARBORIST REPORT) TO BE DONE IN COLLABORATION WITH A QUALIFIED ISA CERTIFIED ARBORIST. THE ARBORIST SHOULD BE GIVEN THE DISCRETION TO ADVISE, MONITOR, AND DOCUMENT ALL WORK WITHIN THE DRIFLINE.
