**ARBORIST REPORT**  
For:  
**WEAVER CONSTRUCTION CO.**  
**TODA Project**  
**2262 78<sup>th</sup> Ave. SE. Mercer Island, WA**

November 26<sup>th</sup>, 2024  
**UPDATED May 20, 2025**

Dates of Field Examination: November 19<sup>th</sup>, 2024 & May 9<sup>th</sup>, 2025

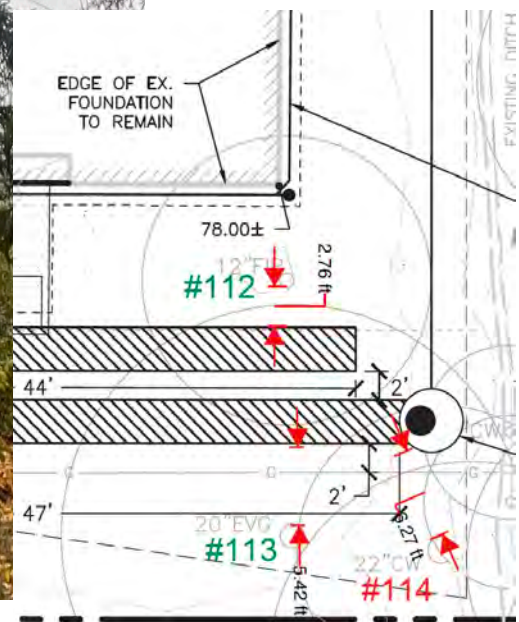
**Tree #113** is a deodar cedar (*Cedrus deodara*) with a DBH of 21 inches and an average canopy radius of 14.25 feet. Its health and structural condition are good, and it is deemed viable. This tree leans to the south with an off-balance canopy in the direction of the lean. The drainage and grading plan shows a trench is to be excavated five feet north of its trunk for installation of a detention pipe. Large structural roots are likely to be severed in this area which would destabilize this tree.
