June 28, 2025

**Project:** Pre-construction assessment for lot re-development at 4115 78<sup>th</sup> Avenue SE, Mercer Island, WA. Parcel number 3623500210.

**Objectives:** Evaluate health of existing trees and establish criteria for the preservation of those to be retained.

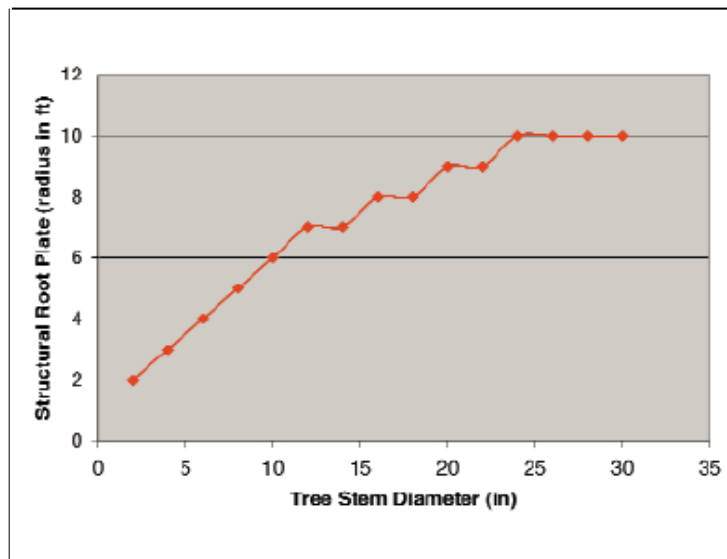
Figure 10. Size of the Structural Root Plate in relation to tree stem diameter. Note that the SRP levels off at 10' for any tree over 24" in diameter. (Coder, 1996)

In this case there are no retained trees which will experience impact to their SRPs.

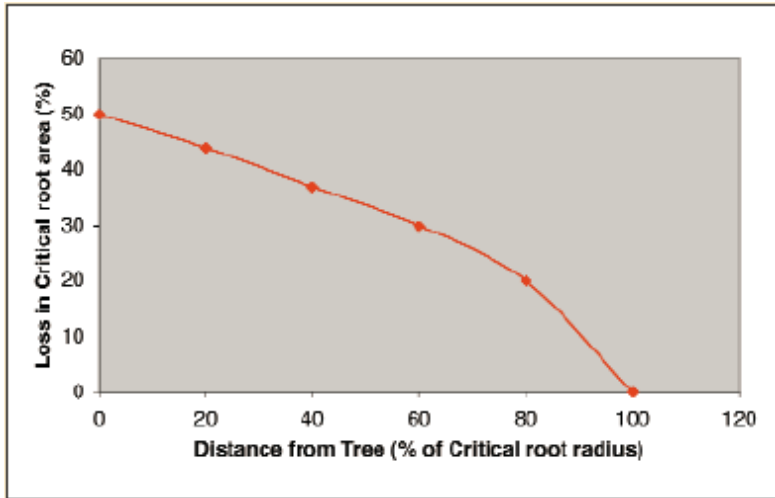
Figure 12. Chart giving the loss in critical root area as a function of the radial distance to the CRZ disturbance. (Coder 1996)

Using the #4 cedar as the example, with the proposed new rear patio 13' from the tree's base and it having a 17" DSH, if the cut for the patio ran all the way across the cedar's rooting space it would result in impact at a linear distance equal to 76% of the tree's CRZ (13'/17'). The chart shows that this could equate to a 22% loss of the cedar's Critical Root Area. However, because the cut will make a right angle turn away from the tree 12' short of its center line the actual loss of rooting space will likely be less than half that volume or around 10% CRA. The cedar should be fine long term.

The #3 fir (26.5" DSH) will experience the same type of notched impact 18' from its base. According to the chart in Figure 12, and using the same rationale as for the #4 cedar, the #3 tree should lose no more than 12% of its Critical Root Area. It will be fine long term.

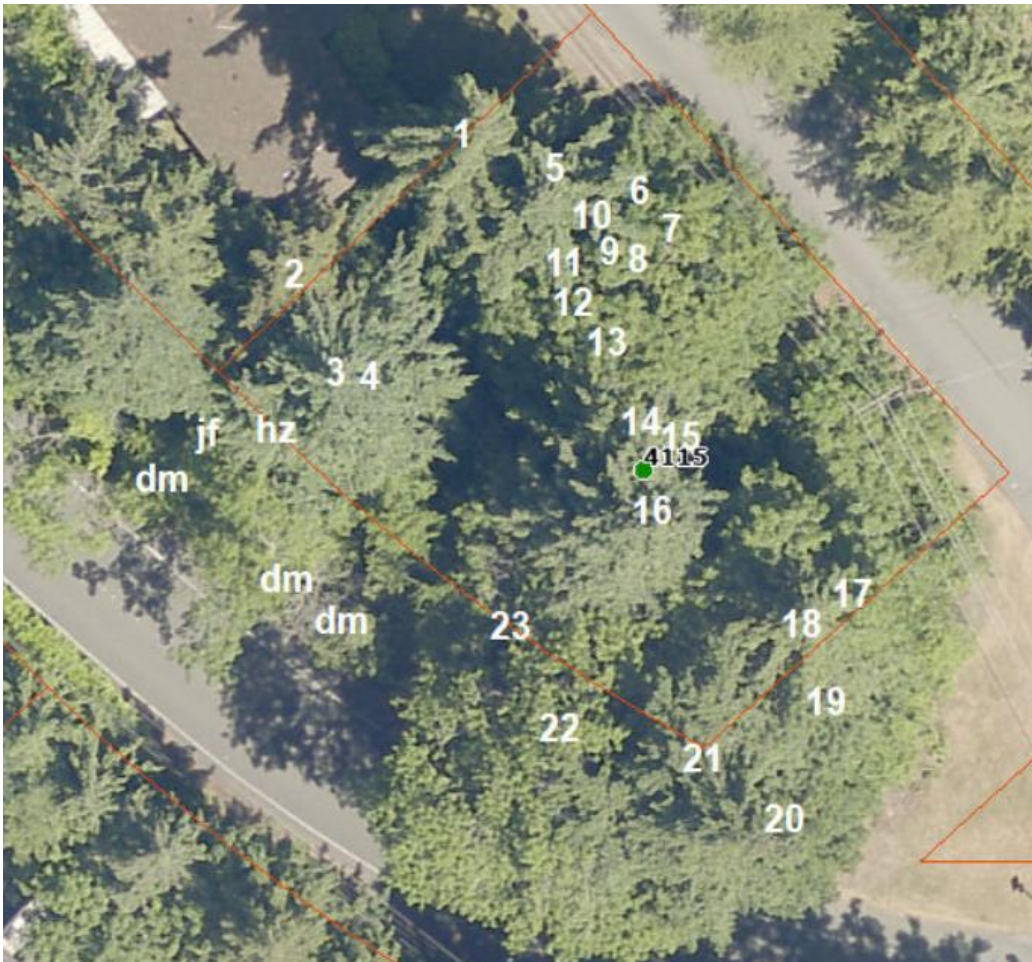
Along the lower part of the west embankment, an area which appears to be in the Mercer Island ROW, is a handful of medium sized dead and dying Big Leaf Maples (*Acer macrophyllum*). They range from 9-12" DSH, 35-45' tall and most are close enough to reach the road below should they fail partially or in total.

Figure 2. Aerial photo circa 2023 showing the approximate locations of the trees noted in the study (white numerals). The dying maples are shown as 'dm'. The locations of the juvenile fir (jf) and large hazel (hz) are also noted.

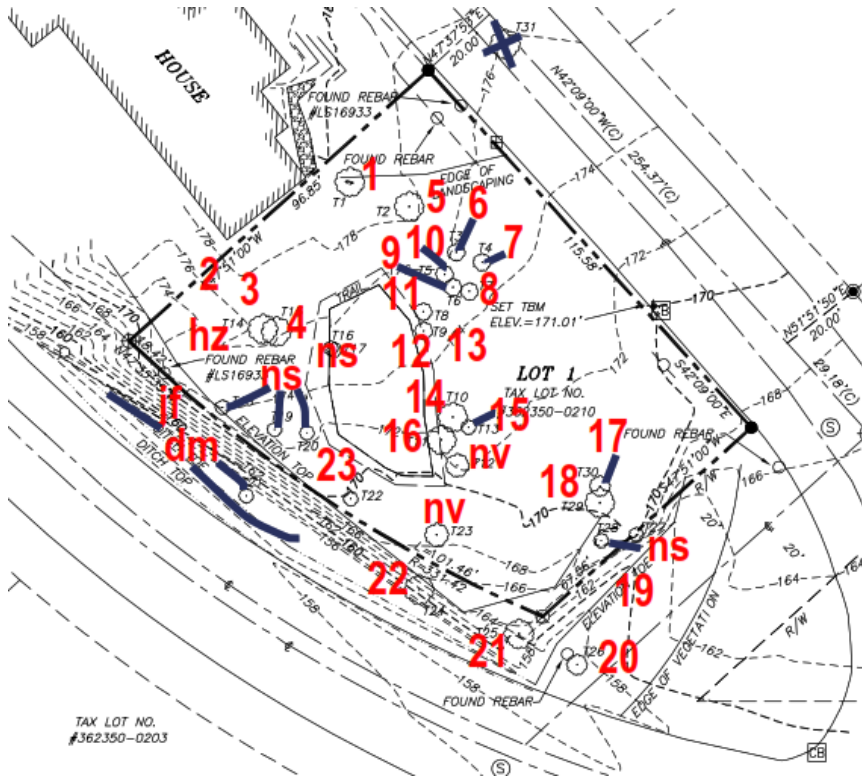
Figure 3. Excerpt from the topographic survey with the tree numbers overlaid. The same annotations are used in this figure as in Figure 2 with the addition of 'ns' for non-significant and 'nv' for non-viable.
