November 6, 2024

Project: Pre-construction assessment for property re-development at 4661 Forest Avenue SE, Mercer Island, WA. Parcel number 4045000065.

Objectives: Evaluate health of existing trees and establish criteria for the preservation of those to be retained. Provide risk assessments as necessary.

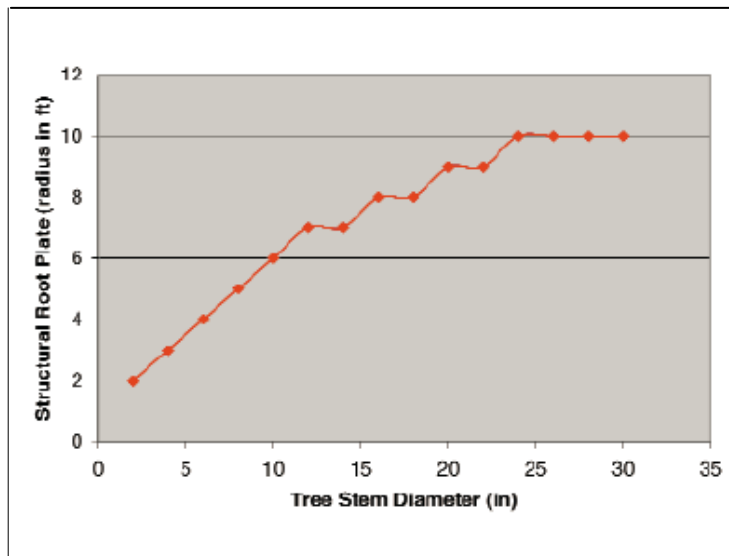
Figure 53. Size of the Structural Root Plate in relation to tree stem diameter. Note that the SRP levels off at 10' for any tree over 24" in diameter. (Coder, 1996)

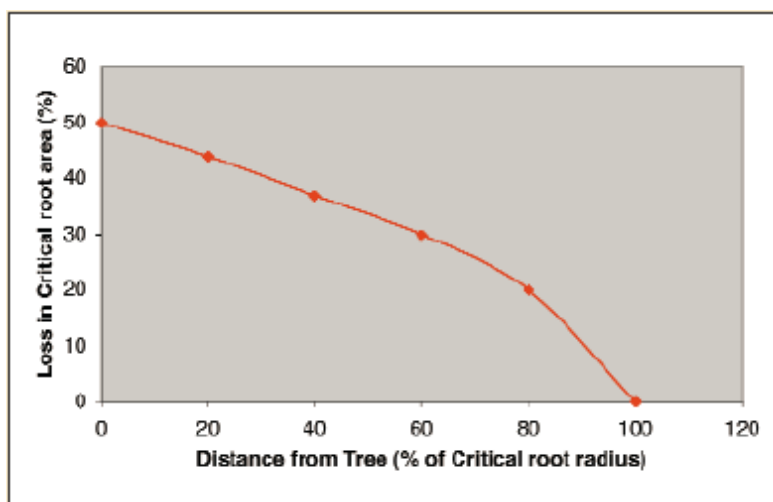
Figure 54. Chart giving the loss in critical root area as a function of the radial distance to the CRZ disturbance. (Coder 1996)

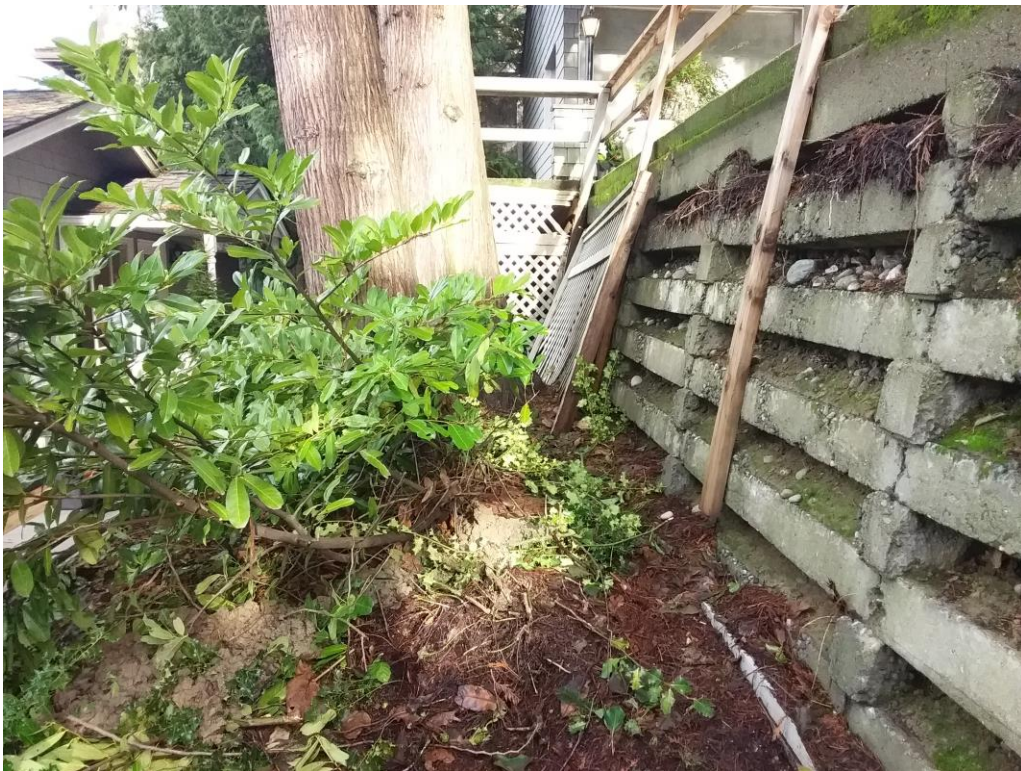
Figure 2. Looking north down the line of the retaining wall system that supports the lower parking area and the garage.

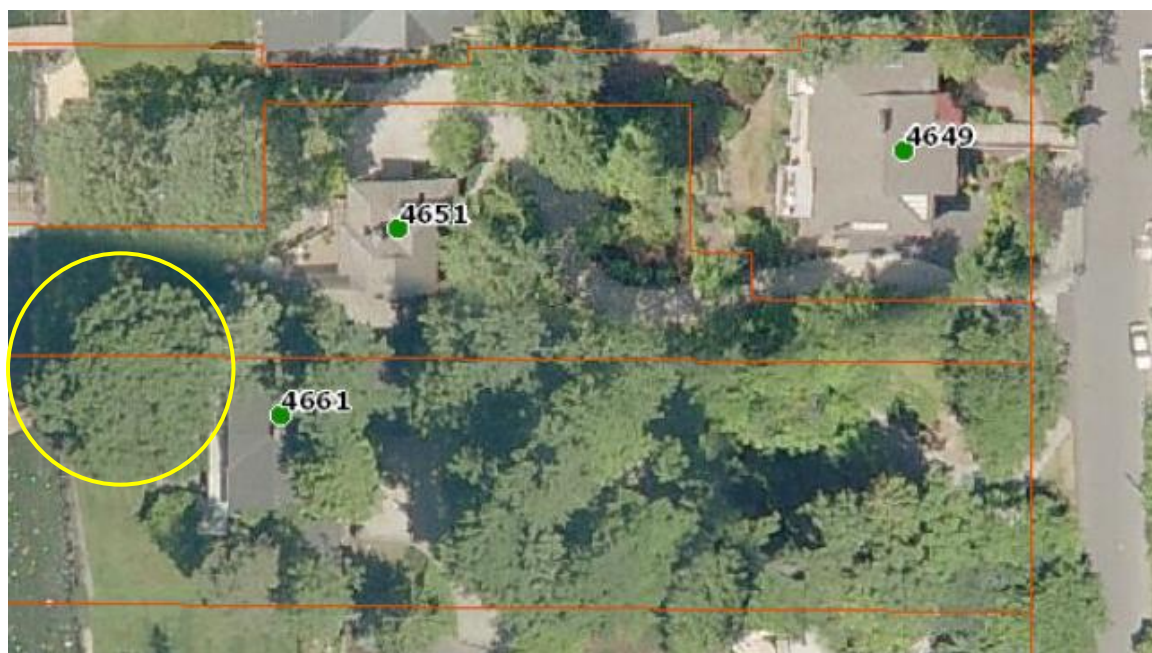
1. Pin oak (*Quercus palustris*) 40" DSH standing 19' W of the NW corner of the existing house, 9' S of the north property line, and 35' E of the sea wall. The tree was cut back to the property line between 2007 and 2009 (Figures 7 and 8) and then was severely stubbed back between 2013 and 2015 (Figures 9 and 10). The top cuts were made between 25' and 28' above grade and the scaffolds were cut back to no more than 8' off the main stem. Currently there are epicormic sprouts extending off each of the cut points in groups of 5-10 and out 12-25' long. There is conflict and some die back present (Figure 11-13). Tree exhibits good health with decent new growth and color. It reaches up to near the 50' level and has a 20' radial spread. There is utility vault, maybe a pump house, in the northwest quadrant of the root spread 4' off the base of the tree (Figure 14). Concrete stairs lead up from the lower yard to the lower concrete patio. The tree has engulfed the top stair and a couple of the large stones lining it (Figure 15). There is uplift of the concrete path leading to the concrete patio and uplift in the patio itself (Figure 16). This tree is Exceptional by definition.

Figure 7. Aerial from 2007 showing the #1 oak

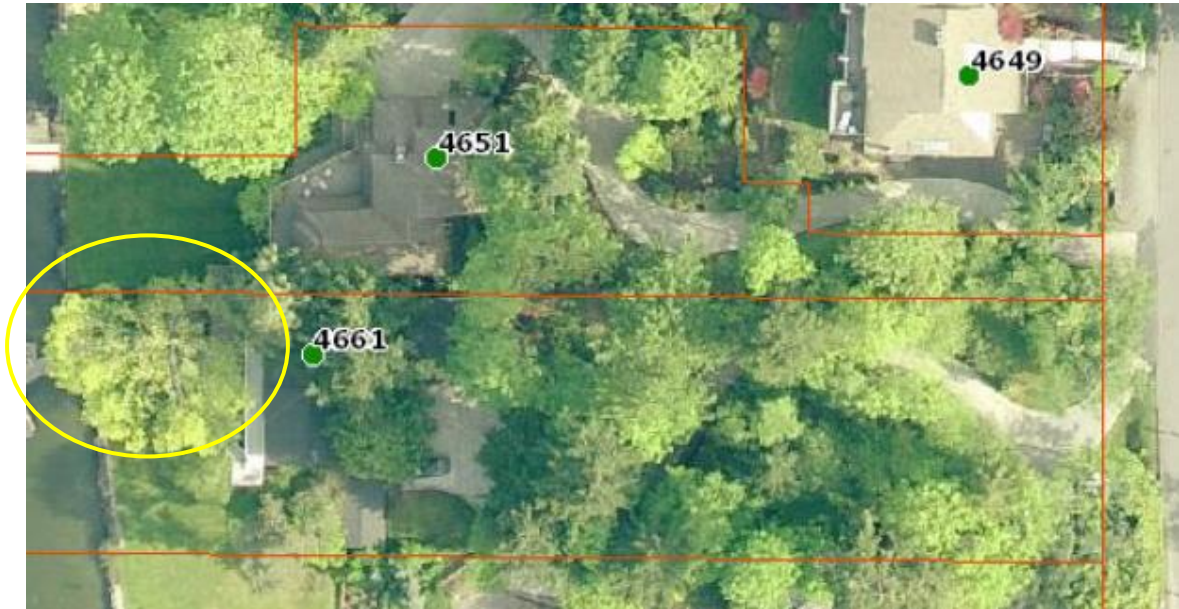
Figure 8. Aerial from 2009 showing the #1 oak having been pruned back to the line

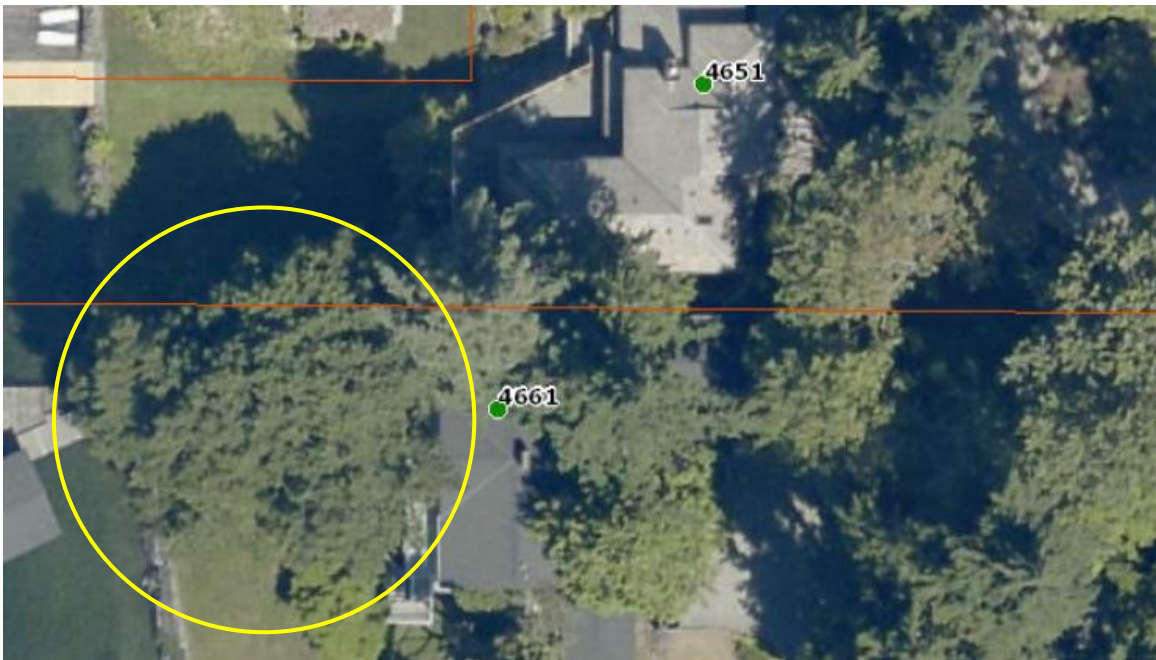
Figure 9. Close up aerial from 2013 showing the #1 oak.

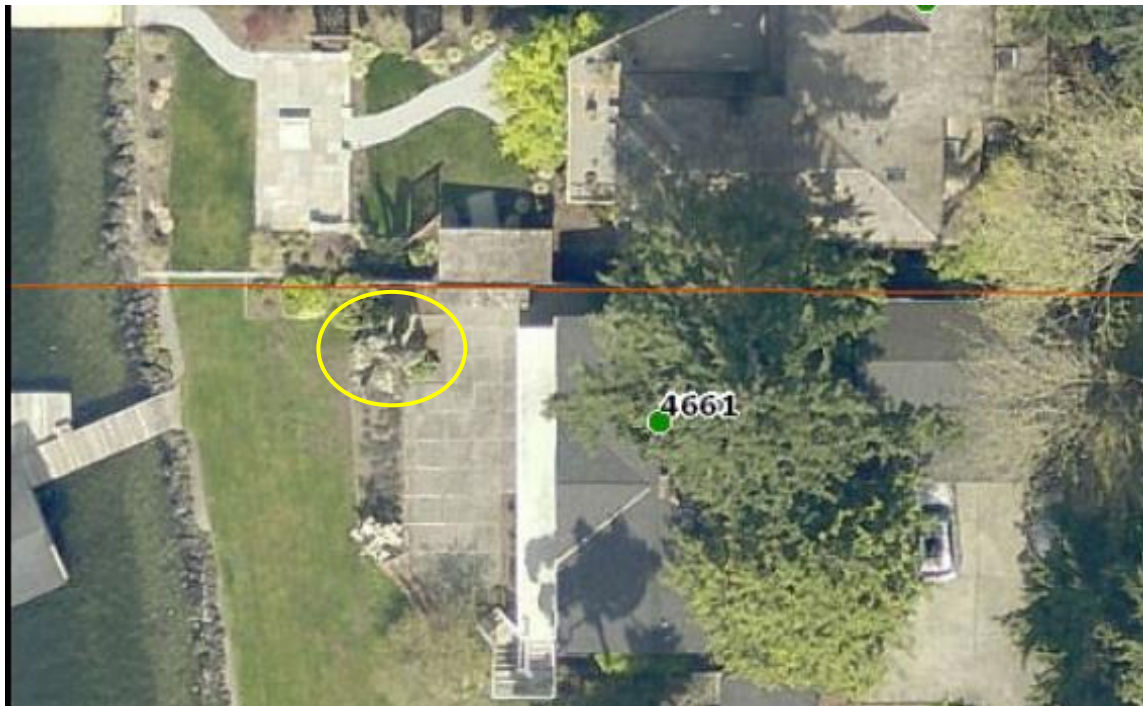
Figure 10. Close up from 2015 showing the #1 oak stubbed back to near nothing.

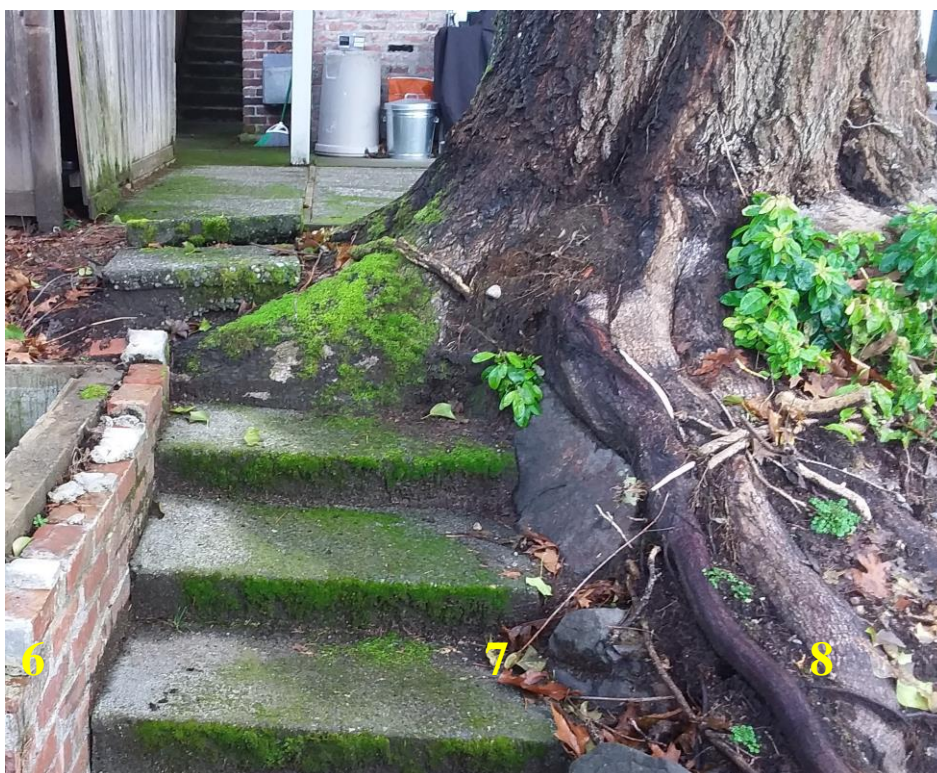
Figure 15. Close up of stairs at the base of the #1 oak.

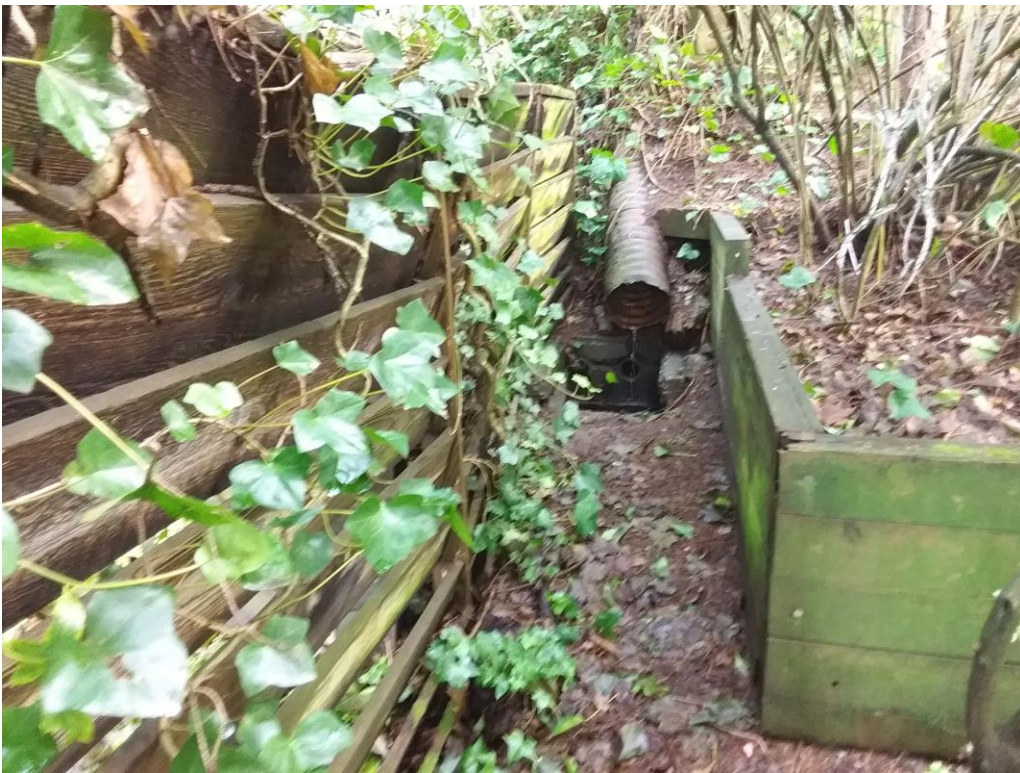
4. Shore Pine (*Pinus contorta*) 24" DSH, 50' tall standing 26.5' S of the house foundation and 8' W of the southwest corner of the little boathouse building. Ivy has filled the canopy to within 8' of the top and out the branches (Figure 18). It was recently cut at the base of the tree. Pine is in fair health but many of the branches are overextended and the canopy is windswept. There is a little existing fence filled with ivy that runs east to west 3' S of the tree. Just outside this fence and 16' E of the base of the tree there is some kind of drain system (Figure 19). This tree is Exceptional by definition.

Figure 19. Looking east at the drainage system

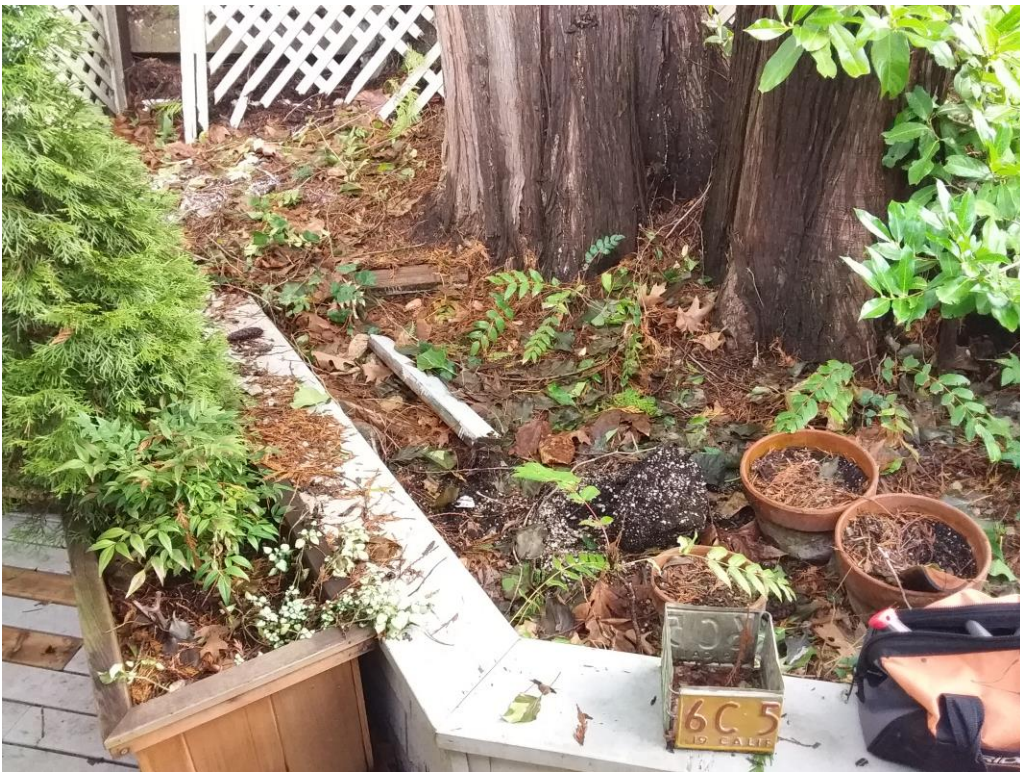
5. Dual stem Western Red Cedar (*Thuja plicata*) 21" and 25" DSH and both were topped near the 18' level at least once. Currently they each have multiple leaders coming off these points going up to the 60' level (Figure 20). On the smaller stem most of the subordinates extend out to the west and southwest before curling vertical 4-6' out from the main stem. On the larger stem the majority of the spars turn vertical within 24" of the column. Almost all the limbs that originate below the topping point are turning up past their midpoints. The tree stands 11' E of the SE corner of the existing house in what is a de facto planter box (Figure 21). The west (house side) of the structure reaches at least 3' down and the retaining wall support system for the lower parking forms the east side. The base of the tree is against the east wall, 3.5' E of the west wall, and 2.5' SE of where the west wall angles to the NE. The 21" stem had poor resonance and is likely hollow.

Figure 21. The base of the #5 cedar in the planter box.

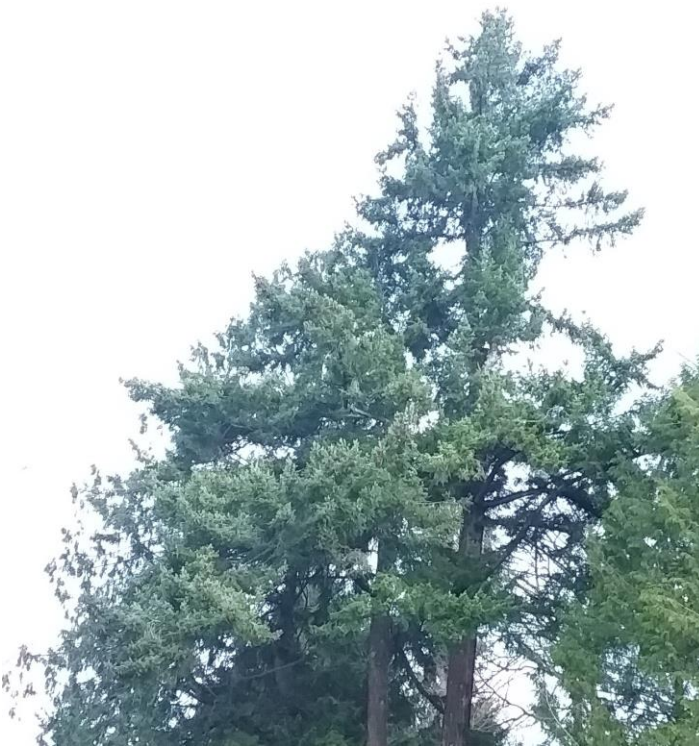
6. Douglas fir (*Pseudotsuga menziesii*) 35" DSH standing at the base of the stairs leading down from the parking/driveway to the house (Figure 22). It's in another constrained, basically glorified planting bed, east of the northeast corner of the existing house. The retaining wall for the garage is 5' E of its base, the stairs leading down to the NE corner of the house are 4' W, of its base, the existing house foundation is 8' W, and the cross walk leading from the garage stairs to the house runs against the south side which has grown over it. The tree was topped or broke out near the 65' mark (Figure 23). The trunk below the topping point is vertical. Two large leaders rise above into the 100' range. One is nearly vertical but its attachment is offset to the column. Low average new growth. A subordinate spar (10" caliper) originates 4' below the cut line and grows up through the two dominants reaching close to 80' tall. Another 8" caliper subordinate comes off in the SE quadrant right at the cut point and reaches 75' tall. There is a torsion fracture low on the south face. Exhibits below average new growth. Tree is Exceptional by definition.

7. Douglas fir 26" DSH growing against the base of the #6 (Figure 24). The stairs are 3' W of its base, the house foundation is 7' W, the retaining wall for the garage is 6.5' E, and the cross walk is 28" S of its base. The foundation for the 4651 house is 14.5' to its north. The tree has two very large cankers in the 6' level (Figures 25 and 26). It leans slightly northwest from its base and never quite comes back to vertical. There is a damage point at the 24' level showing bleeding and indications of surface decay. Top of the tree bends over to the northwest. It might have been damaged by the larger #6 tree and/or have been topped near the 55' mark. The majority of its canopy extends west on large overextended limbs. It shows stunting in the upper canopy and is in below average condition.

Figure 23. Looking up and NE at the tops of the #6 and #7 fir trees.

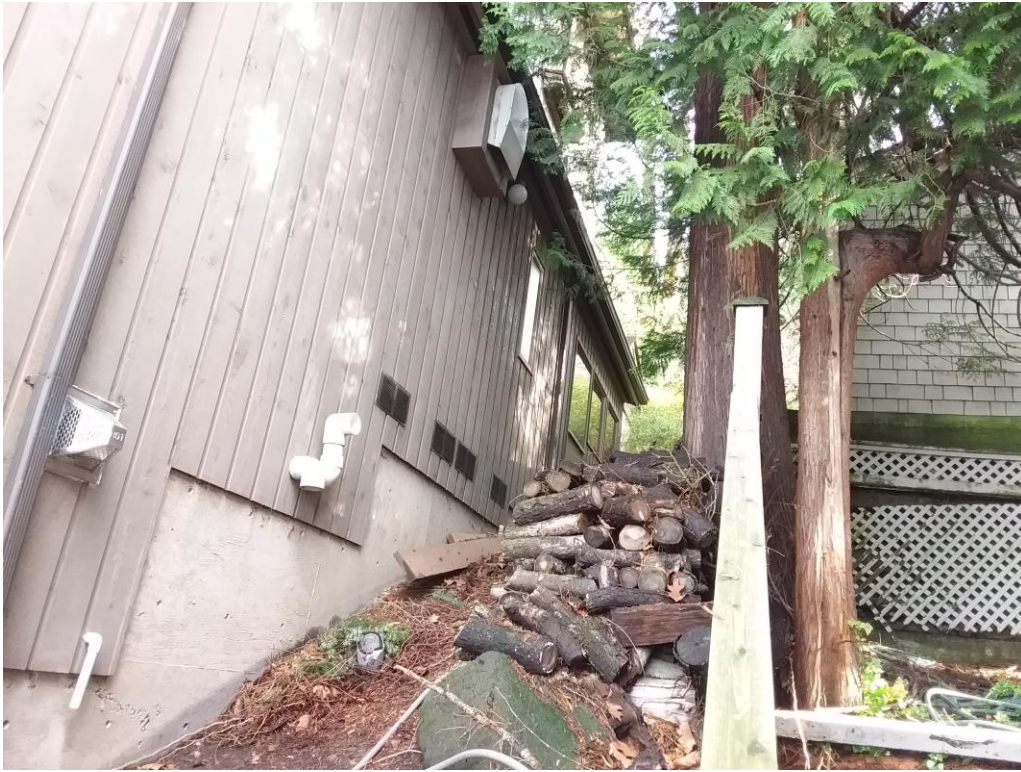
8. Western red cedar 29" DSH standing in the north fence 8' N of the #7 tree, 8' W of the retaining wall foundation for the garage, 6' S of the 4651 foundation, and 12" E of the concrete for the stairs leading down around the north side of the subject house. There is a small wood retaining wall above the concrete and the tree is bowing it out (Figure 27). A subordinate that has been topped comes off the base of the main stem. The subordinate has an exposed decay column and atrophy running down its west face (Figure 28). The main tree was damaged or topped near the 40' level. There is a large leader growing up and out to the northwest that originates at the damage point and a number of subordinate spars reaching out all around the same level. The majority of the canopy extends north over the neighbor's roof. Tree is in below average condition with a light canopy cover and poor color.

Figure 28. Looking east at the lower formation of the #8 cedar.

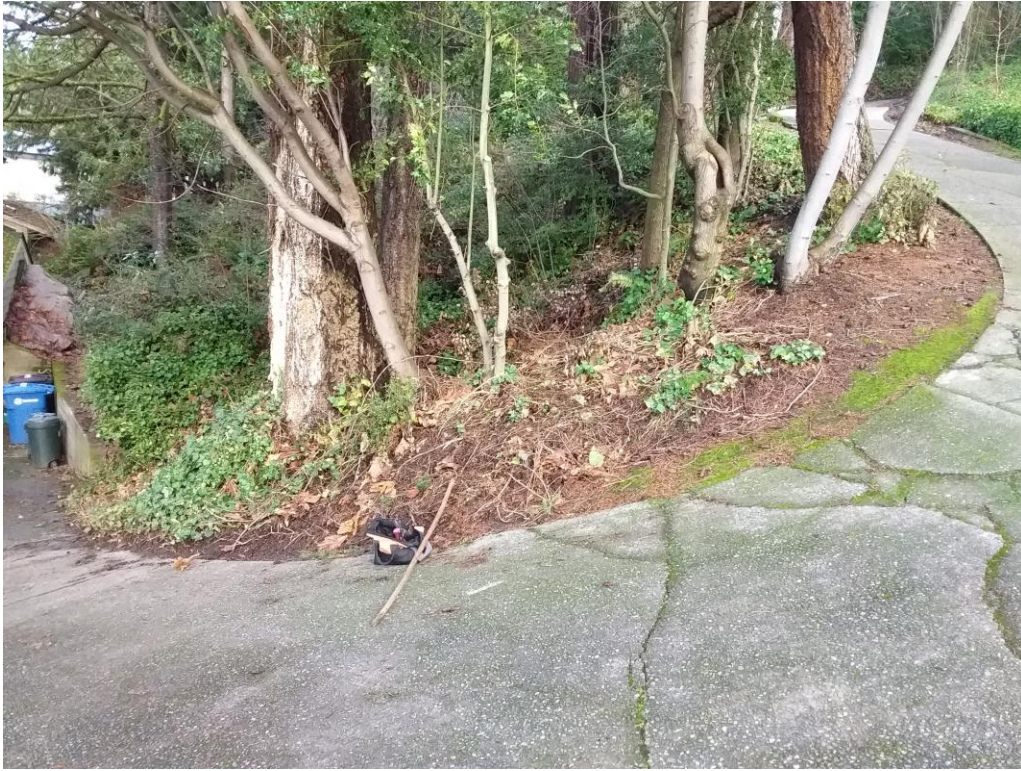
12. Douglas fir 39" DSH, topped or damaged near the 65' mark, now rises into the 90' level. There is an atypical growth pattern around the 65' area with a number of heavy lateral branches present and a larger subordinate coming off at this point. Tree has a subordinate spar that originates at the 20' level that has been pruned down to 8' tall and has a multitude of branches sprouting from it (Figure 31). Tree shows average new growth and color. It stands 40" E of the inside edge of the existing entry drive (Figure 32). The driveway curves completely around the tree scribing close to a 270 degree arc. There is a large amount of pitch leakage on the southwest base of the tree. Tree is Exceptional by definition.

Figure 32. Looking NNE at the base of the #12 fir. The #13 maples are scattered around the east side of it.

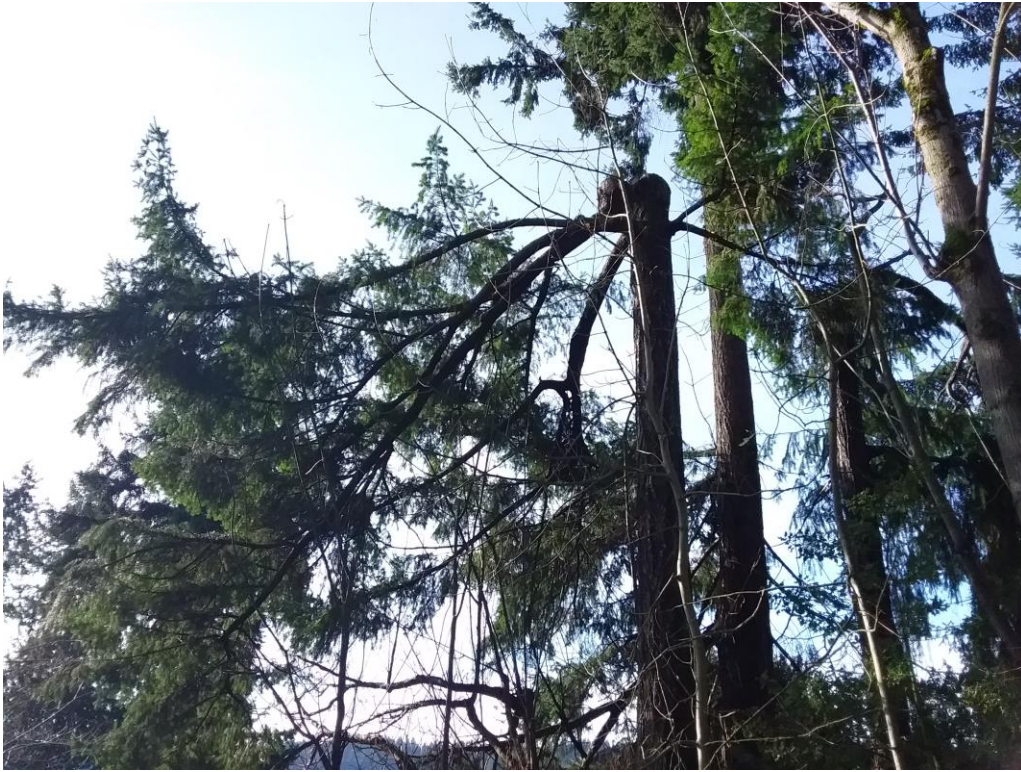
14. Douglas fir 29" DSH, topped off near the 28' level, and only has four live branches coming off around the cut point (Figure 38). The limbs are over extended to the south and reach completely over the entry drive. Exhibits below-average color and new growth. It stands 32" NW of the inside edge of the entry drive.

Figure 38. Looking up and SW at the top of the #14 fir.

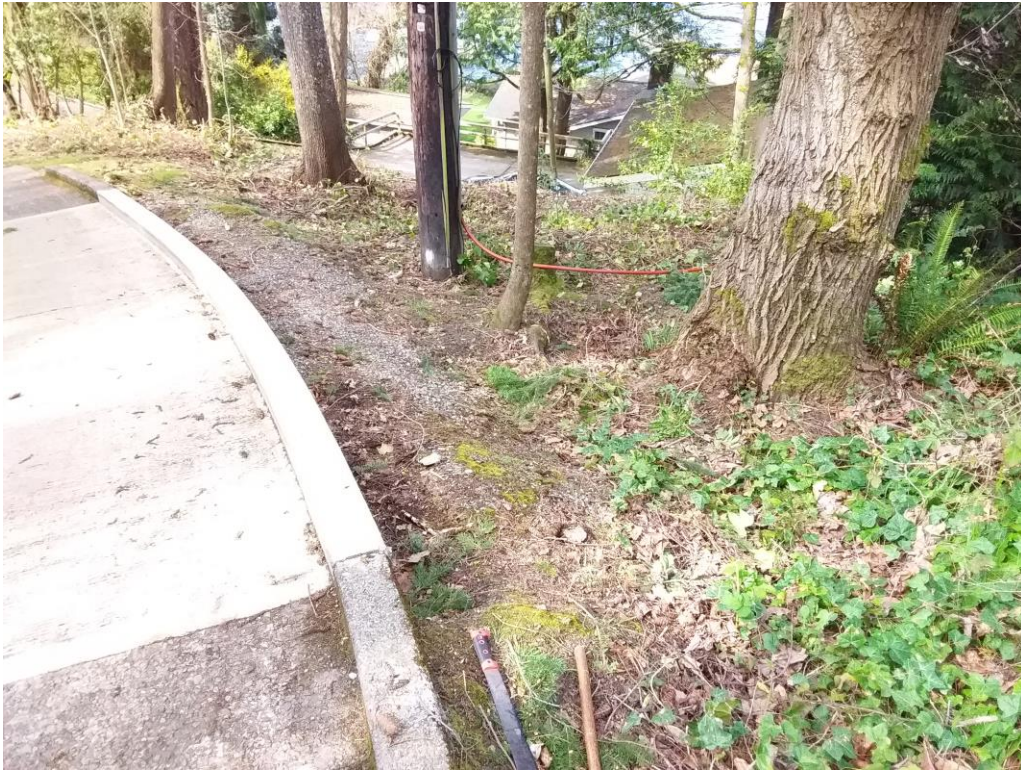
19. Black Cottonwood (*Populus trichocarpa*) 28.5" DSH, 90' tall with a large lateral extending west close to 45', a smaller spar reaching 25' south, and the majority of the canopy carried on the main offset center spar. The tree slightly west from the base, increasingly so above the crook at the 40' level where the spars separate. Below this level there is little canopy, a 16" caliper branch extends to the southeast, another one grows out to the east. Exhibits abundant new growth, including epicormic, and decent color. Large cankers are present at the base and along the lower column. The larger ones show atrophy and decay present. The one at the southwest sector of the base is 42" across and 28" tall (Figure 39). There's one at the 7' mark that wraps the tree for half a circumference and is 20" tall (Figure 40). There's another one near the 11' level on the northeast face that wraps 1/3 of the circumference and is 12" tall (Figure 41). There's more than a dozen smaller ones scattered along the stem of the tree. Tree stands 8' N of the utility pole, 7.5' NW of the entry drive. The entry drive has been replaced recently in this area (Figure 42). There is evidence of large surface roots 27' away bumping up against an older section of the driveway (Figure 43).

Figure 42. Looking south at the area of new concrete east of the #19 tree.

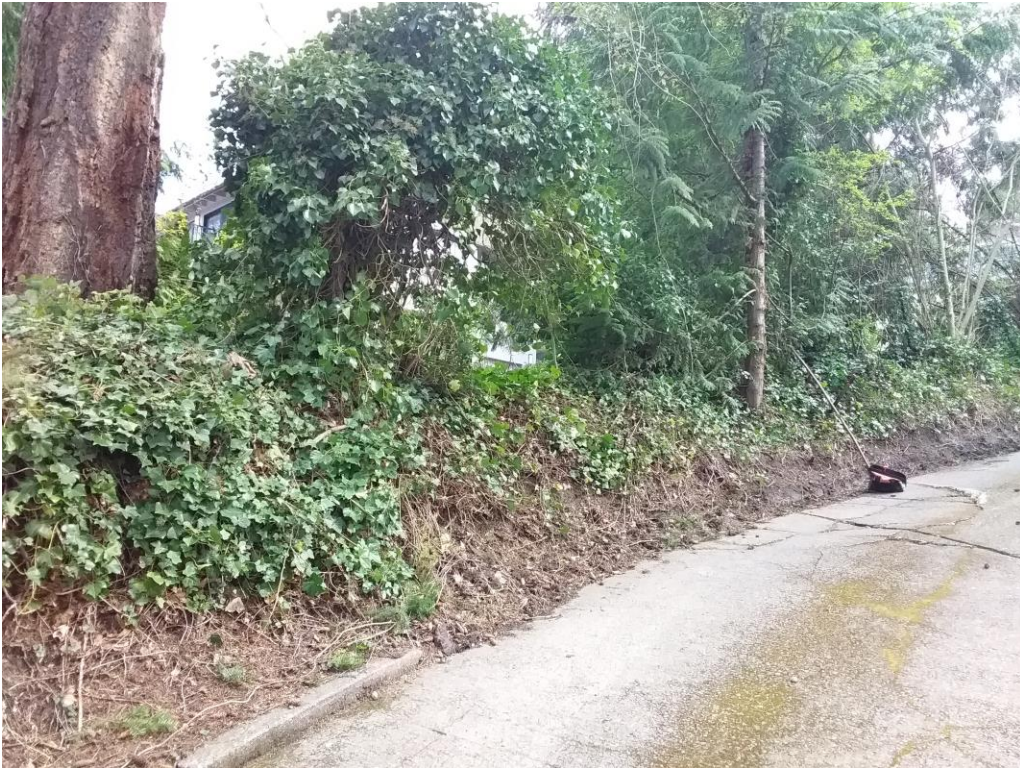
Figure 45. Looking ENE up the entry drive showing the base of the #21 fir and the #22 cedar at the north side.

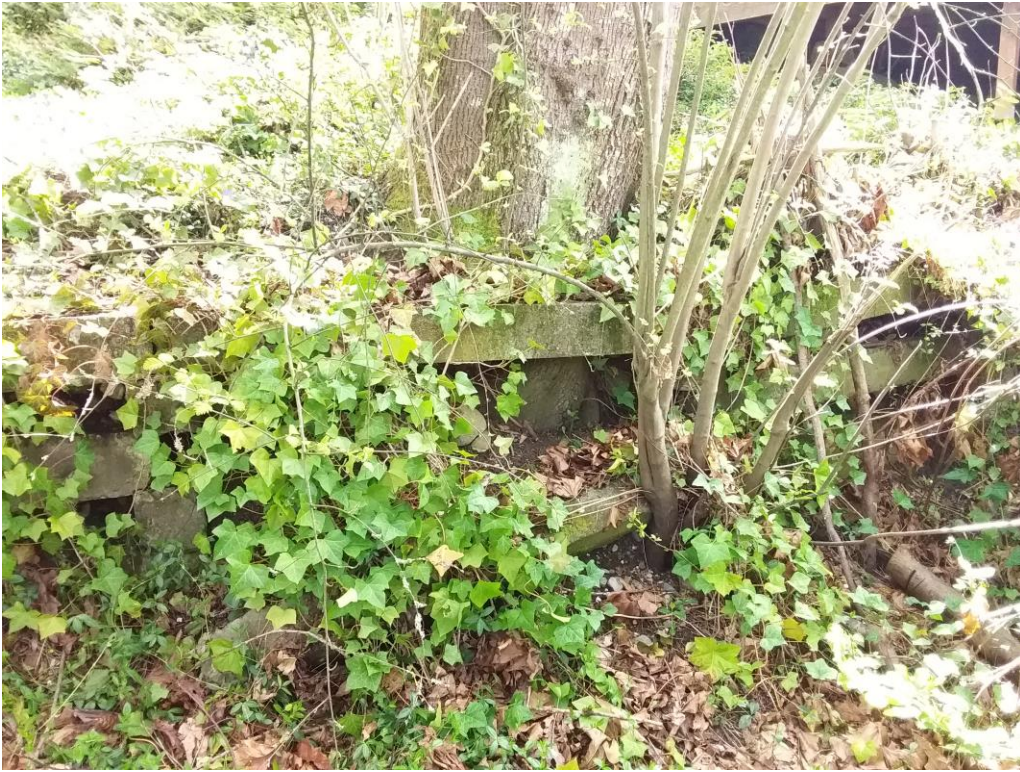
Figure 46. Looking east at the base of the #24 maple coming through the retaining wall.

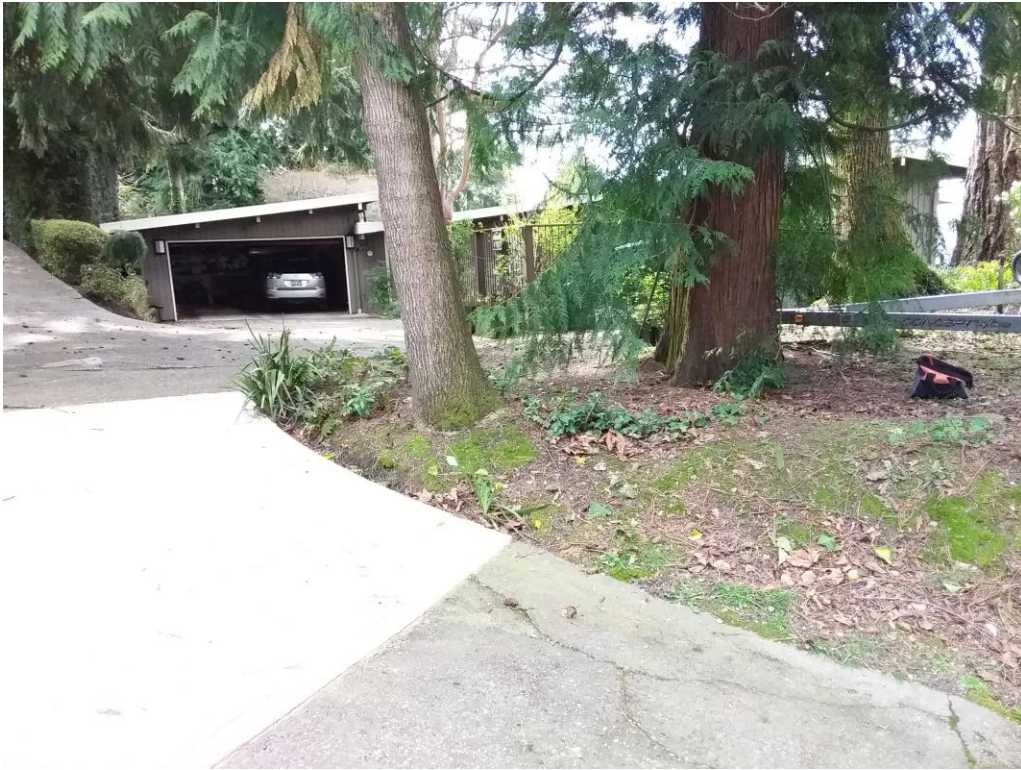
Trees #19, #20, #30, and #31 are in areas where previous work on the existing driveway would have caused root disturbance. Trees #16, #20, #29, #33, and #34 stand in the secondary impact area. Their situations will be discussed below.

Figure 49. Area of new concrete east of the #30 and #31.
