Arborist Report

To: Covenant Living Communities and Services c/o Randy Gross
Site: 9150 Fortuna Drive, Mercer Island, WA 98040
Re: Tree Inventory and Assessment
Date: February 6, 2026
Project Arborist: Julian Garcia
ISA Certified Arborist PN-9969A
ISA Qualified Tree Risk Assessor
Reviewed By: Sean Dugan, Registered Consulting Arborist #457
ISA Board Certified Master Arborist PN-5459B
ISA Qualified Tree Risk Assessor
Referenced Documents: Conceptual Site Plans (Navix, February 5, 2026)
Attached: Table of Trees
Tree Site Map

Summary

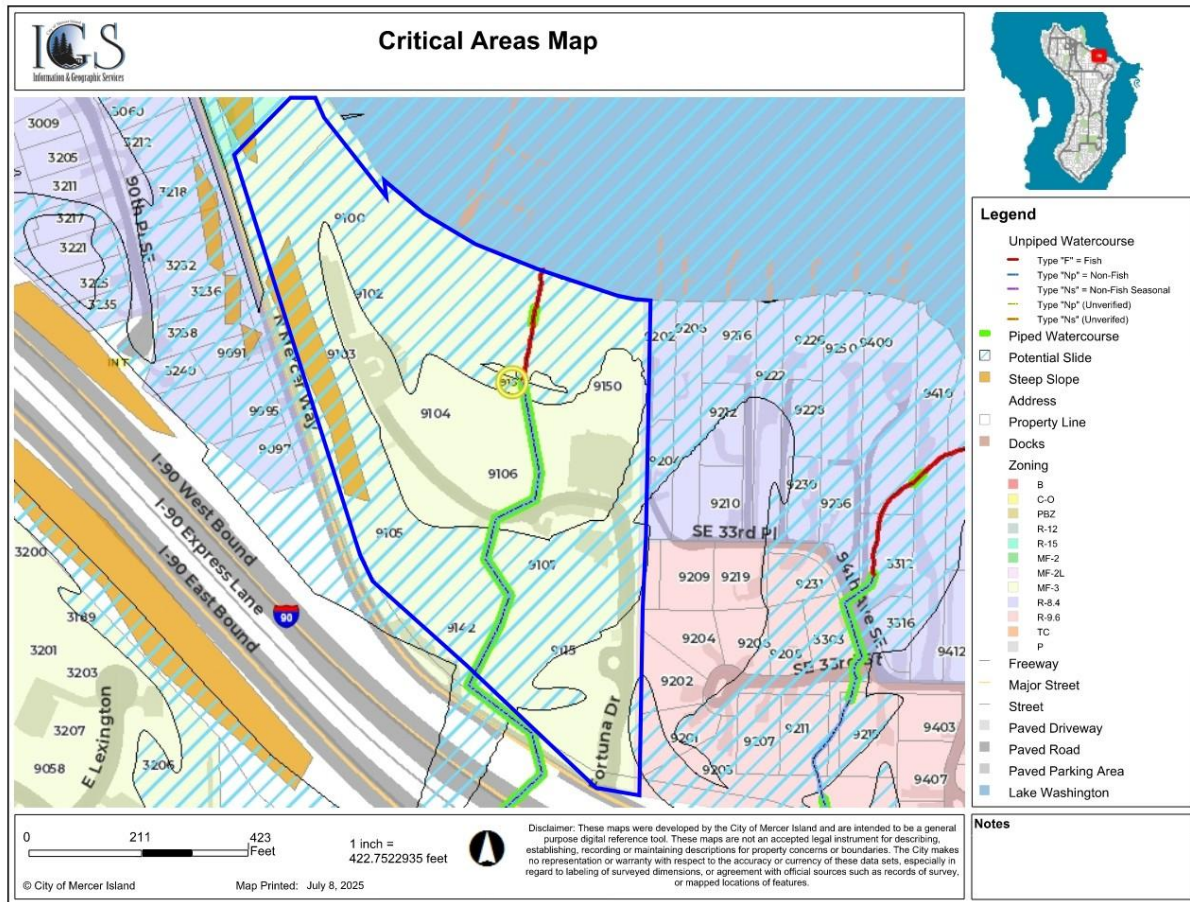
According to the City of Mercer Island GIS Portal, this property is zoned as MF-3 (parcel 072405-9016) and R-9.6 (parcels 413930-0230 and 413930-0225). Per a conversation with the client, the two parcels that are R-9.6 may be rezoned as MF-3 under a separate application to the City. Moreover, five critical areas (CAs) exist on-site including a type F unpipied watercourse that runs through the property from south to north, steep slope area along the southwest property line, newly found wetland, potential slide area, seismic area, and erosion area throughout the property (see Figure 1).

Figure 1. Critical Areas (CAs) Site Map shows property outlined in blue (accessed on July 1, 2025).
