Project: Vegetation management plan for select trees at 4645, 4649, and 4651 Forest Avenue SE, Mercer Island. Parcel Numbers 404500-0075, -0080, and -0085.

Contact: Scott Sinclair – Tree Harmony Arborists, LLC
PO Box 1261, Mercer Island, WA 98040
Phone - 206 275 0991 Email – paulscottsinclair@gmail.com

Objective: Evaluate risk for trees in range of houses, entry drives, walking paths, and parking. Make recommendations for removal, mitigation, and preservation. Promote health, correct structure, and insure longevity of those to remain. Create scenario for any mitigation planting required by the City.

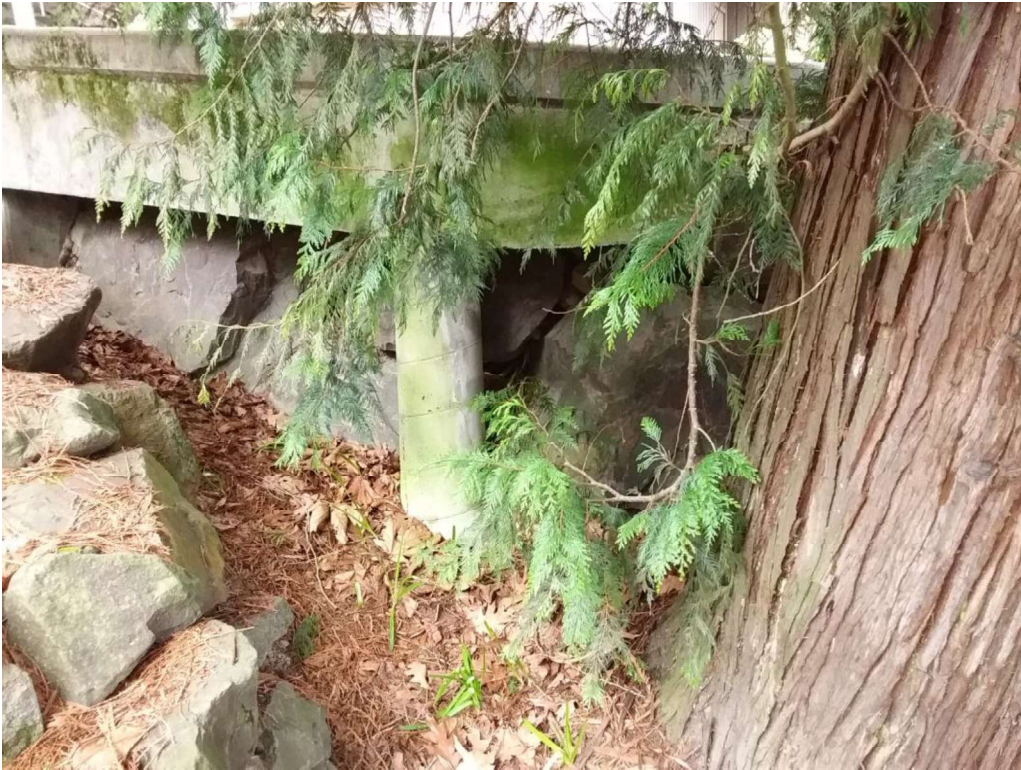
2. Western Red cedar (*Thuja plicata*) 34" DSH, reaches into 80' range on some sections, no more than 60' tall on others. The tree stands with the south side of its base touching a large stone retaining wall for the 4651 house (Figure 5). A concrete pillar corner support for the raised driveway parking area is 30" E of the tree (Figure 6). A second stone wall supports the stairs that lead down to the lake (Figure 7). The area between the two retaining walls is quite narrow and runs 12' out to the east side of the tree. The stairs are formed from Keystone blocks that appear to be set over a concrete and brick framework and run down the north side of the tree 3' off its base. Another concrete block retaining wall system runs east to west 10.5' N of the tree.

Figure 6. Concrete support post for the 4651 parking area.
