## Arborist Summary Memo

Site: 7239 SE 27th Street, Mercer Island, WA

Re: Summary of arborist reports over last 5 years

Date: September 3, 2021

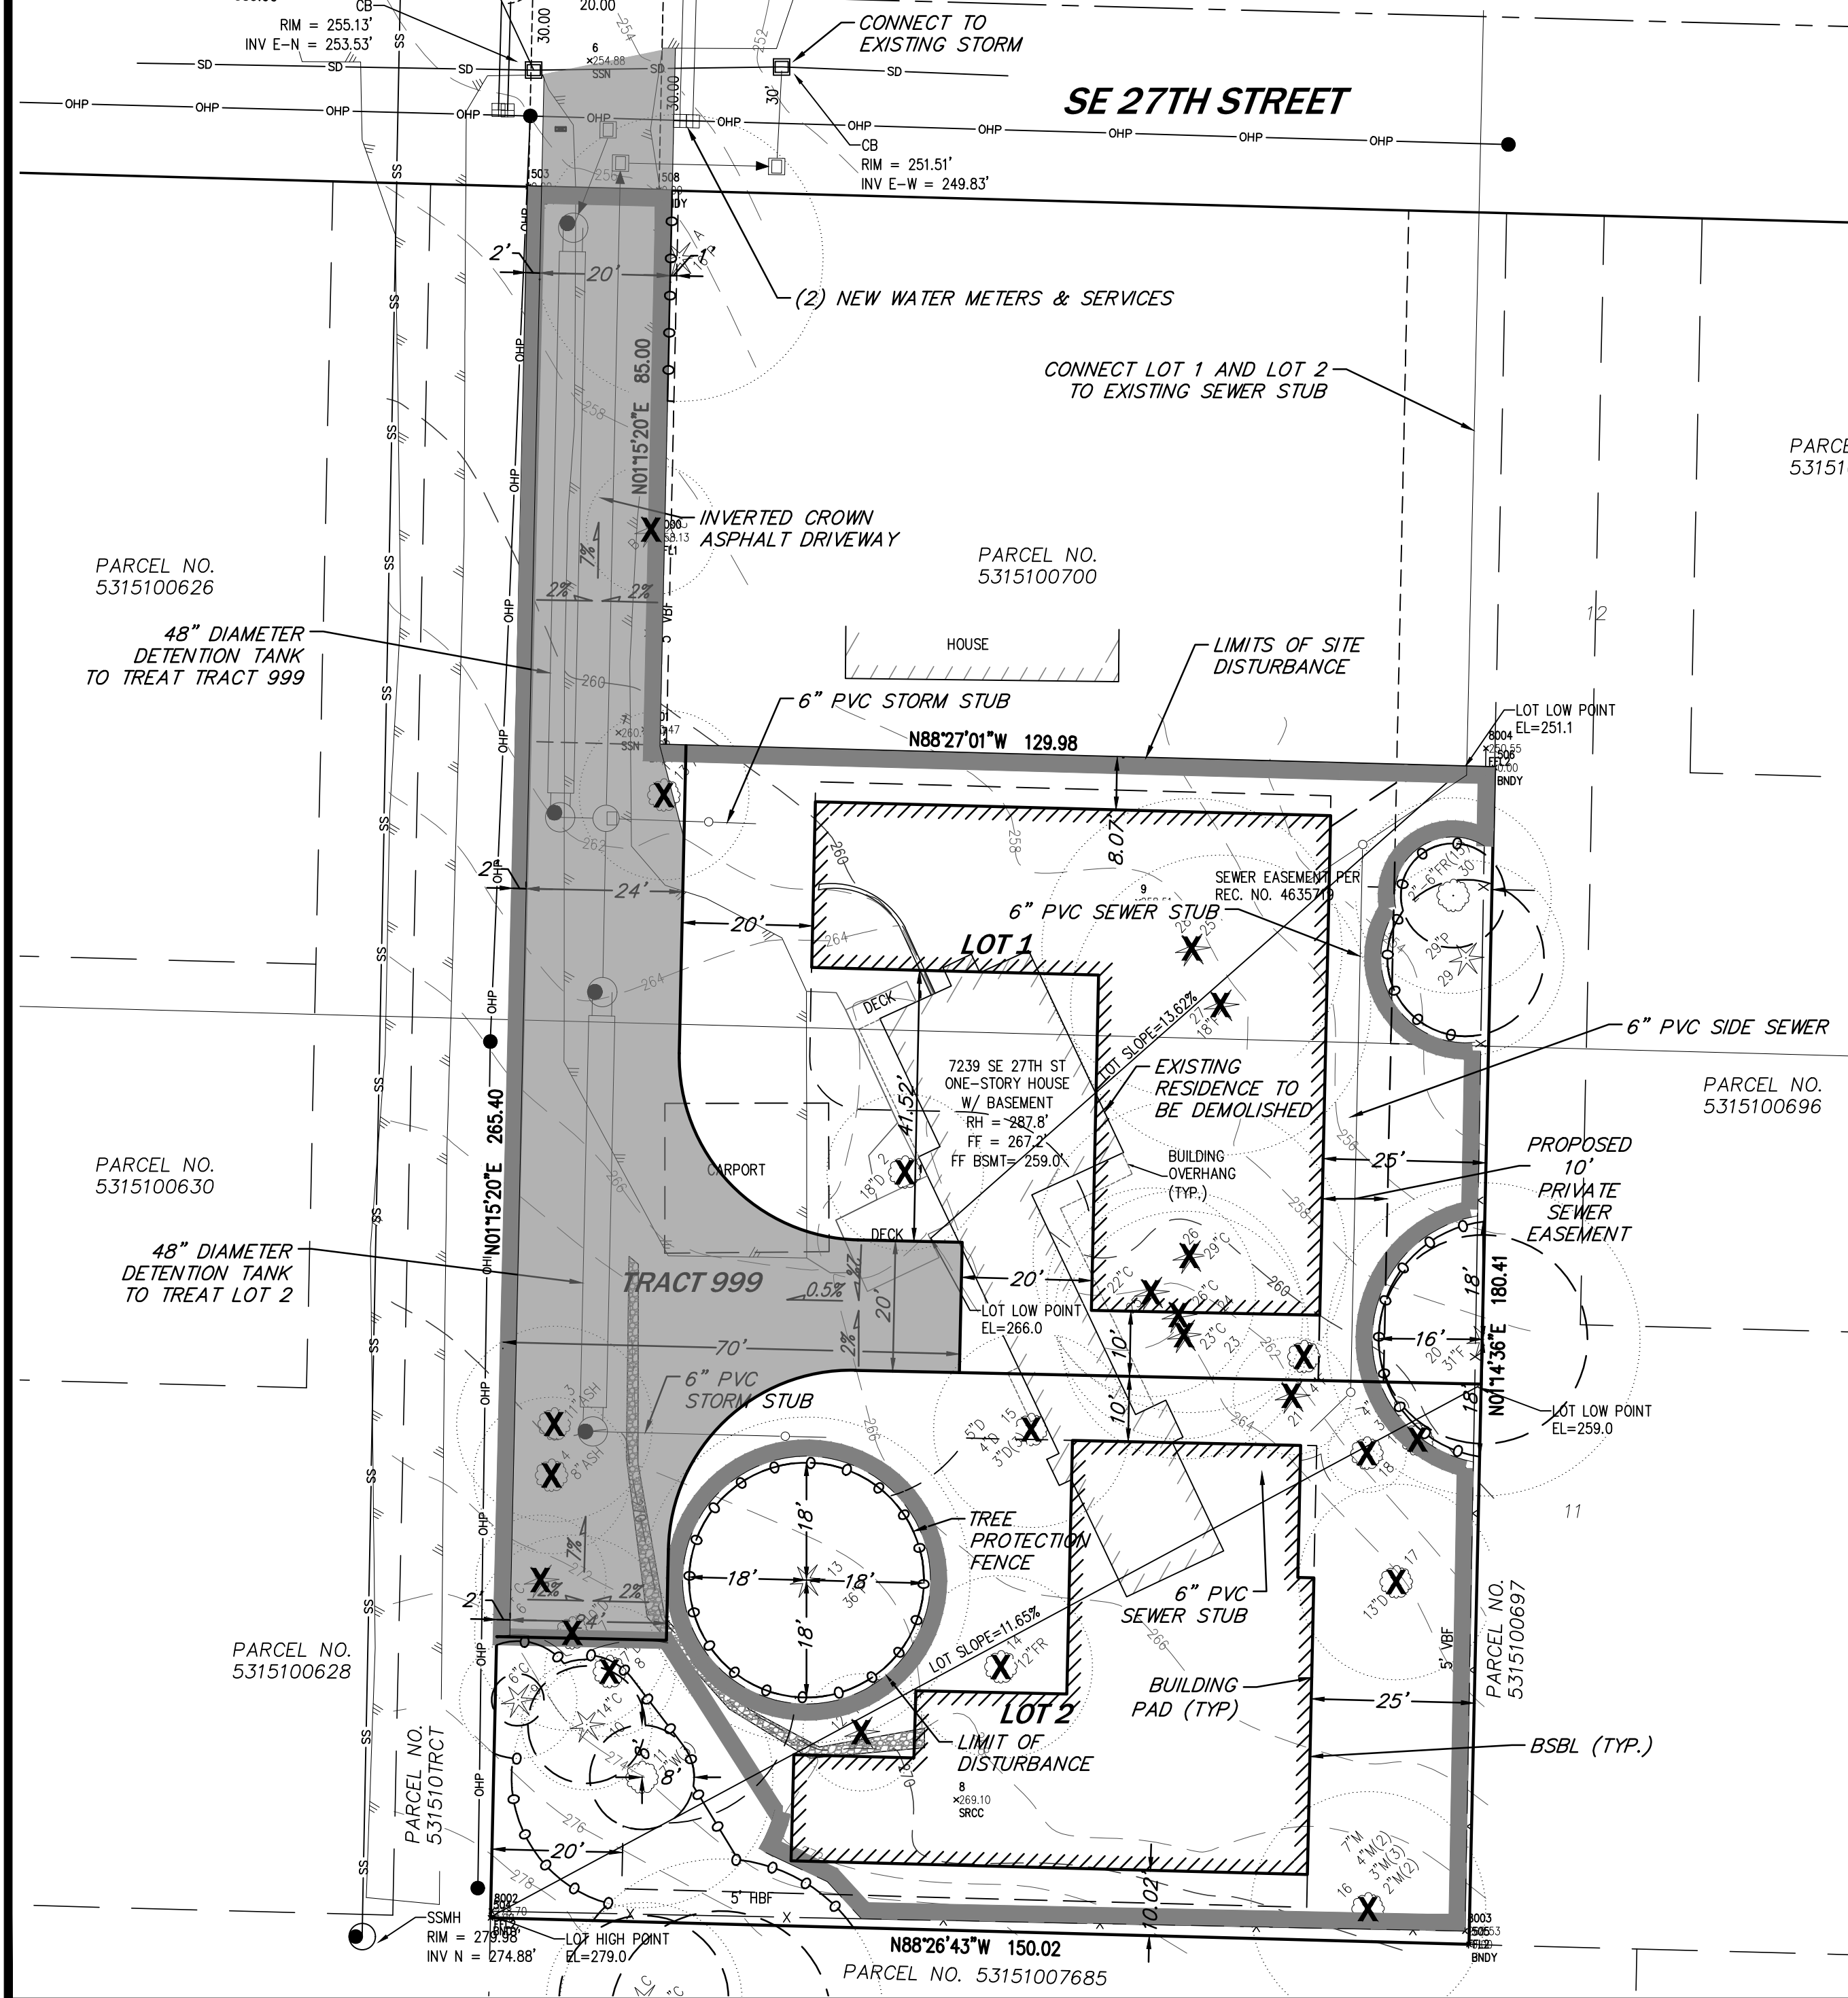
A PORTION OF THE NE 1/4, OF THE NW 1/4, SECTION 01, TOWNSHIP 24 NORTH, RANGE 4 EAST, W.M. CITY OF MERCER ISLAND, KING COUNTY, WASHINGTON

Plan provided to Tree Solutions as 'final plan' by Core Design June 30, 2021

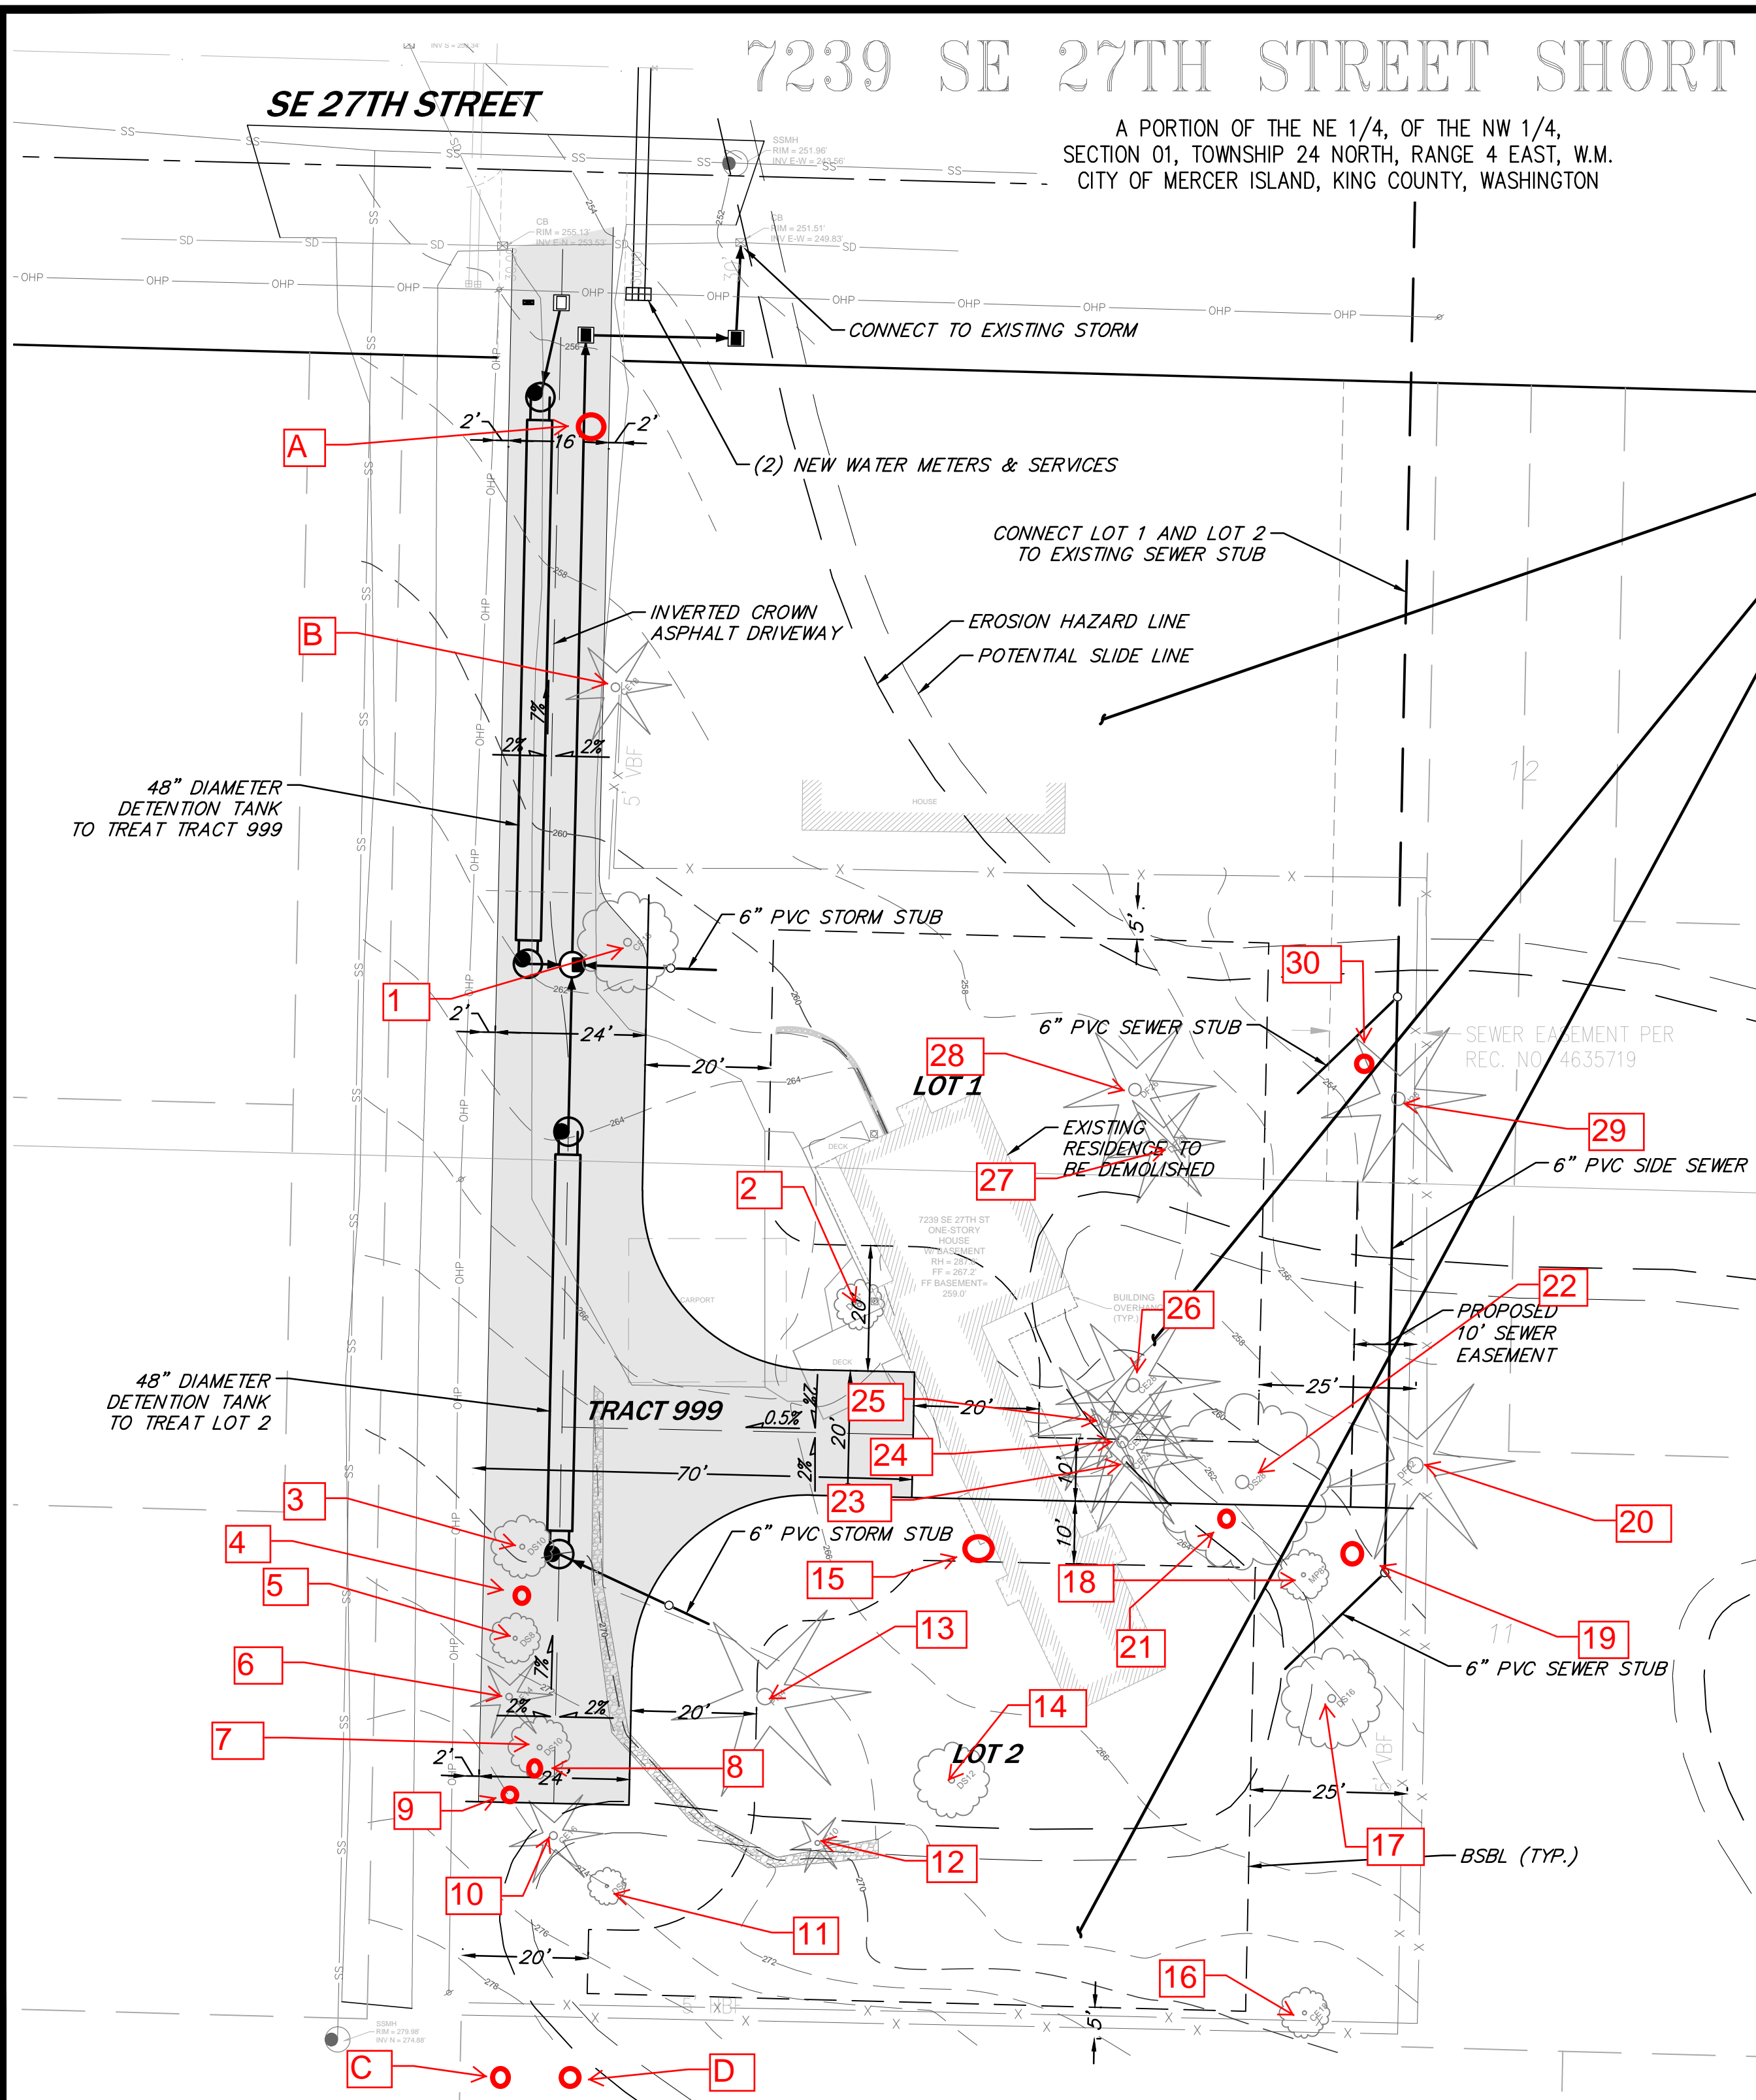
Arborist Map  
dated 2016

THESE 3 LOTS ARE IN THE EROSION/SLIDE HAZARD AREA. WE NEED TO DETERMINE IF THESE LOTS CAN BE EXCLUDED FROM THOSE HAZARD ZONES
