Drainage Report

9116 SE 58th Street– Raquepau Residence

Mercer Island, WA

November 1, 2023

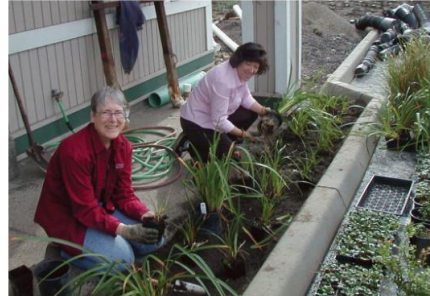
Bioretention during installation

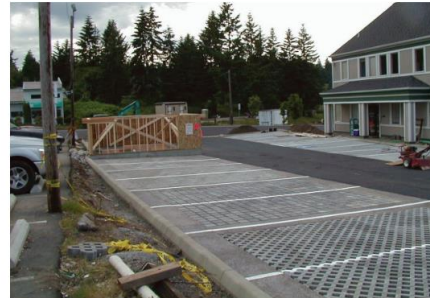
Permeable pavement installation

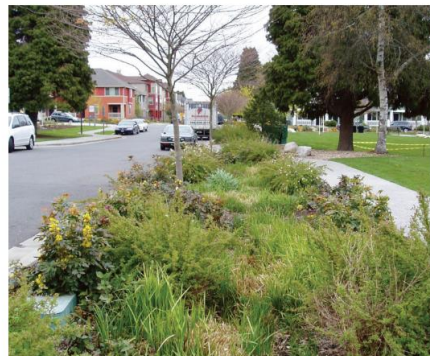
Established bioretention facility
