GEOTECHNICAL REPORT

Ramaiyah Residence

7466 E. Mercer Way
Mercer Island, Washington
Parcel Number: 2579500136

Project No. A-1562-1

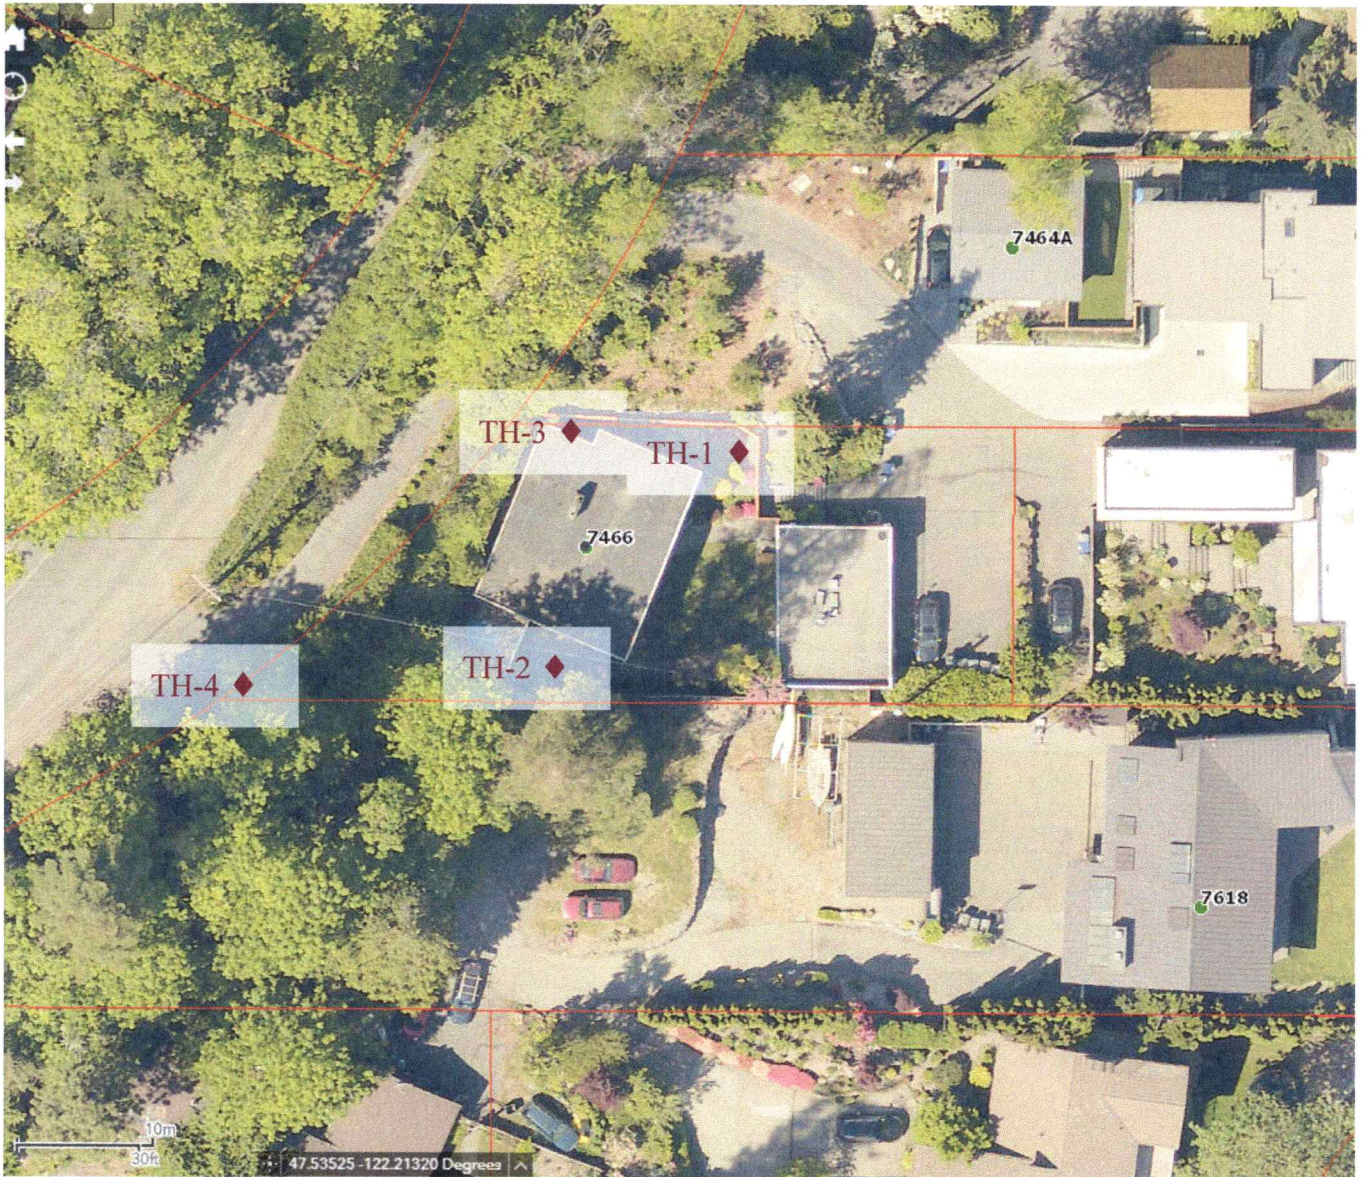
Figure 2

KEY:
 APPROXIMATE LOCATION OF TEST HOLE TH-1 ◆

The subject site area is an irregular shaped residential parcel located at 7466 East Mercer Way in the Clarke Beach area of Mercer Island, Washington. The subject site is currently occupied with a single-family residence located in the eastern central (downhill) portion of the site. A detached garage is located along the sites' eastern property line. A driveway switchbacks down the western end of the site to the detached garage located along the east end of the site. The site is bordered with residential lots to the north, east, and south, and by East Mercer Way to the west. The location of the site is shown on the Site Vicinity Map provided in Figure 1. The current site layout is shown on the Exploration Location Plan provided in Figure 2.

Figures A-1 through A-3 present more detailed descriptions of the subsurface conditions encountered in the test holes. The approximate test hole locations are shown on the Exploration Location Plan provided in Figure 2.

On June 29, 2020 we explored subsurface conditions at the site by advancing four hand-augured test holes to a maximum depth of 7.0 feet below surface grades. We visited the site again on June 21, 2024 to view existing site conditions. The approximate test hole locations are shown on the Exploration Location Plan provided in Figure 2.
