**Stormwater Drainage Report
8020 SE 57th Street
Vann Lanz Residence
Mercer Island, Washington
KC Tax Parcel #294890-0082
Permit #: XXXX-XXX**

Section 1: Project Narrative:

The project will be evaluated for storm water treatment and control using the Amended December 2014 SWMMWW (DOE Manual).

**PRELIMINARY GEOTECHNICAL ENGINEERING STUDY
PROPOSED SINGLE-FAMILY RESIDENCE
8020 SOUTHEAST 57TH STREET
MERCER ISLAND, WASHINGTON**

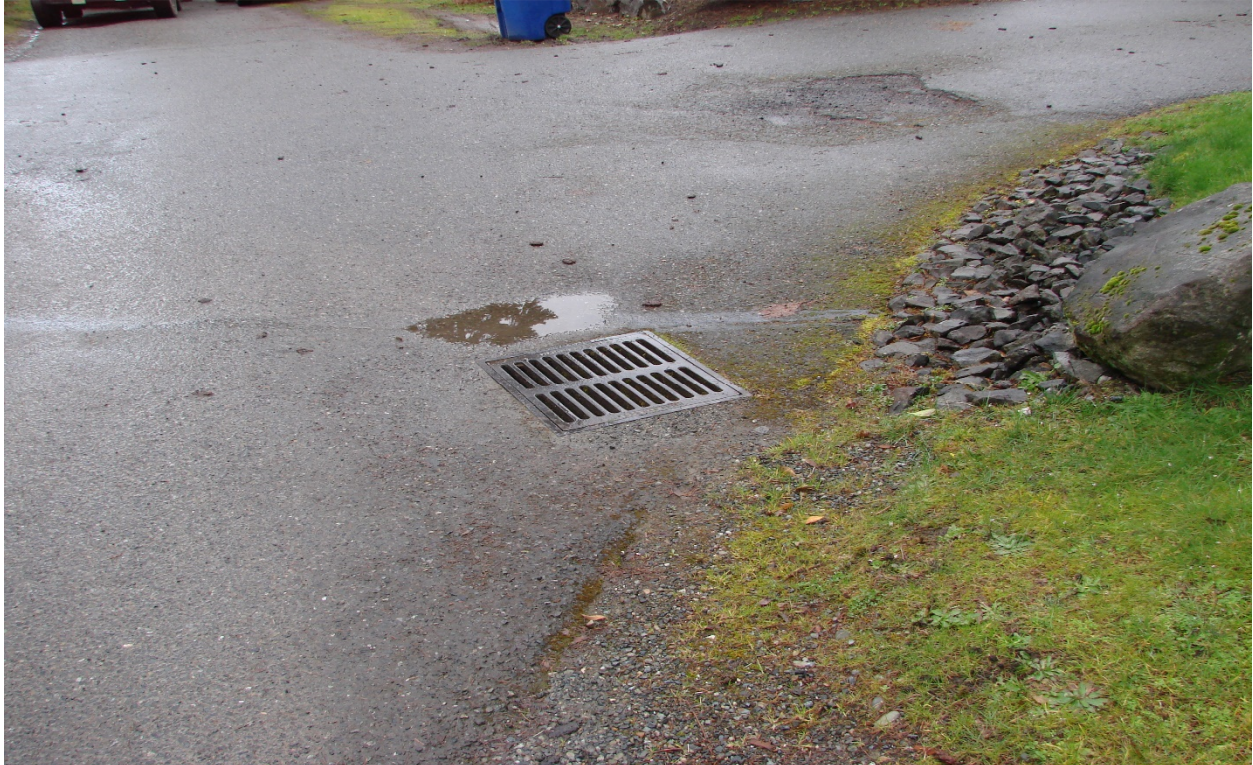
Photo #1 – Existing CB#28b-48 -within east side of 80th Avenue SE

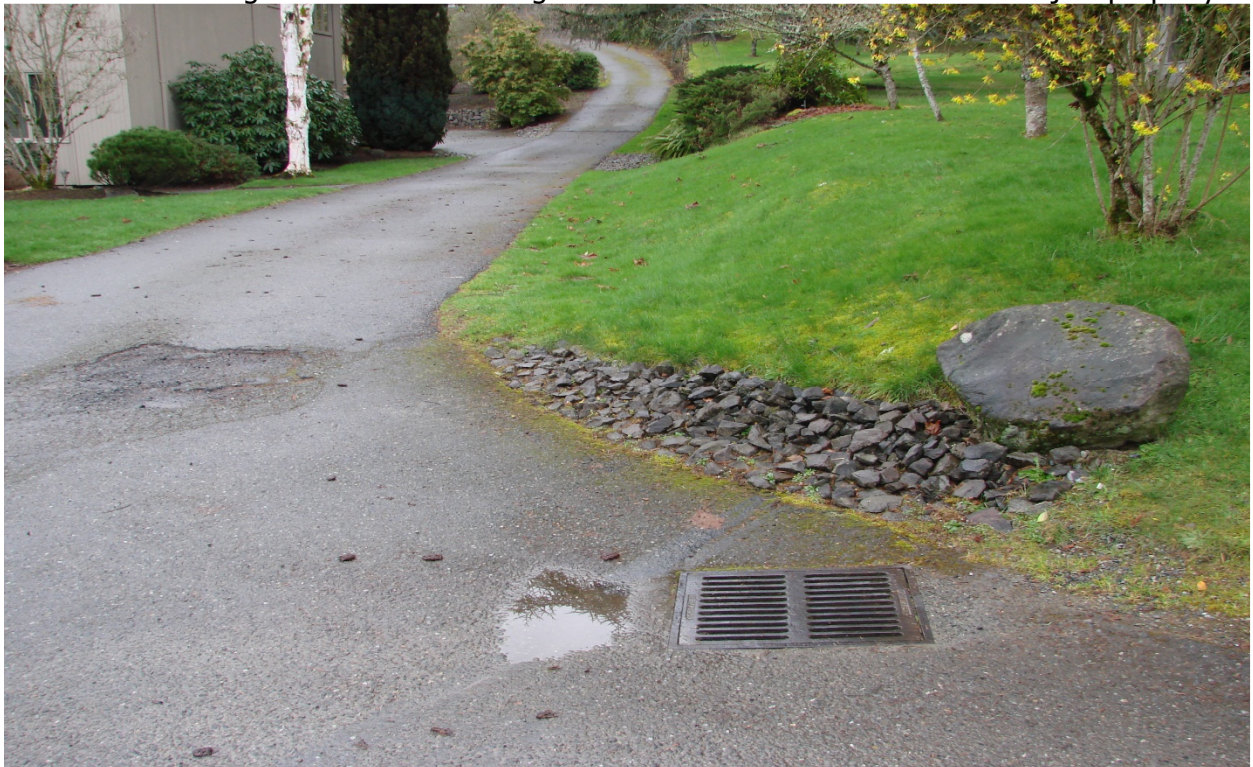
Photo #2 – Existing CB#28b-48 – viewing east from 80th Avenue SE towards subject property

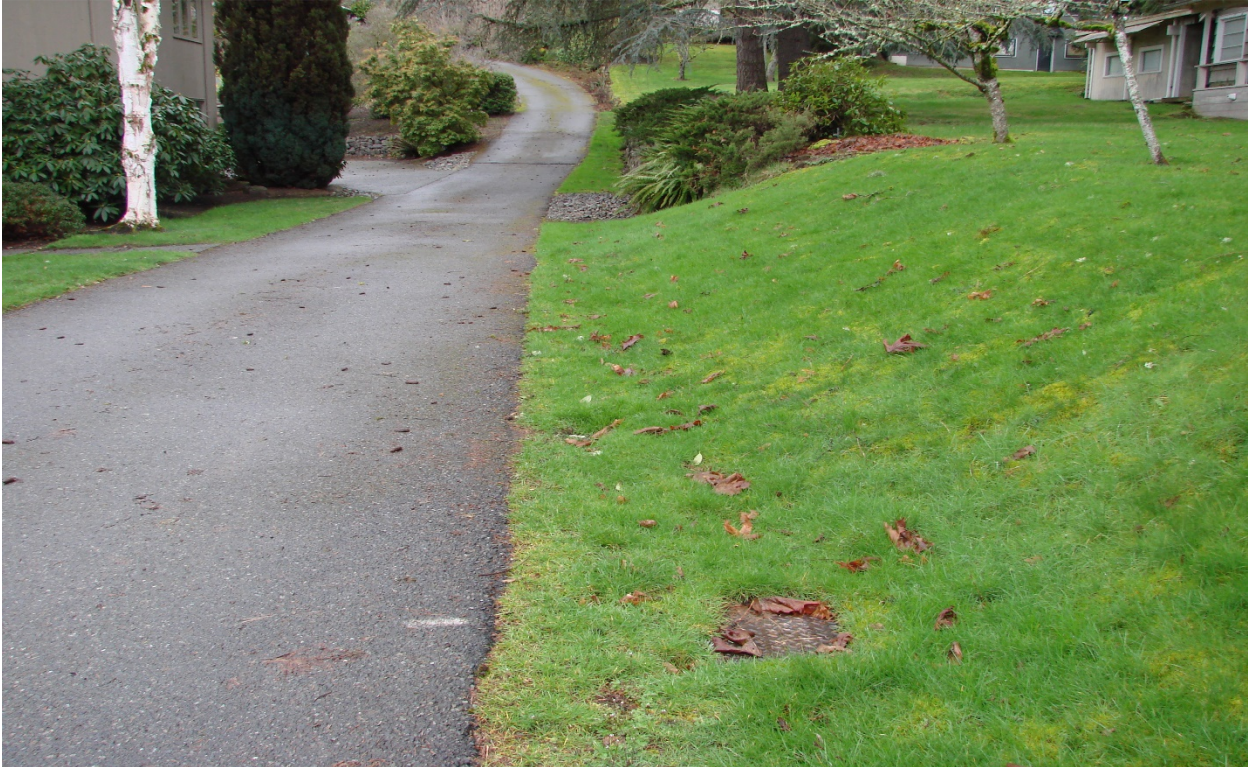
Photo #3 – Existing area drain on south side of driveway heading towards 8020 SE 57th Street

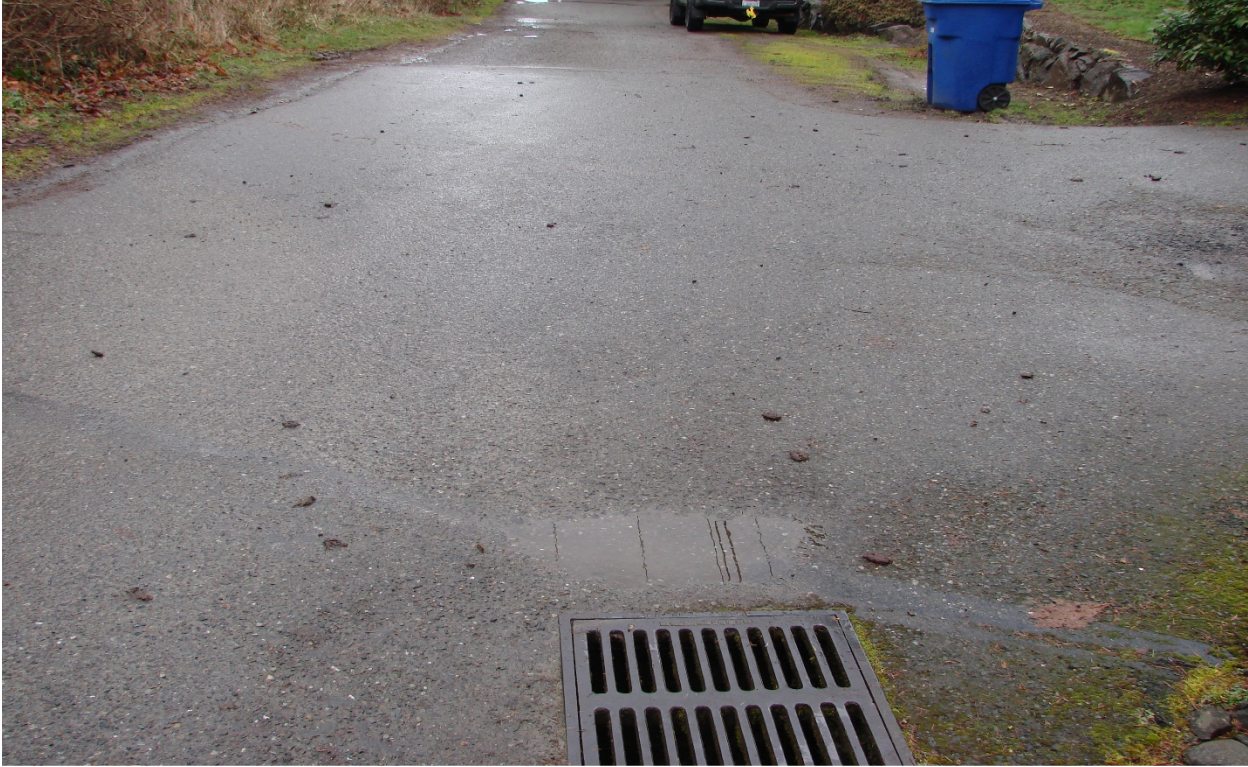
Photo #4 – Existing CB#28b-48 – viewing north on 80th Avenue SE

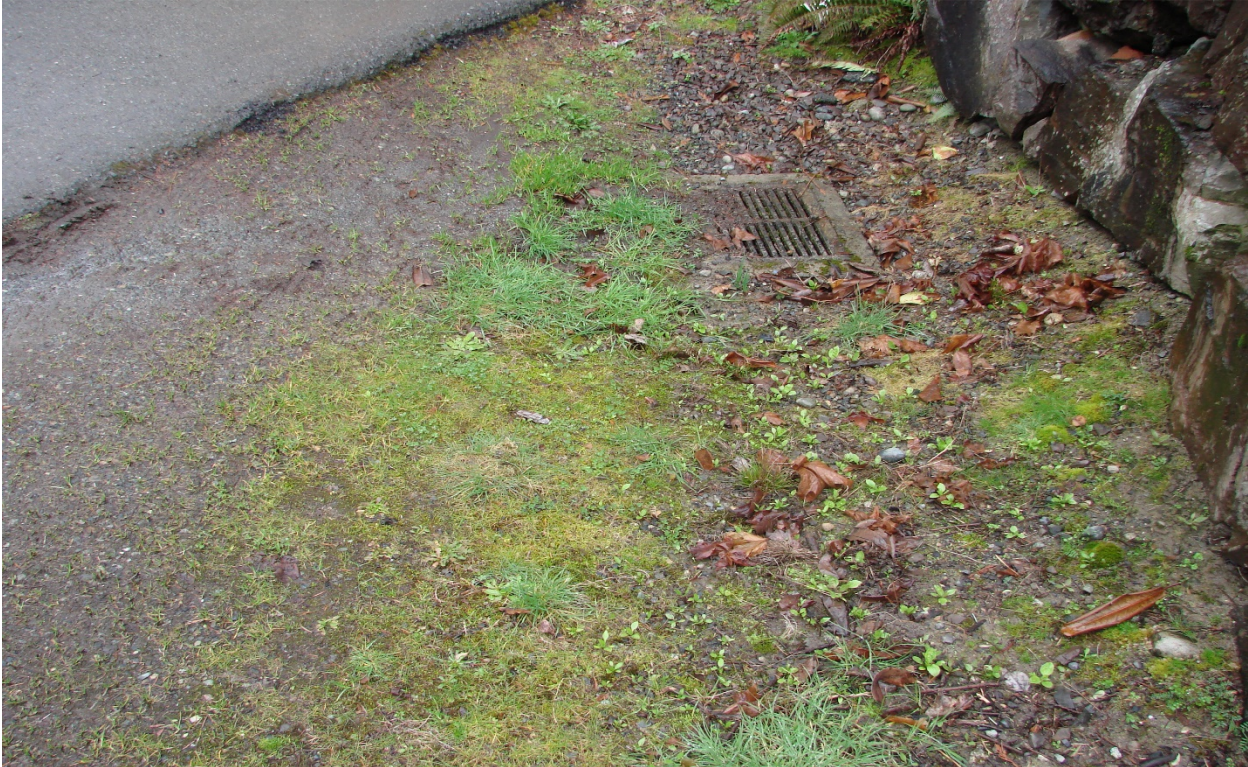
Photo #5 – Existing CB#28b-74 – on east side of end of 80th Avenue SE

The accessible portion of the downstream public storm system downgradient from the subject property natural outfall has no indications of flooding, overtopping, erosion, or scouring. There were no indications of overtopping at of CB#28b-75 into the vegetated slope to the north. There were no indications of overtopping of CB#28b-214, within SE 56th Street Landing, into the gravel area to the west. The downstream system appears to have adequate capacity. The existing catch basins need to have the sumps cleaned out due to debris build-up.

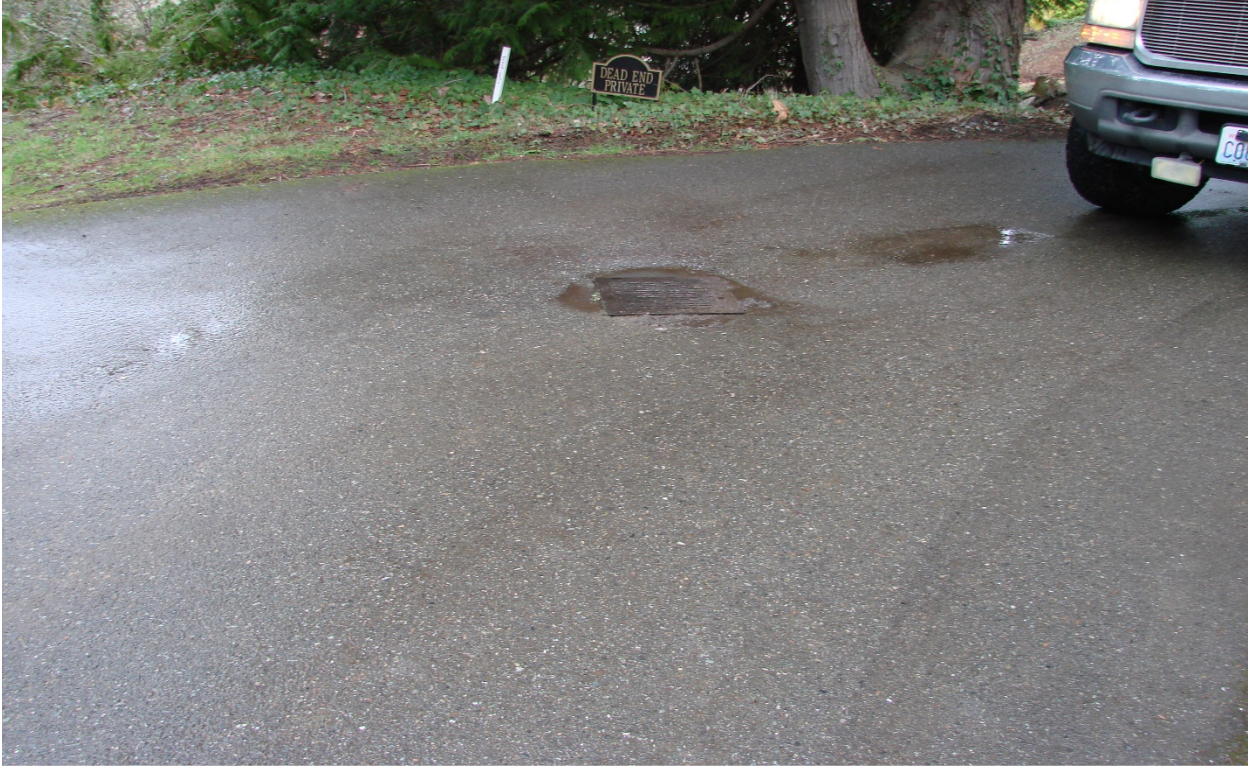
Photo #6 – Existing CB#28b-75 at end of 80th Avenue SE

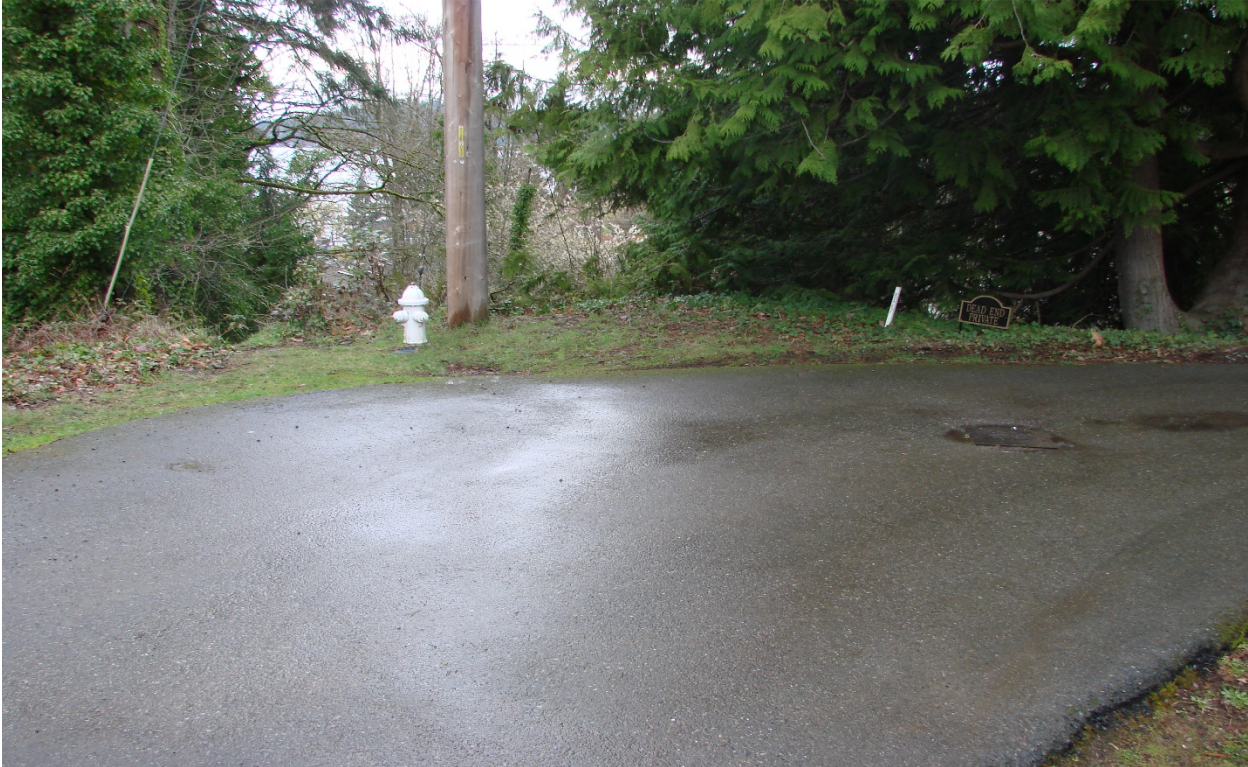
Photo #7 – North end of 80th Avenue SE – before dropping down slope

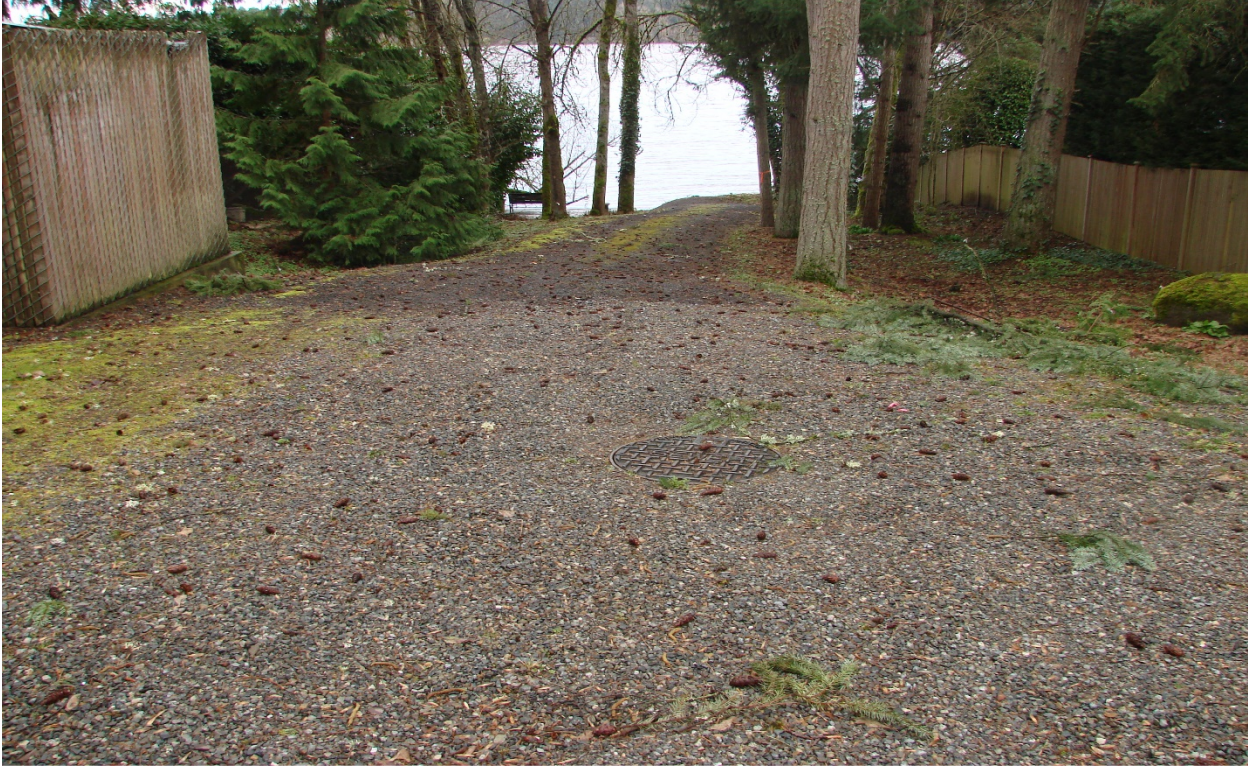
Photo #8 – Existing CB#28b-214 – viewing west towards Lake Washington

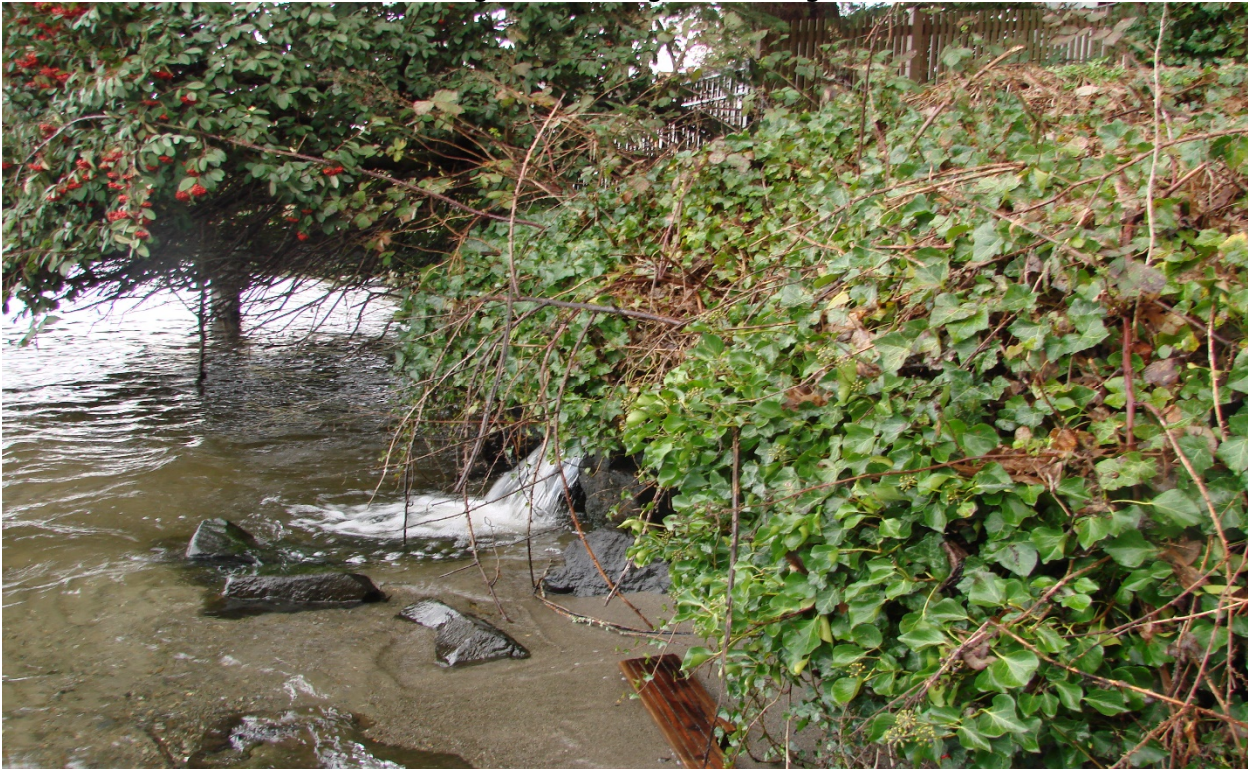
Photo #9 – Outfall into Lake Washington – viewing north along shoreline

Lake Outfall – flowing water, no scouring or erosion present
