Engineering Report

## 5236 W. MERCER WAY STORM DRAINAGE REPORT

October 2017

Tyler Christofferson, PE  
11255 Kirkland Way, Suite 300  
Kirkland, Washington 98033-3417  
425.827.2014  
PACE Project No. 17387

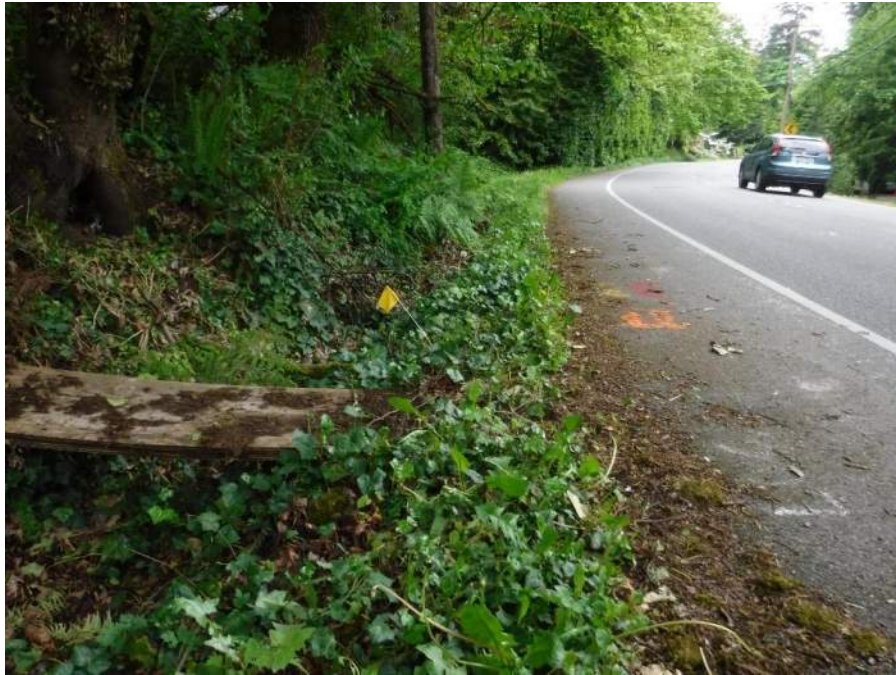
*Image 1: Onsite runoff enters W Mercer Way roadside ditch*

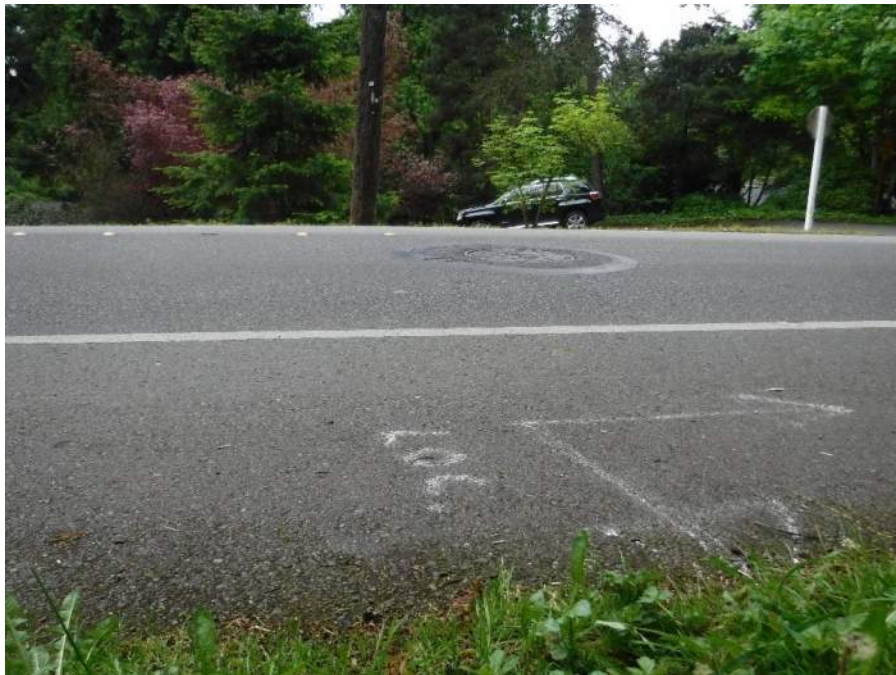
*Image 2: Downstream flows are conveyed northwesterly,  
crossing W Mercer Way via 12" concrete culvert*

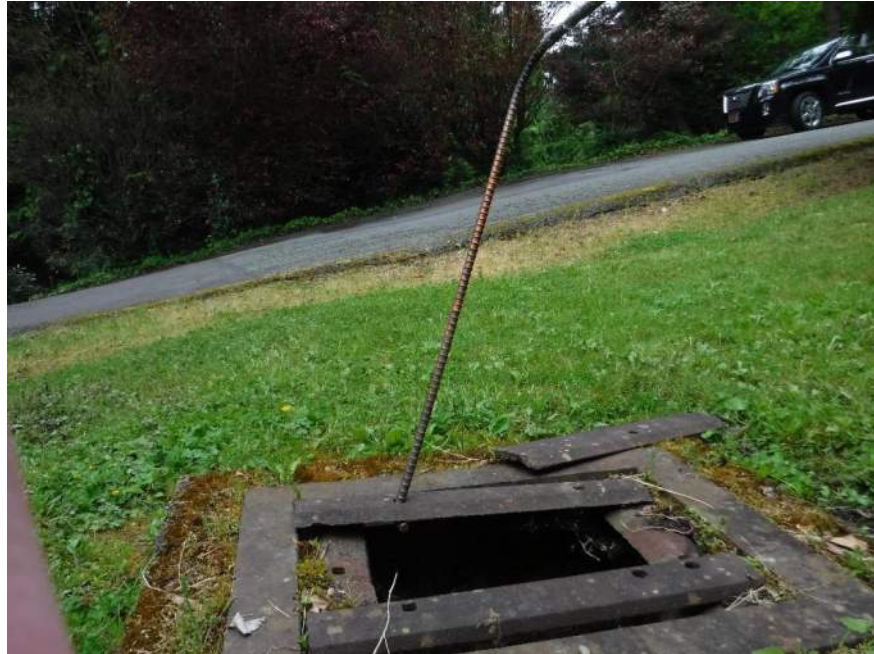
*Image 3: Flows enter this CB located just northwest of W Mercer Way*

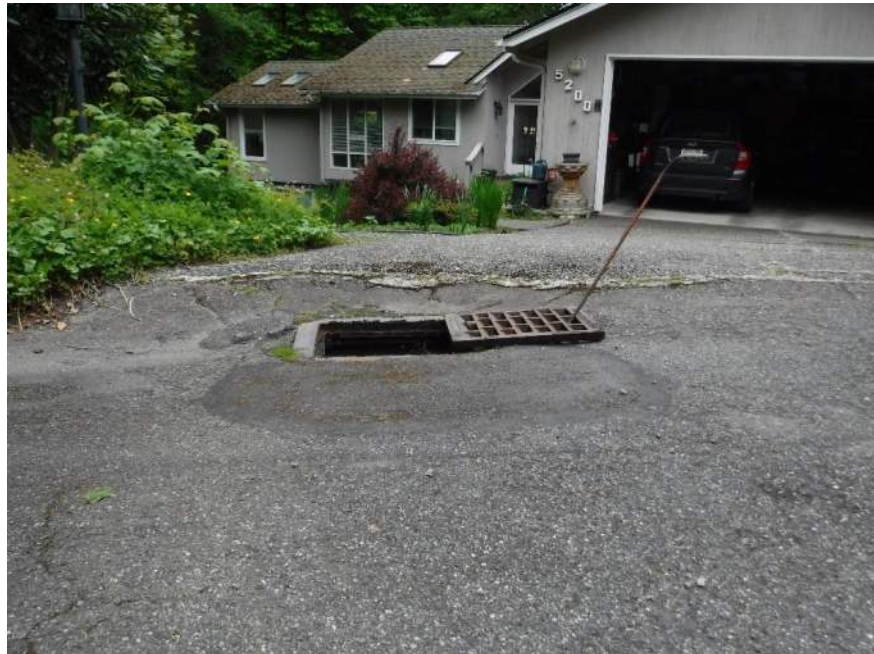
*Image 4: Downstream flows are conveyed to this CB via a 12" concrete pipe*

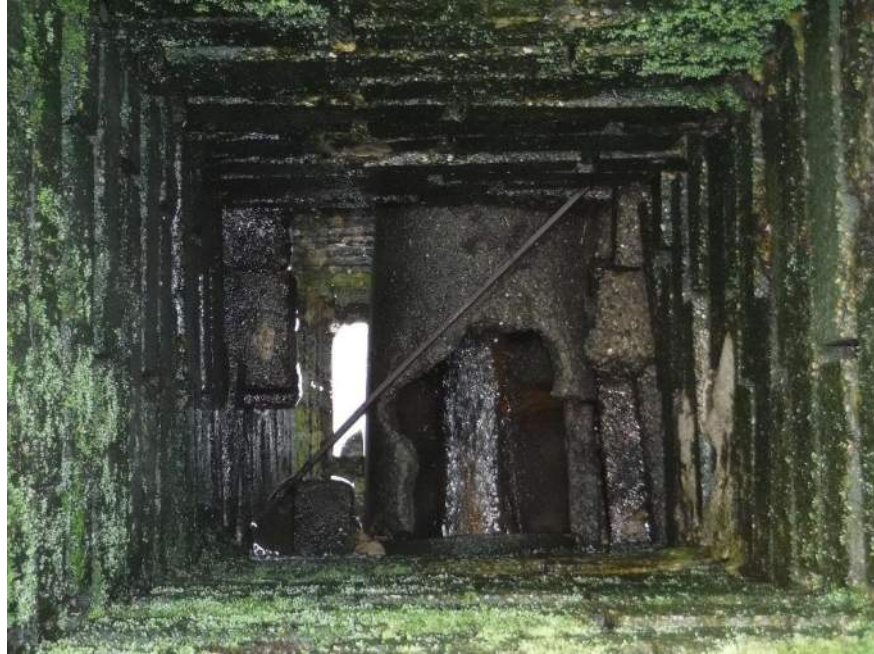
*Image 5: Concrete pipe conveys flows through this CB*

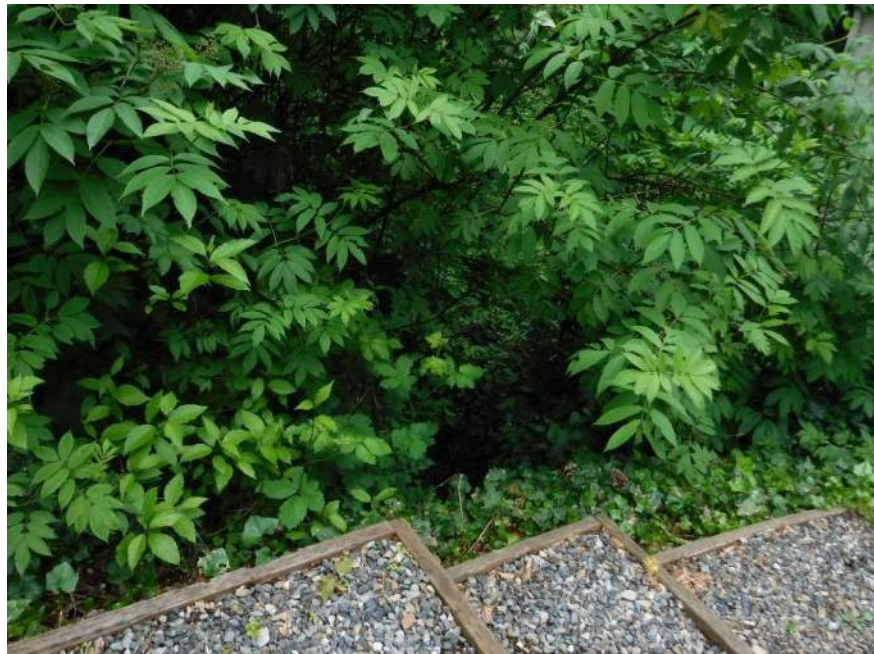
*Image 6: Downstream flows outlet to this open channel  
private watercourse located at 5200 W Mercer Place*

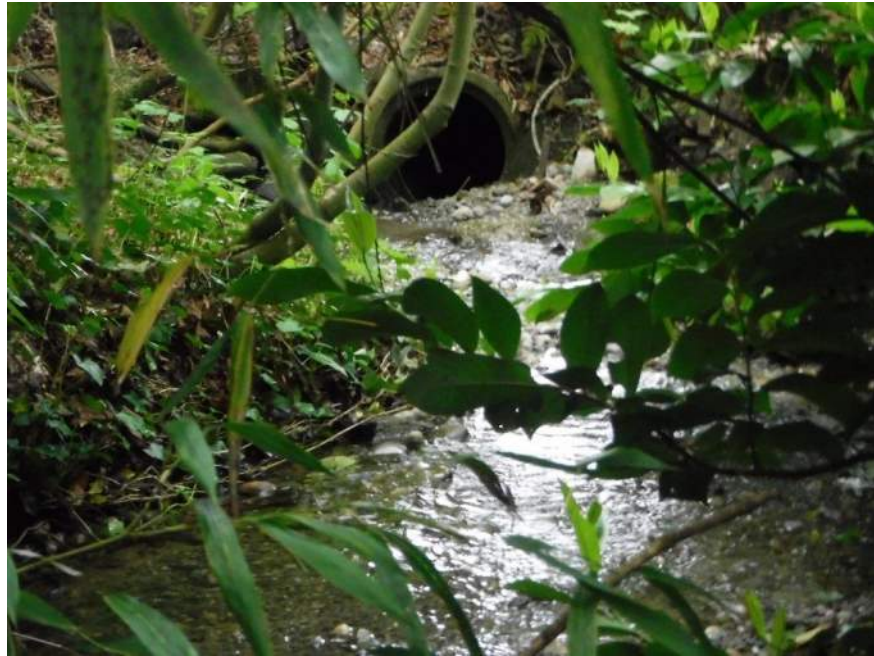
*Image 7: Downstream flows are conveyed through this well-defined and protected open channel*

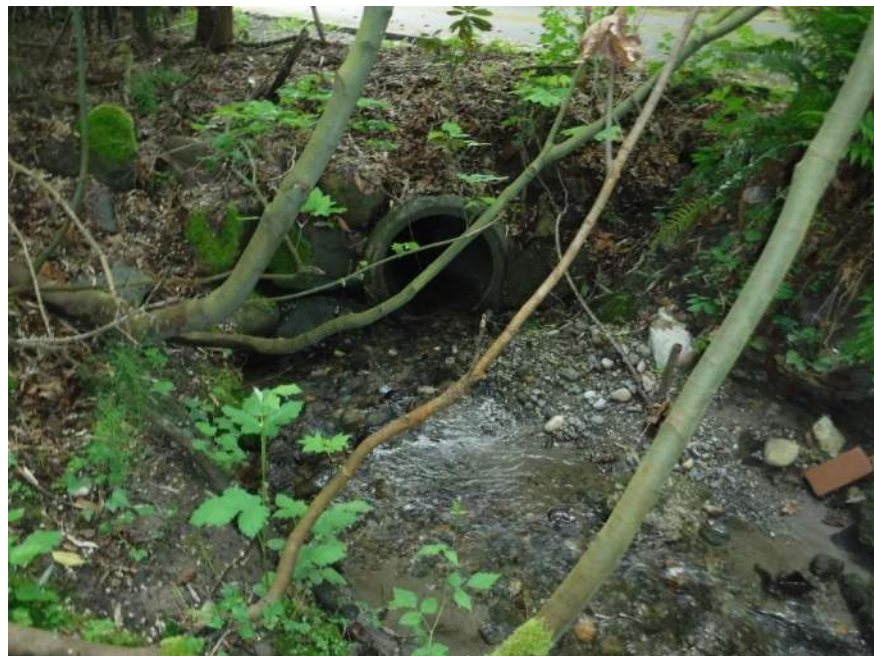
*Image 8: Open channel flows inlet this 24" concrete culvert*

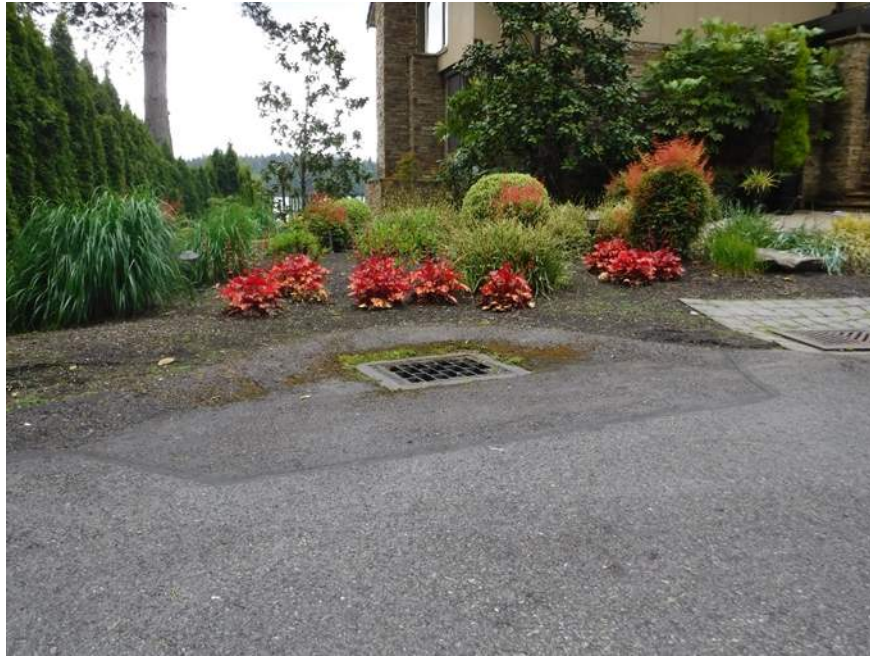
*Image 9: 24" concrete culvert pipe enters this CB and flows continue in the westerly direction via 30" corrugated aluminum pipe through a private drainage easement located at 5067 SE 51st St*

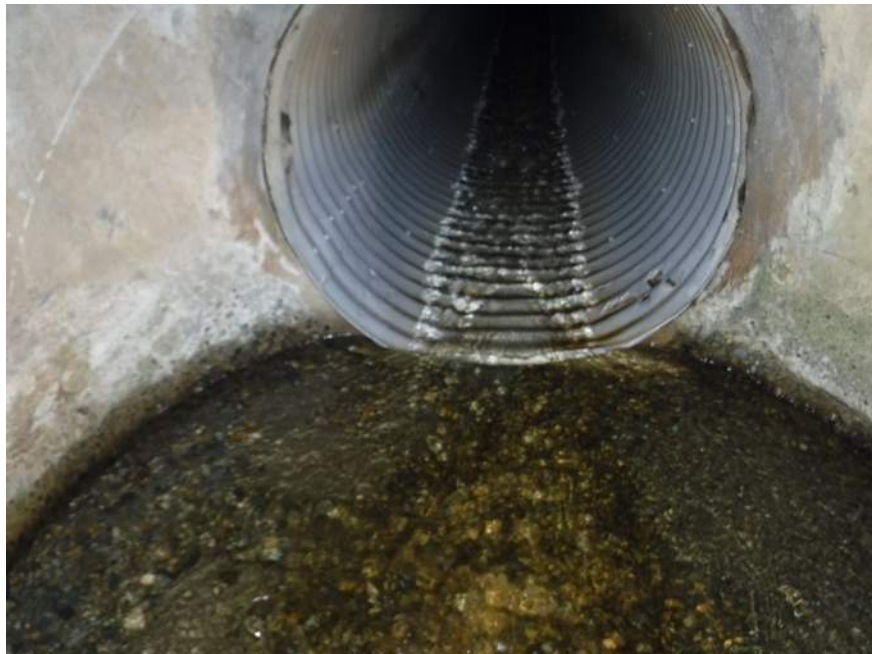
*Image 10: flows outlet the CB via a 30" corrugated aluminum pipe*

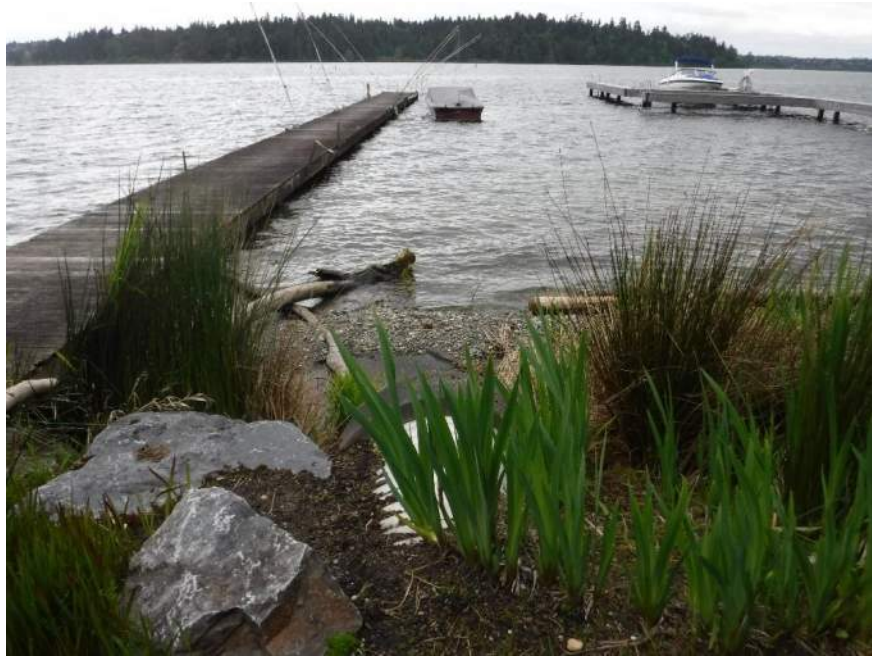
*Image 11: Flows outlet the 30" corrugated aluminum pipe and enter Lake Washington*

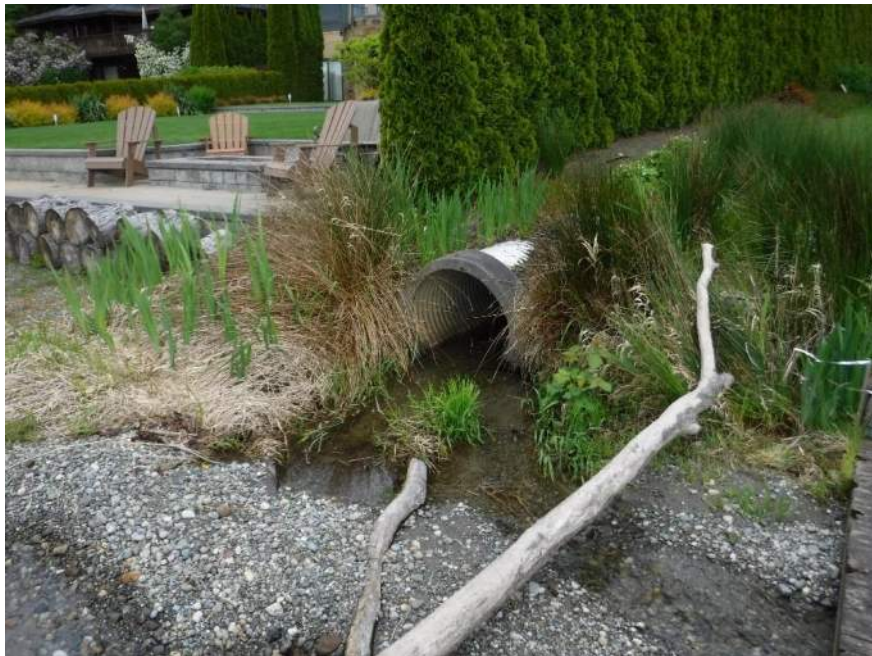
*Image 12: Downstream flows outfall into Lake Washington at 5067 SE 51st St*

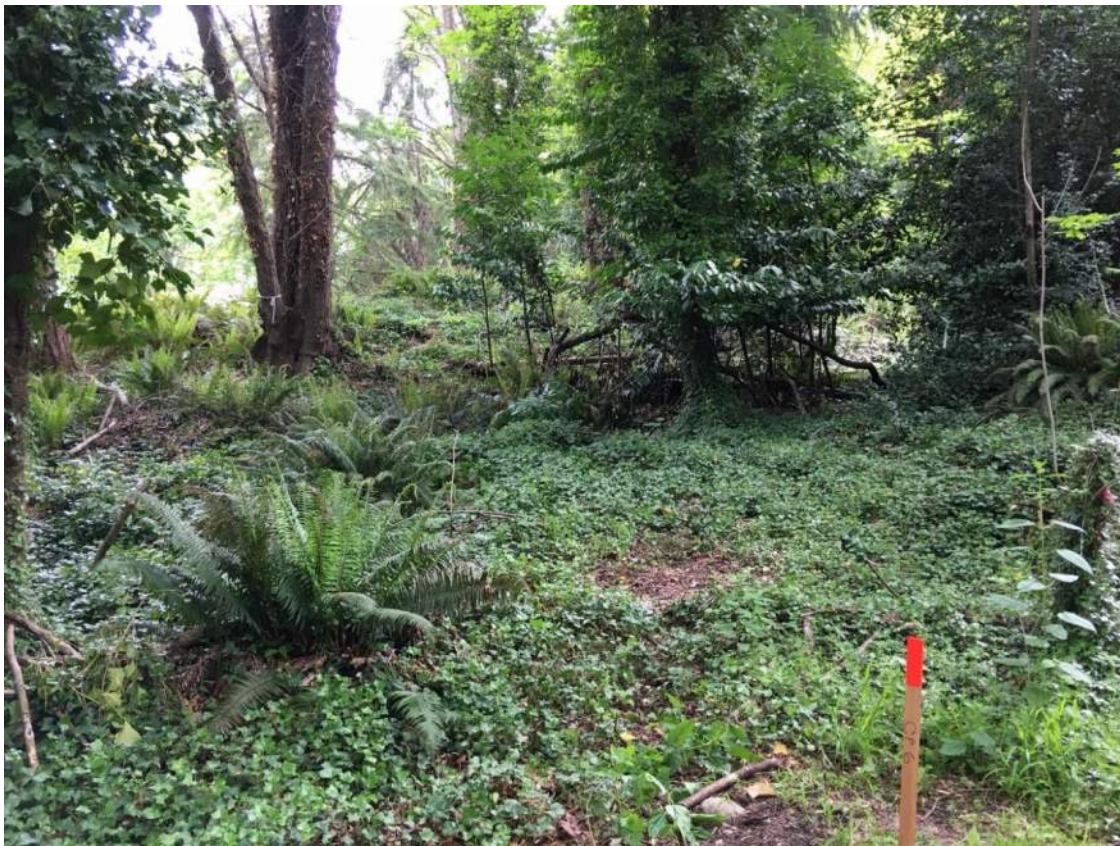
**Plate 1.** Looking northeast near the middle of the site at the general location of the proposed residence.

Plate 1 on the following page depicts current site conditions.
