Subject: **Transmittal Letter – Geotechnical Engineering Study and Critical Area Study**  
Proposed Outdoor Living Spaces and Deck Expansion  
8030 Southeast 20<sup>th</sup> Street  
Mercer Island, Washington

## TEST HOLE LOGS

8030 Southeast 20th Street  
Mercer Island, Washington

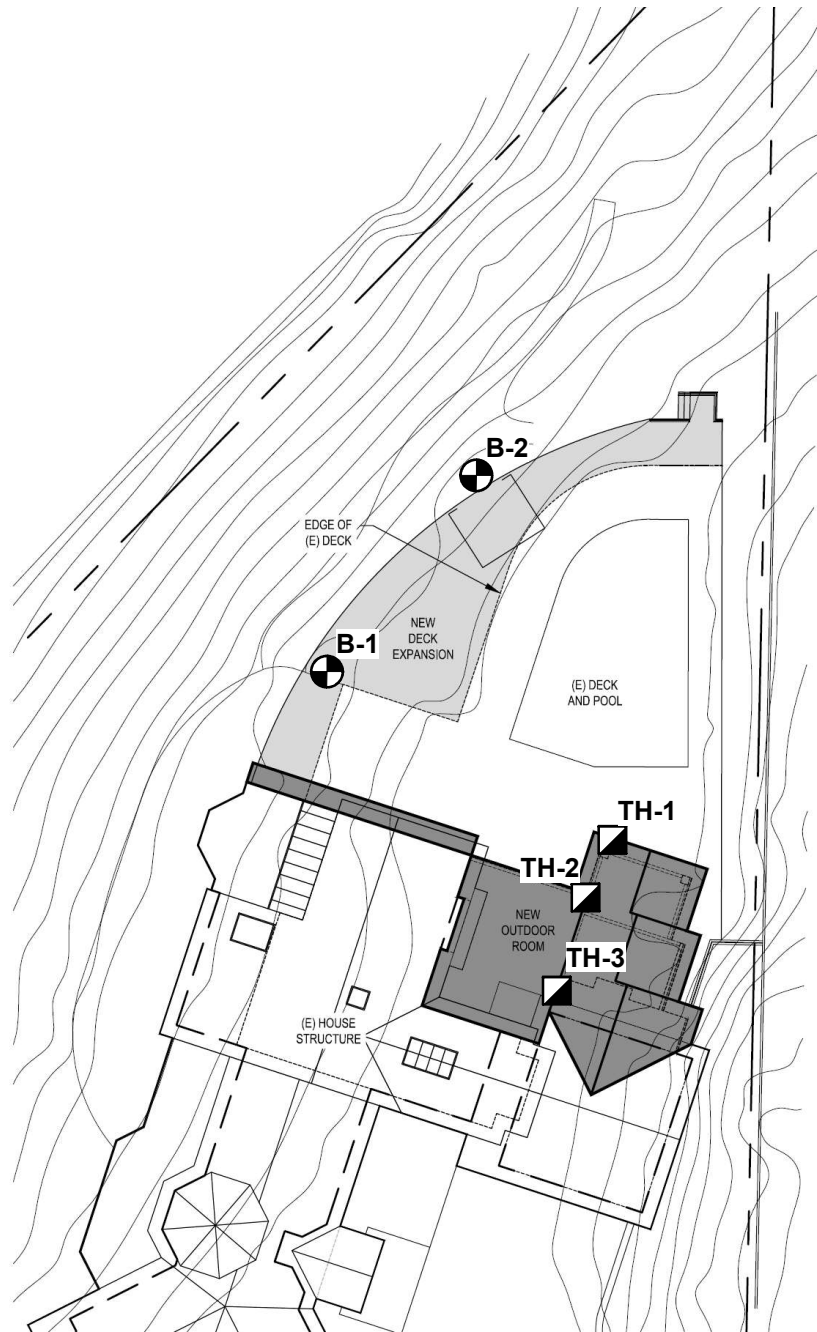
1

\* The City of Mercer Island GIS Tool maps the subject site as a Potential Landslide Hazard Area, Erosion Hazard Area and Seismic Hazard Area. The prescriptive buffers for shallow Potential Landslide Hazard Areas under MICC 19.07 extend beyond the property lines.

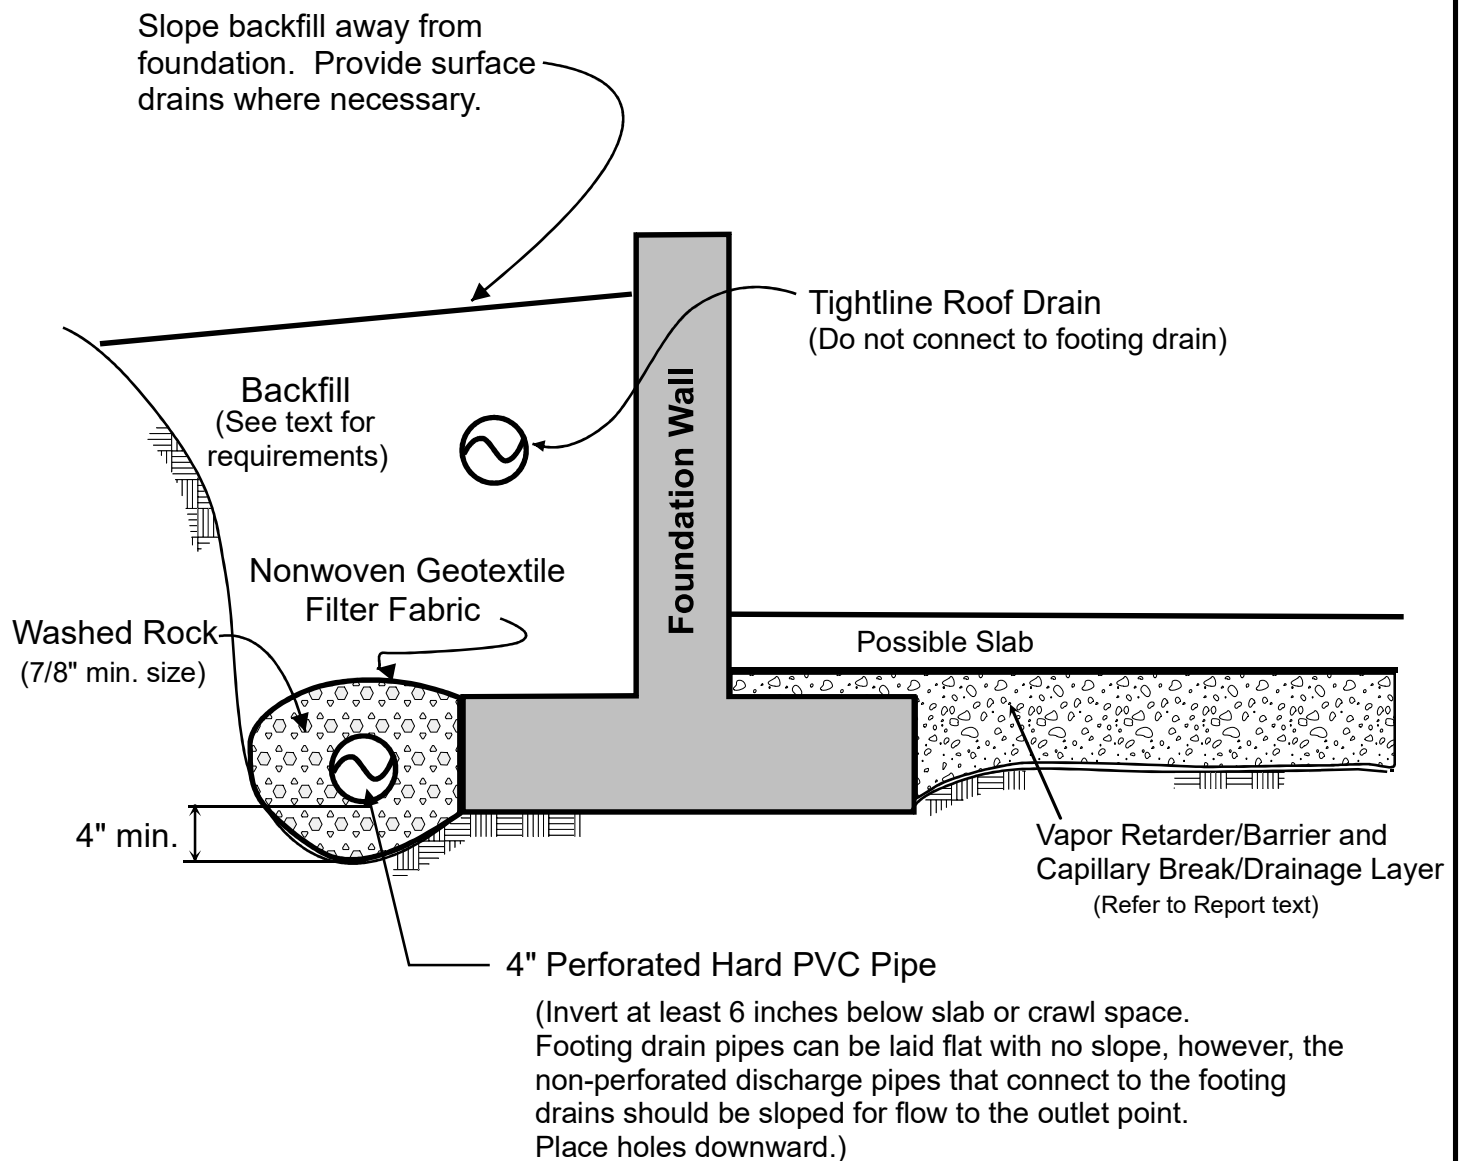
#### NOTES:

- (1) In crawl spaces, provide an outlet drain to prevent buildup of water that bypasses the perimeter footing drains.
- (2) Refer to report text for additional drainage, waterproofing, and slab considerations.
